Firmdale Hotels

**21 – 23 Bedford Place**  
*Basement Impact Assessment*  
*Rev2*

November, 2023

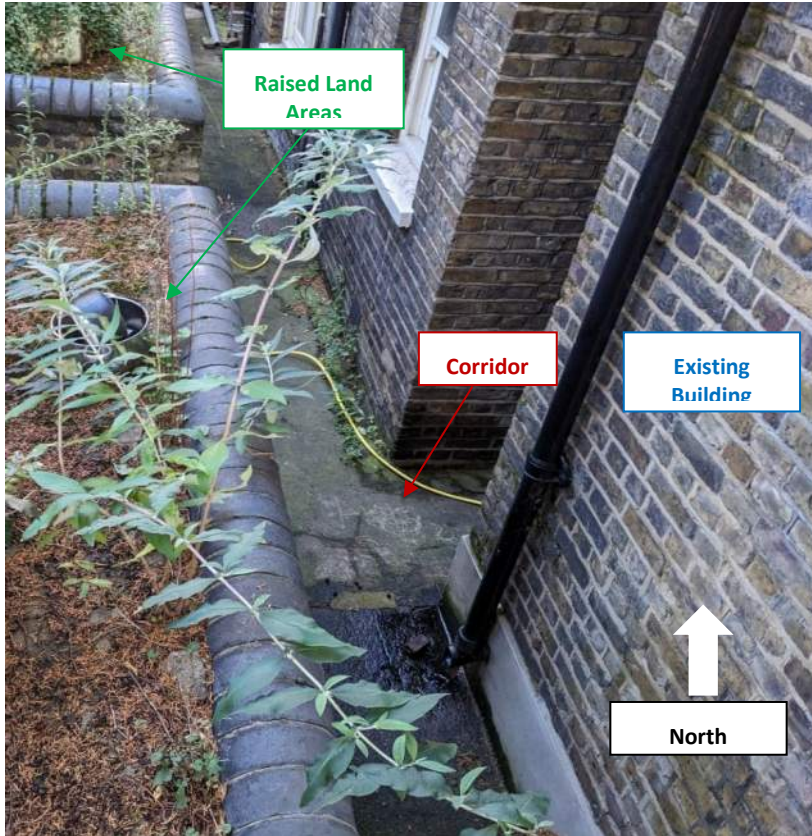
**Plate 2. Rear of the existing building – corridor and raised land areas**

The site is currently occupied by a two to five storey building, inclusive of a single-level basement. As shown in Plate 2 below, at the rear of the existing building, at basement level, there is a relatively narrow corridor (taken as the reference level moving forward) with a direct stepped access up to two raised land areas, which are circa 1.675m above corridor level (+1.675mACL) and are partially concreted over. It is noted that there are several shrubs within the edges of the raised land areas that will likely be removed as part of the proposed works.

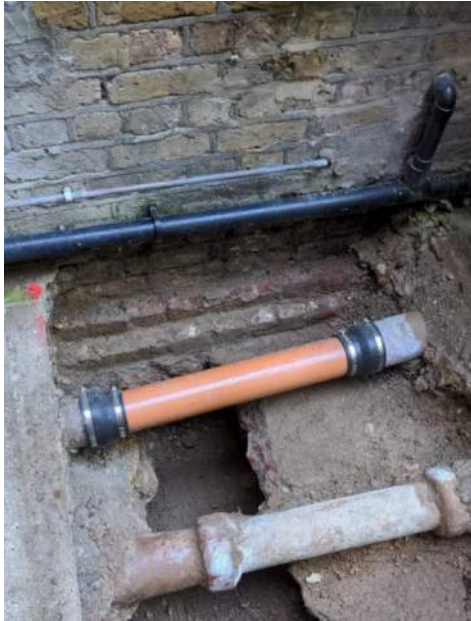
Plate 5. Presence of shallow services at corridor level

In Plate 5, it can be observed that several services/drainage pipes were found at shallow depths, circa 300mm below the existing corridor level.

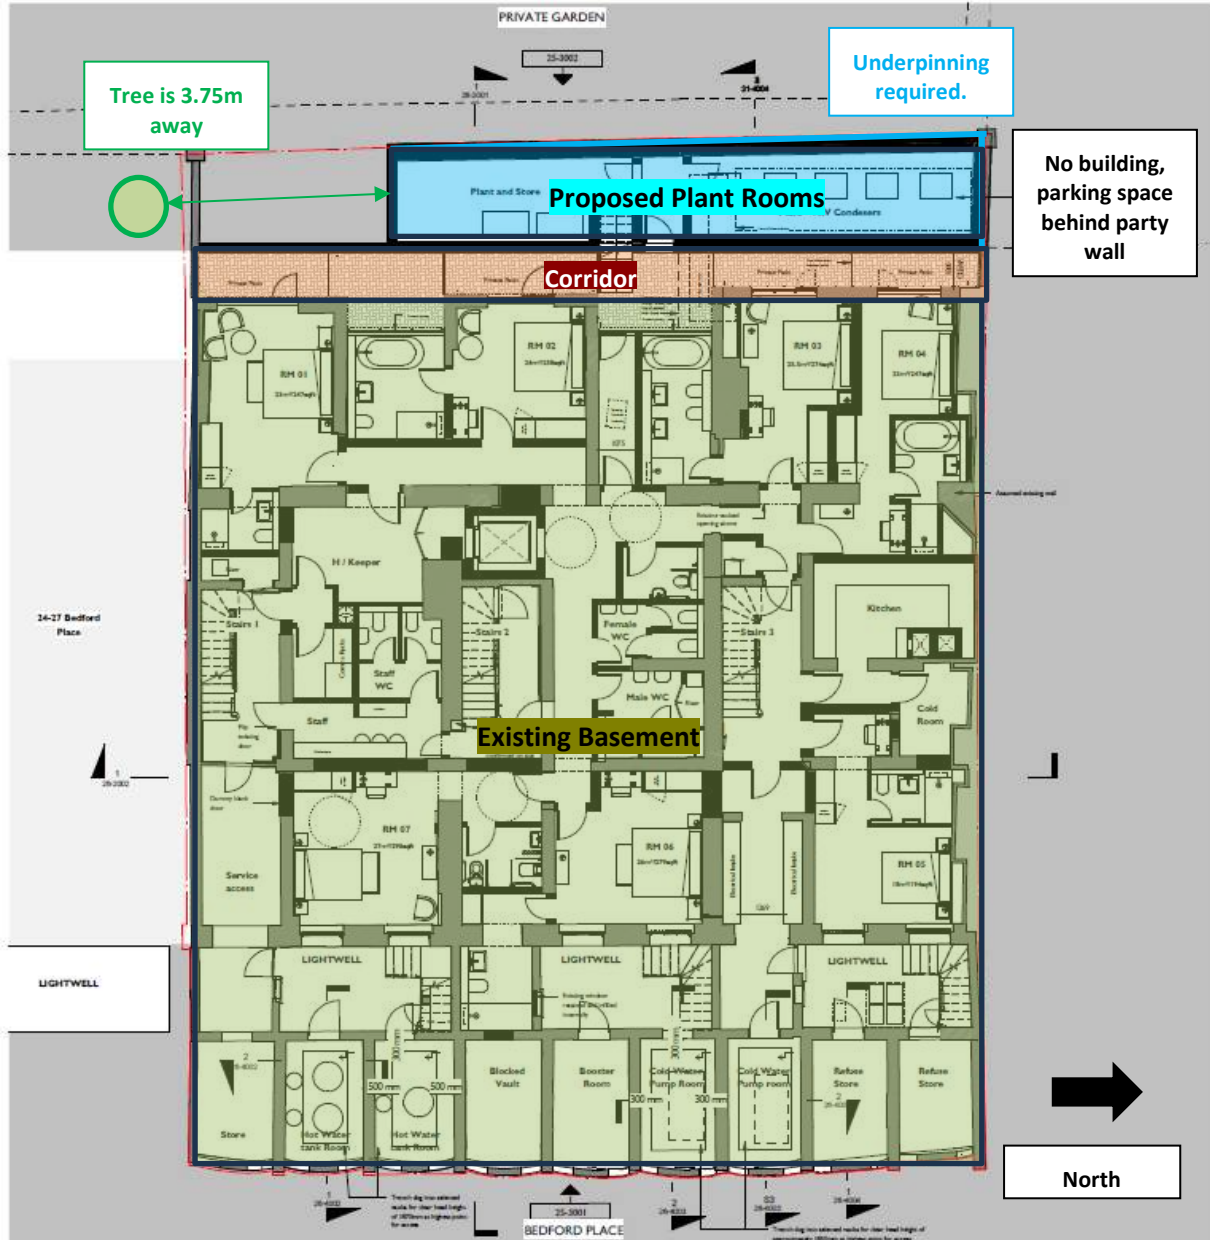
Plate 7. Proposed Plant Rooms - Plan

It is noted that the plant rooms are proposed directly adjacent to the party wall in the north (see Plate 7), which has a parking space directly behind it. Therefore, the proposed works are almost 4m away from the raised terrace at 24 – 27 Bedford Place and the existing tree and even farther away from the existing 24 – 27 Bedford Place building.

It is also noted that a section of the private garden’s boundary wall (see in blue in Plate 7) is to be underpinned to enable the excavation and subsequent construction of the plant rooms. The need for underpinning is further discussed in Section 3.

The portion of the brick boundary wall constructed within the raised land area will be underpinned to enable the construction of the proposed plant rooms (see Plate 7), given that the proposed formation level of the excavation will be below its existing foundation level. However, it is noted that there is no sensitive building/infrastructure directly behind this portion of the boundary wall (parking space and private garden) and thus, the impact of the proposed works is not considered to be critical provided that any underpinning and/or temporary works will be completed with high-level workmanship and following standard good practices and recommendations by a competent and experienced contractor;

The formation level of the proposed excavation will be below the foundation of part of the boundary wall; therefore, along this section, underpinning works will be required (see in blue in Plate 7).

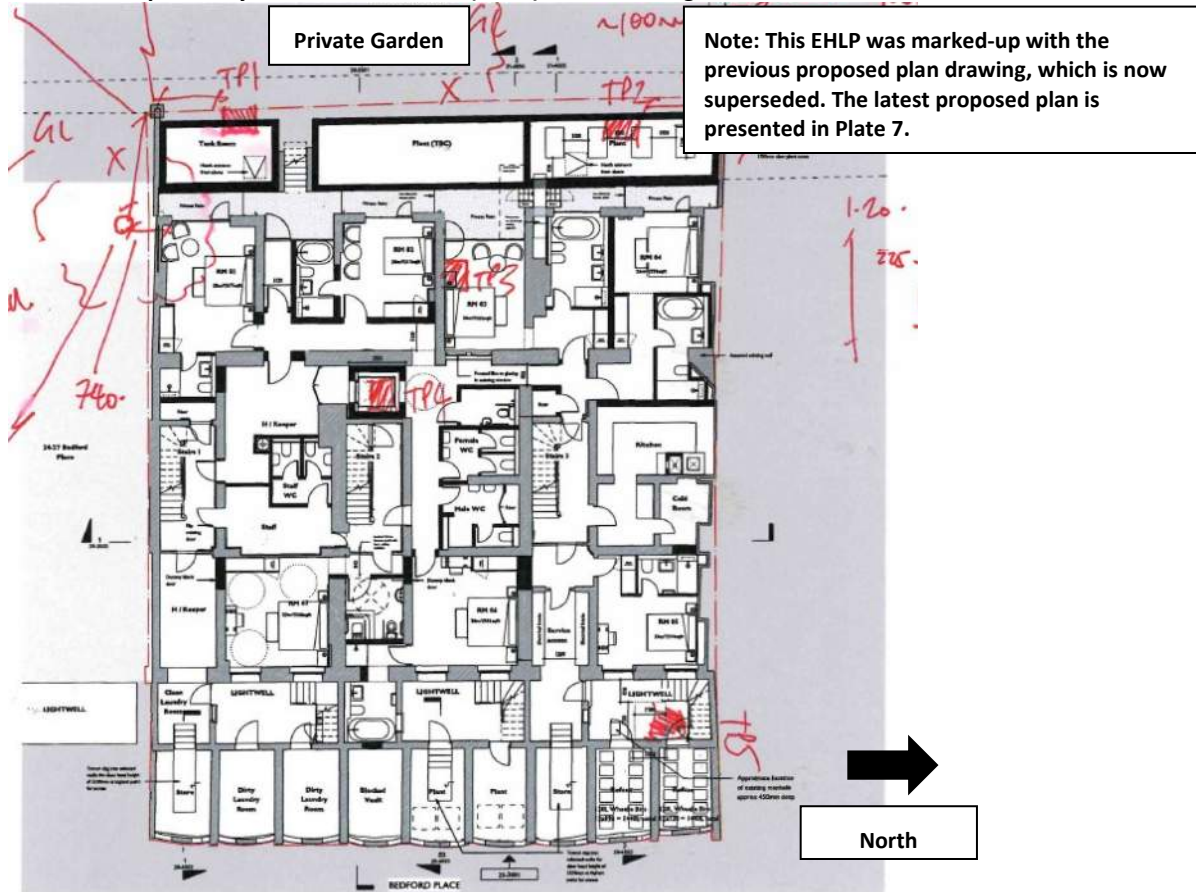
**Plate 14. Exploratory Hole Location Plan (EHL) – Trial Pitting Phase 1**

TP1 and TP2 are external trial pits excavated within the raised land areas at the rear of the existing building against the existing private garden boundary wall to the west. The underside of the existing private garden boundary wall footing was encountered at depths ranging between 450mm and 820mm (+0.78mACL to +1.15mACL), founded on mostly dry granular slightly clayey Made Ground;

TP3 to TP5 encountered the underside of the existing building's footings at depths ranging between 450mm to 700mm below the existing corridor level (-0.7mACL to -0.45mACL), founded on dry reworked Made Ground (TP3), dry natural gravelly sand (TP4) and/or wet clayey gravels (TP5);

It is CGL's opinion that natural Lynch Hill Gravels were encountered within TP4 at circa 0.6m below the existing basement level. The soils encountered in the rest of the pits were logged as Made Ground/reworked clay/gravels;

Groundwater was not encountered during the excavation of the trial pits, and soils were generally observed to be dry and/or slightly moist, except for in TP5. However, it is CGL’s opinion that the wet soils encountered in TP5 may be as a result of a minor localised leak in an existing drain, rather than the presence of a shallow groundwater body (additional details regarding the potential shallow groundwater body present within the Lynch Hill Gravels is discussed in Section 3.2.4).

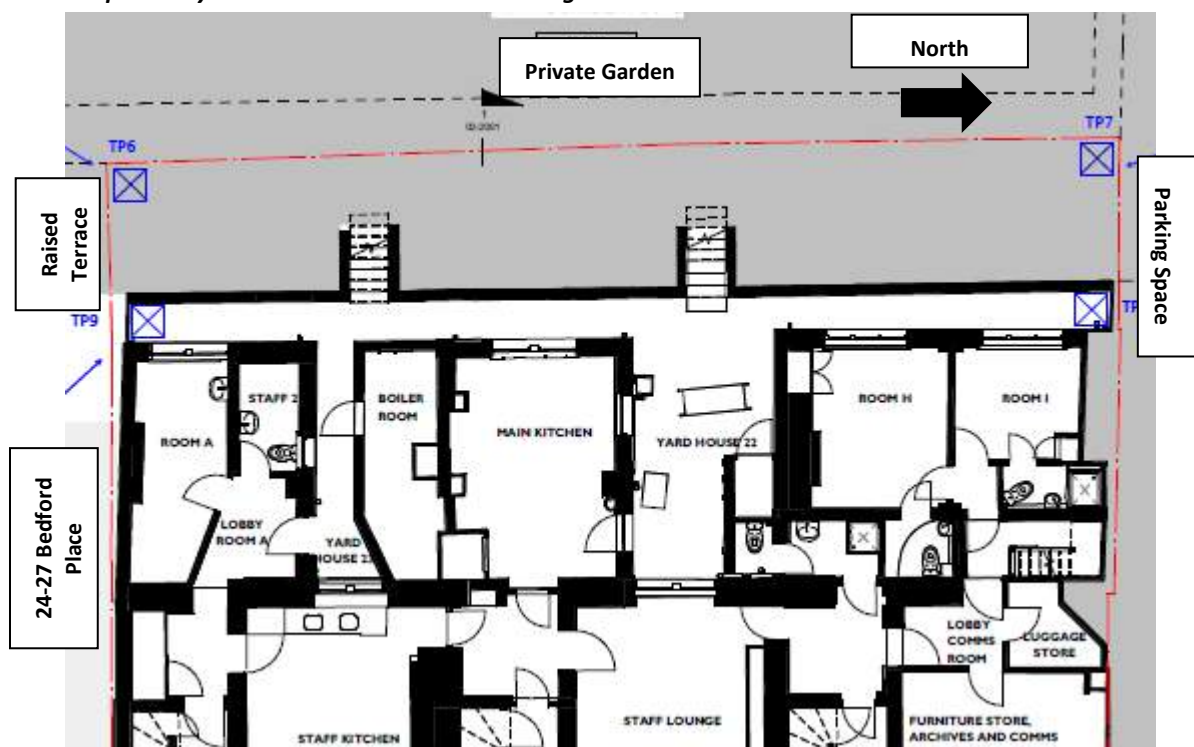
**Plate 15. Exploratory Hole Location Plan – Trial Pitting Phase 2**

No groundwater was encountered in any of the pits and the soils encountered were generally logged as moist reworked clay and/or dry granular Made Ground
-

TP6 and TP7 are external trial pits excavated within the raised land areas against the rear garden wall and both party wall boundary walls, respectively, while TP8 and TP9 are external trial pits excavated within the corridor area against the rear wall of the existing building and both party wall boundaries, respectively.

The depth of the private garden wall ranged between 600mm and 750mm below raised ground level (+0.795mACL and +0.98mACL); while the depth of the existing building’s rear wall ranged between 600mm and 750mm below corridor level (-0.75mACL and -0.60mACL).
-

The depth of the boundary party wall to the south (22 Bedford Place) was found to be 630mm below corridor level (-0.63mACL) and there was no presence/sign of any root system/zone from the neighbouring tree; and,
-

The depth of the boundary party wall to the north (existing parking space) was found to be 560mm below corridor level (-0.56mACL);

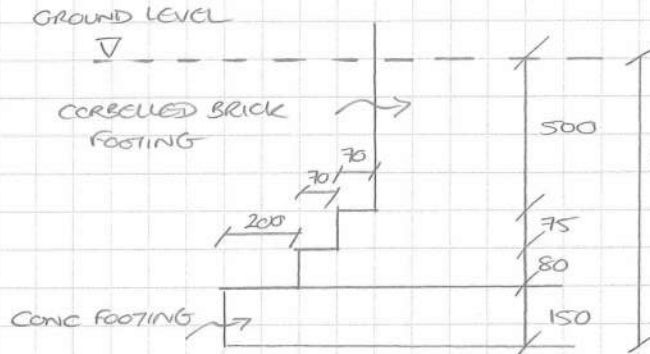
SECTION THROUGH REAR GARDEN WALL

SOIL AT BASE LOOKS  
TO BE DAMP CLAY  
— NO WATER IN  
EXCAVATION
