Landmark Trees

**ARBORICULTURAL IMPACT ASSESSMENT REPORT FOR:**

Land adjacent to 46 Maresfield Gardens  
& 39 Fitzjohn's Avenue  
London  
NW3 5JY

**Ref:** BRF/MRS/AIA/01b

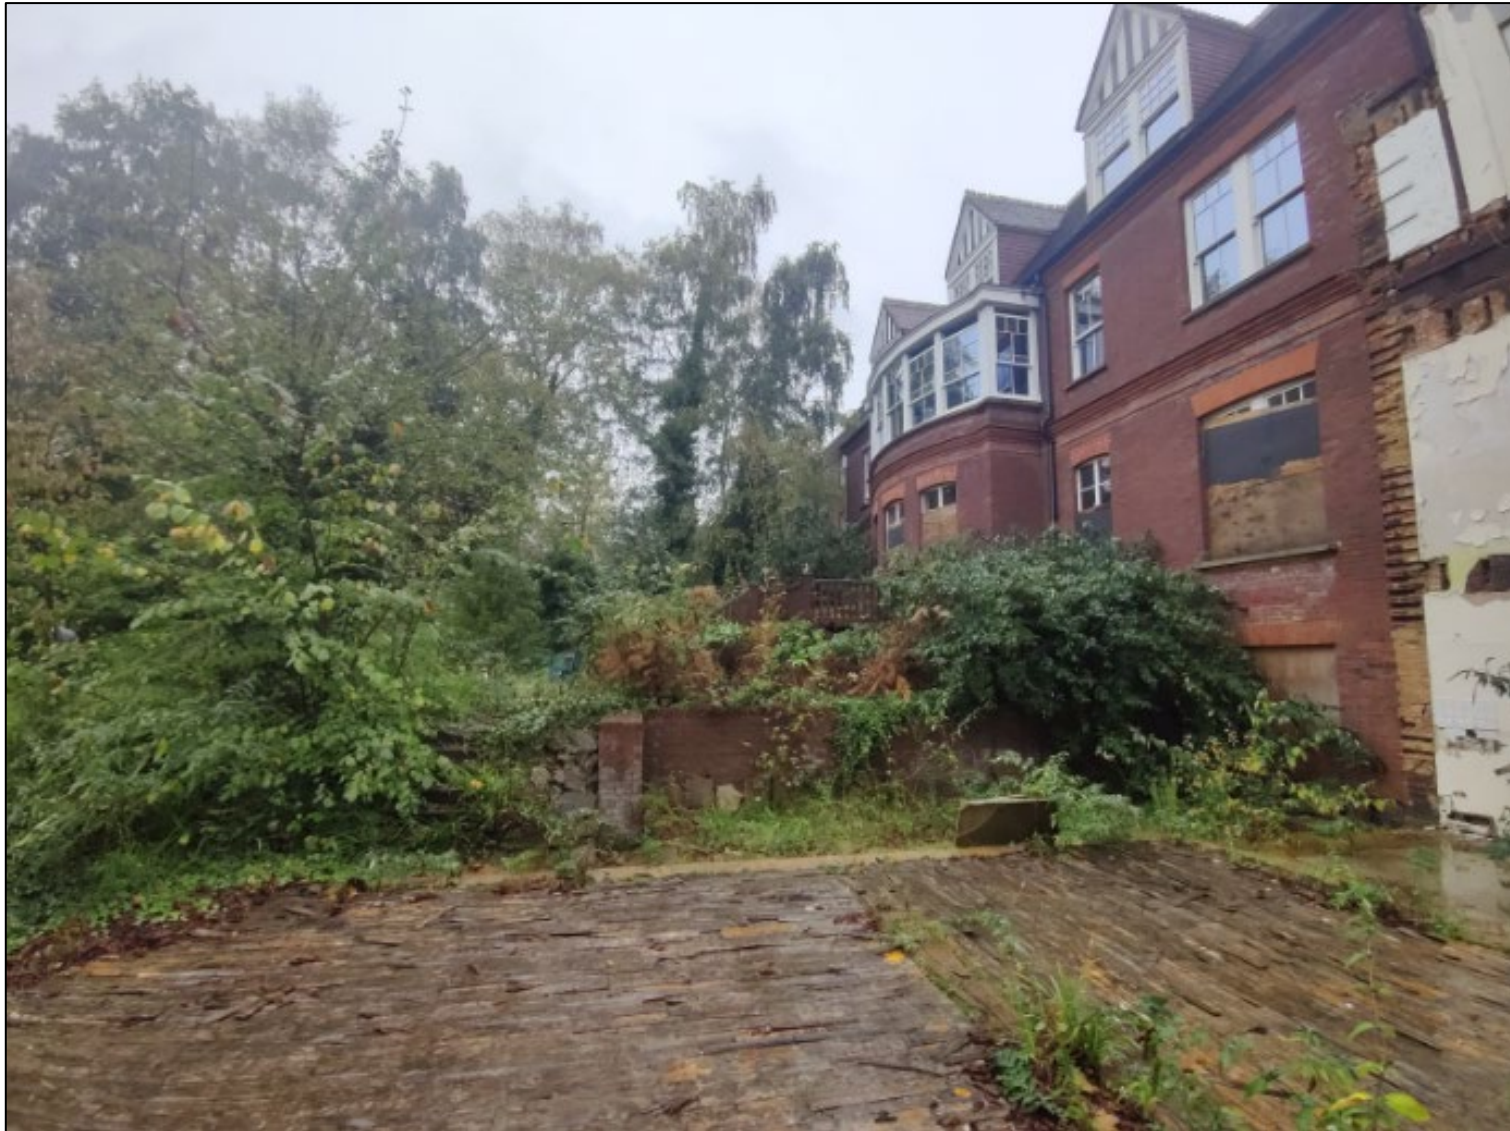
Photograph 2: Rear elevation of 39 Fitzjohn's Avenue with T's 33-37 visible in background

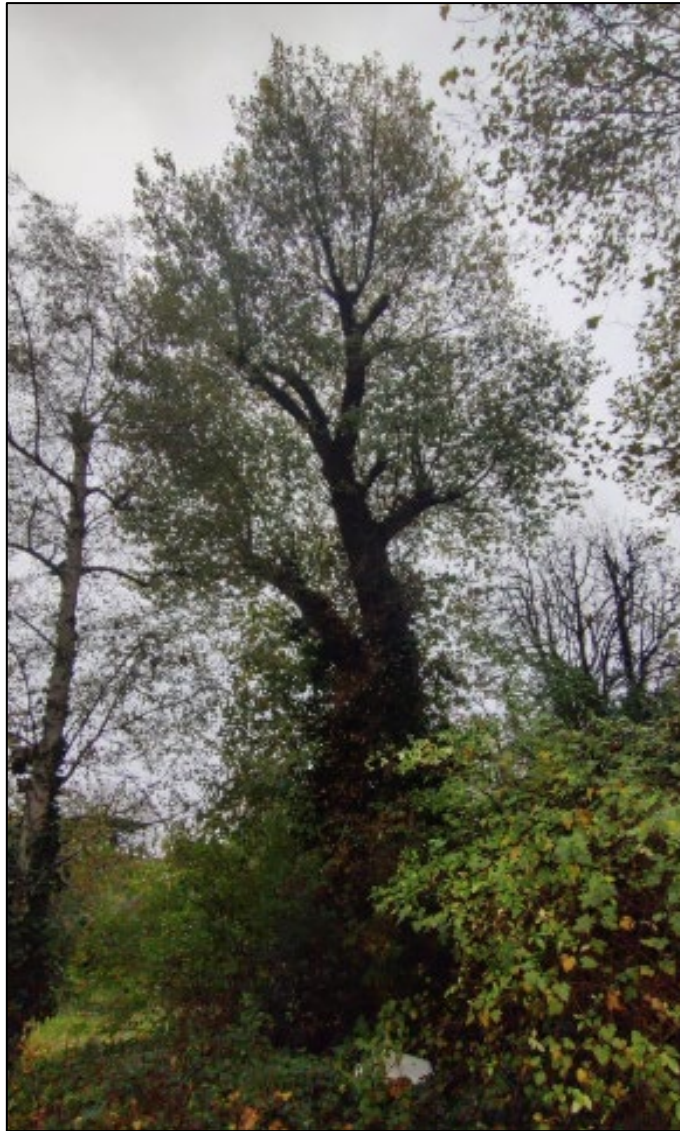
Photograph 3: Hybrid poplar T3

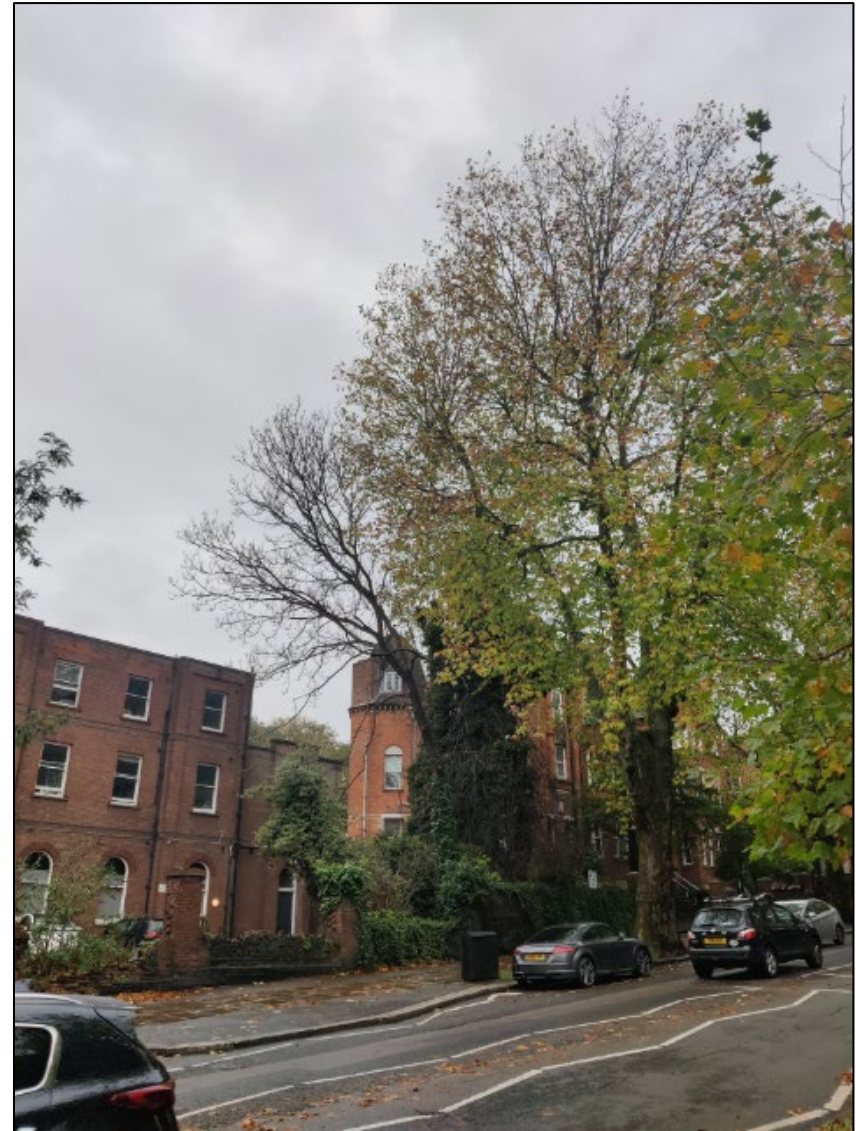
Photograph 4: The high quality T49 with T45 beyond

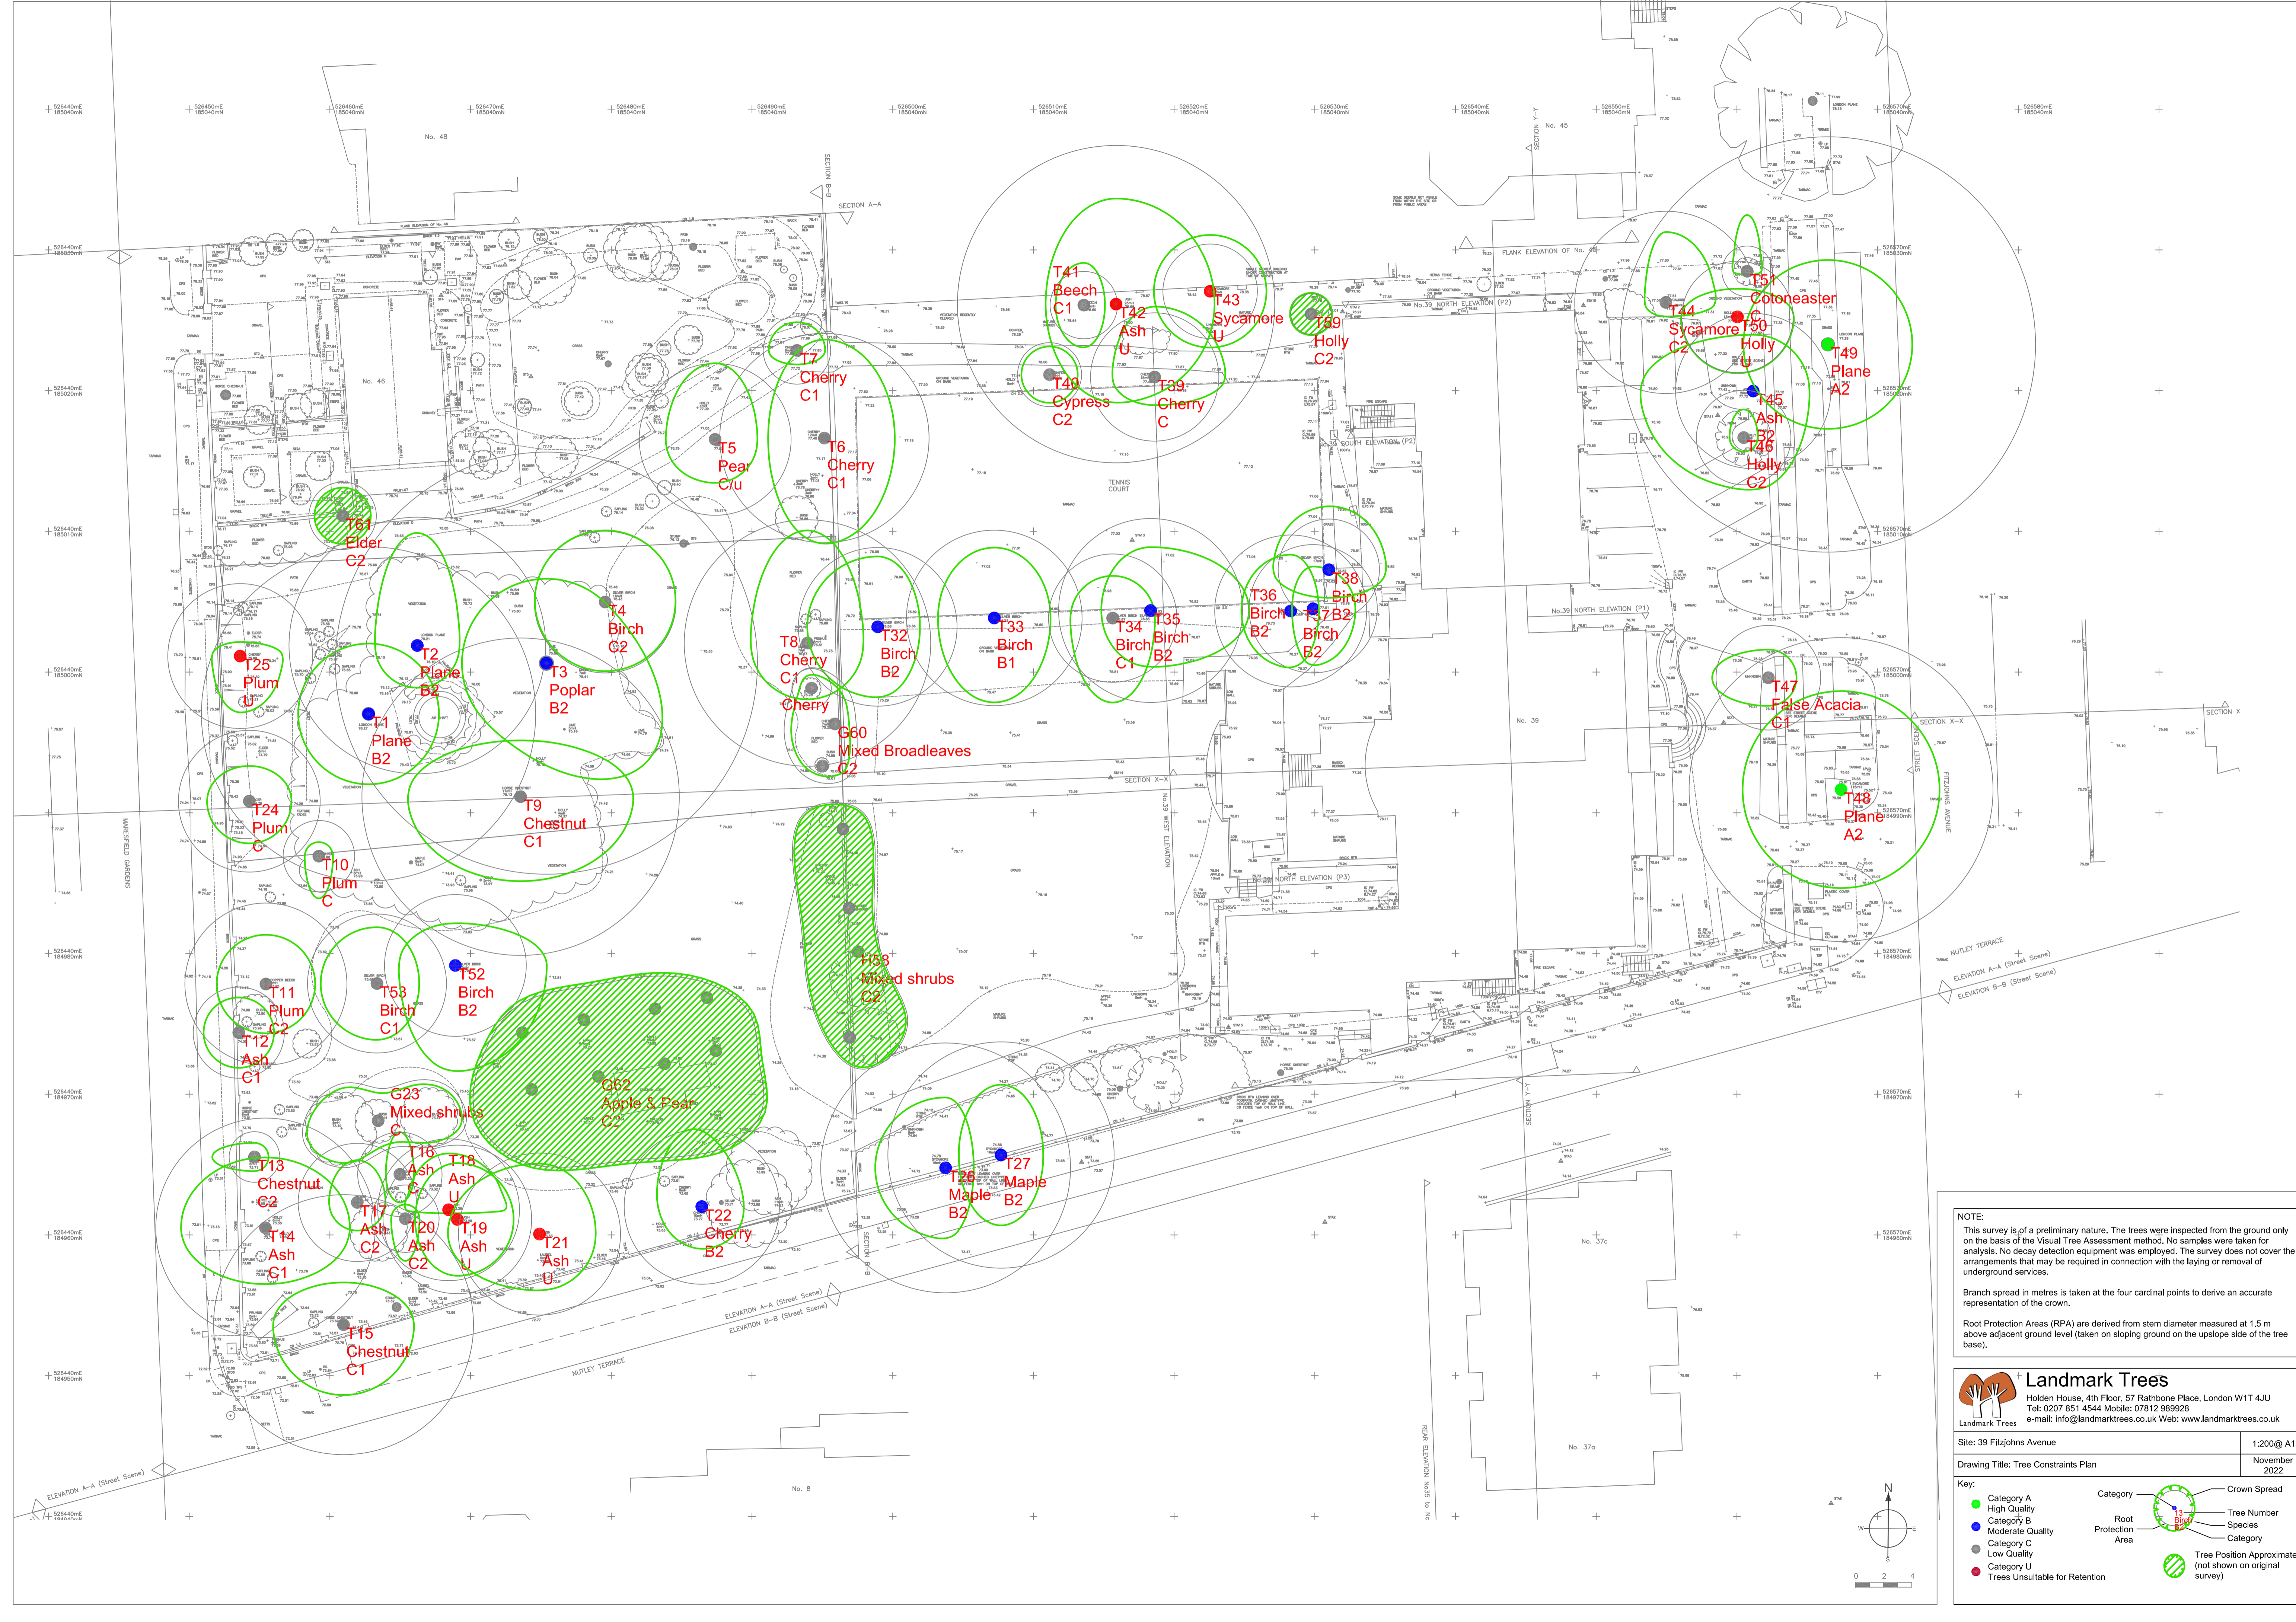
**TREE CONSTRAINTS PLAN**

- 3.3.1 Of the 54 surveyed trees, 2 are category\* A (High Quality), 14 are category B (Moderate Quality), 30 are category C (Low Quality), 1 is category C/U (Low / Poor Quality) and 7 are category U (Poor Quality).
- 3.3.2 The tree species found on the site comprise London plane, hybrid poplar, silver birch, pear, wild cherry, horse chestnut, purple plum, common ash, Indian chestnut, Norway maple, hawthorn, cotoneaster, holly, Lawson cypress, common beech, sycamore, false acacia, apple and elder
- 3.3.3 In terms of age demographics there are predominantly semi-mature, early mature and mature specimens present.
- 3.3.4 Full details of the surveyed trees can be found in Appendix 1 of this report.
- 3.3.5 There are recommended works for 11 trees. These are listed in Appendix 2.

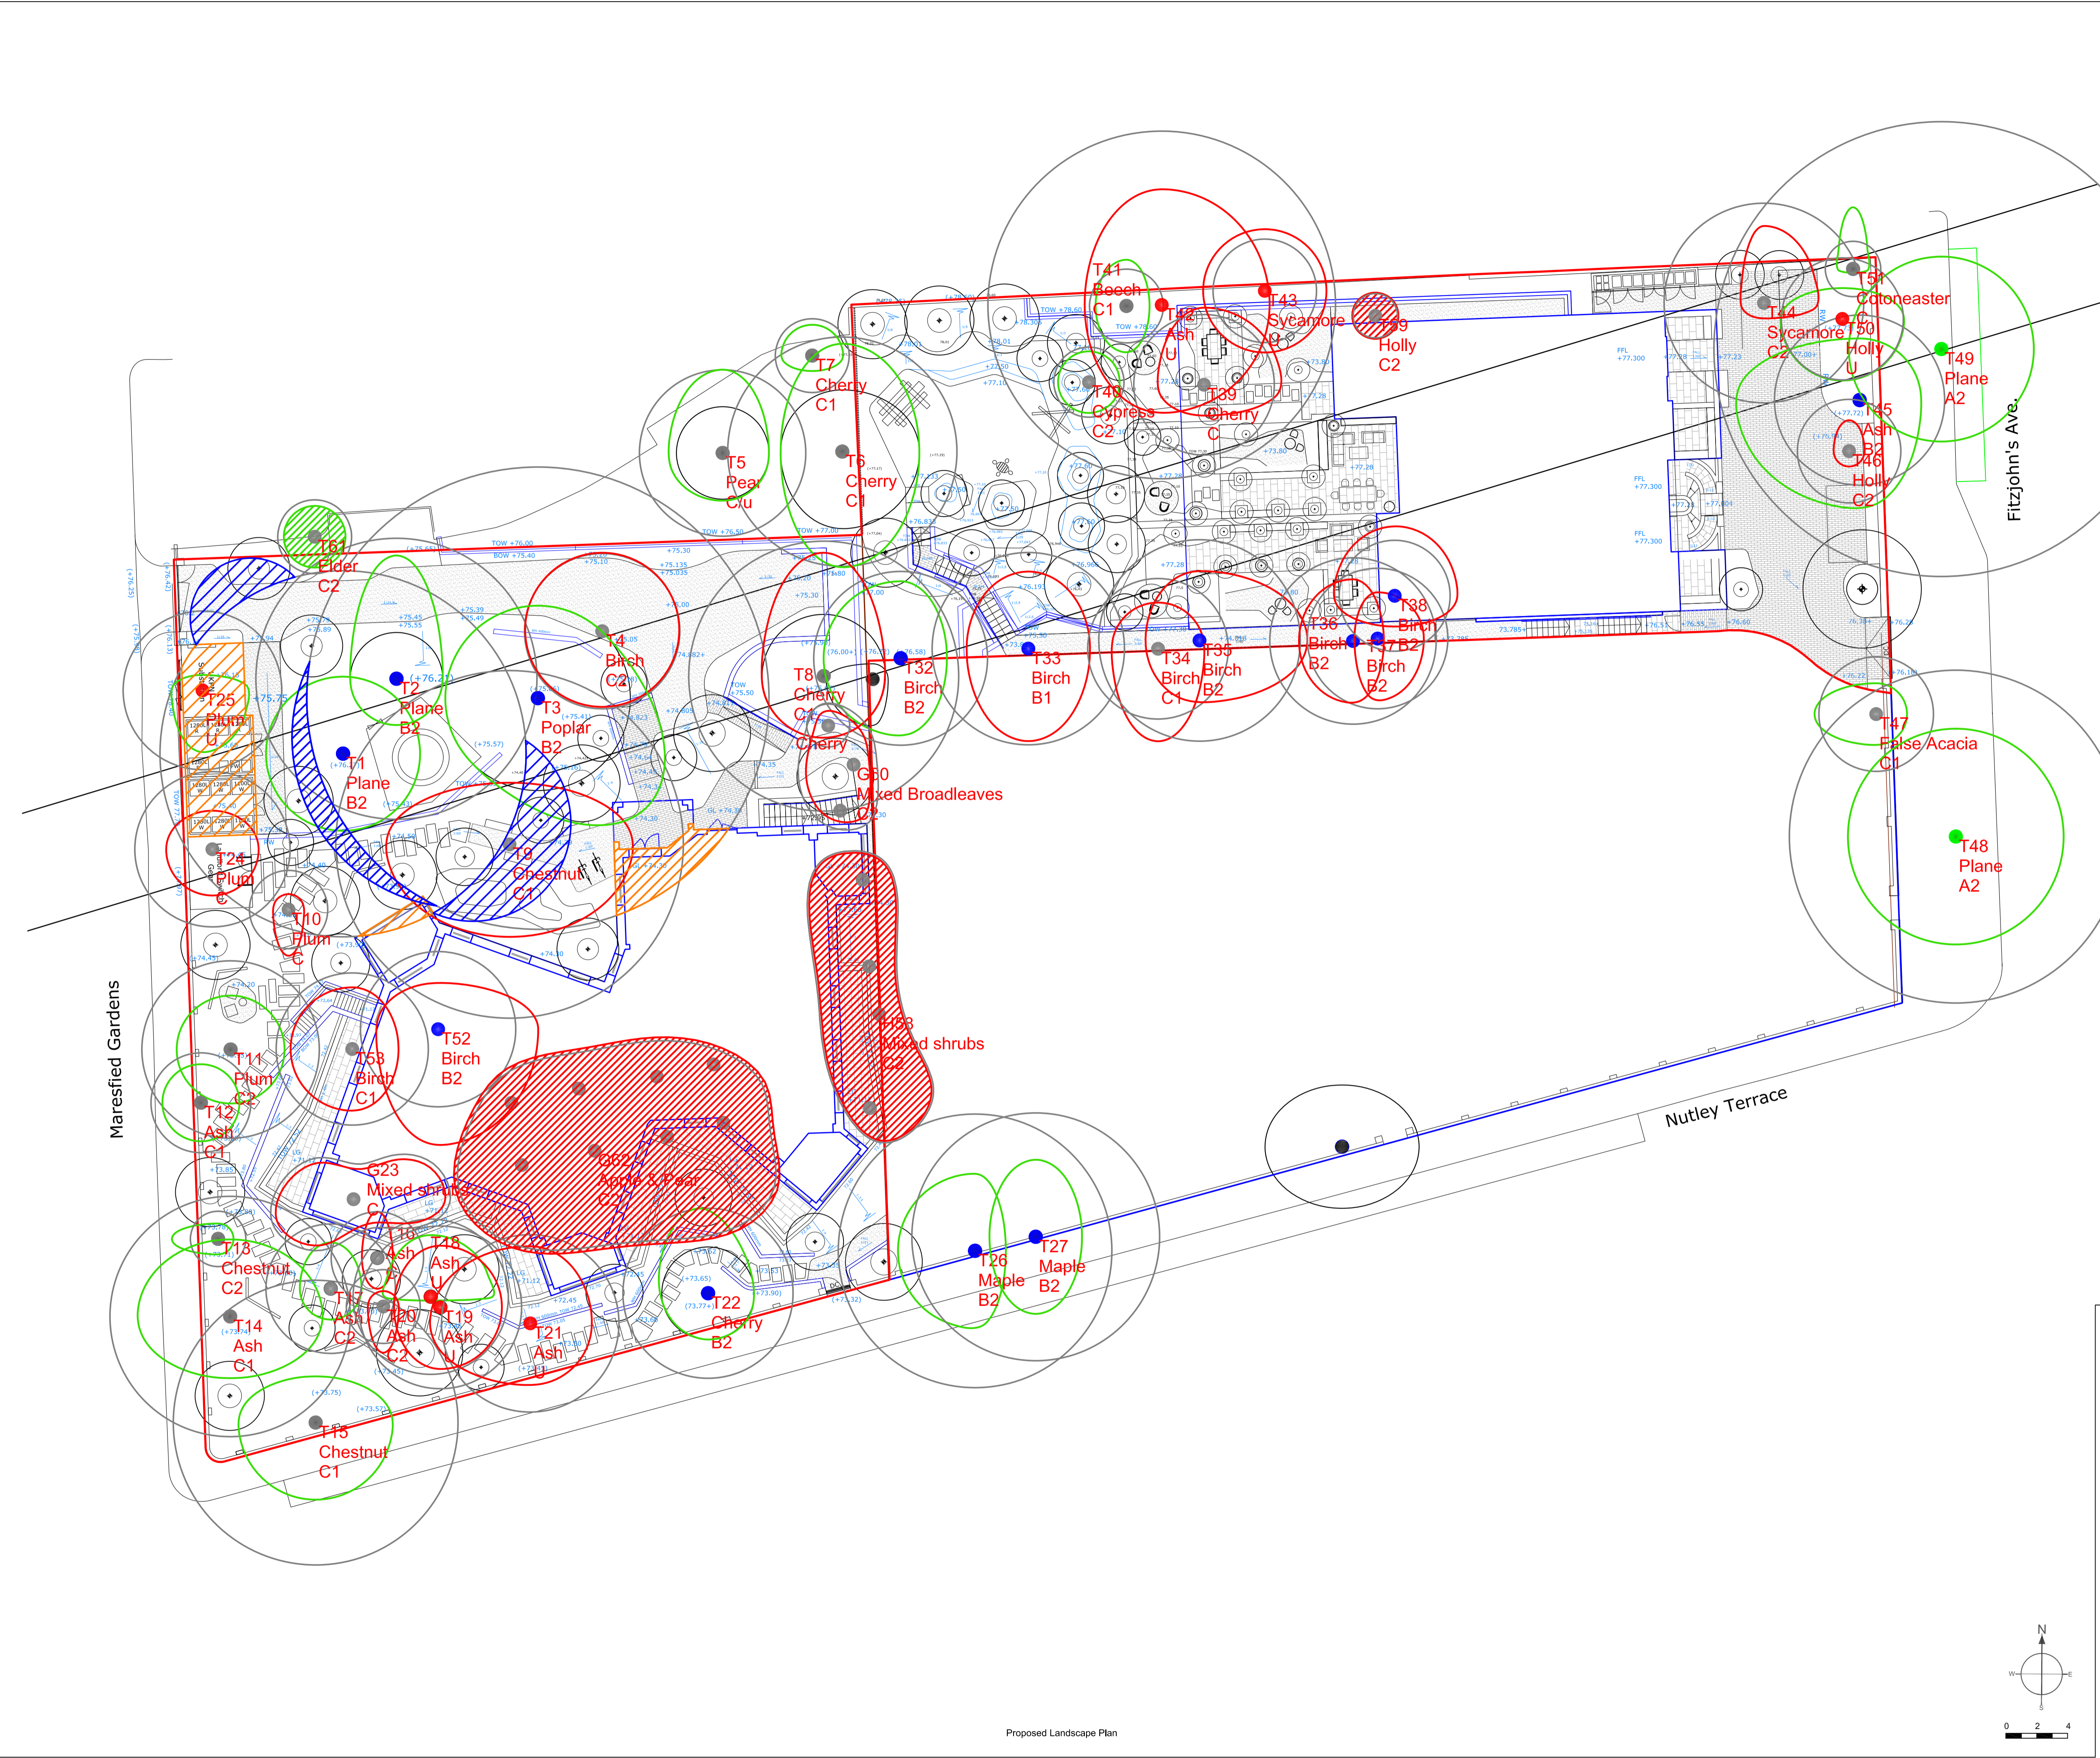
**ARBORICULTURAL IMPACT ASSESSMENT PLAN (S)**

- 6.1.1 The principal impacts in the current proposals are the removal of the 27 trees listed in Table 1. Whilst in purely numerical terms, this is half of the trees present, in terms of canopy cover, it is a significantly smaller portion of the whole. Those removed generally have more collective than individual specimen value, exceptions being T's 33, 35, 36, 37, 38 and 52. Overall though their loss could be mitigated with new planting, bringing its own benefits of enrichment and diversification to a relatively unmanaged and subsisting resource. It will also be noted that the removal of a number of these trees is recommended regardless of development and that the overwhelming majority of tree removals are internal to the site with the wooded envelope remaining. The immediate reduction in canopy cover through felling is therefore rated as a medium impact unlikely to harm either the resource or the wider conservation area over the medium-long term.

- 6.1.6 As per BS5837 recommendations (at 5.3.1a), the above assessment demonstrates that the tree(s) can remain viable and as per the equivalent hatching in Plan 2 of the Appendices that the area(s) lost to encroachment can be compensated for elsewhere. The guide also recommends (at 5.3.1b) the arboriculturalist propose a series of mitigation measures (to improve the soil environment that is used by the tree for growth). These are provided at 6.3 below.

- 6.3.3 The path of the mansion block foundations through RPAs will be manually excavated to 750mm depth under arboricultural supervision; any roots encountered within the trenches / pits will be cleanly pruned back to an appropriate junction with a sharp pruning saw or secateurs back to a junction. Roots larger than 25mm diameter may only be cut in consultation with an arboriculturalist and the prior approval of the Local Authority.

- 6.3.4 The bin store, substation, switch gear building and garden wall encroachments will require the use of specialised foundation techniques, such as mini-piling or pad and raised beam. The foundation pits within the RPA should be trial-excavated by hand using a double-headed spade ("shove-holer") or similar to minimise breadth of hole required for inspection.

- 6.3.7 The replacement paving/hard landscaping at the front of the site will require a no-dig construction technique, either using a cellular confinement system with no fines aggregate for the sub-base or simply building upon the existing sub-base without disturbing the ground below. Choice of construction method will initially depend upon root penetration within the existing sub-grade. The key principle is not to excavate in the presence of roots and to provide a porous surface to promote healthy soil water relations for future root growth. A further consideration in the use of a more expensive cellular confinement system or similar, may be the claimed reduction in risk of possible future slab / surface displacement by roots of trees growing in paved areas.
