Date: 11/03/2024

Whilst the concrete repairs undertaken at UCL's IOE differ from those detailed in Historic England's document on the Conservation of Concrete which primarily details the nature of repairs resultant of external damage, cracking, corrosion and water ingress, Overbury have looked to adopt elements from the report that were pertinent for the making good works they have undertaken. Specifically, as relates to the preference for retention of existing fabric and, where not possible, the maintenance of the original appearance by matching the aesthetics of original, exposed concrete.

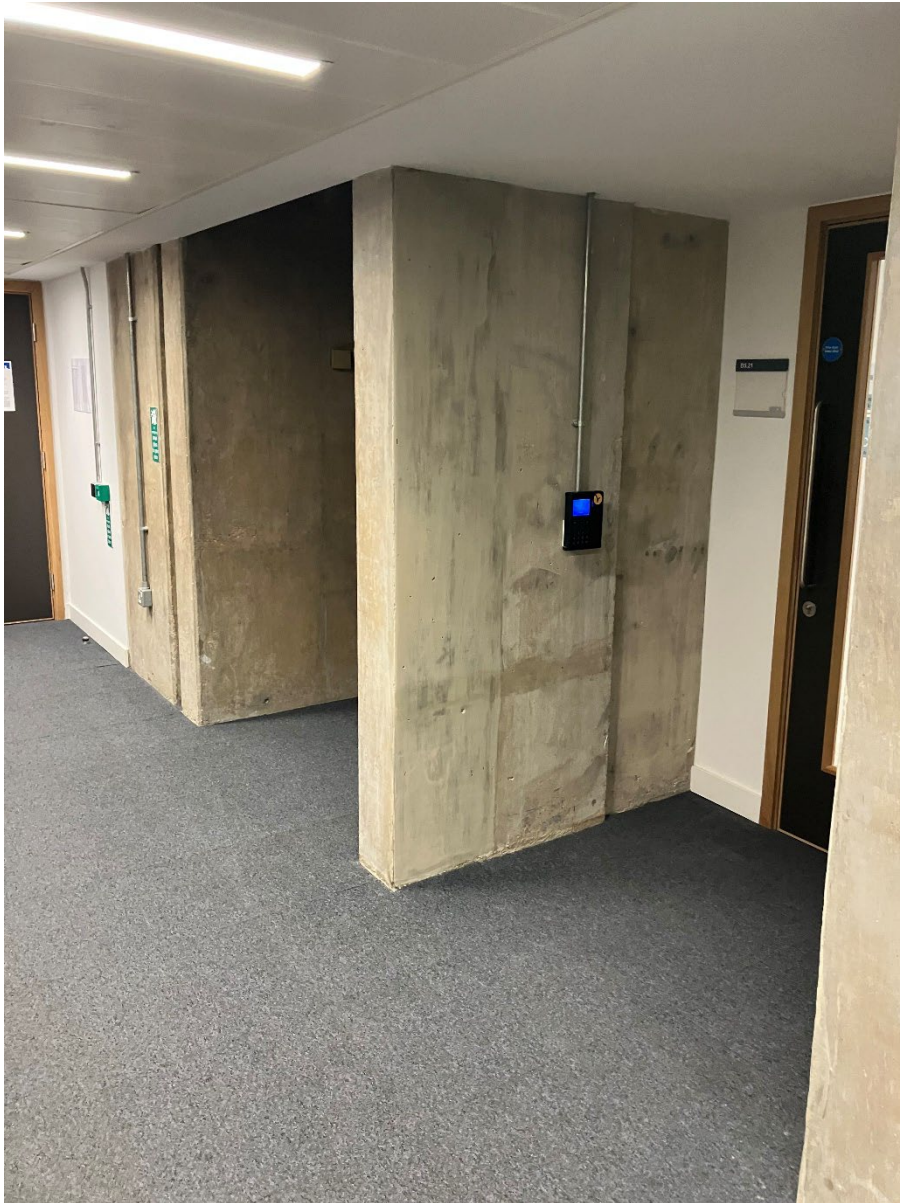
Face 1:

See below pictures of the completed concrete repair on both faces of the formed structural opening.

The product selected for this was Fosroc Renderoc HB40 as the application was suitable to make good both vertical and horizontal surfaces at the depths required, for the specific criteria, to provide a best match to existing concrete in appearance, colour and look whilst also providing a robust, long-term solution. Please refer to the Renderoc HB40 data sheet for details.

Further to the application of the Fosroc Renderoc HB40, Overbury will apply an additional coat of Fosroc FCR which will achieve a smooth surface finish that matches that of the original concrete. Selected with the recommendation of the manufacturer, the product can be applied to a feather edge over both the existing Renderoc previously applied as well as small sections of the existing concrete itself (where this may occur in product application). This will provide a smooth and seamless finish between existing and 'made good' surfaces.

The Fosroc FCR will not visually affect the current 'look' of the Renderoc applied, however to ensure that Overbury achieve a finish that is acceptable to address all concerns from a heritage perspective, Following various trials the whole concrete repair area has been completed.
