Objection to retrospective planning application for replacement of the front hardstanding to 251 Goldhurst Terrace.

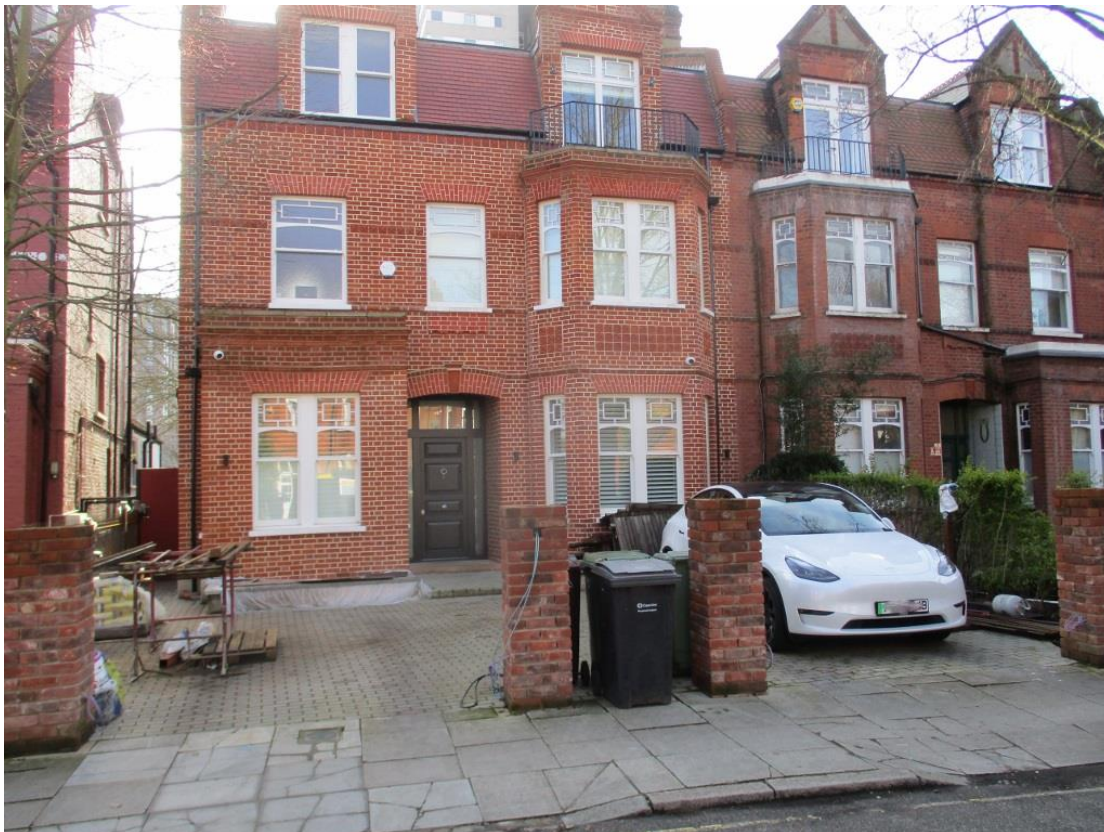
Above: The new hardstanding in the 'front garden' appears to allow for no planting or soft-landscaping around its perimeter, unlike the hardstanding that it has replaced (see picture below). It is also not clear how/where the new hardstanding drains to (no evidence of a soakaway drain?), and there appears to be no differentiated central 'path' to the front door.

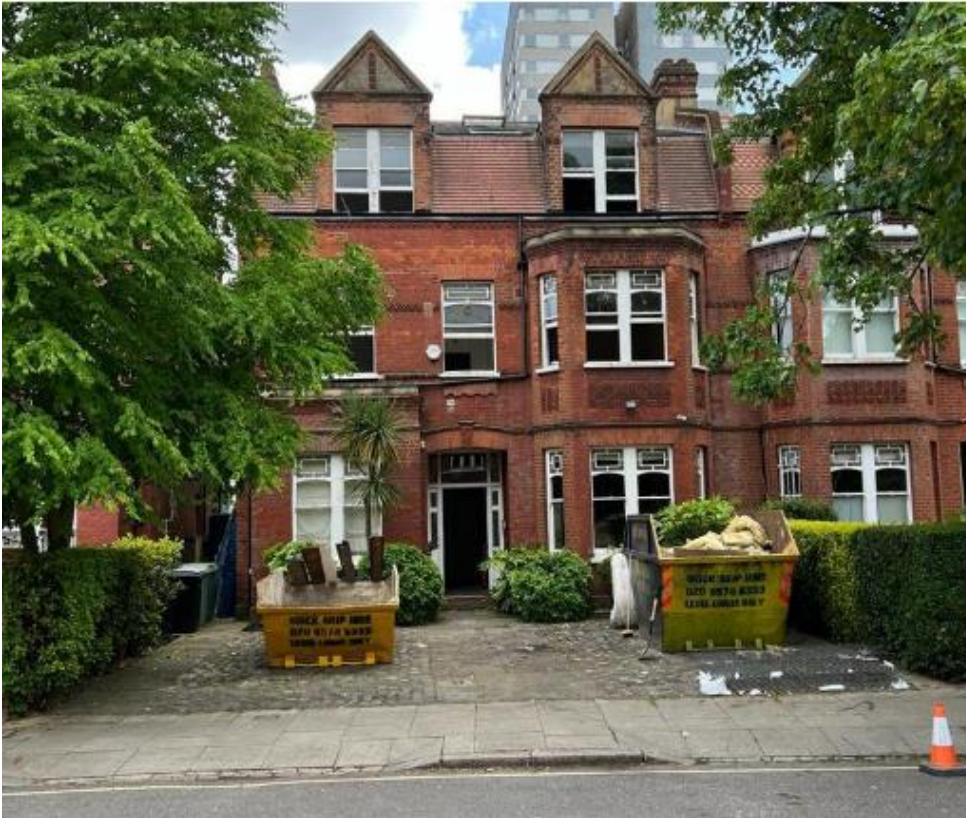
Above: The previous hardstanding allowed a generous margin on three sides for hedges (on either side) and large, attractive shrubs (in beds in front of the two bay windows near the house).

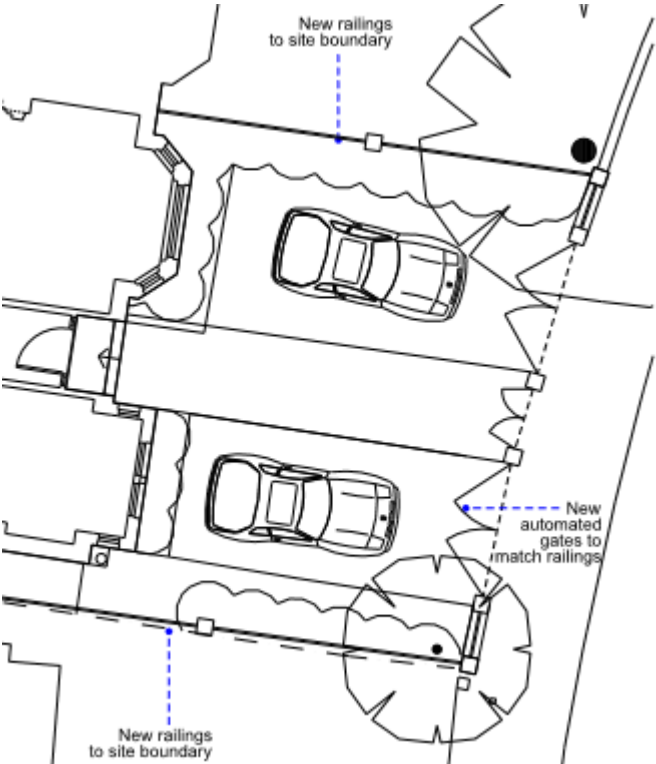
Above: An extract from application 2019/4236/P (for the installation of the front railings, gates and brick piers to the front) showing the then-existing (and proposed to be retained for that application) soft landscaping and generous/wide vegetation along each side boundary of the hardstanding area and in front of both the bay window structures. (Note: although this application substantially post-dates the earlier 2016 application for a large basement excavation including two large front lightwells, it does not appear to show the lightwells that were a part of the earlier application).

None of this soft-landscaping/vegetation is now present, but all is shown in the 'Photo 1' on page 10 within the 'Heritage Report' –apparently taken a few years ago and representing the 'before' situation. The

Why has all the soft-landscaping and substantially-sized greenery been removed and with no stated intention to re-instate the hedges or the large shrubs in front of the bay structures? Note, the above diagram also shows some sort of 'path' between pavement and the front door, that is suitably differentiated in its surface treatment from the block/brick paving used for the hardstandings on either side. This was indeed a feature of the previous hardstanding, now removed, but seemingly this feature has not been replicated in the new version?

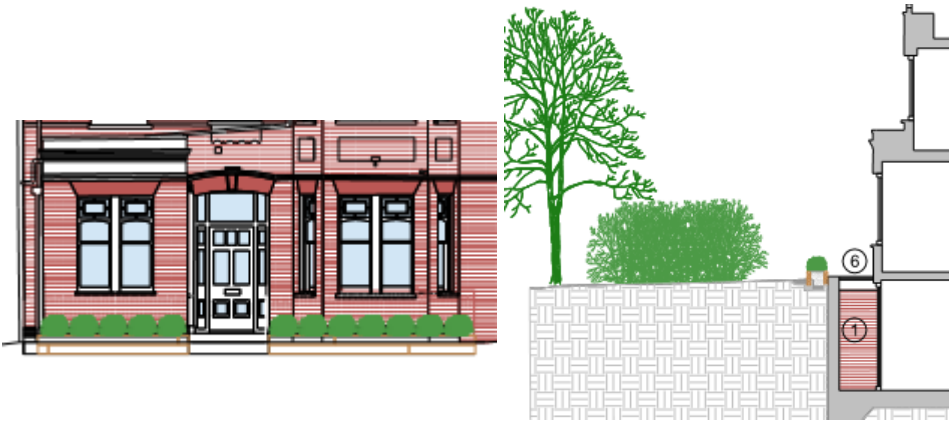
Above: The two extracts above are from plans/elevations provided with application 2016/6697/P (excavation of large basement with two front lightwells) and clearly show the intended re-planting of some small shrubs to the front of the house adjacent to the edge of the lightwell. This has not yet been done, and the paved area of the new hardstanding has encroached into the proposed planting area, and needs to be trimmed back by around 50—60cm from the lightwells in order to allow for this shrub planting.

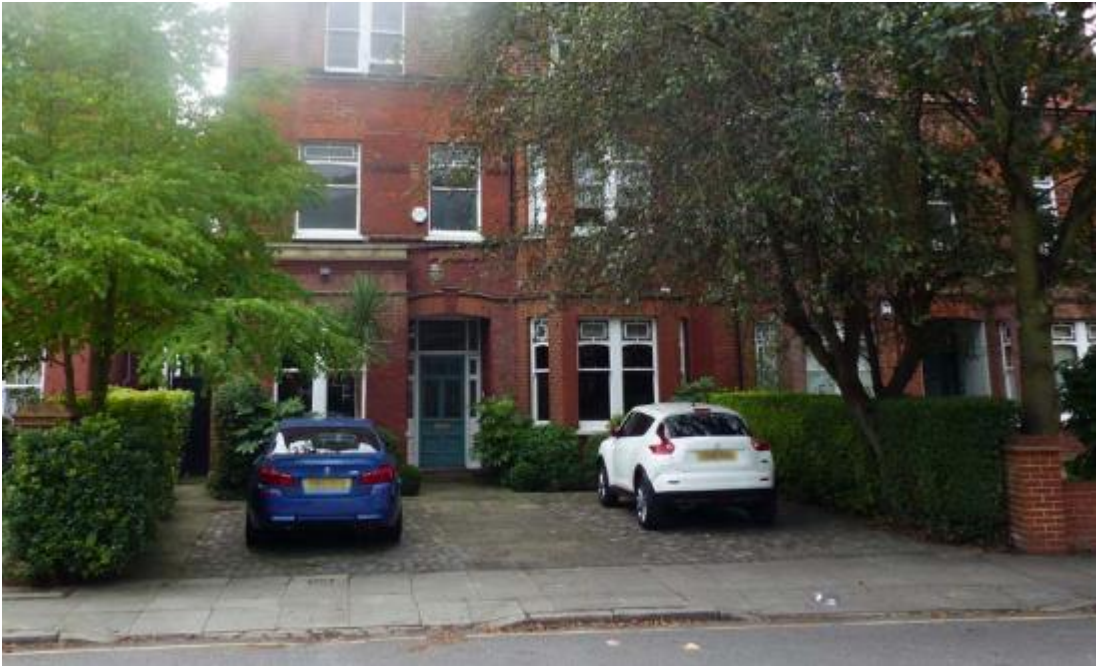
Above: View of front garden in 2016 showing the former extensive hedges on both left and right-hand boundaries of the former hardstanding, as well as extensive tall shrubs and even a small palm-like tree in front of the left and right-hand bay window structures. None of this vegetation and soft-landscaping is present now (all was presumably removed when the basement was excavated) and should be required to

be re-instated so as to improve the visual amenity of the 'front garden' and comply with the key SHCA characteristics in the CA Appraisal document, and improve absorption of heavy rainwater run-off.

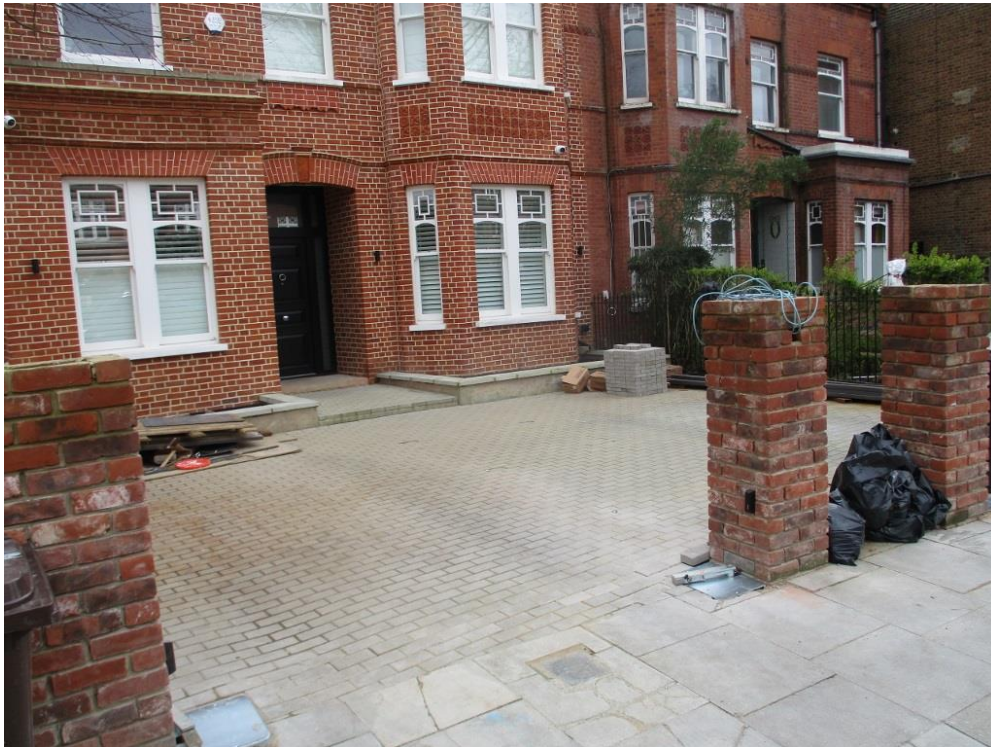
The three pictures above (taken in early March 2024) show the current replacement hardstanding in the 'front garden'.

The top picture shows no differentiation in surface treatment between the two parking spaces and the central path to the front door. This differentiation is clearly visible in the previous version of the hardstanding- please see the earlier pictures of the old hardstanding where cobbles define the parking spaces and larger block paving stones define the path. It also shows that no space has been left for soft-landscaping/re-planting adjacent to the two lightwells. This needs to be created by removal of a band of some 50-60cm of paving around the lightwells with re-planting to follow.

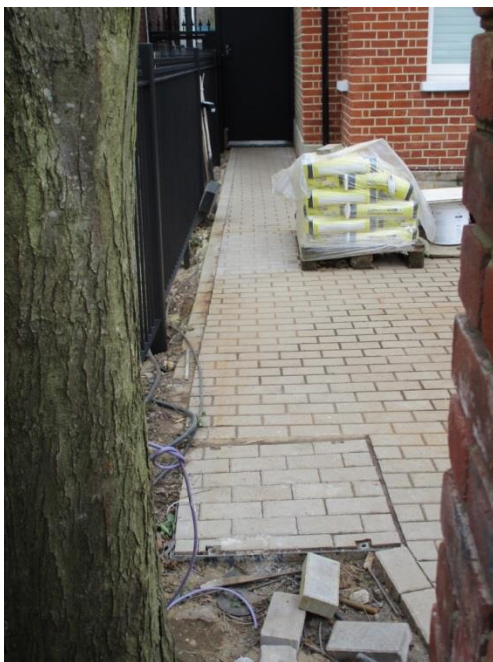
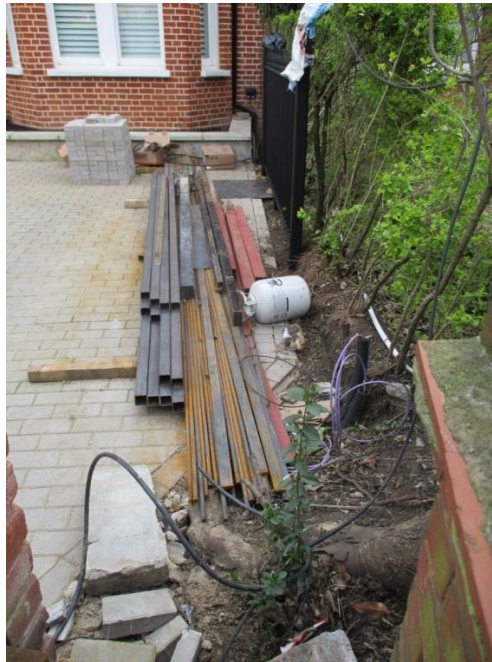
The bottom left picture shows the left-hand boundary with the new paving bricks/blocks coming right up to the fence on the boundary, with no room for a replacement hedge to be successfully planted. The bottom right picture shows the same lack of space for successful planting of a hedge on the right-hand-side boundary. Soft-landscaping space on both sides needs to be created by removal of a band of some 50-60cm of paving blocks on each side, with hedge re-planting to follow.
