Landmark Trees

ARBORICULTURAL IMPACT ASSESSMENT REPORT FOR:

61 Redington Road
London
NW3 7RP

Ref: HGH/61RDR/AIA/02a

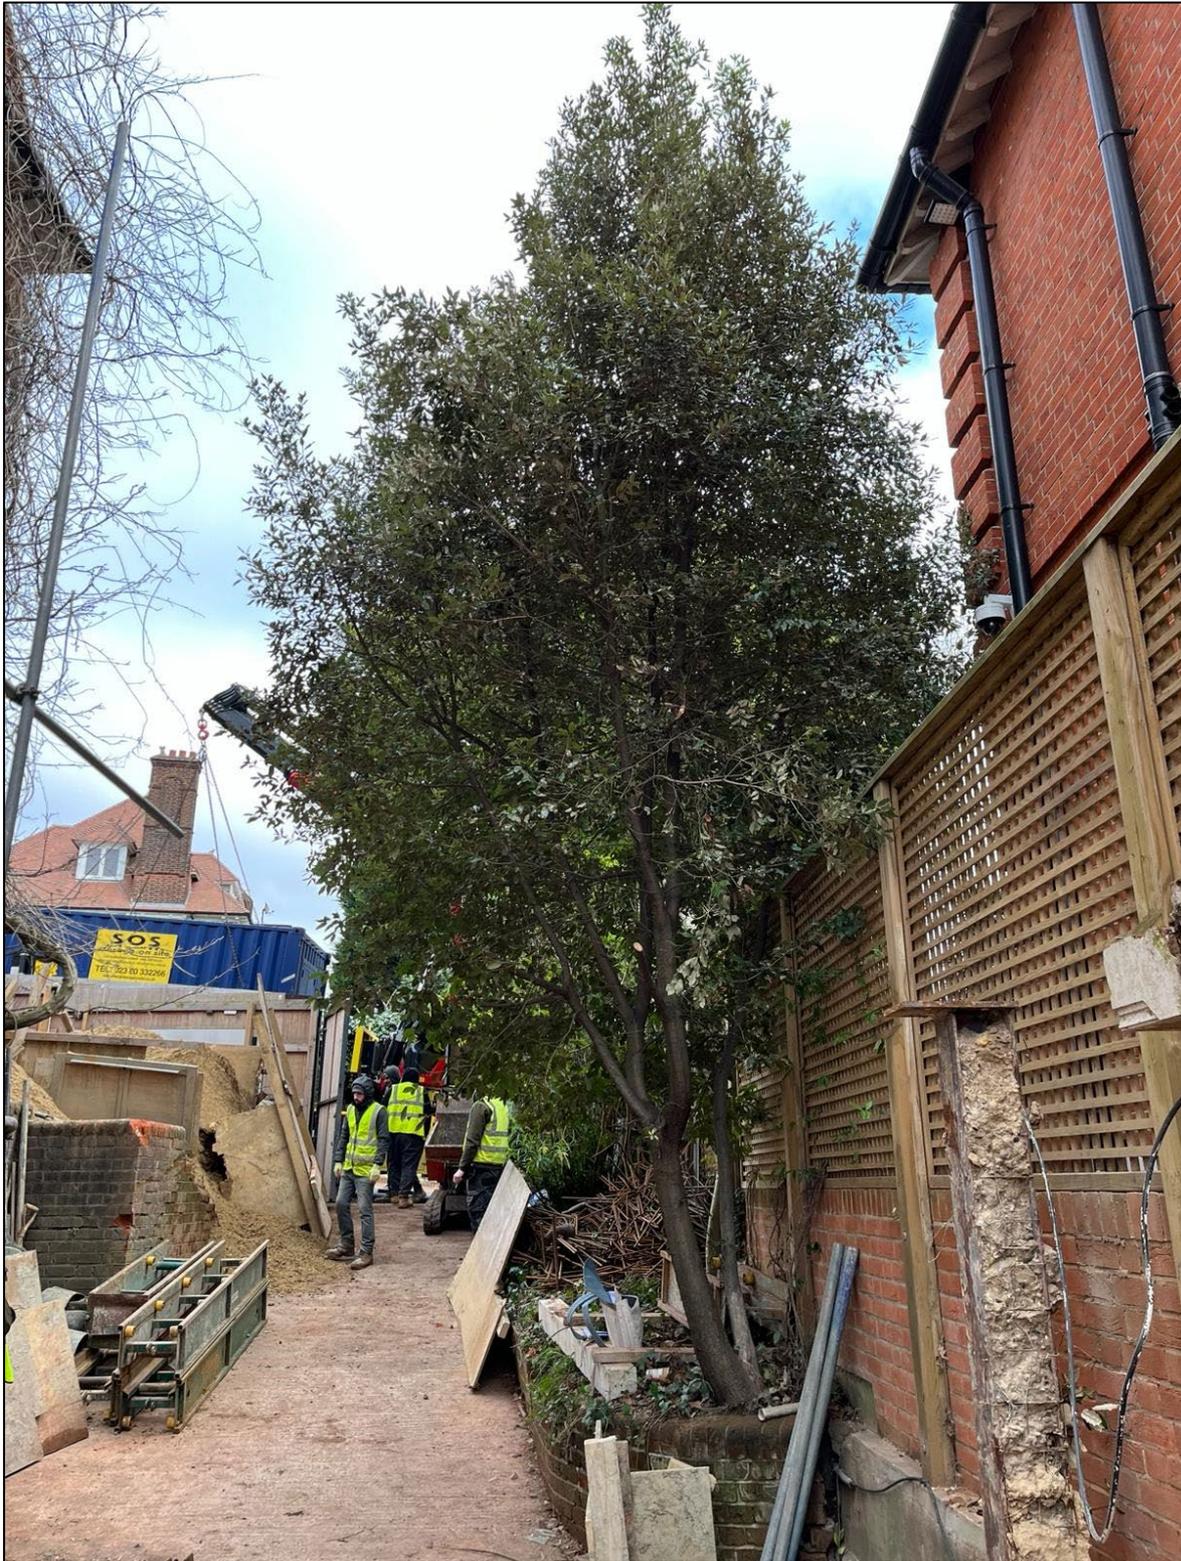
Photograph 2: The low quality Holm oak T10

- 6.1.1 The principal impacts in the current proposals are the removal of the sweet chestnut T2 and Holm oak T10. In terms of resource management, these comprise a very small portion of the canopy cover across the site as a whole. These trees have more collective than individual specimen value such that their loss could be mitigated with new planting / landscaping, bringing its own benefits of enrichment and diversification to a relatively unmanaged and subsisting resource. The immediate reduction in canopy cover through felling is therefore is rated as a low impact unlikely to harm either the resource or the wider conservation area and we note that LB Camden have confirmed the loss of these T2 would be acceptable.

Tree No.	English Name	B.S. Cat	Height	Ground Clearance	Crown Spread	Recommended Works	Comments/ Reasons
2	Chestnut, Sweet	C	9.5	4.5	2231	Fell	Crown lifted for hoarding Lifting pavement / drive, limb removed over drive, will cause damage to pavement. To allow landscape enhancement
10	Oak, Holm	C	5	1.5	2111	Fell	To allow landscape enhancement
