BS5837 Arboricultural Impact Assessment & Method Statement

34 Belsize Lane, Camden, London, NW3 5AE

Client: 34 Belsize Lane Limited

Job Reference: 04030Rv2

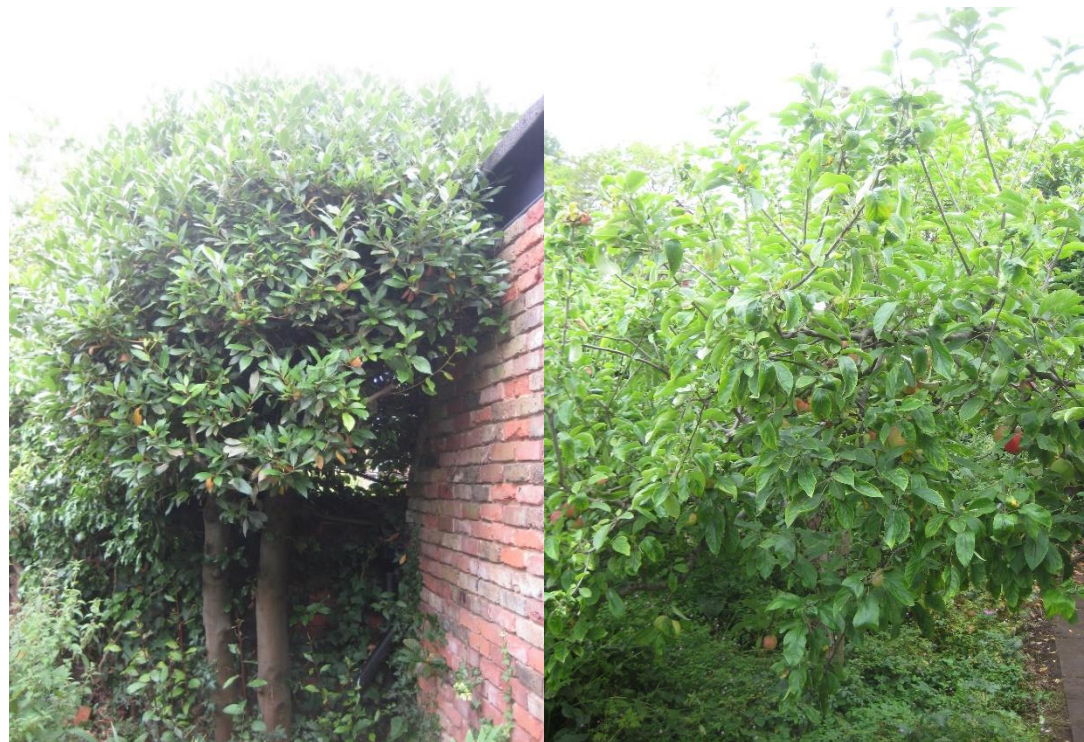
5.3.1 It is proposed to remove T4 (Apple) T5 (Bay Laurel) & T9 (Eucalyptus). These trees are small BS5837 Cat C trees of minimal local and wider amenity. It is proposed to prune T12 (Magnolia) to shape as a result of its proximity to the existing building and developed asymmetrical canopy form. Provision is made from some pruning to T2 (Acer) but this may not be required depending on the suitable work clearance to deliver the proposal. T11 (Bay Laurel) has established white rot within the basal area of the stem (*Ganoderma* spp) and is identified for removal on the health and safety grounds.

Fig 8 – T4 (Apple) – right and T5 (Bay Laurel) – left are proposed for removal.

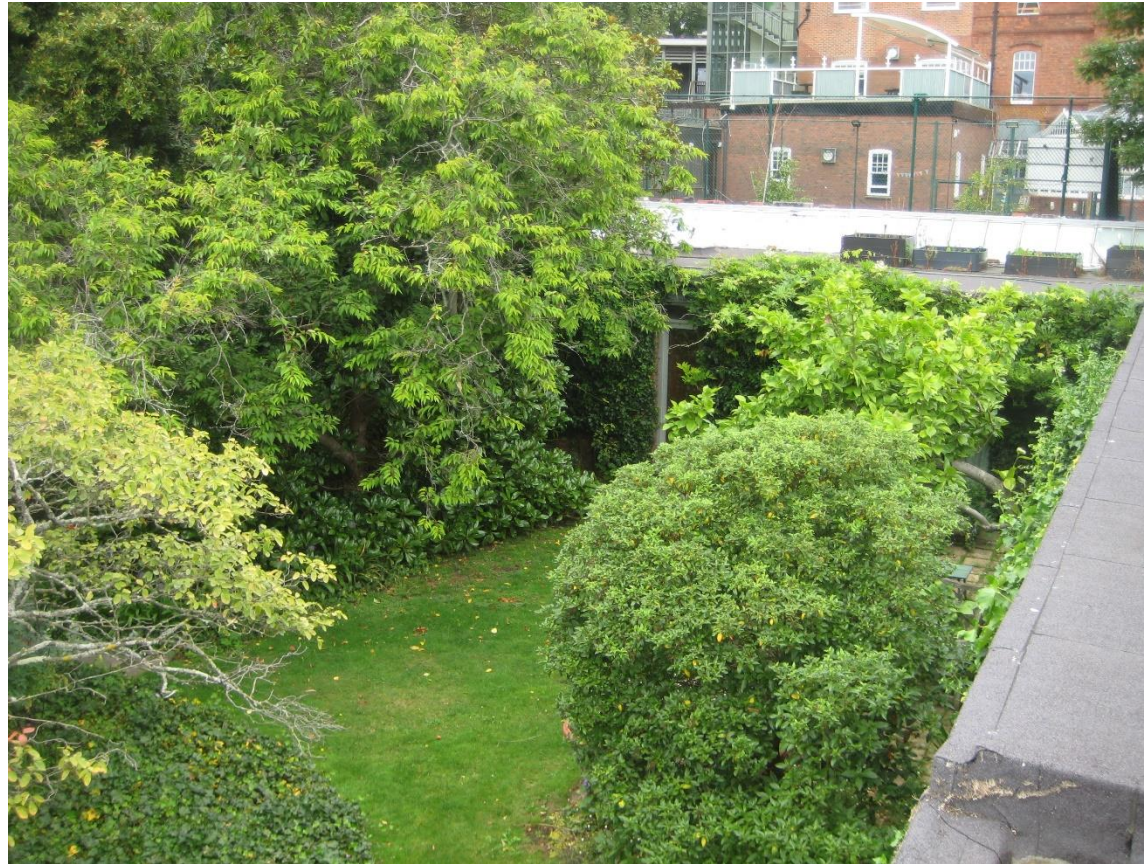
Image 1 – The internal garden area and trees from the roof.

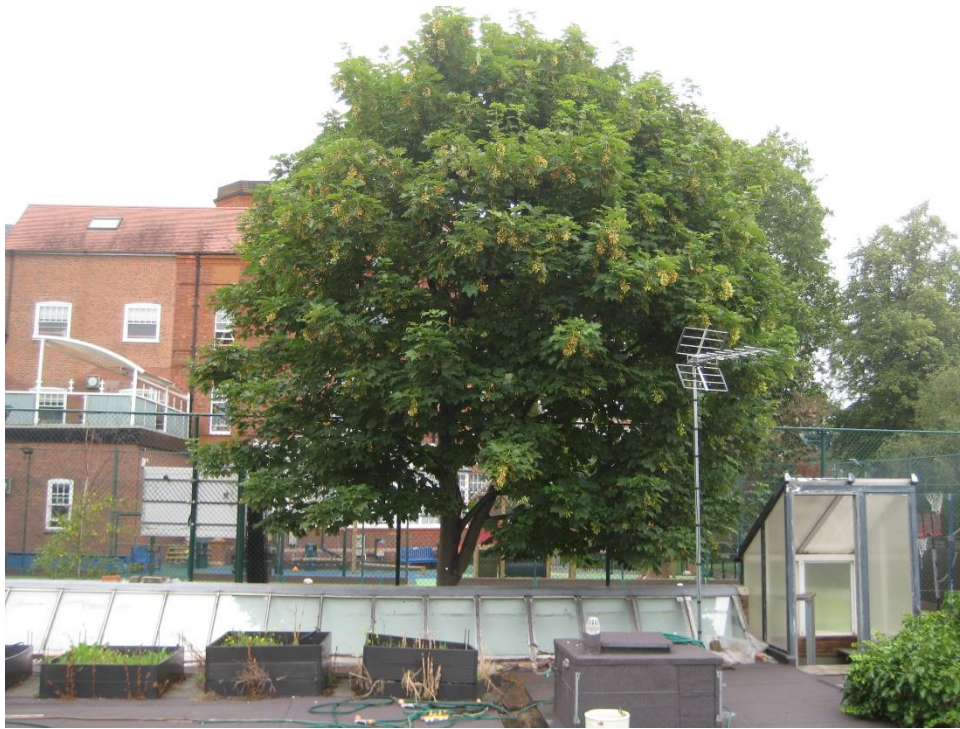
Image 2 – T2 – 3rd party Acer.

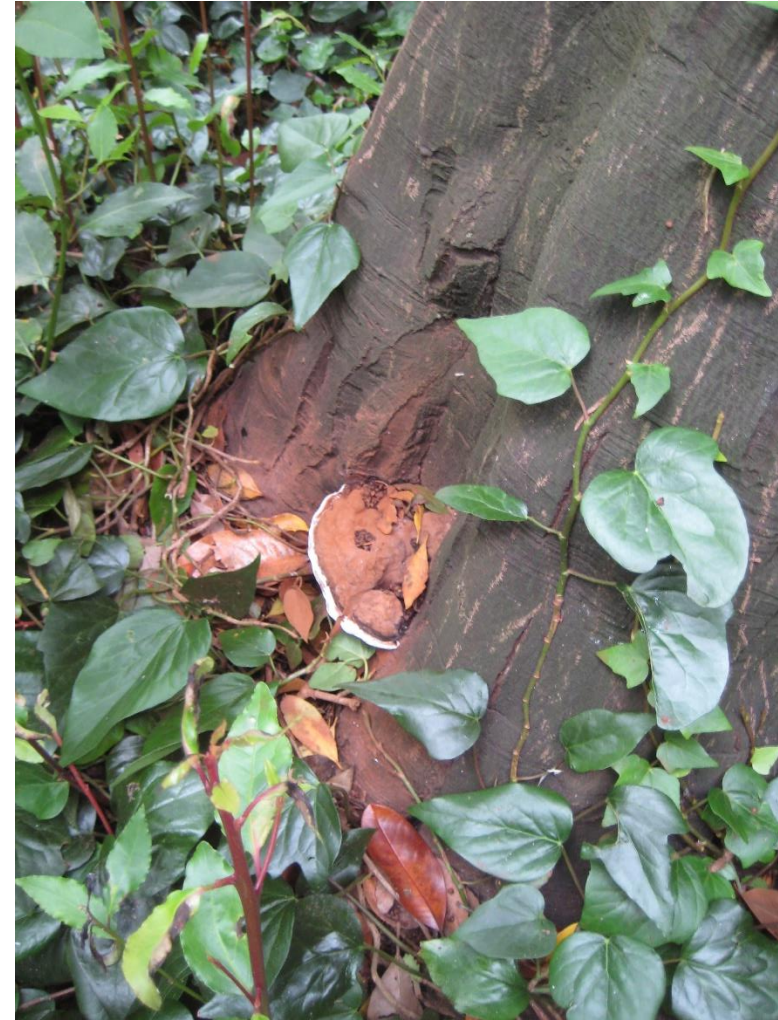
- 1.2 The property and grounds have become overgrown in recent years with minimal ‘normal’ garden management. It is proposed to remove T4 (Apple) T5 (Bay Laurel) & T9 (Eucalyptus). These trees are small BS5837 Cat C trees of minimal local and wider amenity. It is proposed to prune T12 (Magnolia) to shape as a result of its proximity to the existing building and developed asymmetrical canopy form. Provision is made for some pruning to T2 (Acer) but this may not be required depending on the suitable work clearance to deliver the proposal. T11 (Bay Laurel) has established white rot within the basal area of the stem (*Ganoderma* spp) and is identified for removal on health and safety grounds.

Image 3 – Ganoderma at the base of T11
