**Re: 7 Aberdare Gardens, London, NW6 3AJ**

## REPORT

7 Aberdare Gardens, London, NW6 3AJ

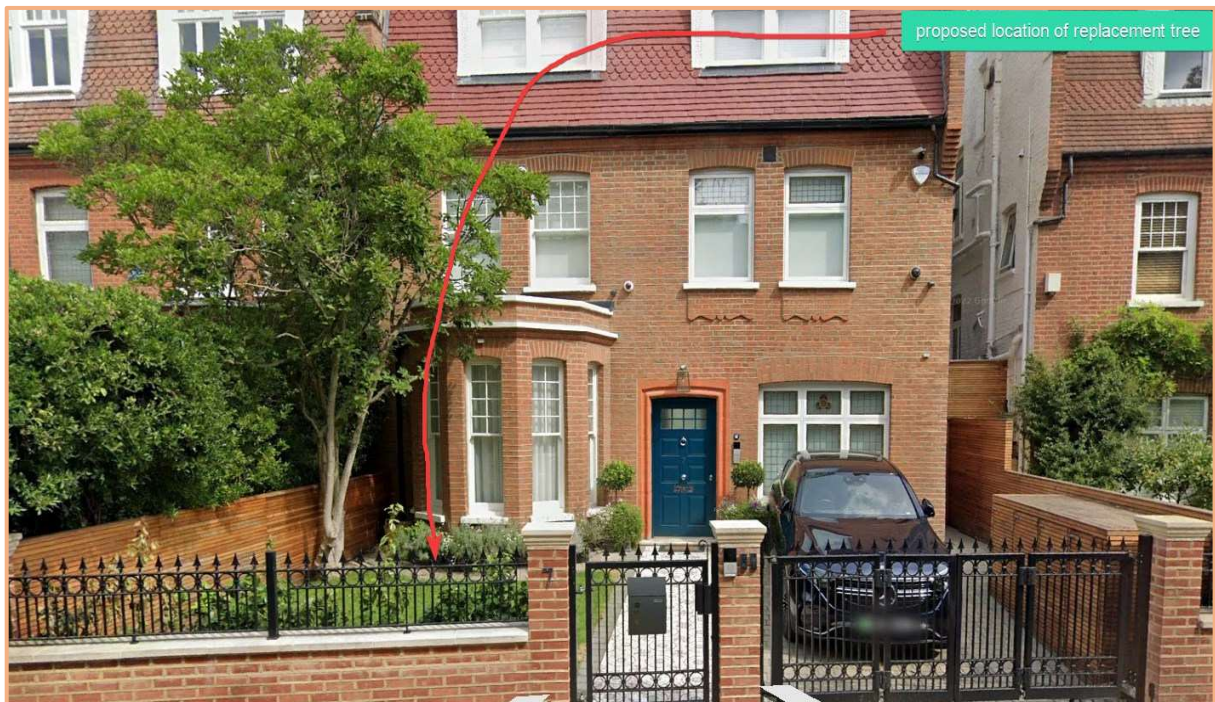
9 Annotated photo

The matter can reasonably be resolved by an undertaking and action on the part of the owner to plant a replacement tree in the location indicated on the annotated photo below.

Plant a tree selected from the following list :

**Mespil (*Amelanchier* 'Robin Hill')**

**Oriental thorn (*Crataegus orientalis*)**

**Mediterranean crab apple (*Malus trilobata*)**

**evergreen Magnolia (*Magnolia grandiflora* 'Galissonniere')**
