**PHOTO SHEET**

**2 PRIMROSE GARDENS**

**LONDON NW3 4TJ**

**Proposal - replacement of 2.no roof level uPVC doors with uPVC windows**

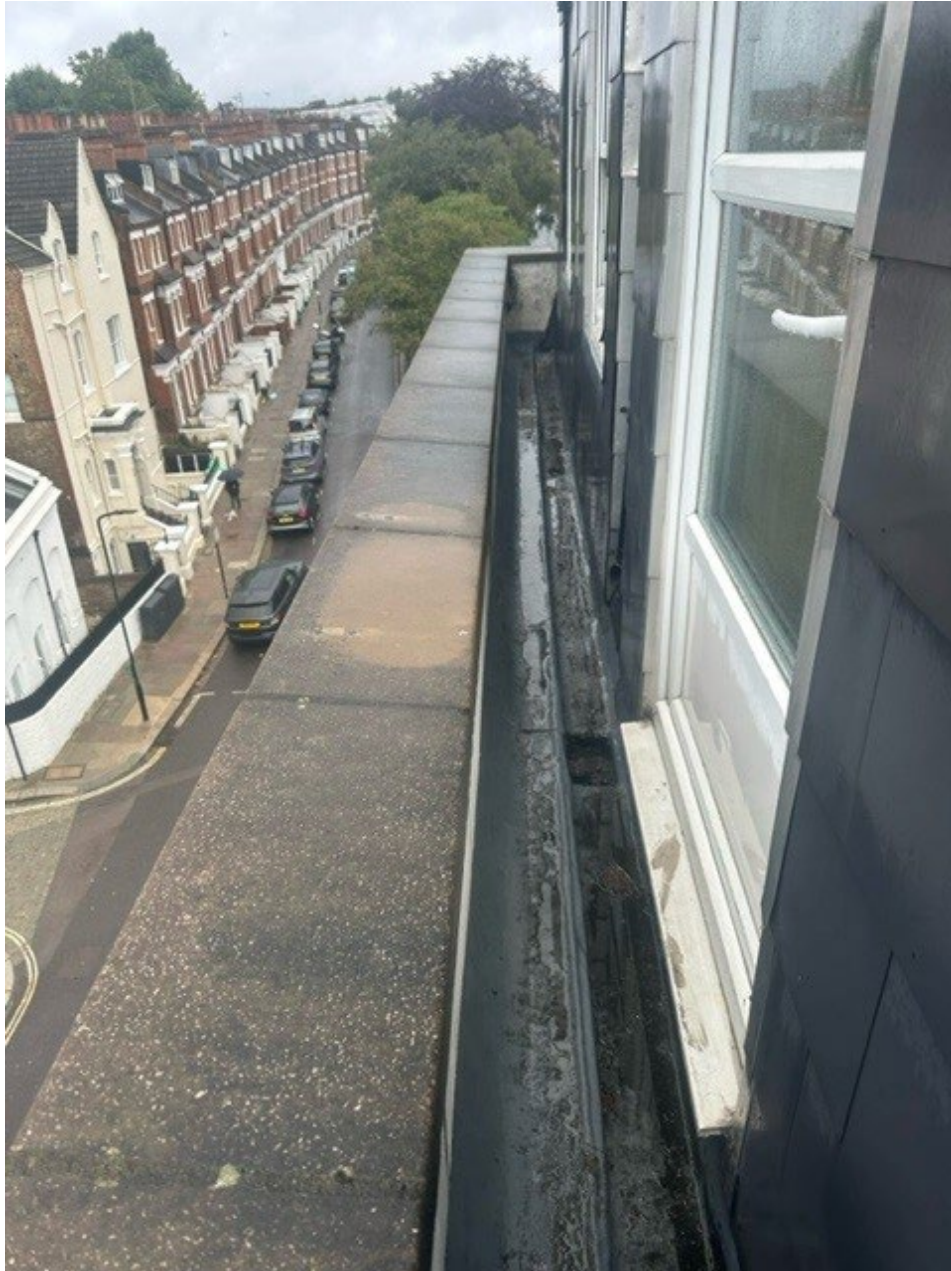
Photo 1 – roof level box gutter, showing existing upvc door, to be stripped out and replaced with a upvc window to match the existing window units on the elevation.

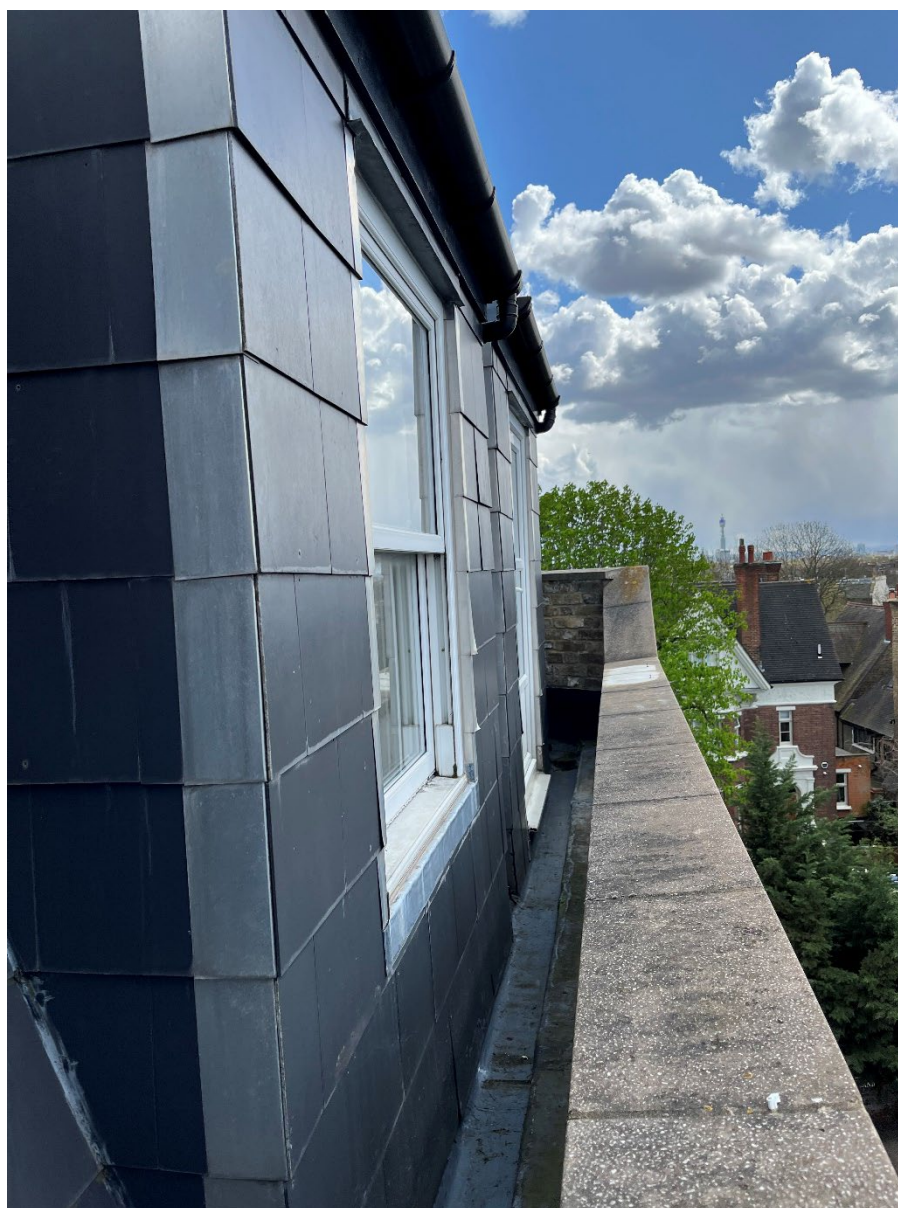
Photo 2 – existing box gutter uPVC window, new units to match. Newly formed opening to be finished at low level with a weather proofed external insulated wall finished externally in slates to match.

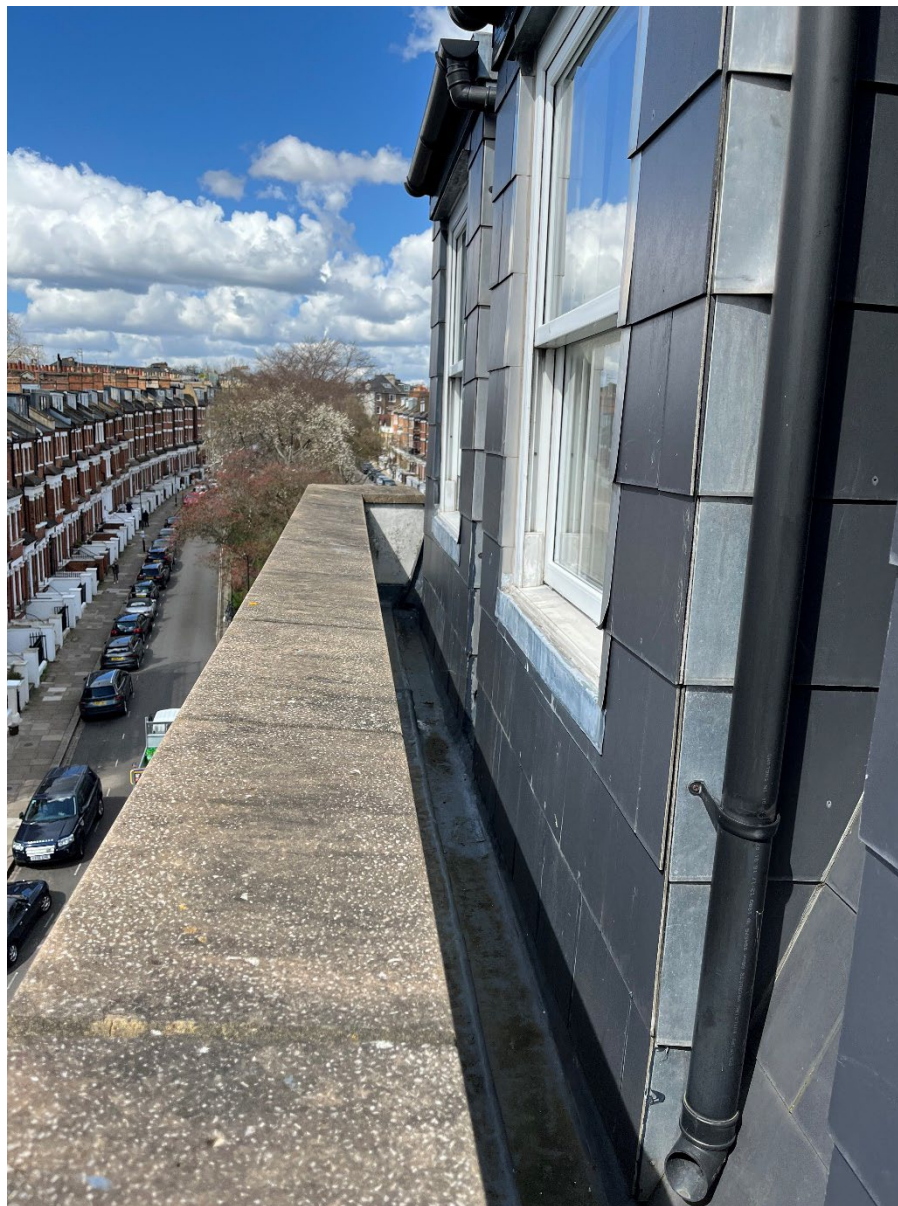
Photo 3 – existing box gutter uPVC window, new units to match. Newly formed opening to be finished at low level with a weather proofed external insulated wall finished externally in slates to match.

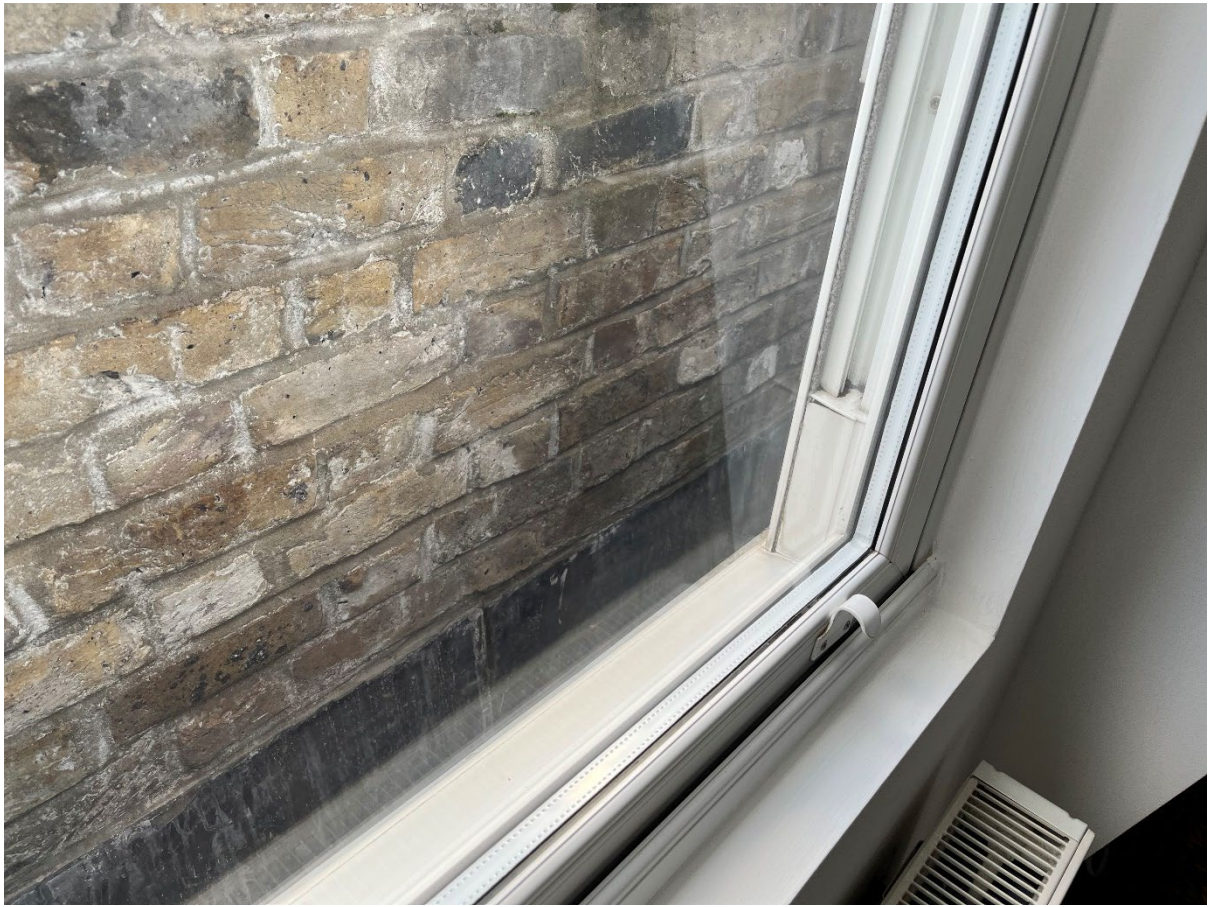
Photo 4 – interior of box gutter level uPVC window. New units to match.

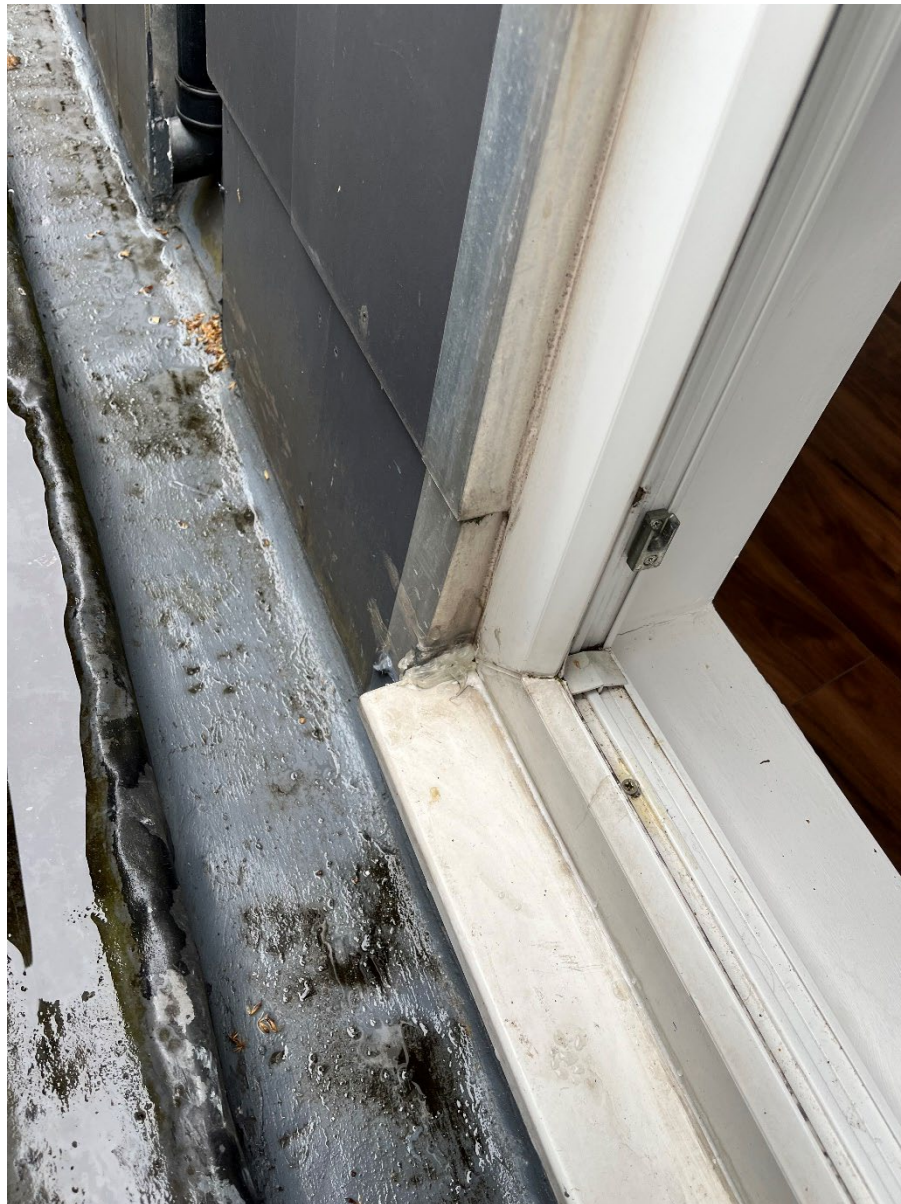
Photo 5 – threshold of existing door openings too low, causing damp ingress problems.

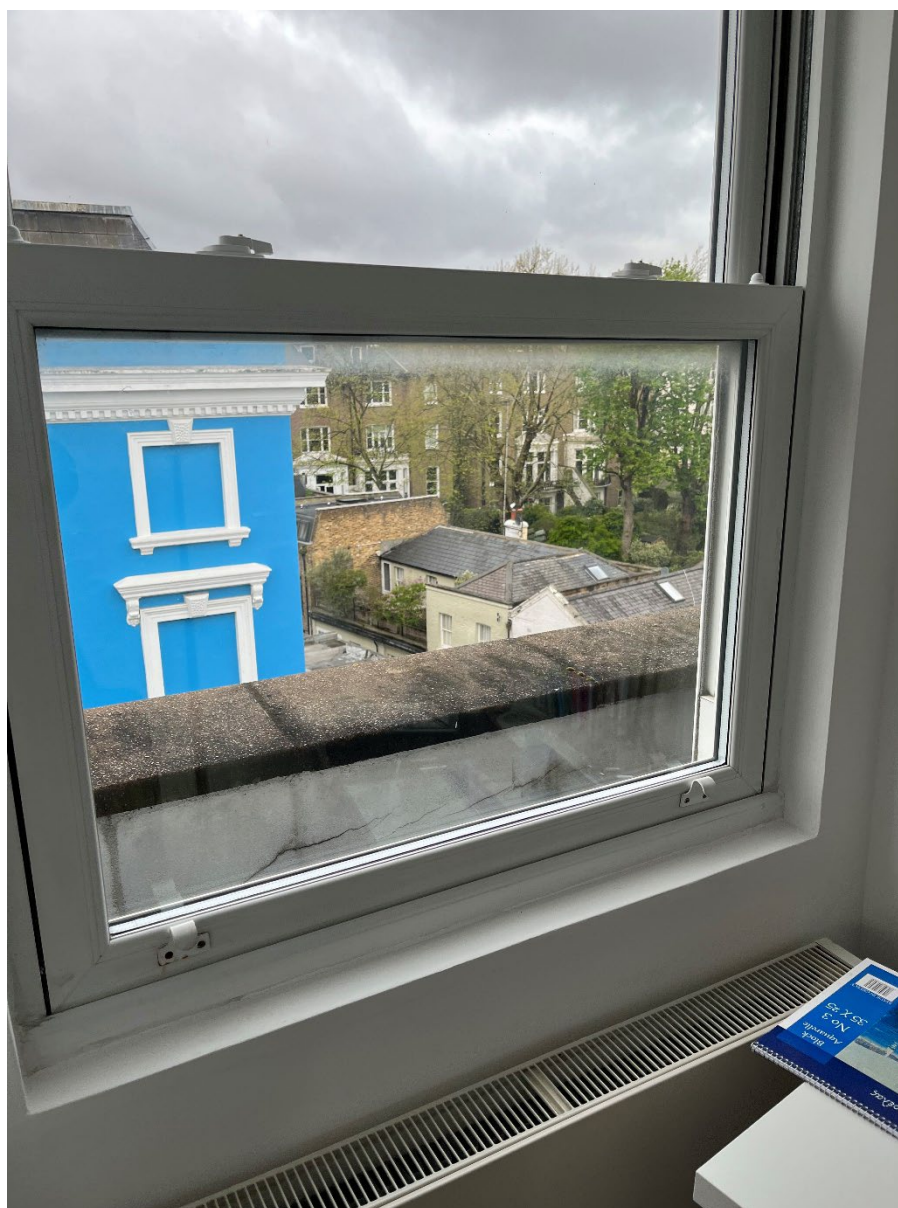
Photo 6 – interior of box gutter level uPVC window. New units to match.

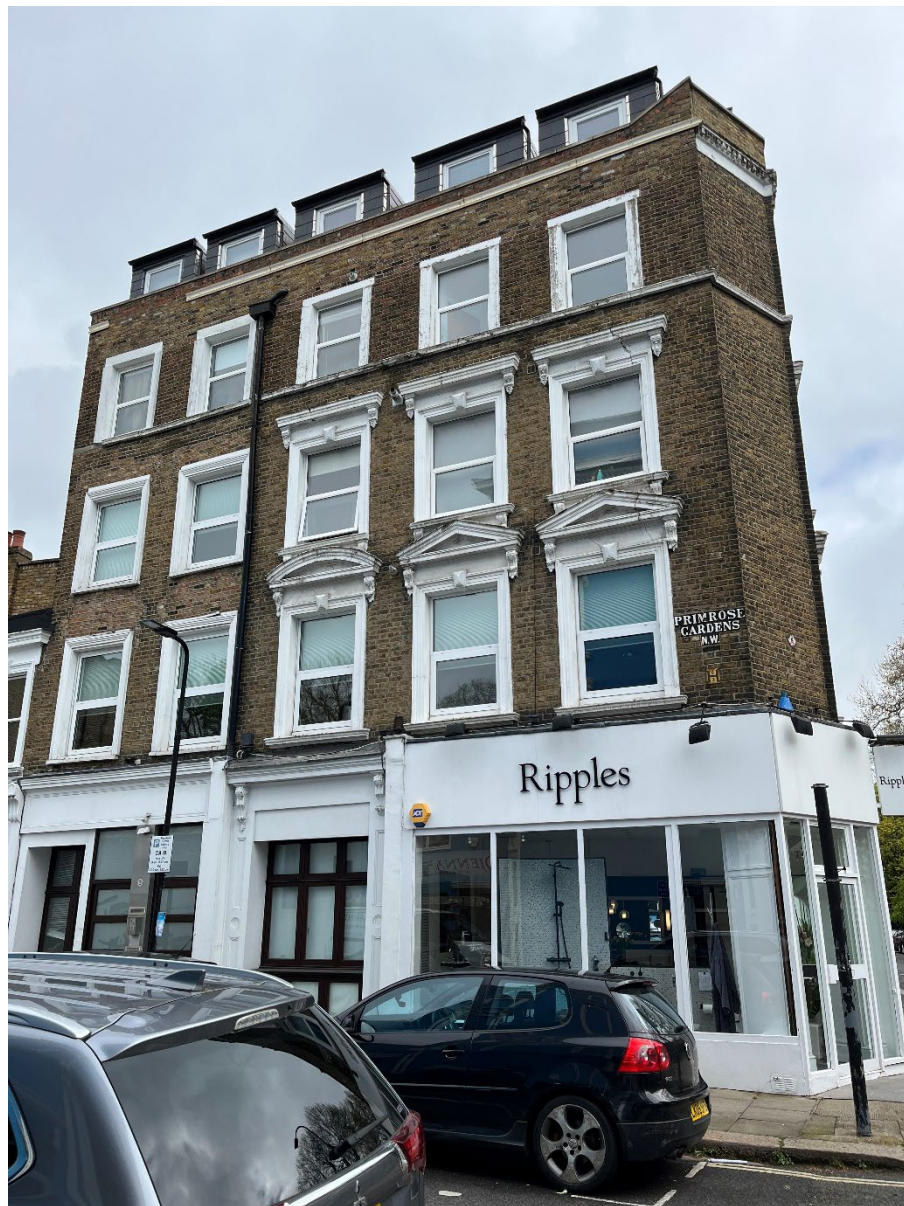
Photo 7 – view of box gutter windows from ground level.
