7 Pilgrim Lane, Hampstead, NW3 1SJ

Heritage and Planning Statement accompanying planning and listed building consent application for demolition and rebuilding of existing boundary wall

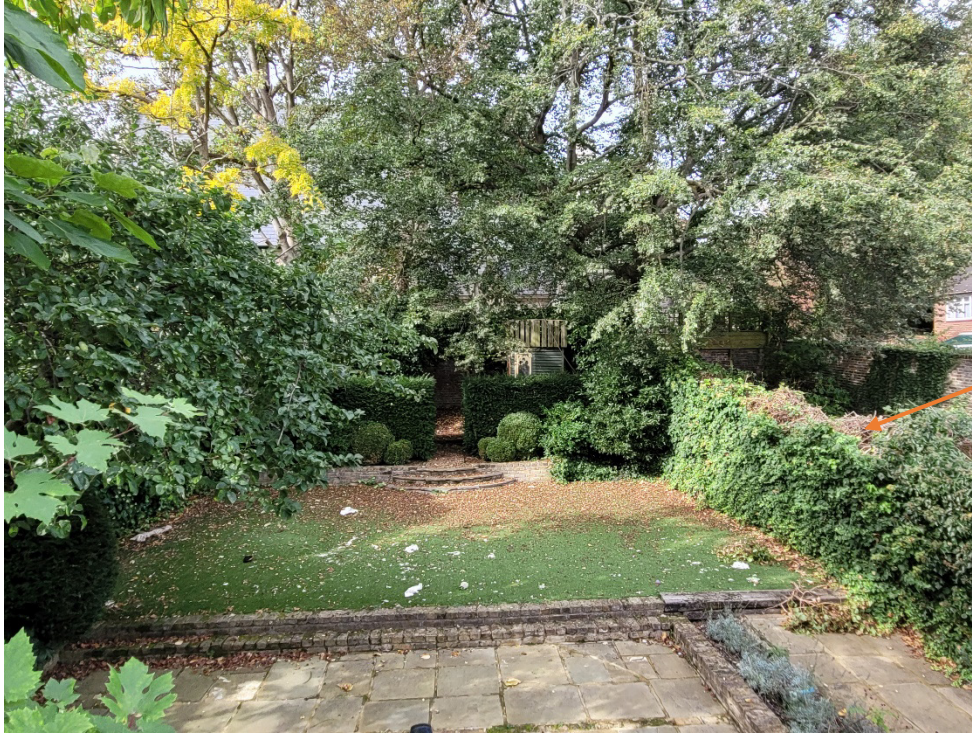
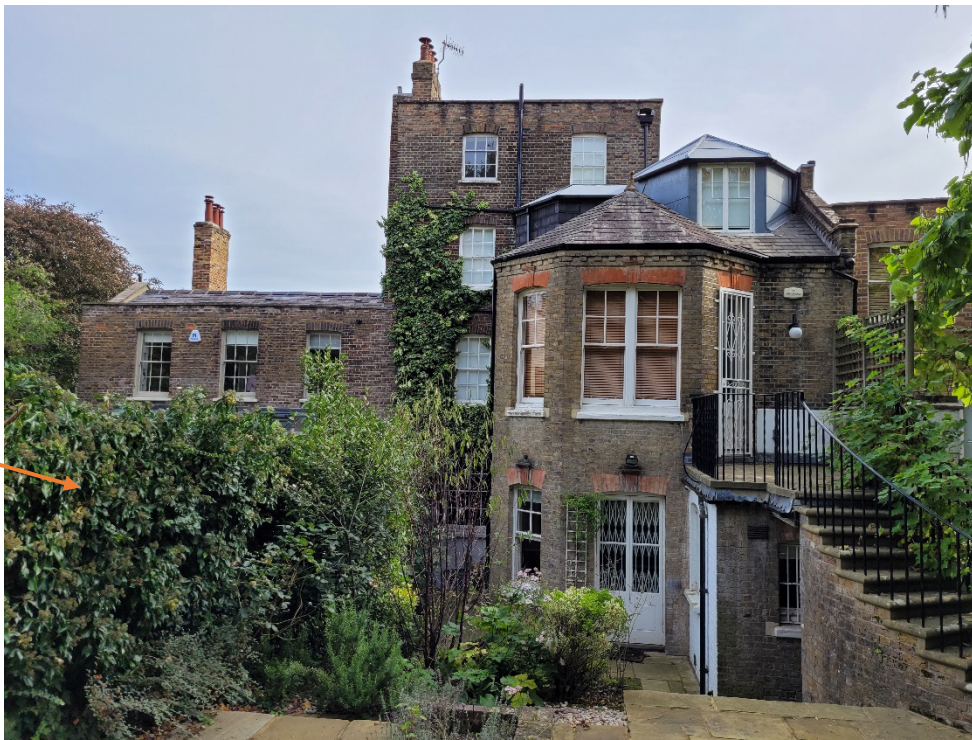
Photos taken before problems with wall were evident – as can be seen, the wall was entirely hidden by ivy on the wall and trellis, which had hidden the structural problems.

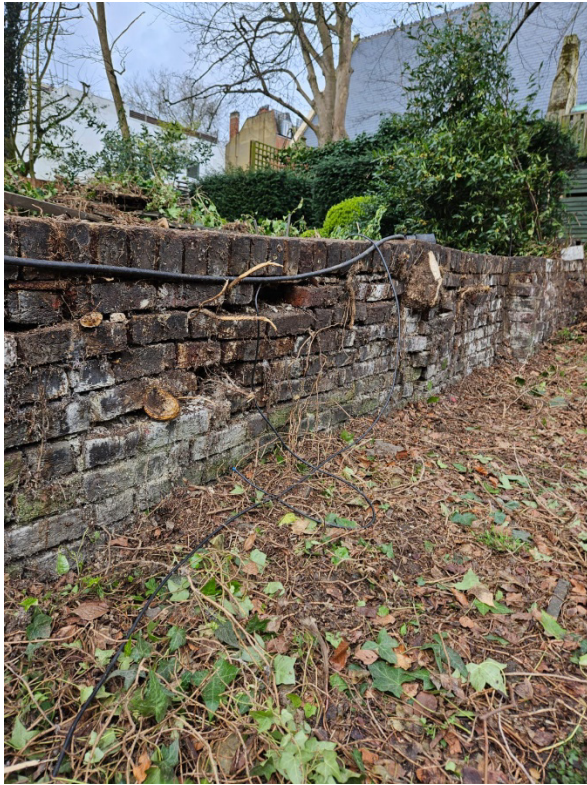
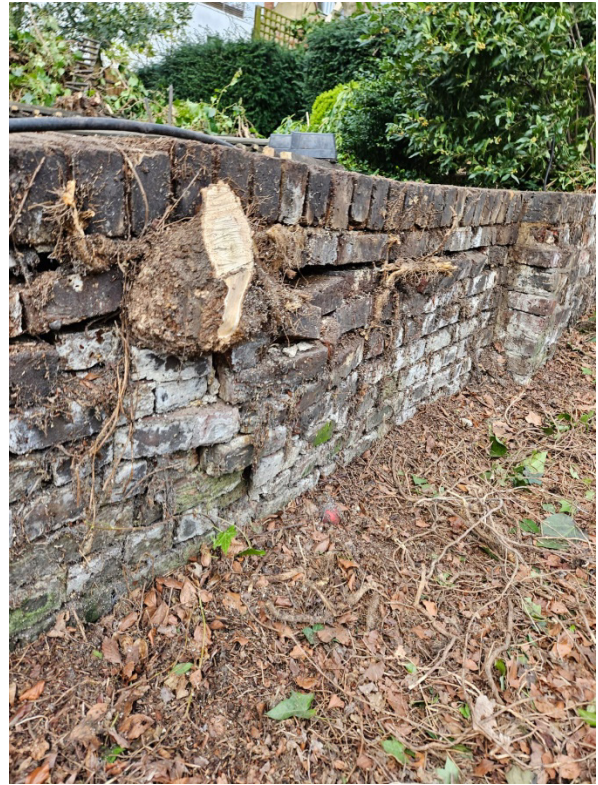
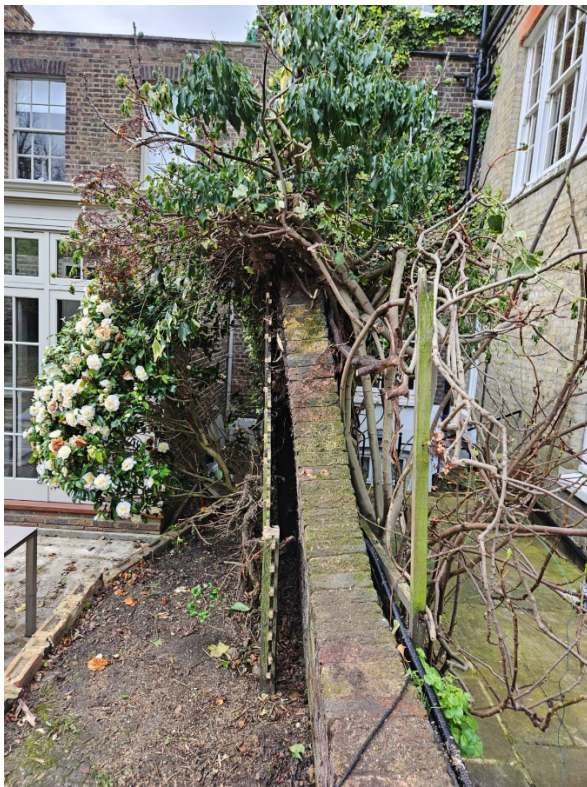
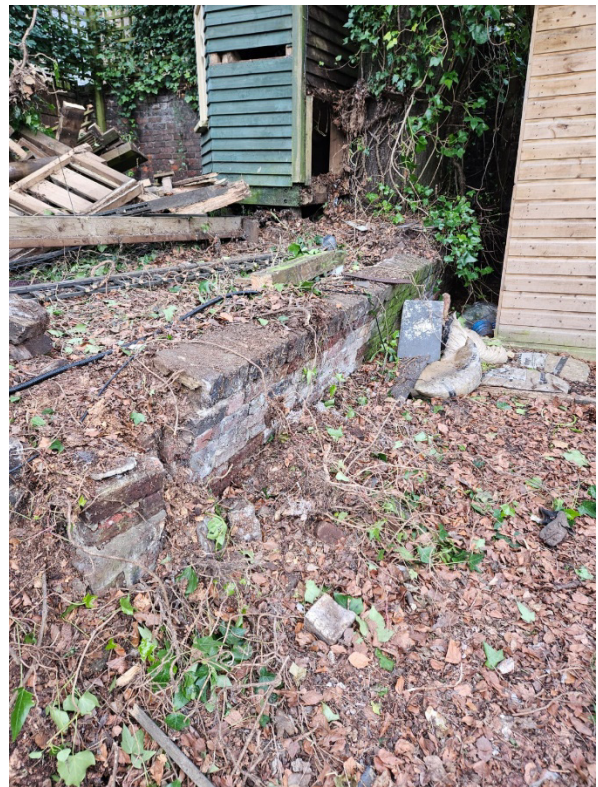
8. Unfortunately, a lack of maintenance of the garden over the years means the new owners of the house have recently found the wall is now in a perilous condition. The ivy-lad trellis has collapsed, and this has revealed that the wall itself has been undermined by self-seeded trees that grow into the wall. This has made parts of the low wall collapse, and there is a dangerous lean in the higher part of the wall towards No. 9. The enclosed Structural Statement and the Design & Access Statement explain this situation, and photos are attached.

Wall when seen after removal of trellis and ivy, showing collapse and dangerous lean towards No. 9

9. The proposed works are to demolish the damaged areas of wall, retain bricks, and then rebuild in the same form using those bricks in the correct pattern and bond. In the absence of sufficient retained and reused bricks, then suitable bricks to match of correct size and appearance will be used. A replacement fence will be put on top of the wall. This will have planting on the fence as before but, unlike in the past, there will be proper maintenance to avoid damage to fence and wall.

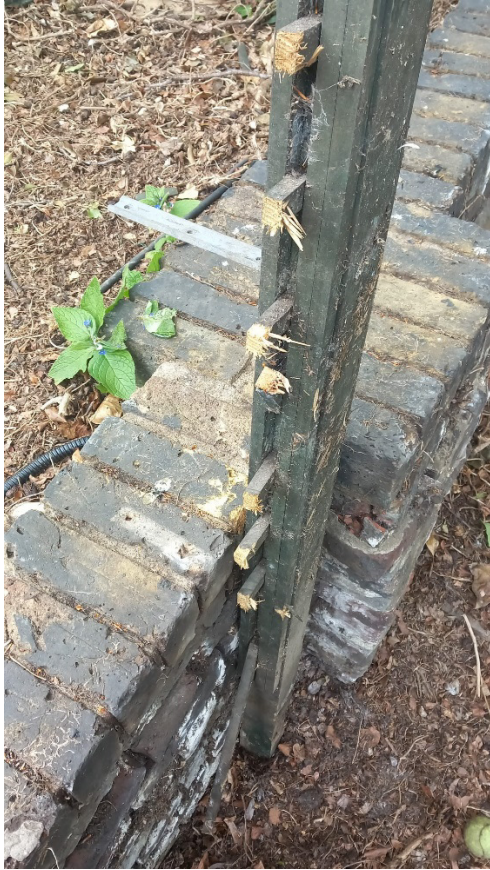
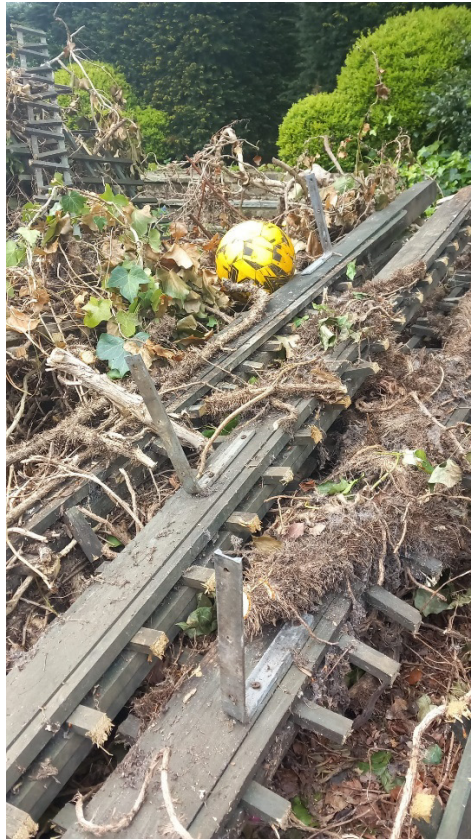
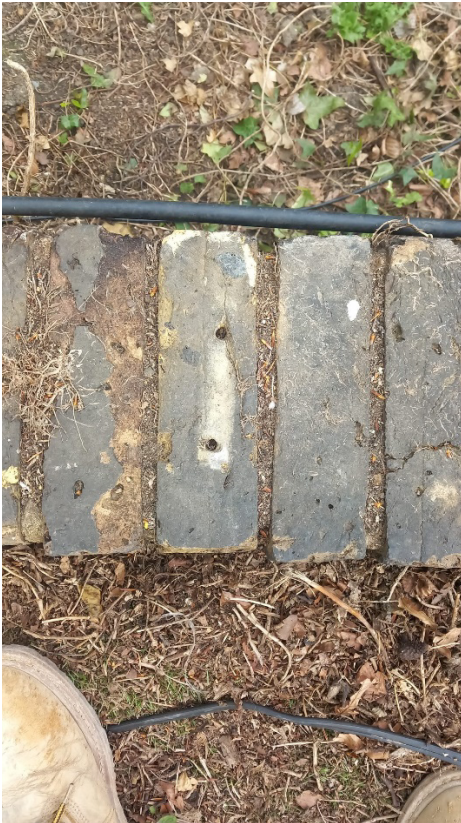
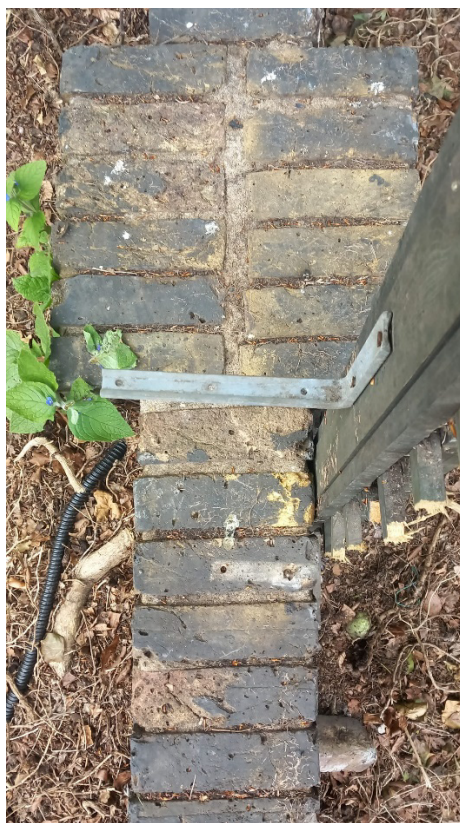
Photos showing trellis that was attached to the wall, during removal
