Refurbishment and repairs at

45 Great Ormond Street, London WC1N 3HZ

Heritage and Impact Statement

ROGER MEARS ARCHITECTS

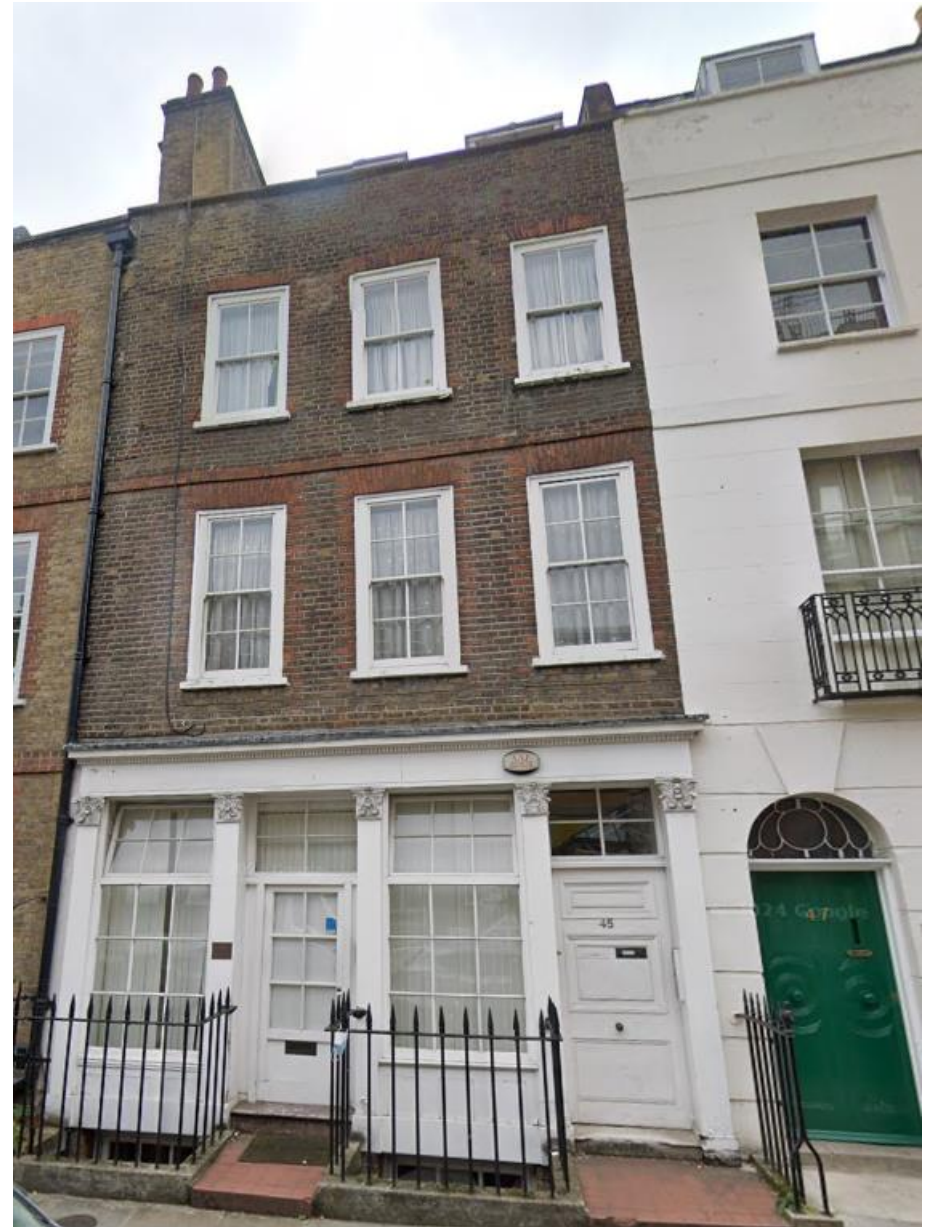
No 45, External view

Although the shopfront has retained its original design, the ground floor windows and doors have changed.

The lightwell is bridged over with concrete slabs to access the two doors. The railings are a modern replica and painted in black.

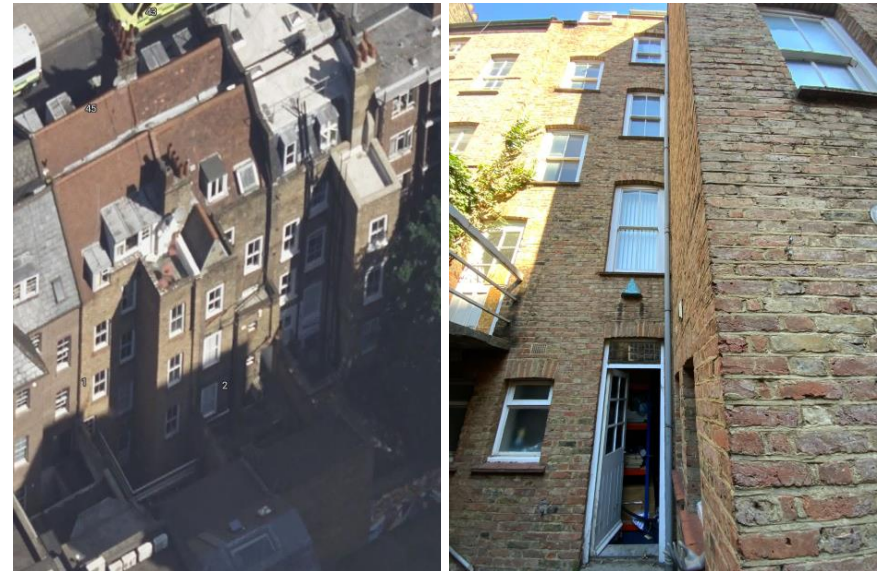
No 45 – Aerial view and rear elevation

The mansard roof is covered with clay tiles. A drone survey has revealed that some tiles have slipped or are heavily stained. Ridge tiles have missing pointing to joints. The valley dormer and front/ rear parapet have a zinc covering which is in poor condition. The dormer has a cover section missing to roll. The parapet to the front has a build-up of detritus as well as the central valley. The rear parapet has limited access as the dormer is built up against it so it cannot be maintained. There are loose cables over the roof covering. The vent local to the central valley has no cover. There is missing flaunching to chimney stacks, a pot missing to a small stack to the rear leaving an open flue.

There is a single grey uPVC rainwater downpipe to the rear elevation. Cast iron down pipe within the lightwell serving the rear yard with some small waste drainage within the lightwell.

A vent pipe exists at the rear elevation at high level. Internal soil pipework to be investigated small external uPVC waste pipe located in the lower ground yard.

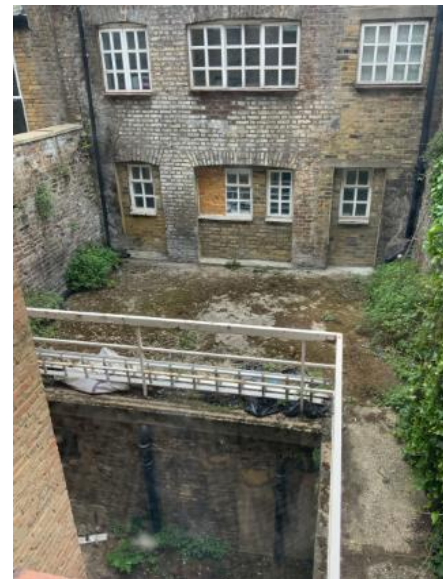
Rear Yard

The rear yard features a concrete slab with vegetation growth over it. The steel handrail finish is lifting, exposing corroded metal. There are areas of brickwork to the wall that need to be repaired further due to vandalism that occurred some years ago.
