Landmark Trees

ARBORICULTURAL IMPACT ASSESSMENT REPORT FOR:

95 Avenue Road
London
NW8 6HY

Ref: HUB/95AVR/AIA/01a

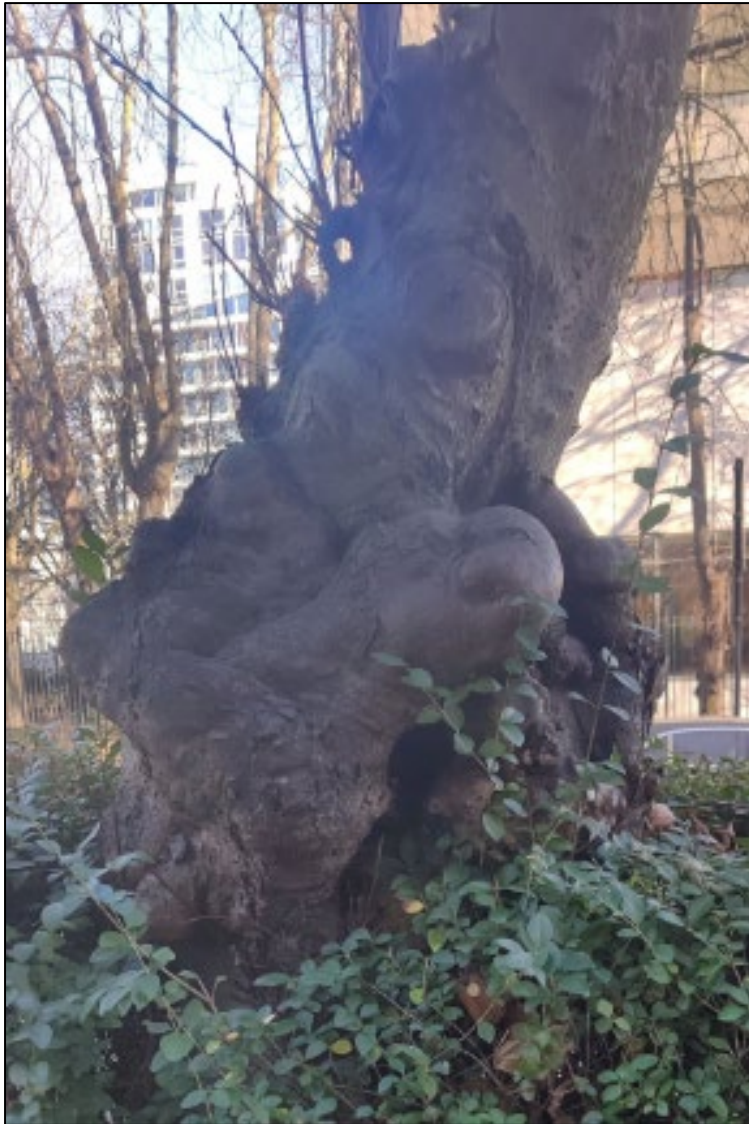
Photograph 3: Cavity in base of T6

6	Cherry, Bird	12	4,4,3,5	3.0	430	Mature	5.2	Normal	Poor	C/U		<10	Historically reduced Leaning to SE, suppressed Cavity @ SW side probed to 30cm+ on main stem, significant compensatory thickening growth around defect

- 1.2 There are 25 trees on the property and adjoining land outside of the application boundary that are within proximity to the development and need to be assessed. These are judged mostly moderate and low-quality trees, but with high quality trees T1, T3, T4 and T23 as standout high quality specimens. All trees are material constraints on development, but these latter require particular consideration. At the other end of the spectrum, the removal of T6 is recommended regardless of development.

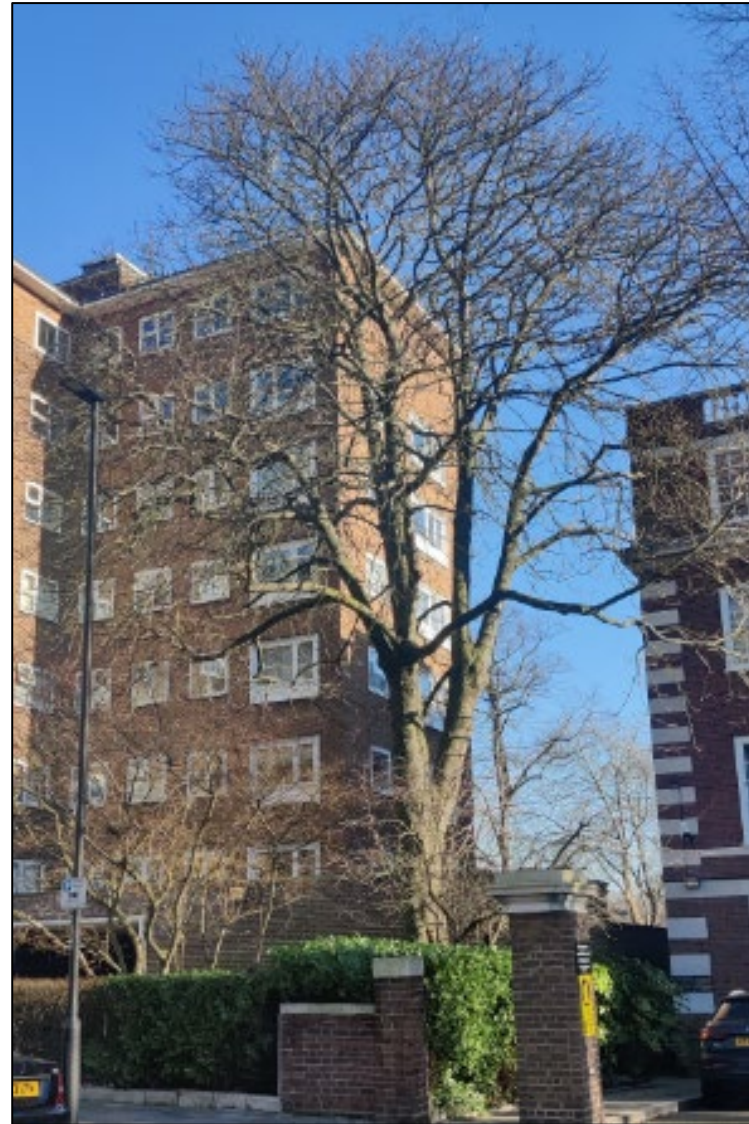
Photograph 4: Category A horse chestnut T23
