## ARBORICULTURAL IMPACT ASSESSMENT REPORT FOR:

95 Avenue Road  
London  
NW8 6HY

**Ref:** HUB/95AVR/AIA/02a

**Date:** 5<sup>th</sup> July 2022

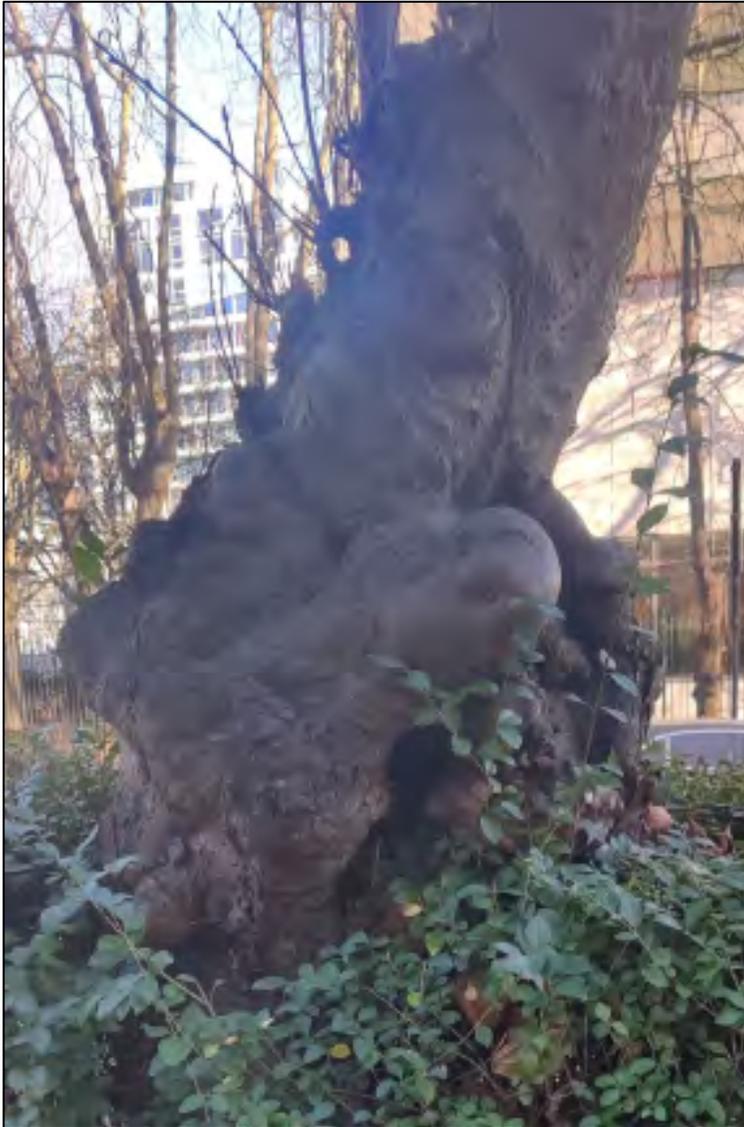
- 1.2 There are 25 trees on the property and adjoining land outside of the application boundary that are within proximity to the development that need to be assessed. These are judged mostly moderate and low-quality trees, but with high quality trees T1, T3, T4 and T23 as standout high quality specimens. All trees are material constraints on development, but these latter require particular consideration. At the other end of the spectrum, the removal of T6 is recommended regardless of development.

Photograph 3: Cavity in base of T6

6	Cherry, Bird	12	4,4,3.5	3.0	430	Mature	5.2	Normal	Poor	C/U		<10	Historically reduced Leaning to SE, suppressed Cavity @ SW side probed to 30cm+ on main stem, significant compensatory thickening growth around defect

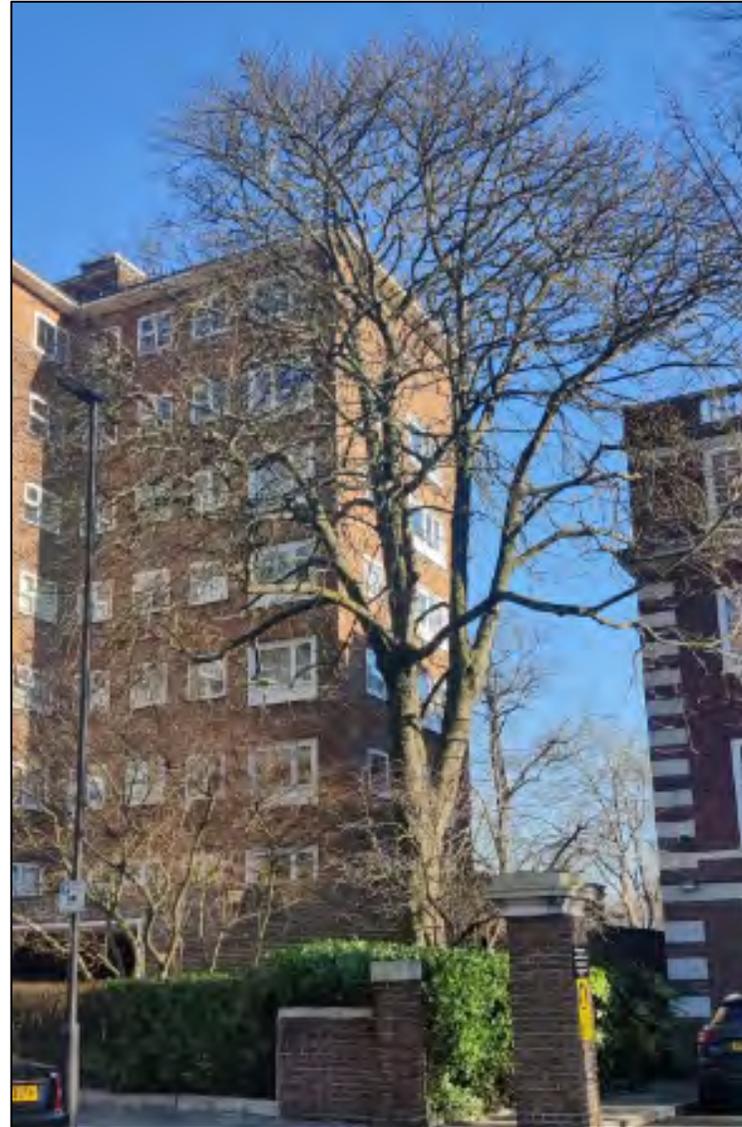
Photograph 4: Category A horse chestnut T23
