**14 Templewood
Avenue,
London**

Heritage Note – Roof Repairs and Upgrade

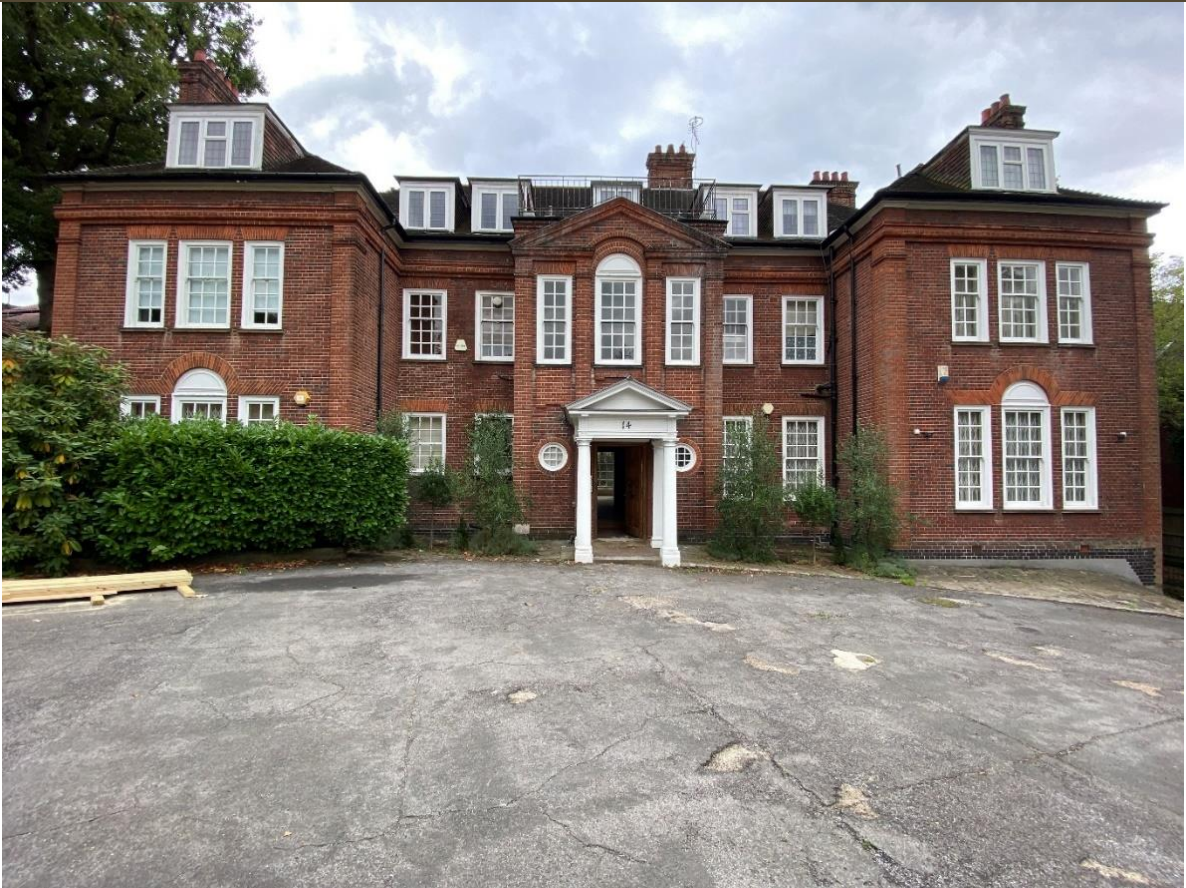
Figure 4: Front elevation from within the boundary of the study site. This view omits the single storey projecting addition which is located on the left of the frame. This is consented to be demolished and the tiles are proposed to replace damaged clay tiles on the roof.

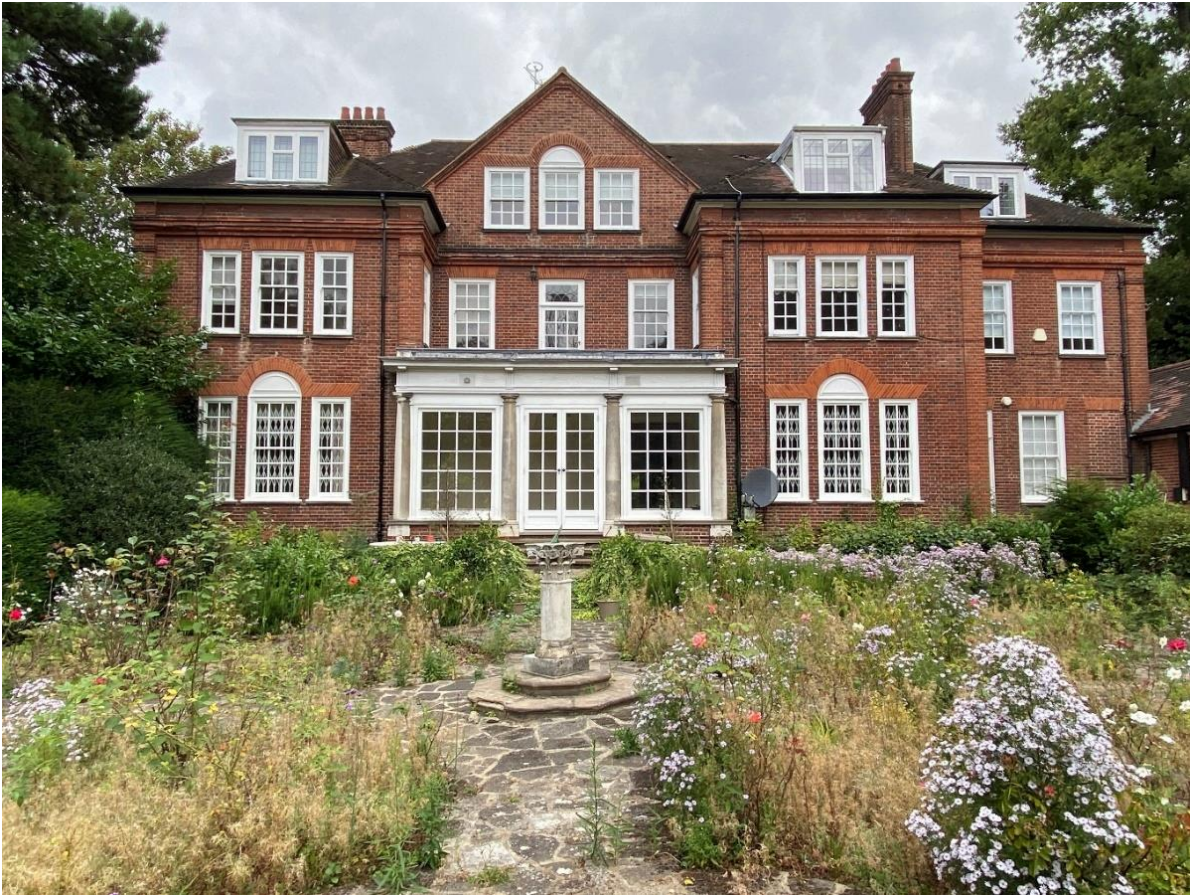
Figure 5: Rear elevation from the rear garden. There is a small rear extension, permitted in the 1960s, just discernible to the edge of the frame on the right.

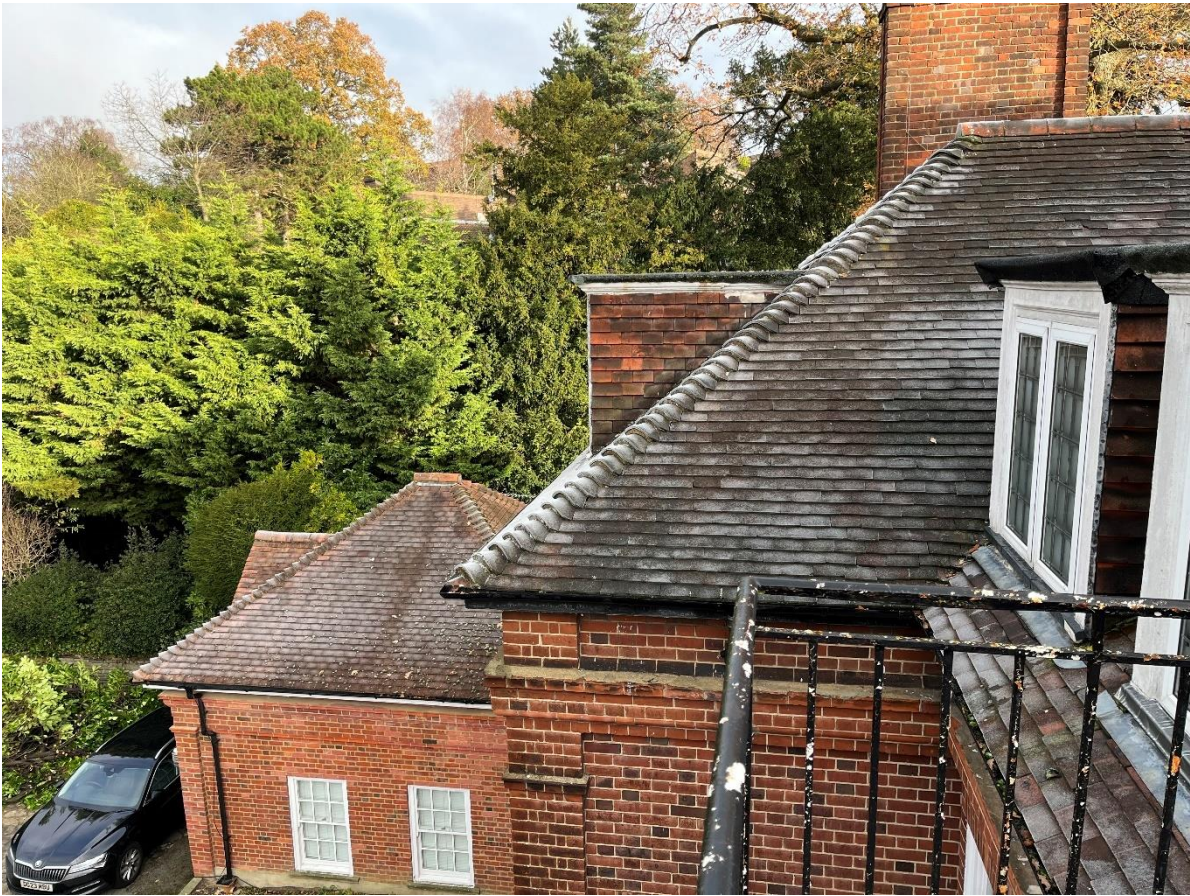
Figure 6: View of the front roof slope from the central balcony looking to the northern wing of the house. This photo shows three dormers on this side of the roof with cheeks that have tile hanging, some lead flashing and flat, felt roofs. The main building has brown clay tiles, though the ridge tiles appear to have been replaced with reddish clay tiles. The hipped roof of the front project single storey extension is also visible in this view. Any clay tiles on the main building are proposed to be replaced in part with the clay tiles from this single storey extension (consented to be demolished).

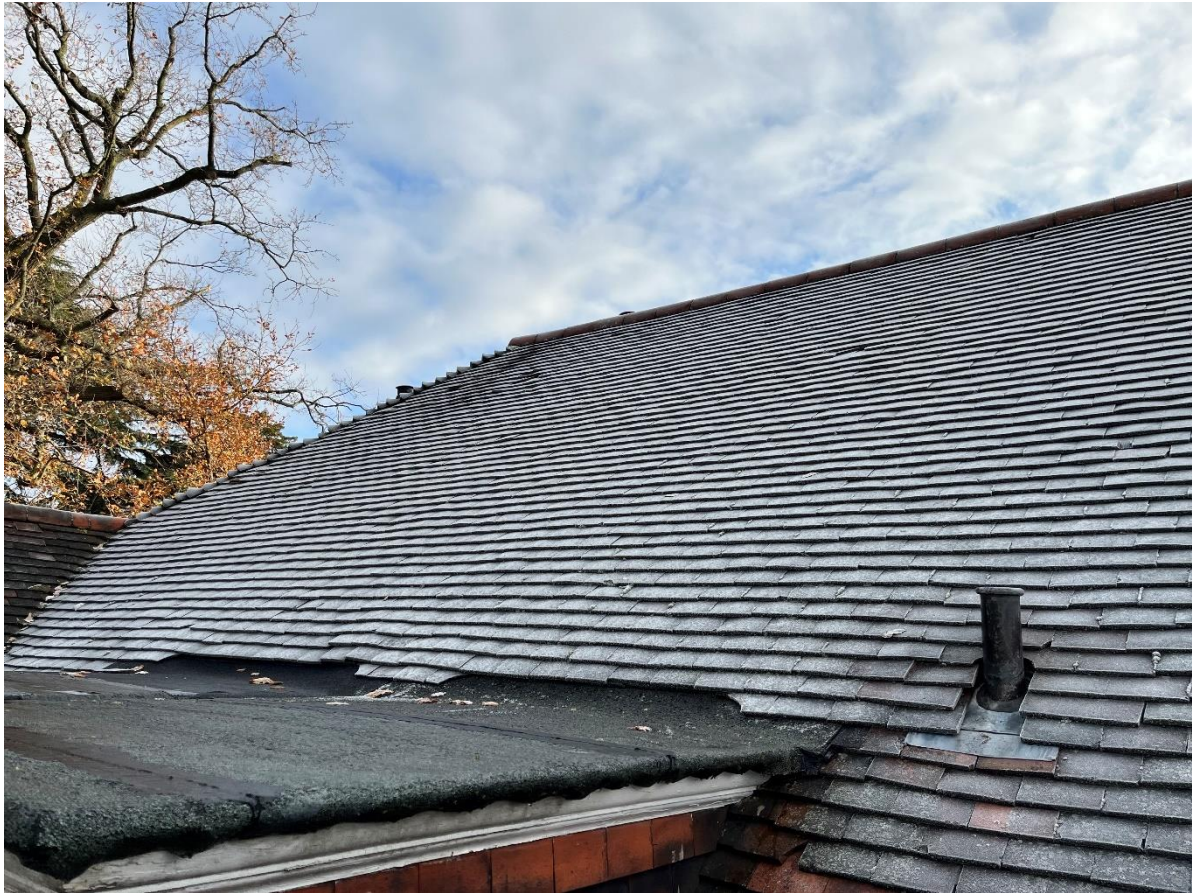
Figure 7: Front slope looking northeast. Note the junction of the tiles with the felt roof of a front dormer, and the missing string of clay tiles. There are clearly some patches in the roof with missing/ broken tiles that are in need of attention. The felt roof on the dormers are to be replaced with lead – a more durable, historically appropriate material for a dormer.

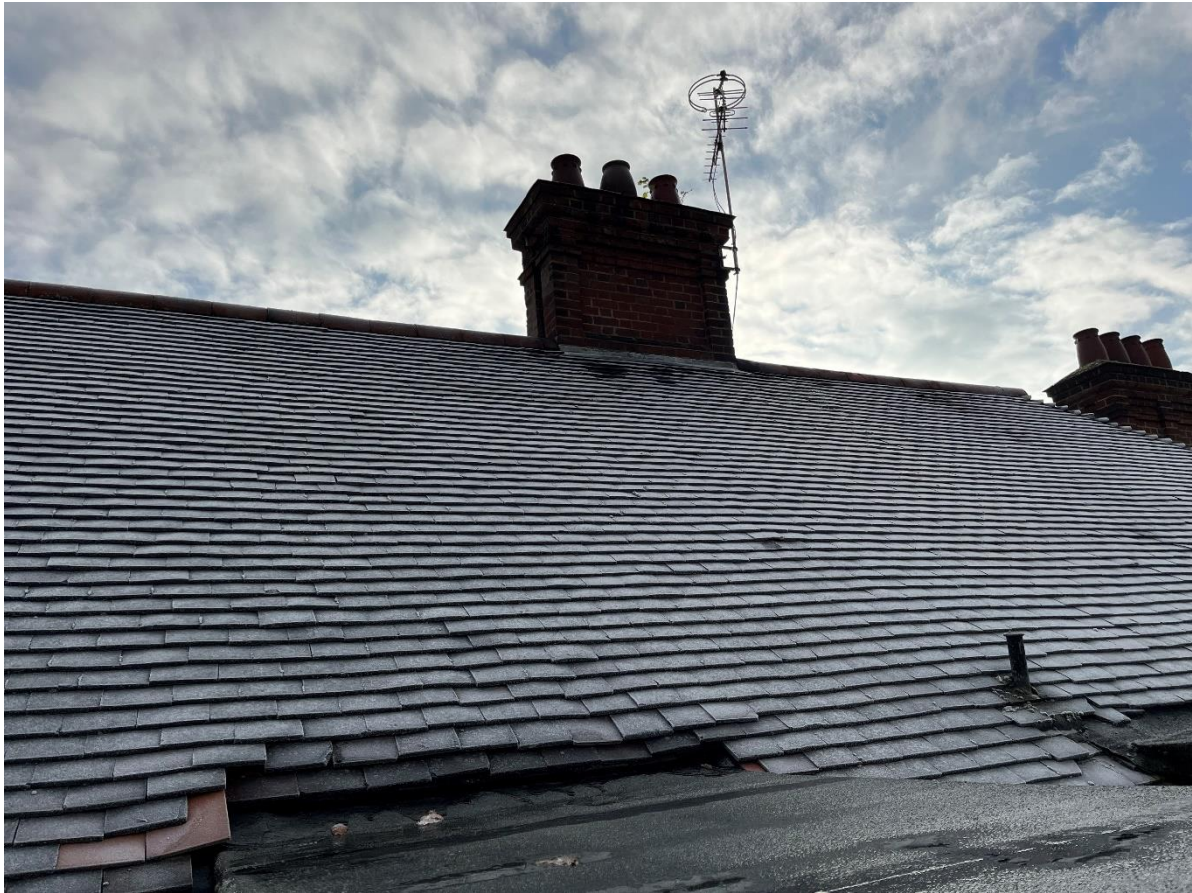
Figure 8: Central section of the front slope of the main building. There is one prominent chimney stack in this section of the roof and another chimney stack on the southern wing of the house to the right of the frame. There have been some replacement tiles at the junction with the dormer suggesting there have been some previous issues with leaks.

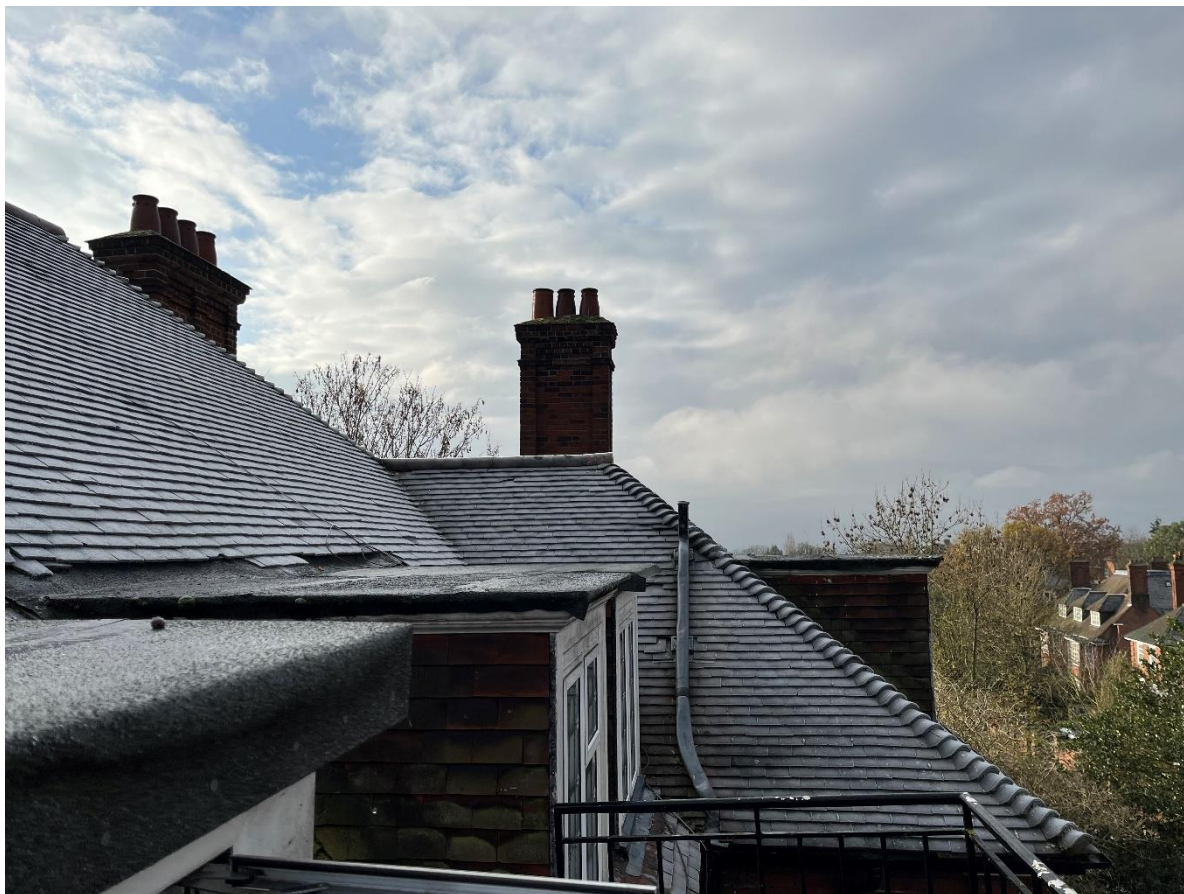
Figure 9: View of the front roof slope from the central balcony looking to the southern wing of the house. There are four dormers in this view with tile hanging, flat felt topped dormers and obtrusive vent on the projecting south wing. The condition of the chimney stacks will be reviewed during the roof works.

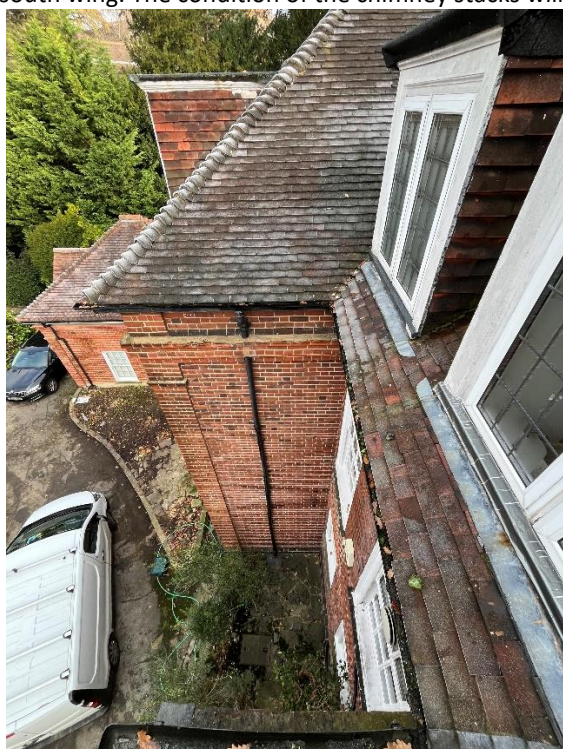
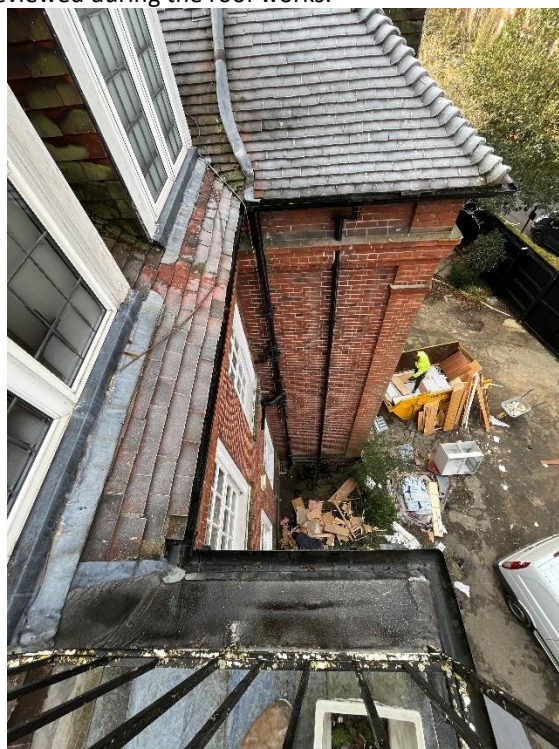
Figure 10: Views looking down in the recesses either side of the central projecting balcony. The dormers feature lead flashing and there are four rows of clay tiles to the eaves. The property features a mix of cast iron and uPVC gutters. It is proposed to replace any uPVC with cast iron.

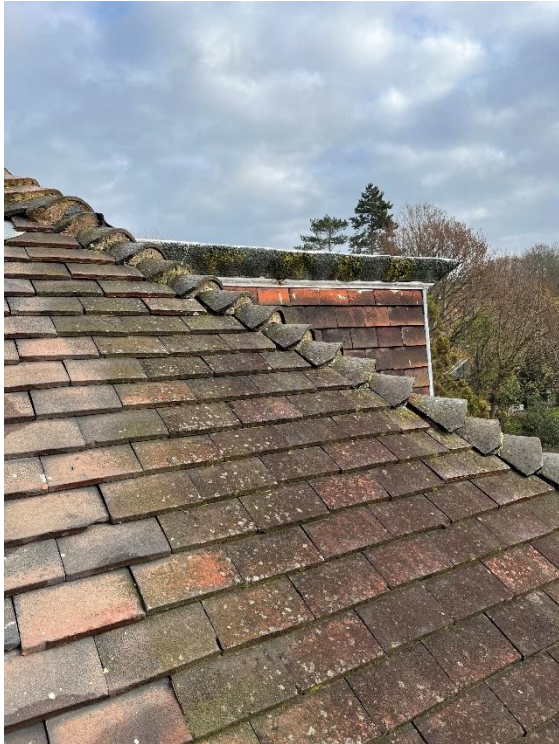
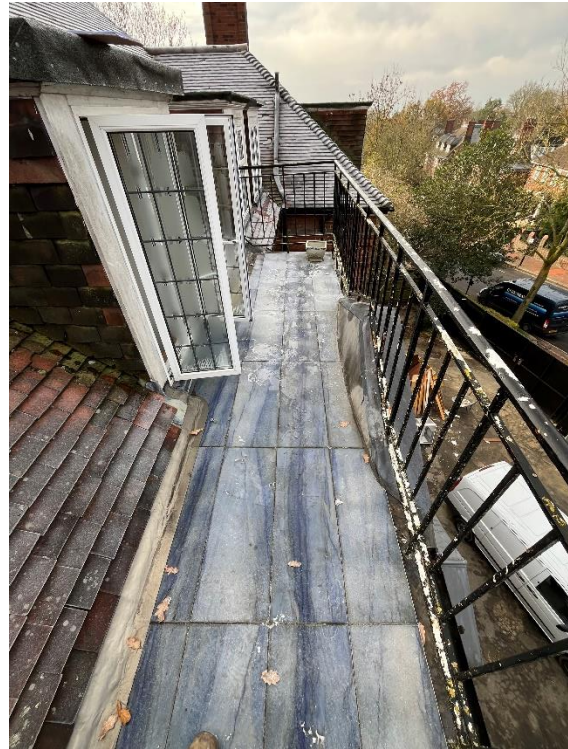
Figure 11: Left, detail of roof hip and dormer. Right, view of central balcony and railing and casement windows to dormer for access.

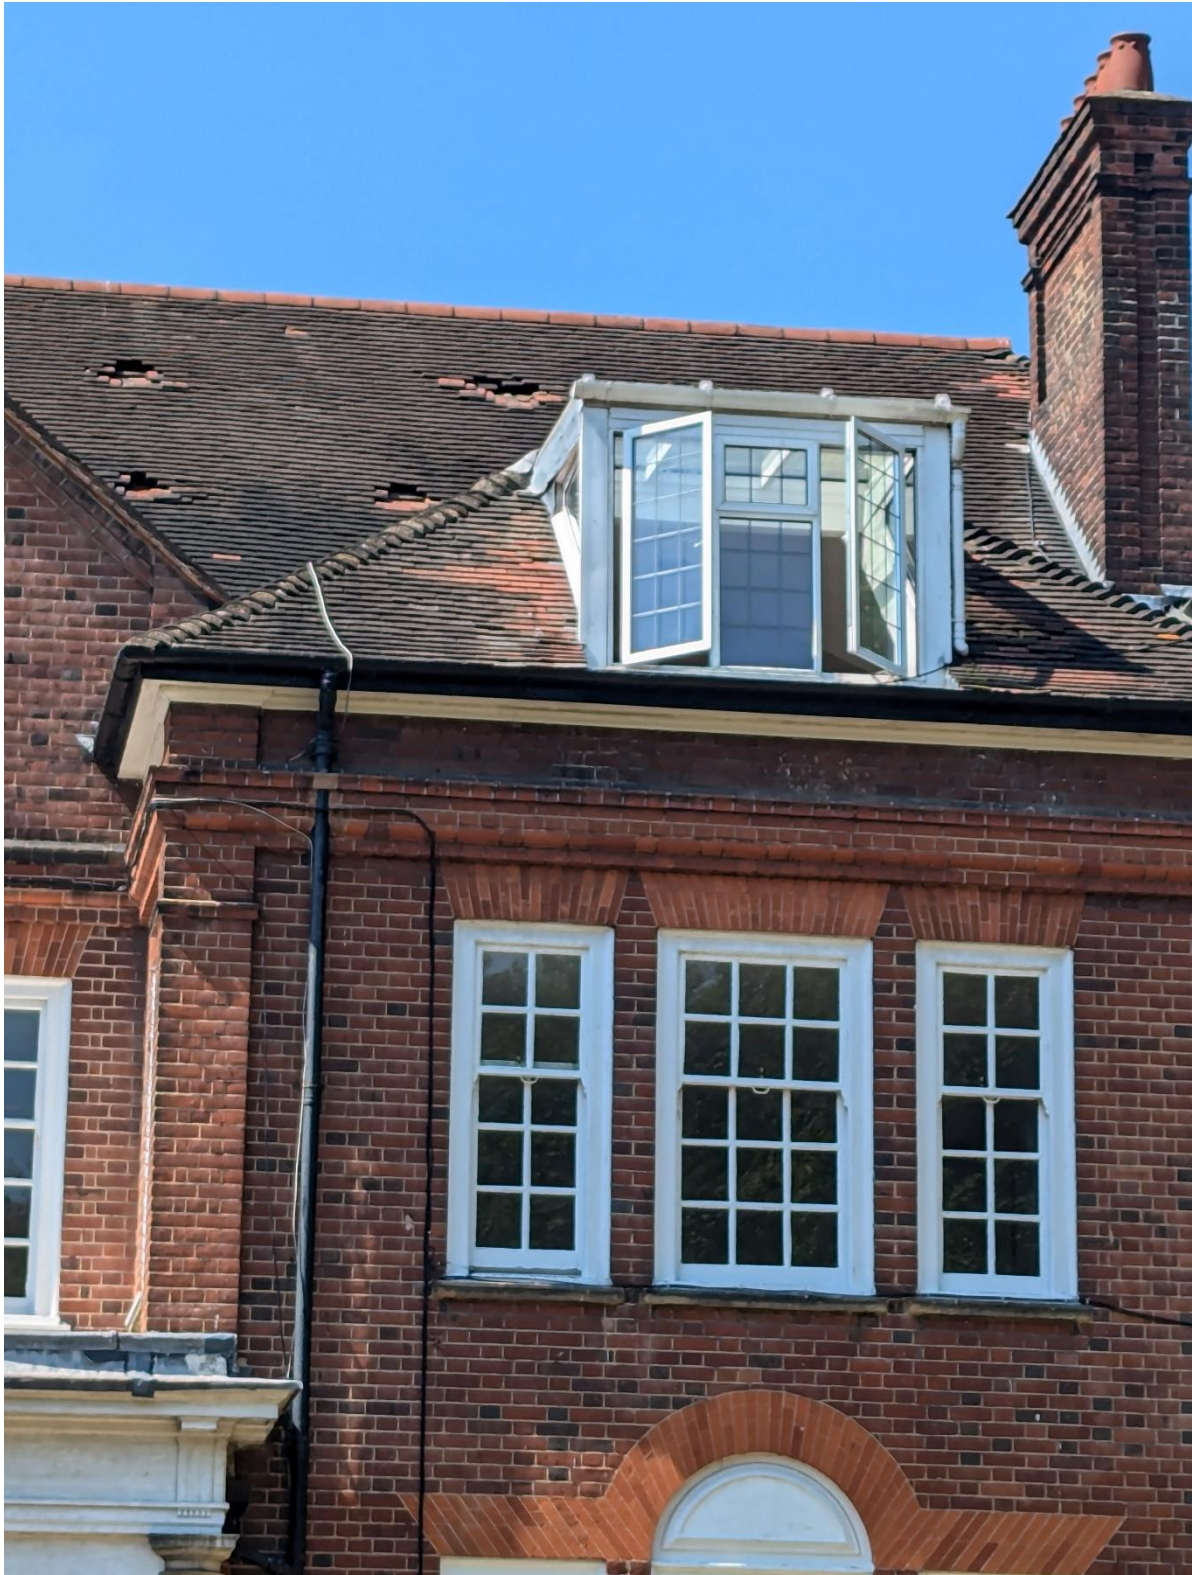
Figure 12: View of the rear roof slope. It is clear in this image the holes in the roof and the patch repairs around the glazed dormer. These holes are the source of the water ingress and associative damage throughout the property.

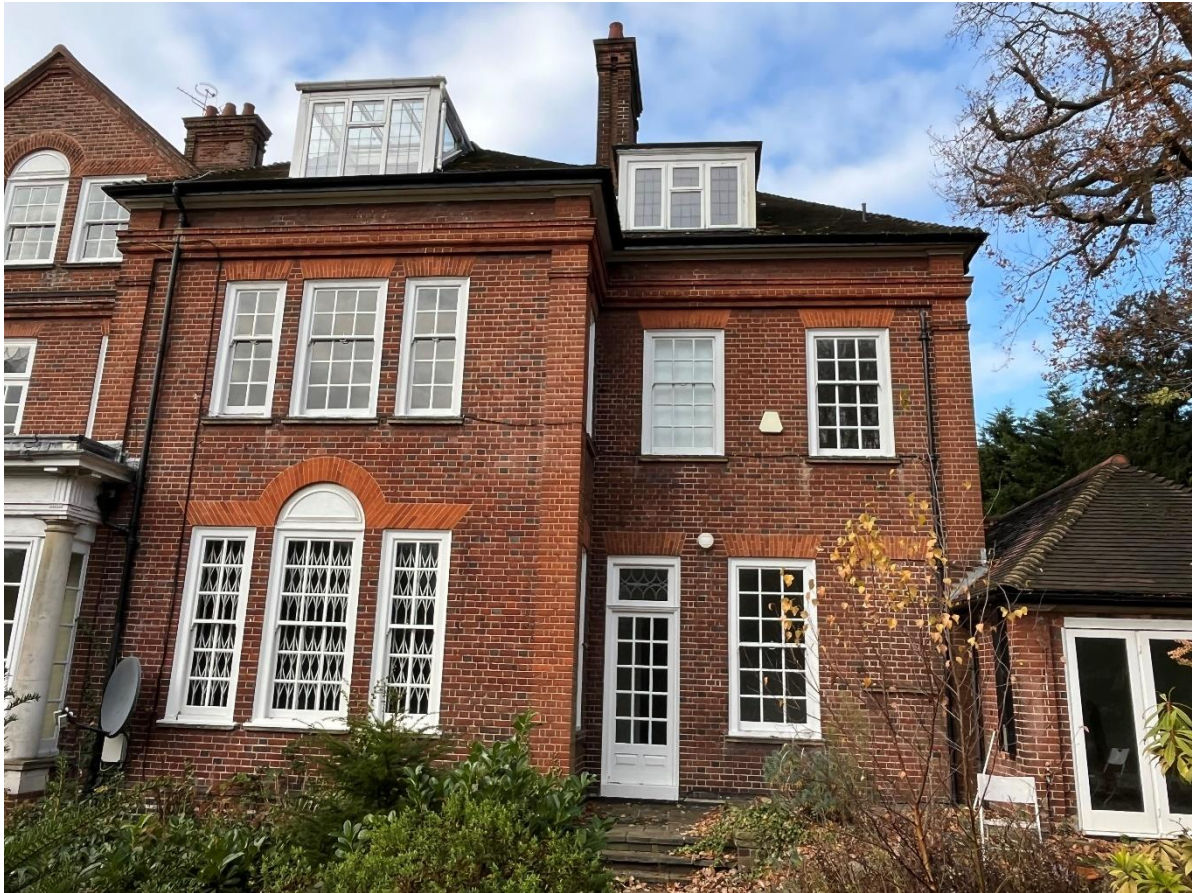
Figure 13: View of the fully glazed dormer at the rear.

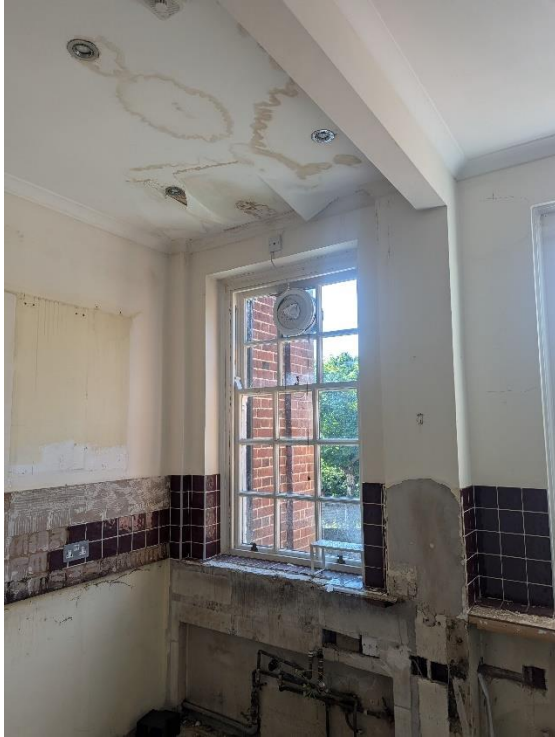
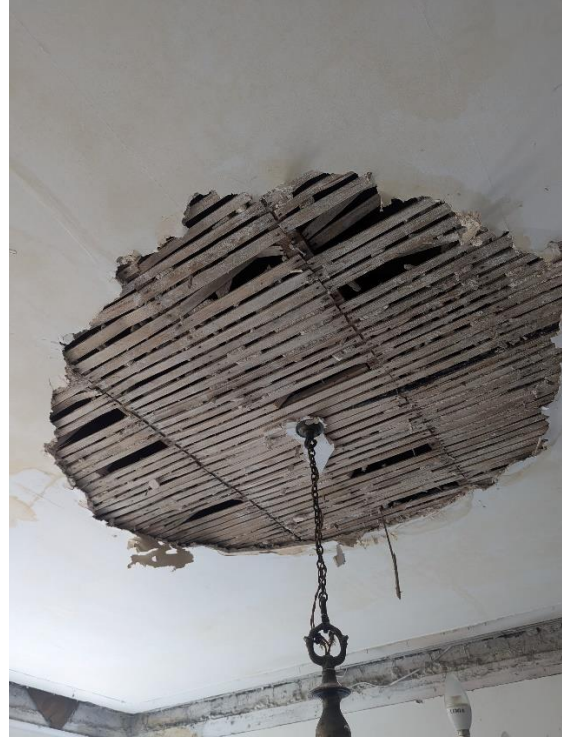
Figure 16: Left, water damage to ceiling on first floor, former kitchen, and right, water damage to lathe and plaster ceiling on the first floor in the stair hall. It is unknown whether there was a ceiling rose prior to the damage.

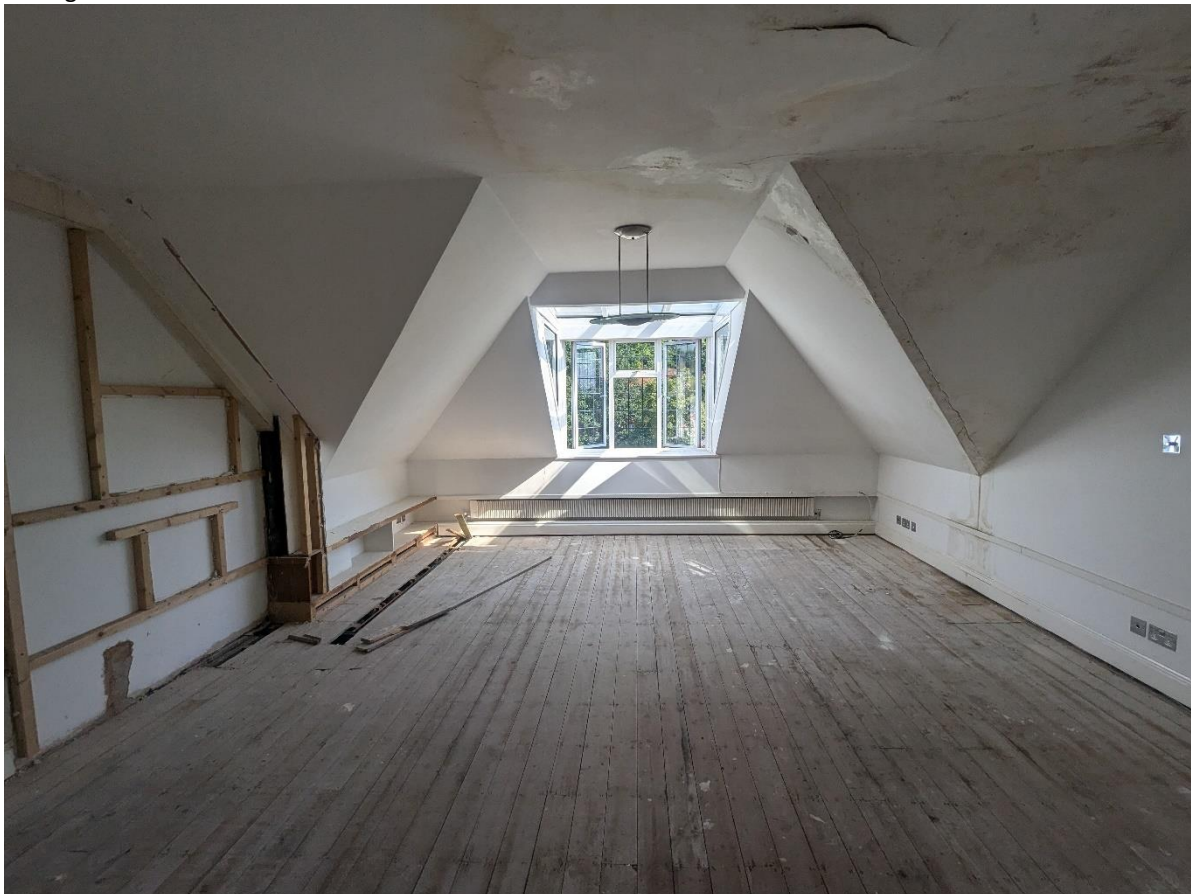
Figure 17: Water damage to the ceiling and dormer alcove.

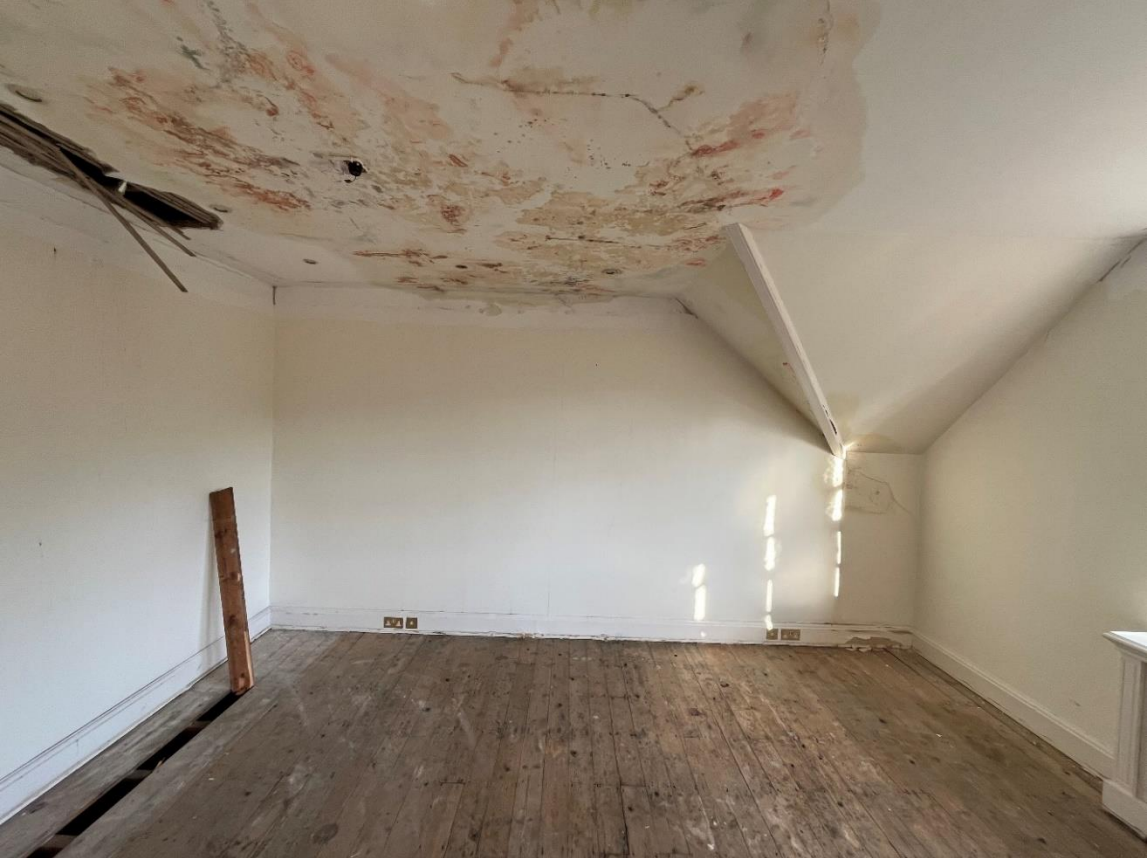
Figure 18: Water damage to lath and plaster ceiling on second floor.

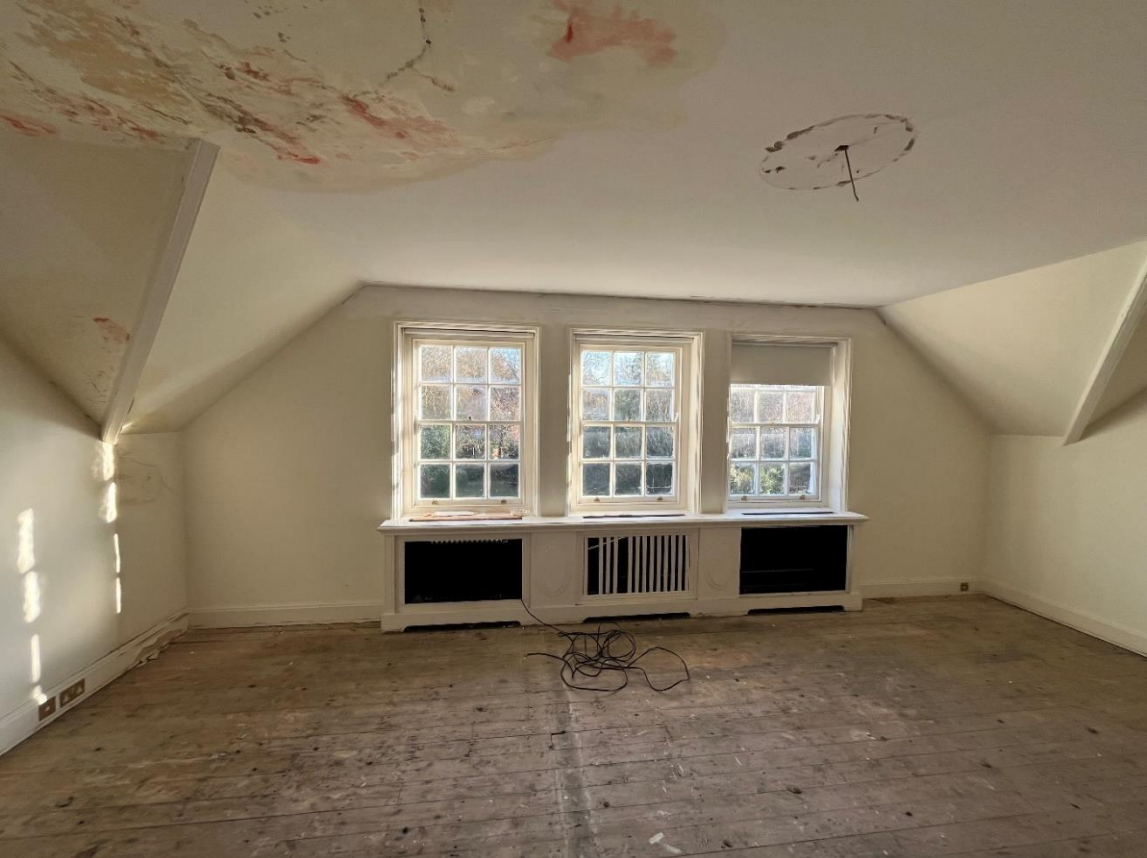
Figure 19: Water damage to lath and plaster ceiling on second floor.

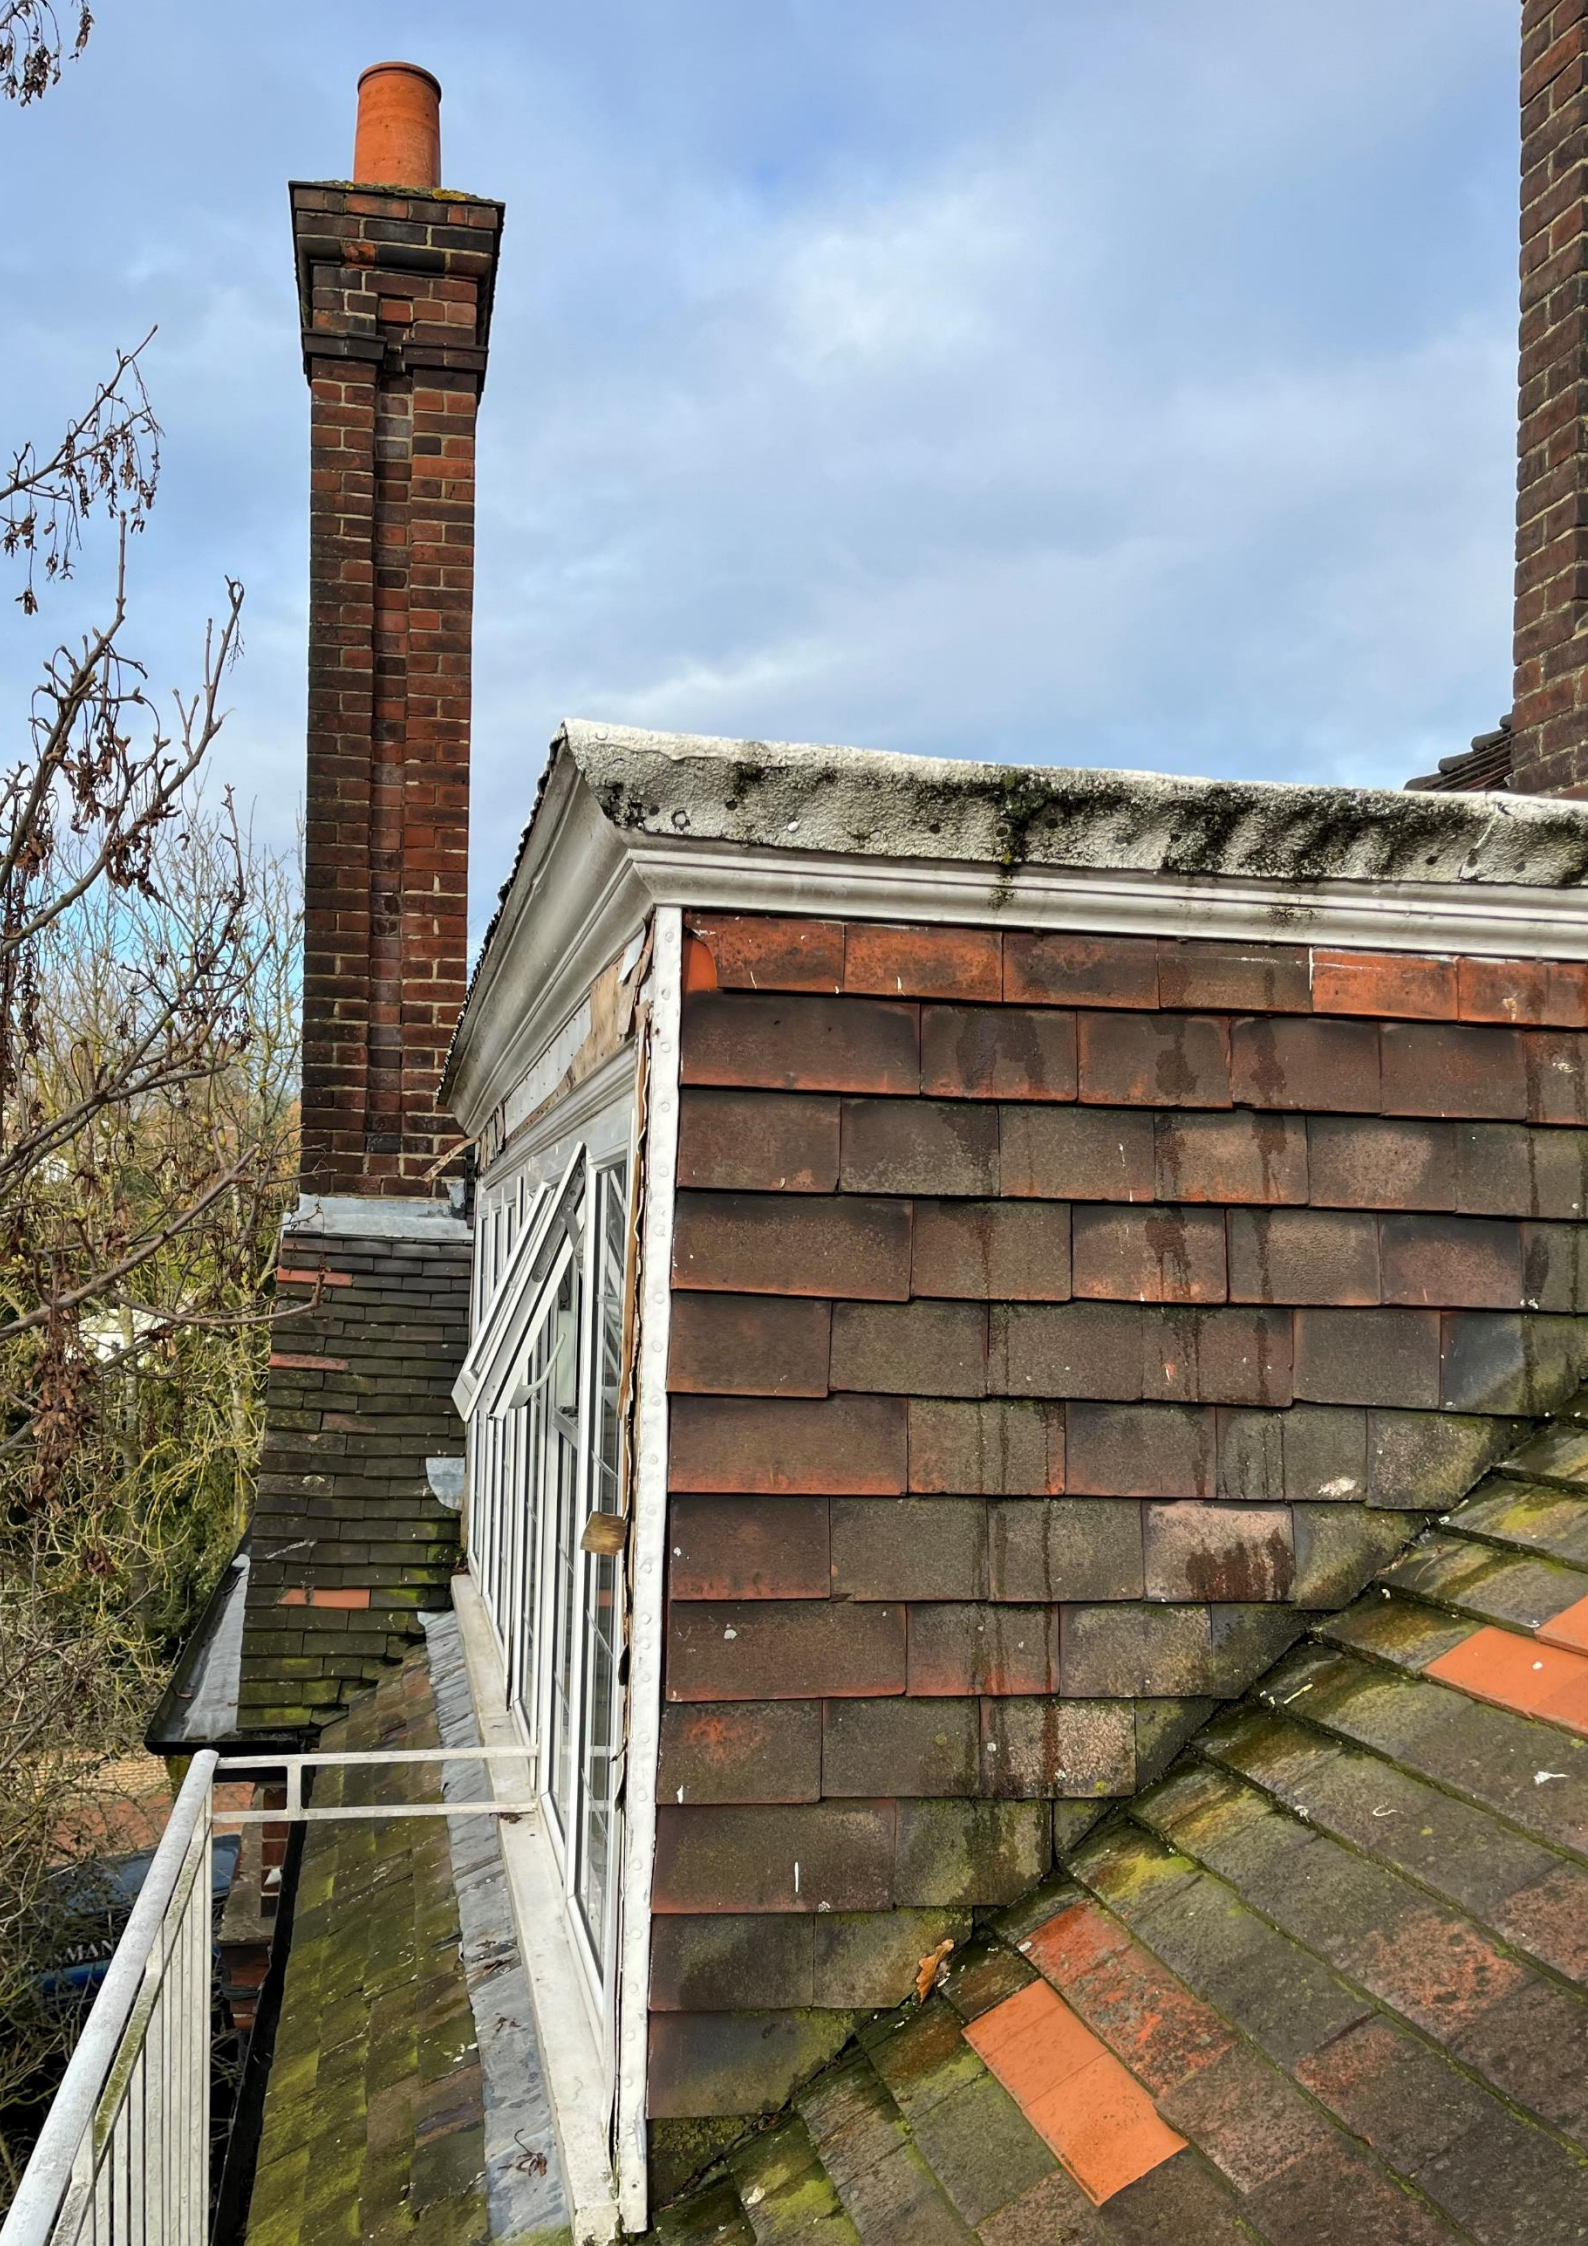
- **Substantial beneficial:** effects which ensure the long-term future of the most significant historic fabric by providing viable and appropriate uses and, impacts which substantially improve the setting of a Listed Building/historic parkland/Conservation Area, and which repair and conserve the most significant fabric of the Listed Building.
