STRUCTURAL ENGINEERING STATEMENT

UCL INSTITUTE OF EDUCATION

PHASE 2

(PLANNING APPLICATIONS 2a -2d)

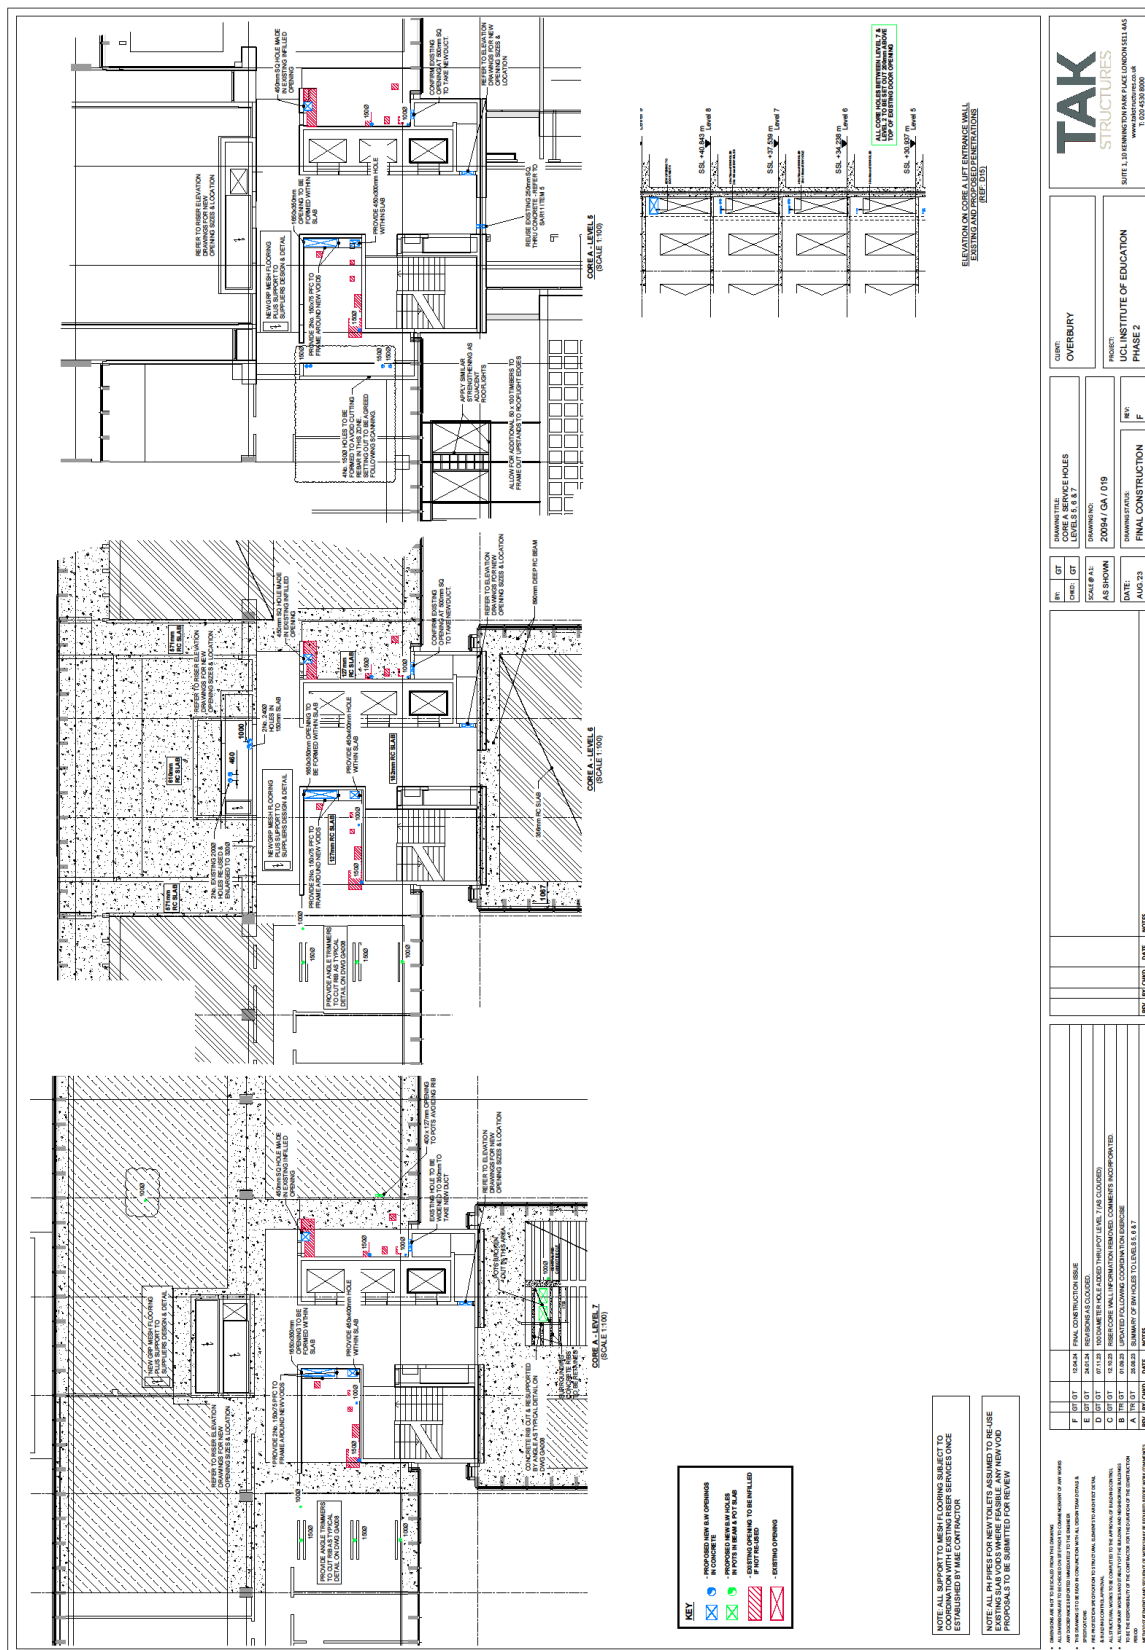
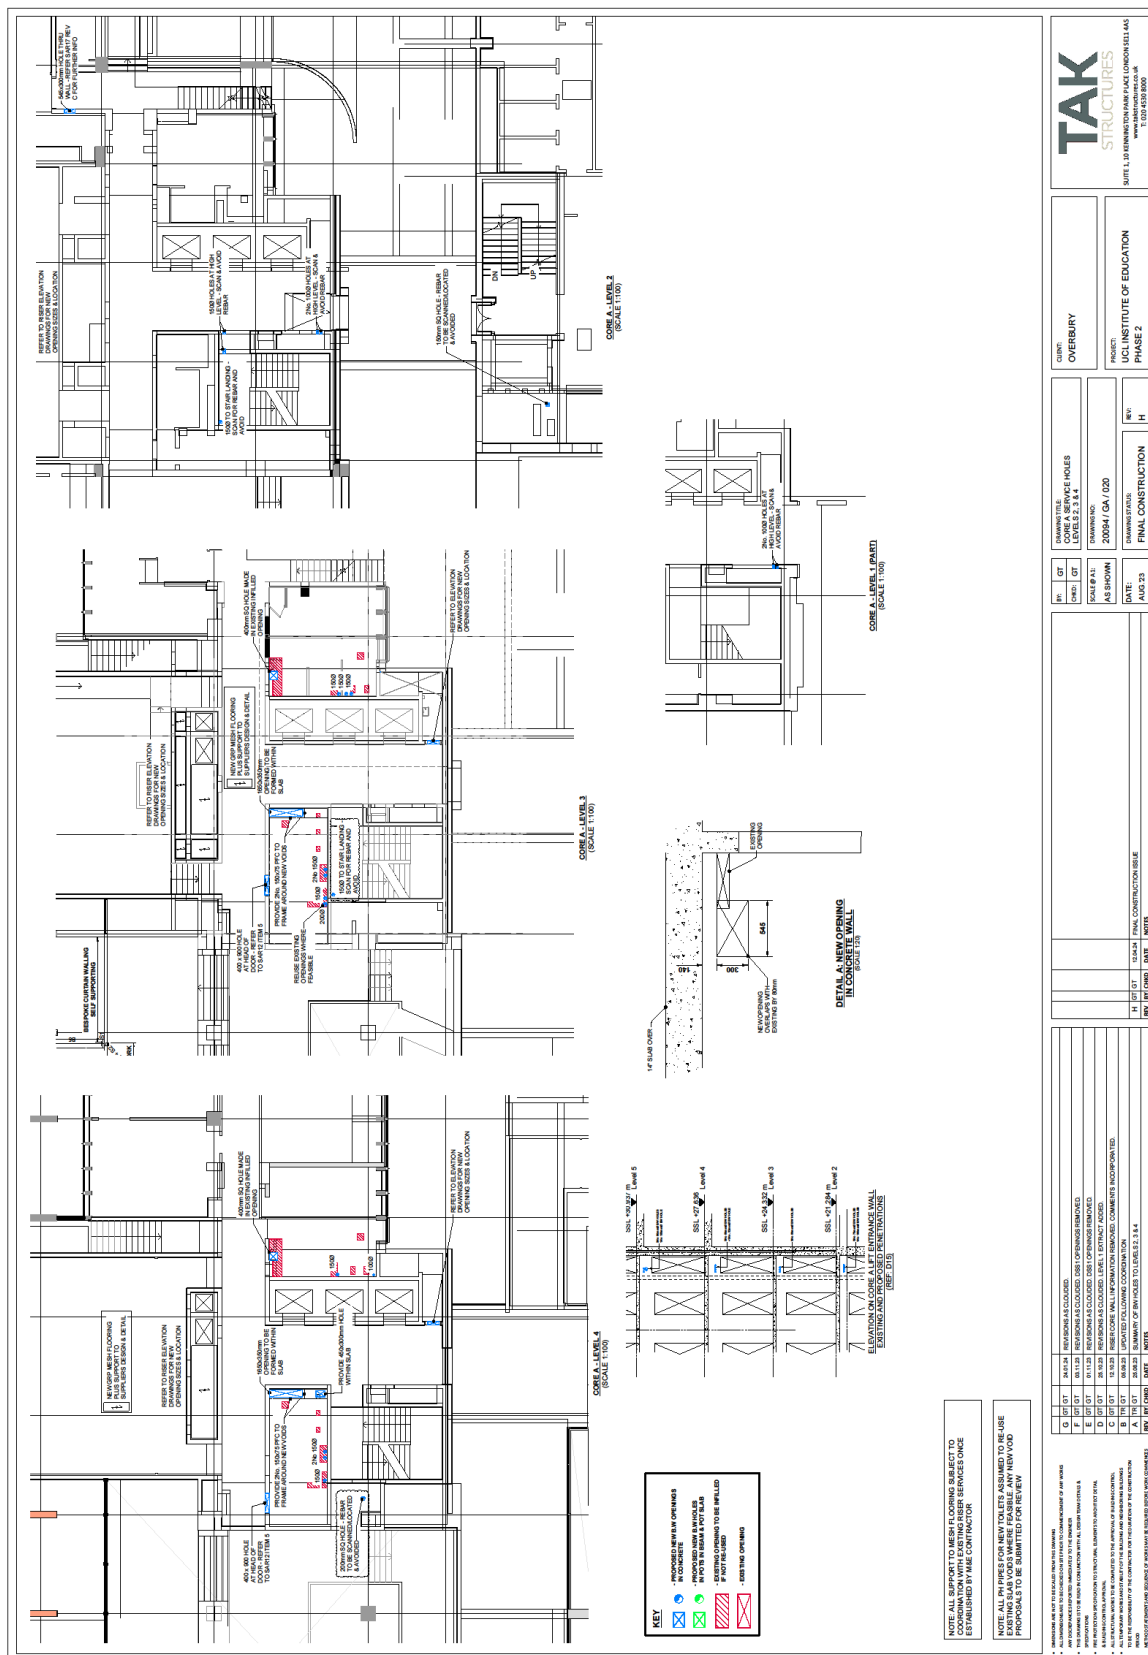
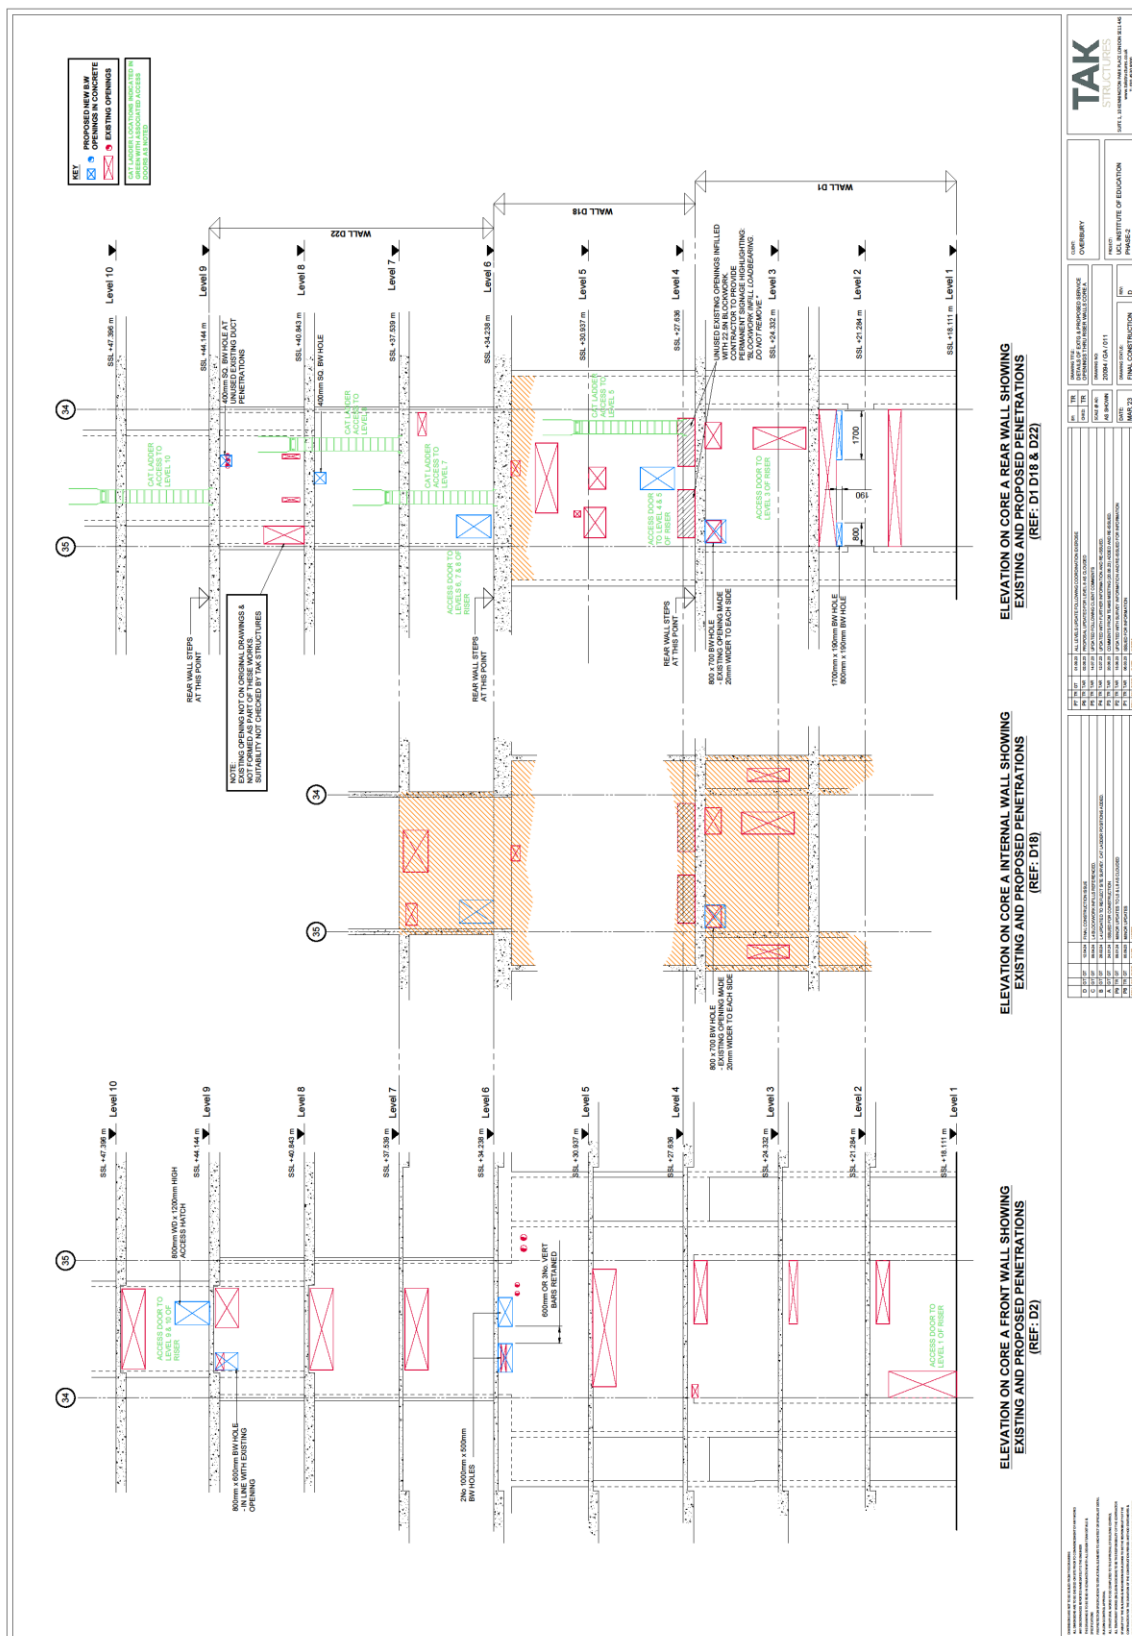
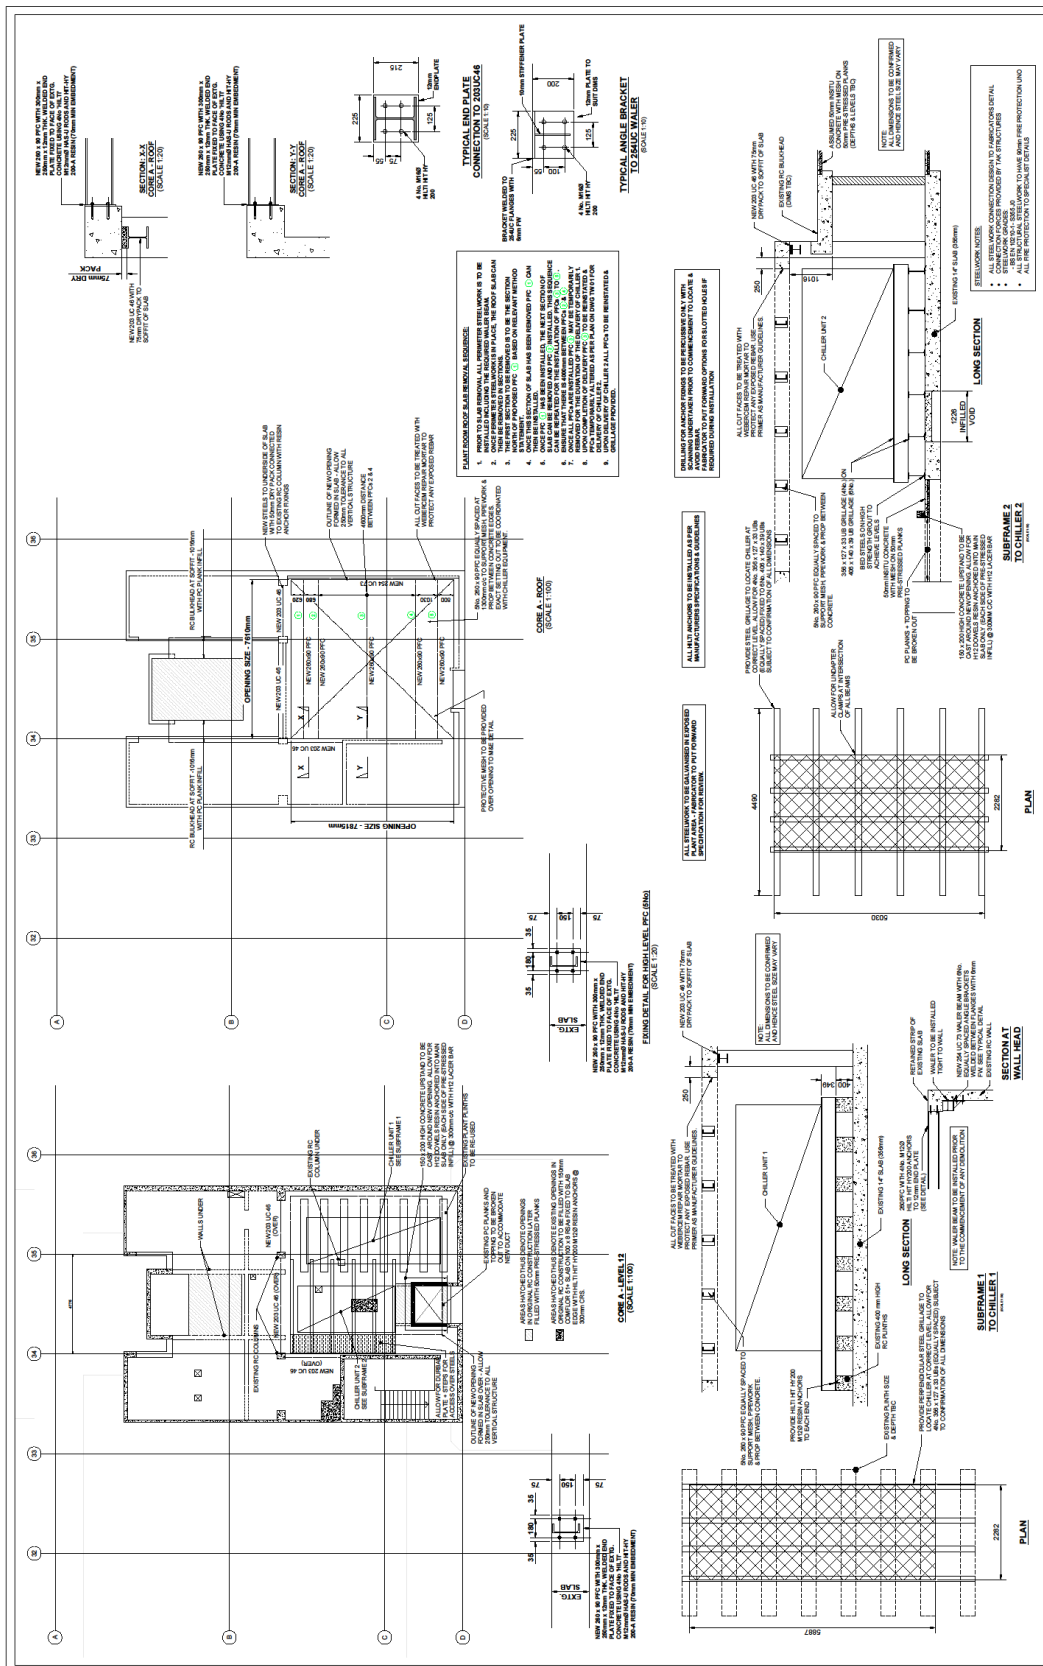
ELEVATION ON CORE A LEFT ENTRANCE WALL
EXISTING AND PROPOSED REINFORCEMENT

- 4.5 Where existing floor openings remained unused they were infilled with concrete.
- 4.6 Holes through (non-riser walls) were again located to suit existing reinforcement bars. Thorough assessments were made on the removal of sections of concrete and the adequacy of the remaining concrete sections checked.
- 4.7 Riser core walls to both cores A & B were modelled full-height via Finite Element analysis to provide an in-depth assessment on the proposed openings in the concrete. Key structural locations within the walls were design checked for adequacy due to the alterations. A summary of the extent of the new openings is included in the appendix to this report where red openings are existing original and blue are new.

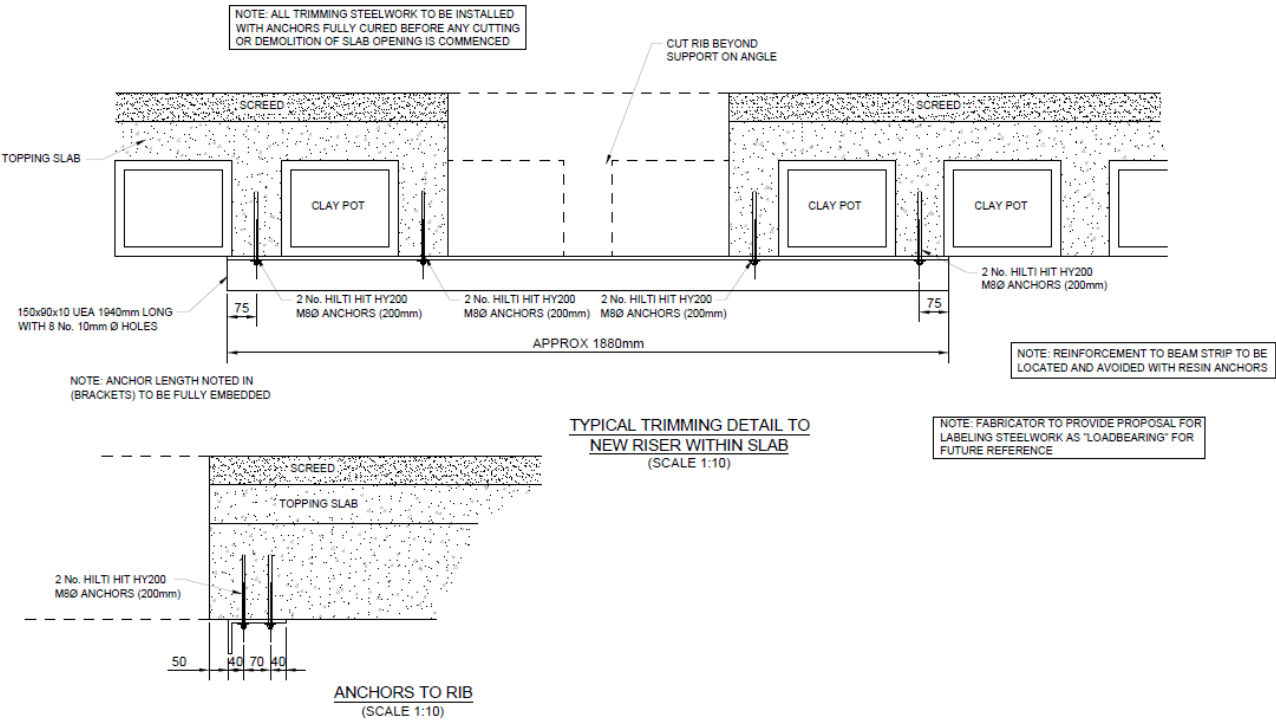
Rib trimming detail for Structural Alteration 02

- 1.2 These standalone risers are mostly orientated to be parallel with the ribs in the floors.
2. Alterations and Challenges
 - 2.1 Any increase in the holes will be parallel to the ribs to minimise their impact on the ribs.

- 2.2 It is the risers that are located in the beam strips that have had the greatest impact on the structure. Again, the same principle applies with any opening being extended across the width of the building, so the beam strip is not weakened further.

3. Solution
 - 3.1 Openings in slab to be in the direction of the ribs, i.e. across the width of the building.
 - 3.2 Enlarging any openings in the beam strips will be resisted as far as possible with duct routes altered to suit.

- 3.3 If necessary, trimming can be introduced to any ribs that need to be cut as SK01 Appendix 02.
