ADDENDUM ARBORICULTURAL REPORT

SUBSIDENCE CLAIM

22A Harley Road, Hampstead, London, NW3 3BN

15 August 2024

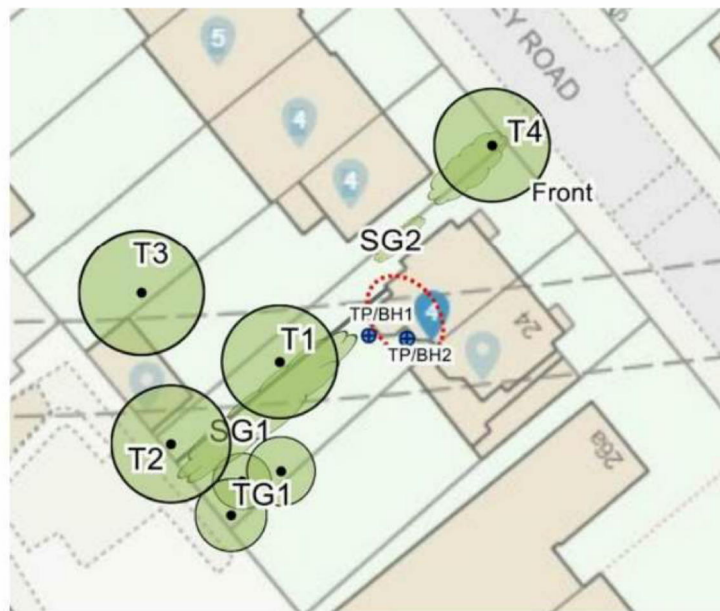
Plan not to scale – indicative only

Approximate areas of damage

Following our initial inspection it was established that the damage to the property was caused by subsidence, believed to be as a result of root induced clay shrinkage. The single storey rear bay and conservatory are the focal point of concern.

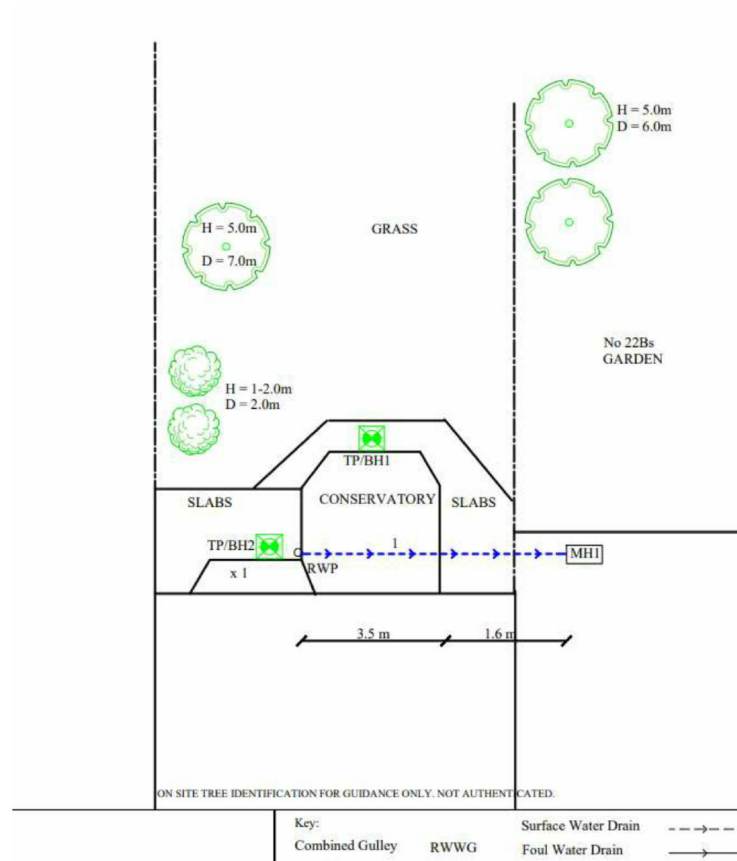
Site investigations undertaken 03/05/2022 confirm 370mm to 700mm deep foundations bearing on clay that has high to very high plasticity, meaning it can significantly change in volume due to seasonal variations in moisture content, particularly if influenced by tree roots extracting moisture.

Laboratory tests confirm significant desiccation has occurred where roots were observed, the moisture contents being at or significantly less than 0.5x the Liquid Limit at the depth of observed roots, this indicates abnormal soil drying in the presence of tree roots.

It is notable that the sampling was undertaken at a time of year when soil moisture deficits due to root activity would be low following winter rehydration prior to tree root activity during summer months and we would expect significantly drier soil during summer months when roots are active.

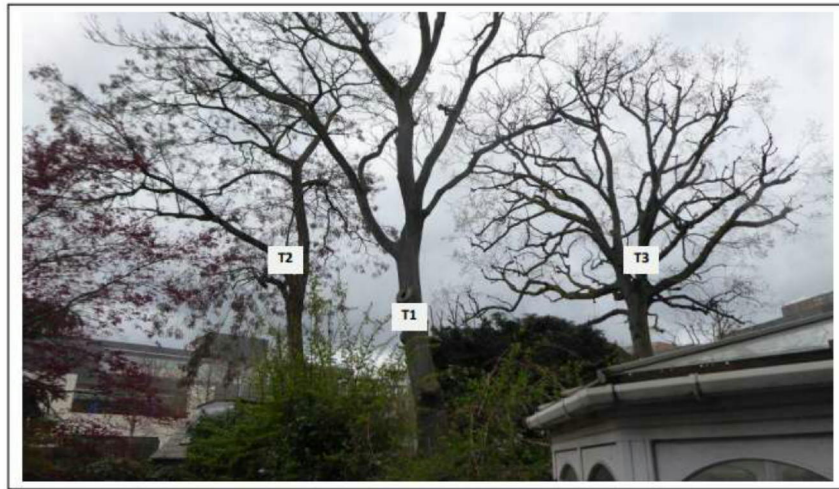
View of T1 Tree of Heaven, T2 False Acacia and T3 Oak

The trees T1 & T2, at 7.8m and 15m, are therefore within their species' potential rooting and influencing distance of the building and would be capable of causing seasonal soil drying beneath foundations. The site investigations confirm significant rooting beneath foundations in any event.

Root identification positively implicates Ailanthus T1 & False Acacia T2 in the damage.

T1 Tree of Heaven - Fell to near ground level (subject to consent being granted under the TPO)

T2 False Acacia – Fell to near ground level (subject to consent being granted under the TPO)

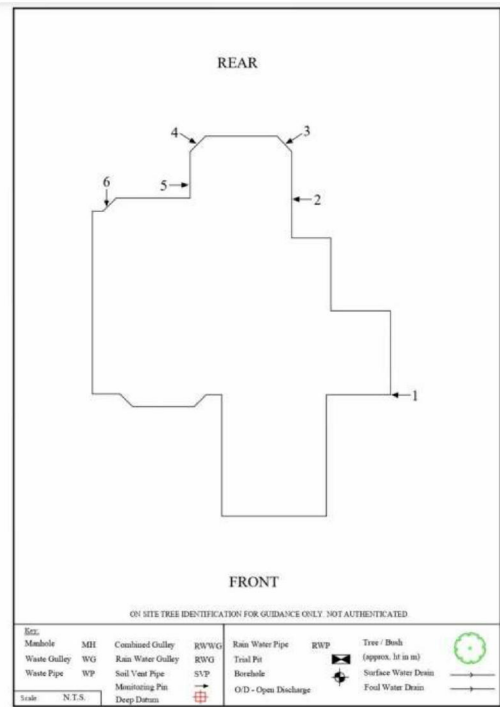
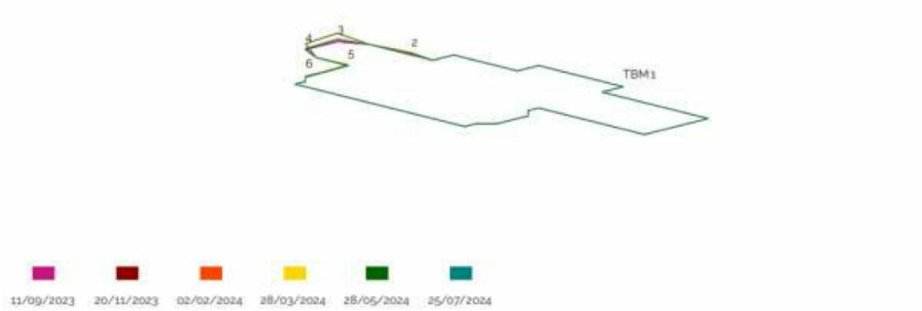
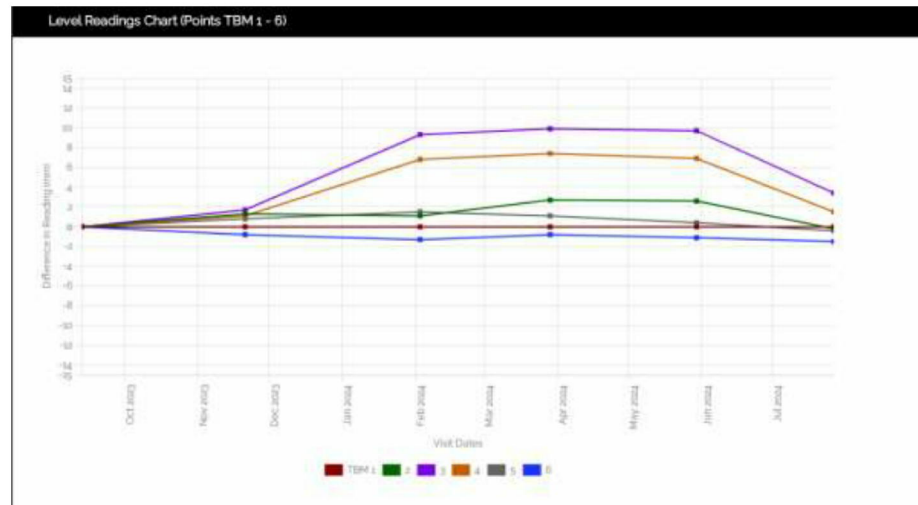
Precise Level Monitoring

Relative Movement (Relative Survey, for illustration purposes only)

The level monitoring indicates a clear seasonal and cyclical pattern of movement consistent with root induced clay shrinkage, foundations moving upwards during winter months then downward during summer months, with the greatest amplitude of movement being consistent with the locations of trees T1 & T2.
