ARCHER HUMPHRYES ARCHITECTS

Presentation of duct to AV room and various options of possible re-route Date: 30 - 09 - 2022

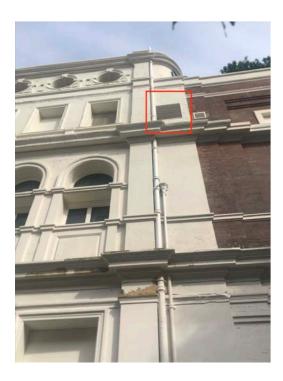
Image 1: showing front elevation

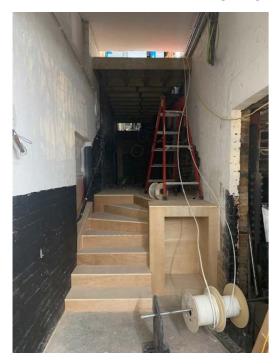
Image 2: Double height space converted into AV room – As built

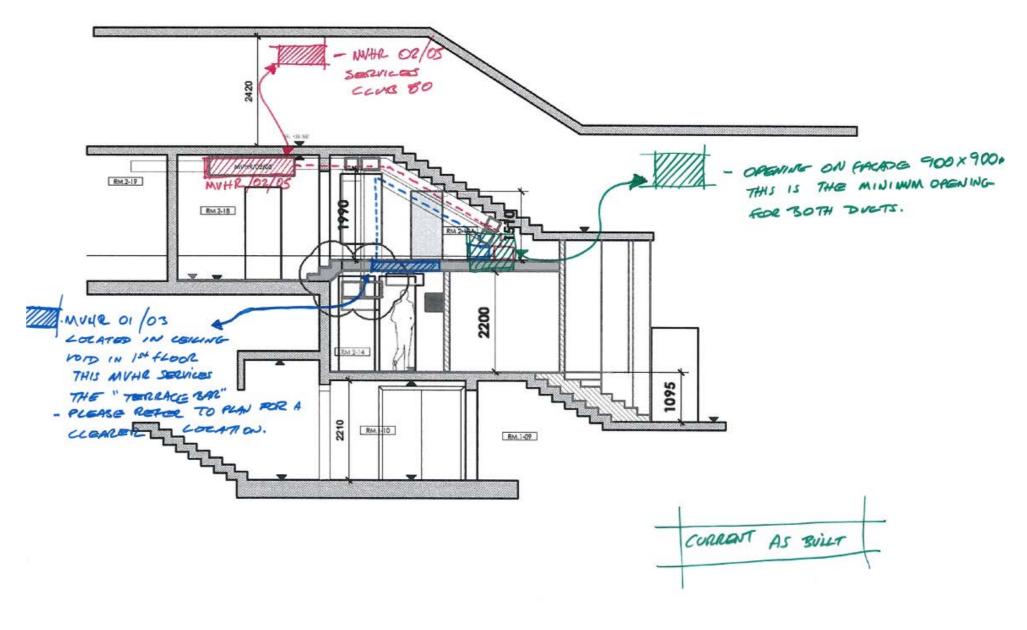
Image 6: Current location of MVHR 01/03 shown in Blue, this is currently now closed in by new listed decorative ceilings.

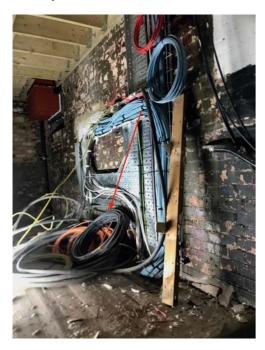
Image 3: Lower part of AV room

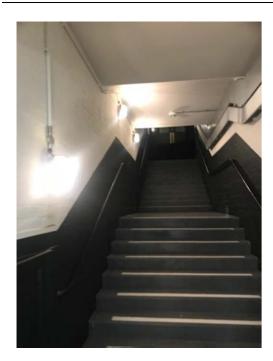
Image 4: Escape stair shown here with electrical tray on the right shown on the sketch as pink route.

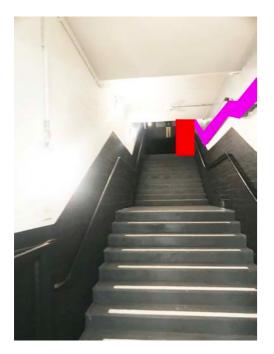
Image 5: Pink line shows electrics – RED duct location in schematic depiction.

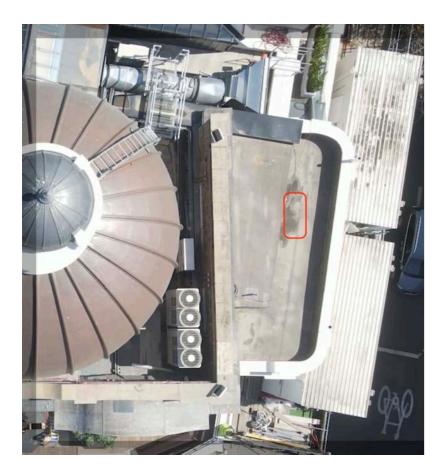
Image 5: RED area shows potentially duct penetration through roof slab.

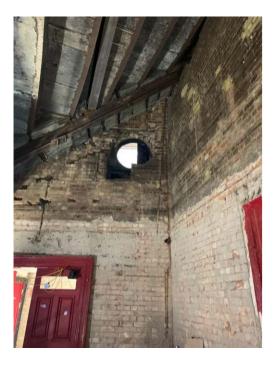
Image 6: Current location of MVHR 01/03 shown in Blue, this is currently now closed in by new listed decorative ceilings.

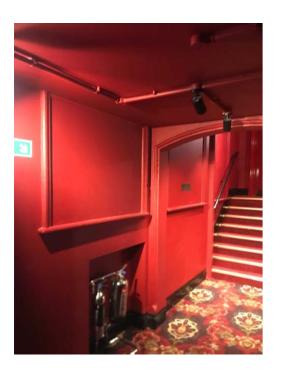
Image 6: Window in corridor below the AV room We cannot penetrate these windows as they are listed painted glass. Please refer to the image below. Therefore we would have to go to a level below.

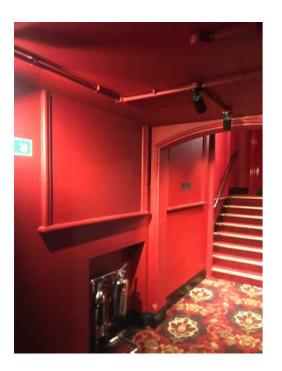
Image 6: Window in corridor RM - 10 below the AV room in first floor shown on sketch.

We cannot make opening on these windows as they are listed painted glass. Please refer to the image below. Therefore, we would have to go to a level below. Please see comments below on this option from consultants.
