Appendix A – Front elevation of the site

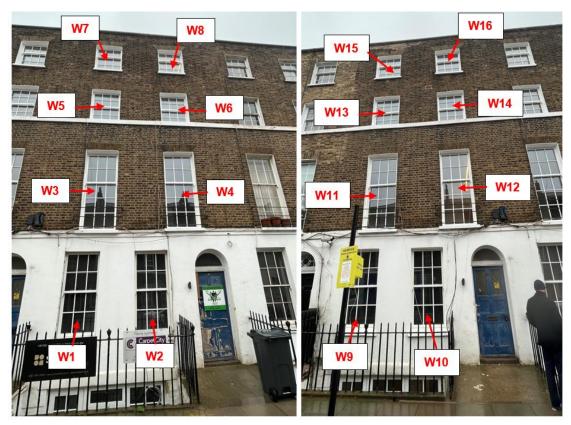
No.18 [left] and 20 [right] – SIXTEEN unauthorised laminated timber/composite sash windows (**W1 - W16**) - ground to third floor levels.

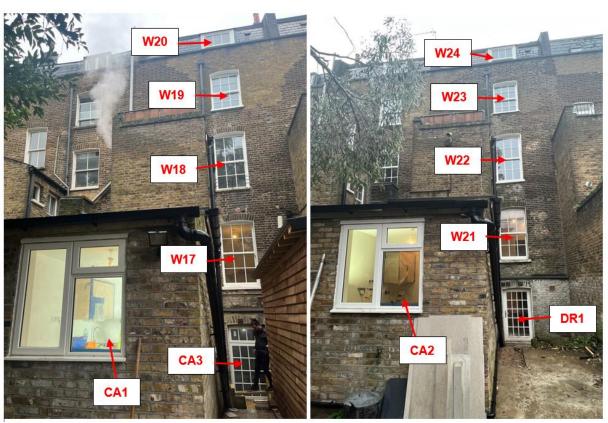
Appendix B - Rear Elevation of the site

No.18 [left] & 20 [right]: EIGHT unauthorised laminated timber/composite sash windows (**W17 - W24**), TWO unauthorised laminated timber/composite casement windows (**CA1 & CA2**), ONE unauthorised laminated timber/composite top-hung casement window (**CA3**), ONE unauthorised laminated timber/composite door (**DR1**) - basement to third floor levels.

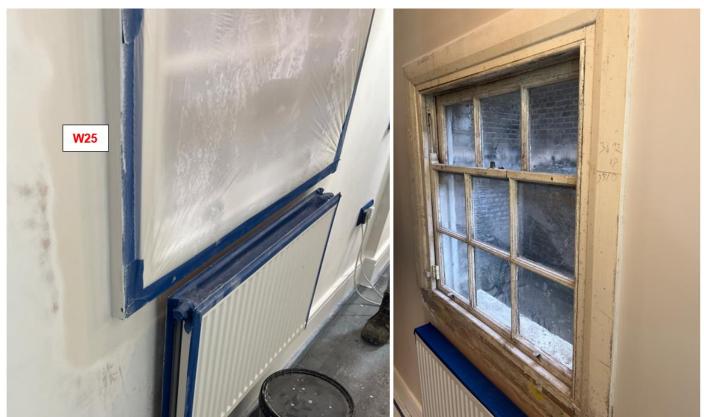
Appendix C – Flank elevation sash windows of the rear extensions

No.18 [left] & 20 [right]: ONE unauthorised laminated timber/composite sash windows (No.18 only) (**W25**) – ground floor.

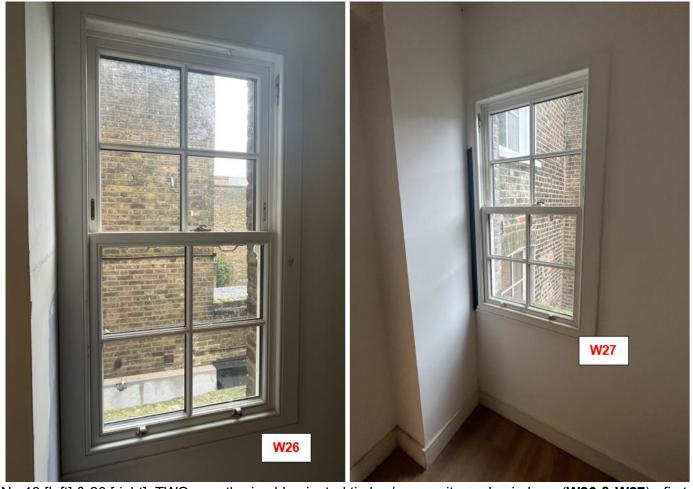
No.18 [left] & 20 [right]: TWO unauthorised laminated timber/composite sash windows (**W26 & W27**) - first floor.

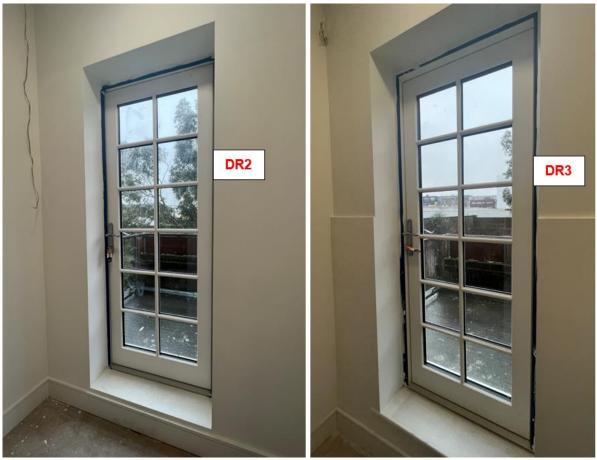
Appendix D – Rear terrace doors at the second floor rear extension

No.18 [left] & 20 [right]: TWO unauthorised laminated timber/composite doors (DR2 & DR3).
