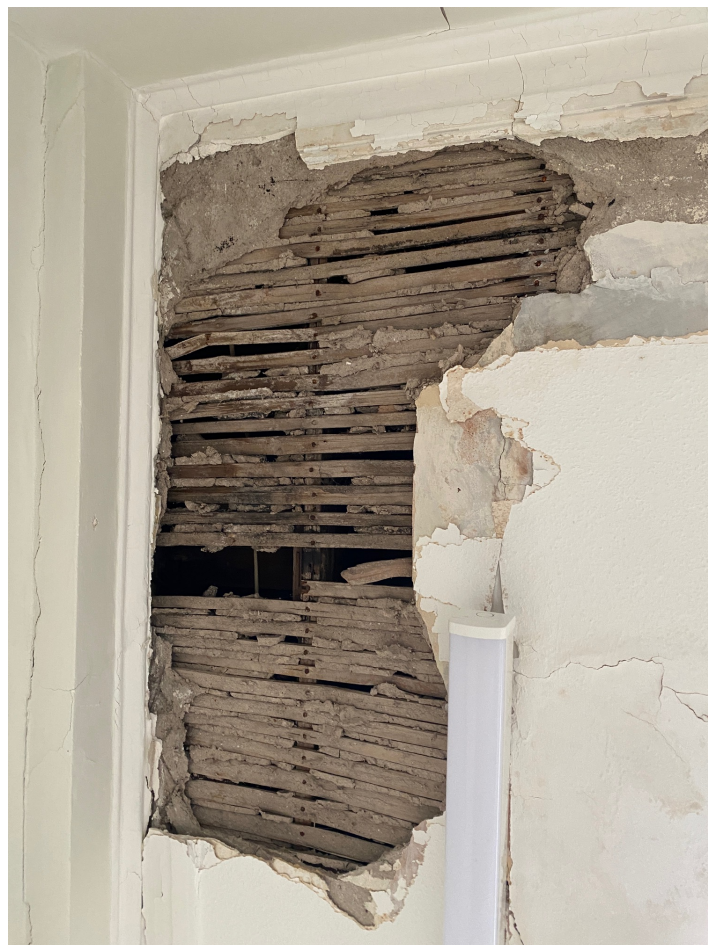
The lath and plaster ceiling and wall finish will be protected and retained where possible. Where it has failed or blown or is damaged due to water ingress it will be carefully repaired.

Lath and Plaster Ceiling

“The lath-and-plaster construction build up of the ceiling is to be retained and stabilised where possible. Ceiling lights and smoke/heat detectors will not be recessed within the lath-and-plaster ceilings but will be surface mounted and fixed through the lath-and-plaster ceiling directly into the structural timber collar ties of the roof. This is to avoid any additional weight being added to the lath-and-plaster ceiling. Any required cabling will be laid from above, when the roof is repaired, avoiding any unnecessary disturbance to the existing ceiling build up.”

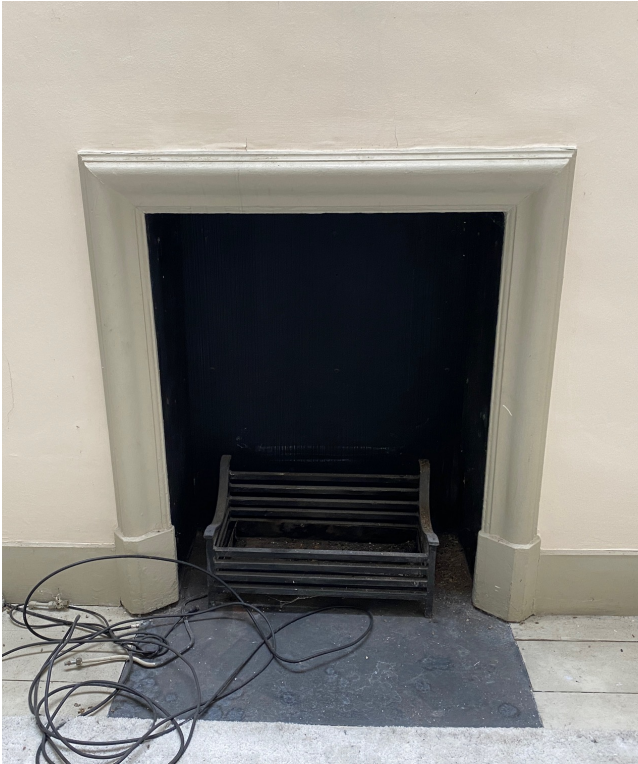
In The Painting Room the existing fireplace surround, corbel, mantel, hearth and size of the opening is not original. A painting by William Logsdail at 5 Primrose Hill Studios in 1883 (below) indicates a much grander fireplace and surround. The intention is to open the fireplace up to its original reveal size. Likewise the bricked up fireplace in the Models' "Retiring" room is to be unblocked and reinstated.

Painting Room Fireplace

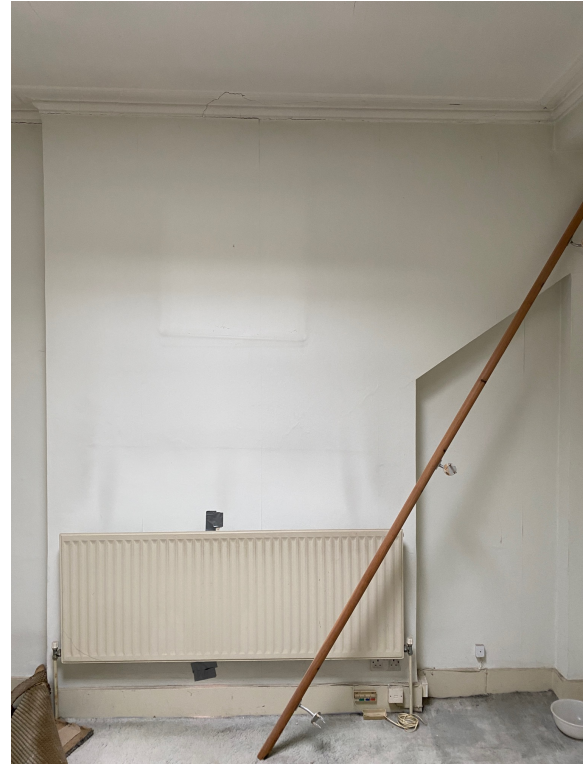
Models' "Retiring" Room Blocked up Fireplace

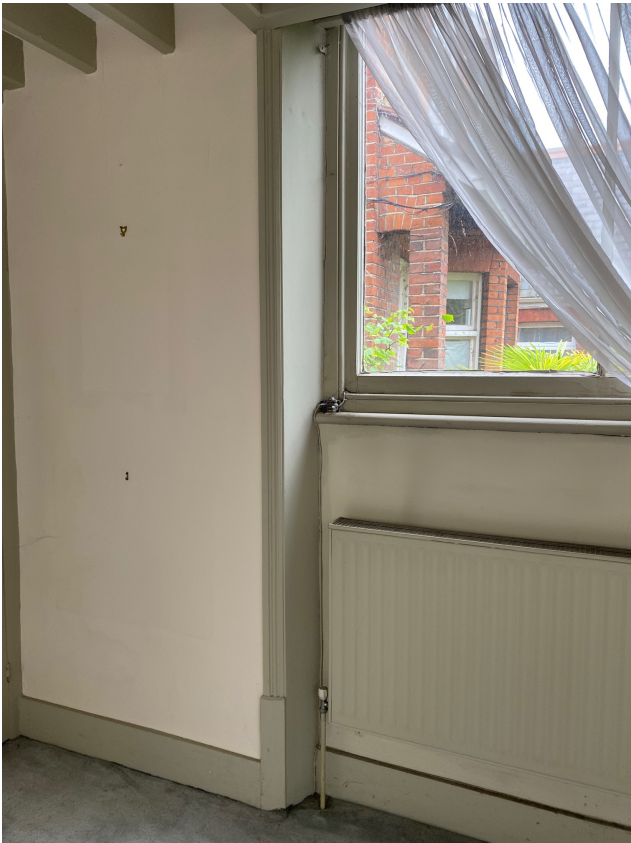
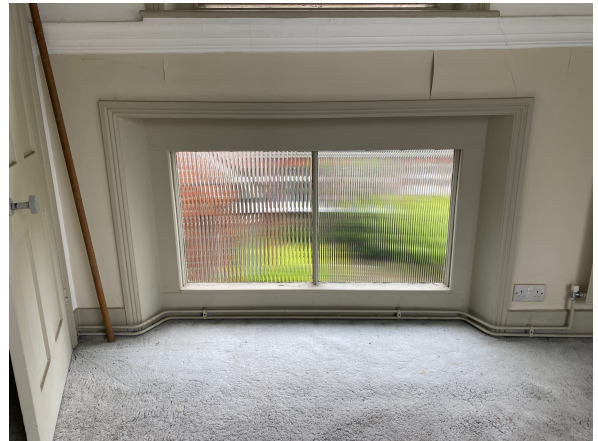
View of the timber lining above and below the mezzanine to the large window

The large window to The Painting Room (bisected by the mezzanine) and the small sash window on the mezzanine above have timber lining to their reveals. These timber linings are to be carefully protected, retained and refurbished.

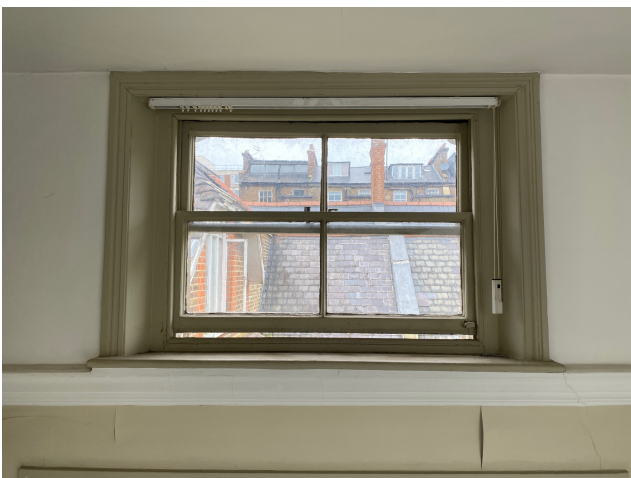
View of the timber lining to the small sash window on the mezzanine

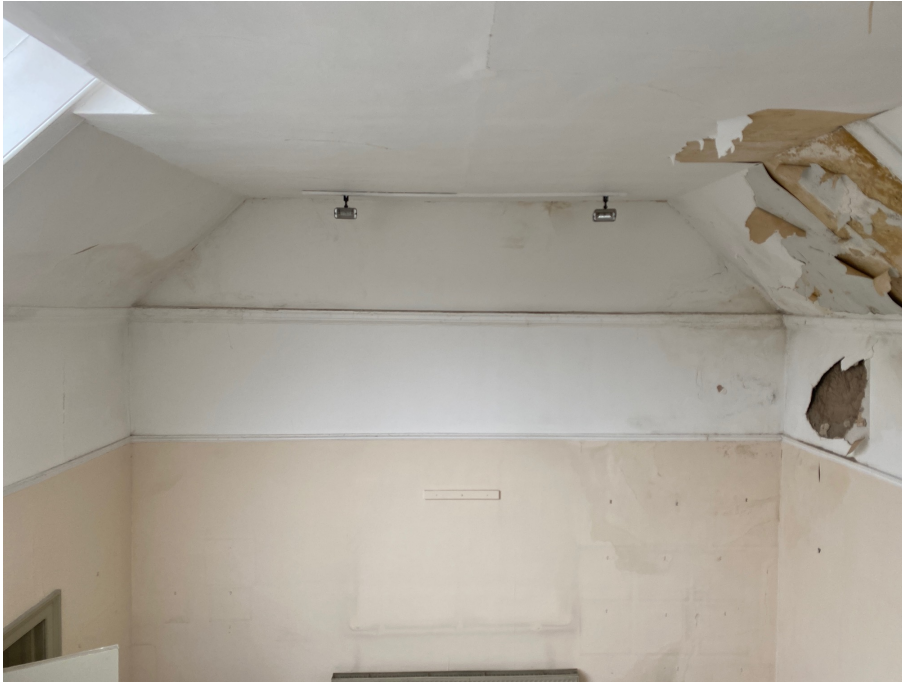
View of cornice with the timber picture rail below

Throughout the Painting Room is a timber picture rail and a plaster cornice. These are to be carefully protected, retained and refurbished. Elsewhere the only surviving original cornice is in the Models' "Retiring" Room (pictured in Section 8 above the blocked up fireplace) This will be protected, retained and refurbished.

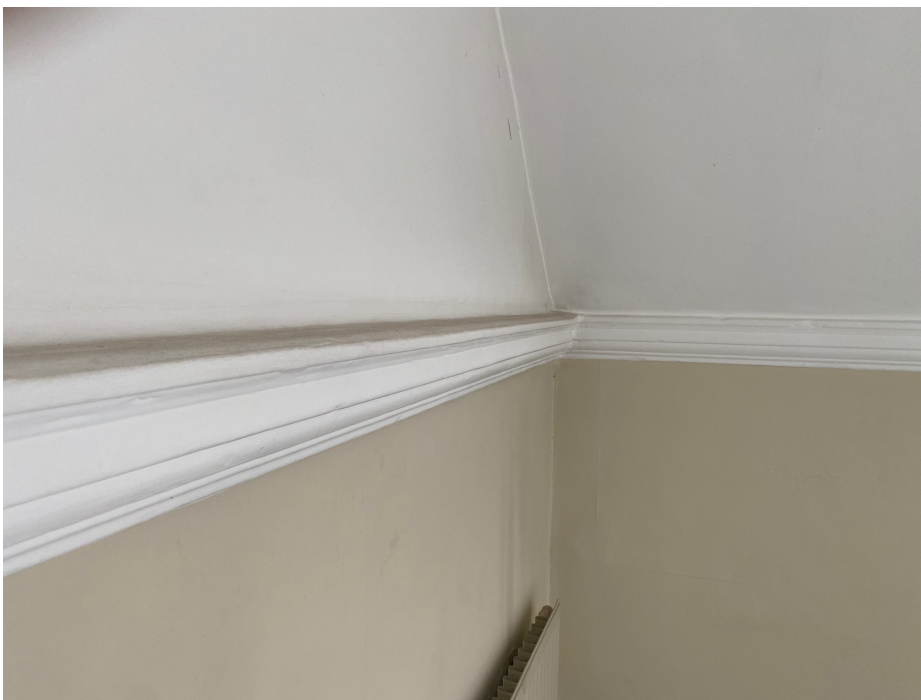
View of cornice with the timber picture rail below

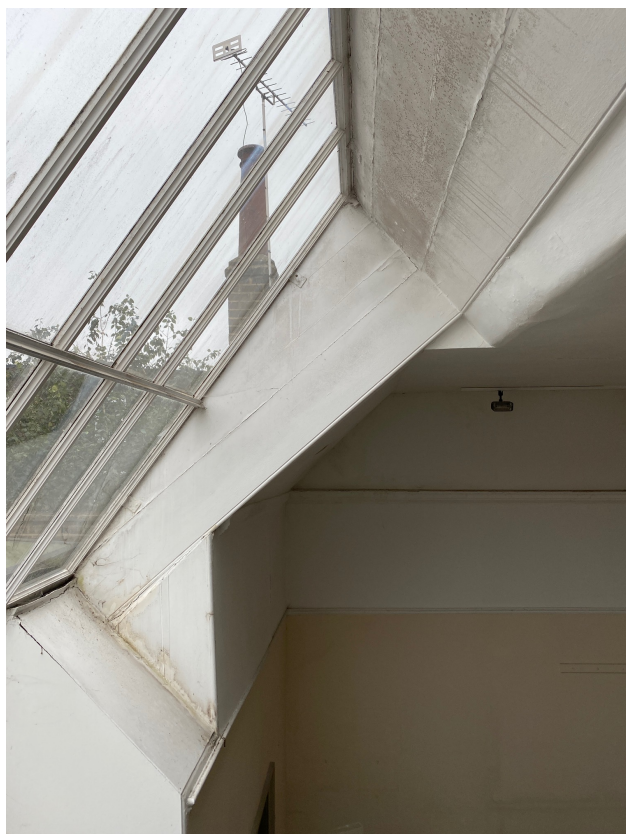
Timber panelling to North Rooflight.

The timber panelling to the rooflight reveals are to be retained and refurbished.

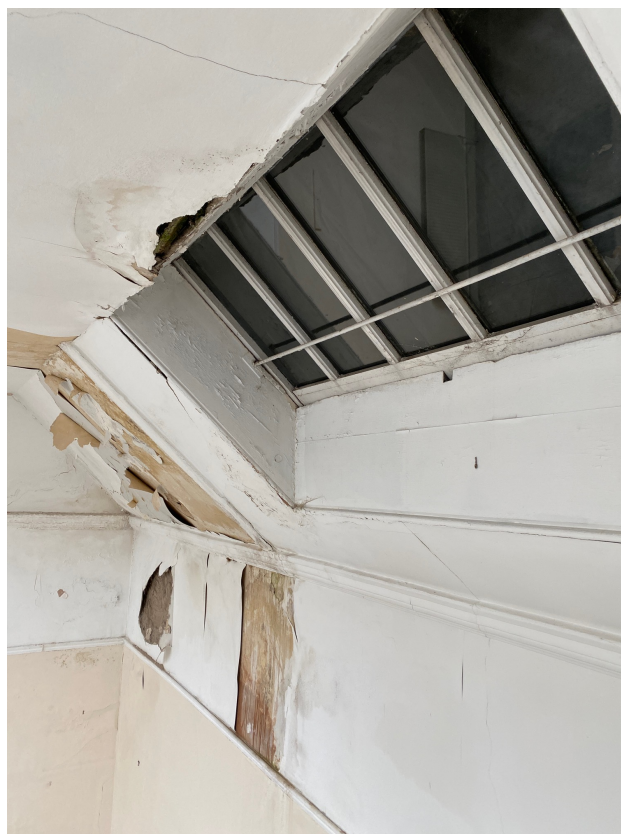
Timber panelling to South Rooflight
