**B.S. 5837 Arboricultural Report
Implications Assessment
at
10 Abbots Place
Maida Vale
NW6 4NP**

**Client: James Wainwright
10 Abbots Place
Maida Vale
NW6 4NP**

Prepared by
Simon Hawkins Dip Arb L6 (ABC) N.D Arbor M. Arbor. A.

Date
19/12/2023

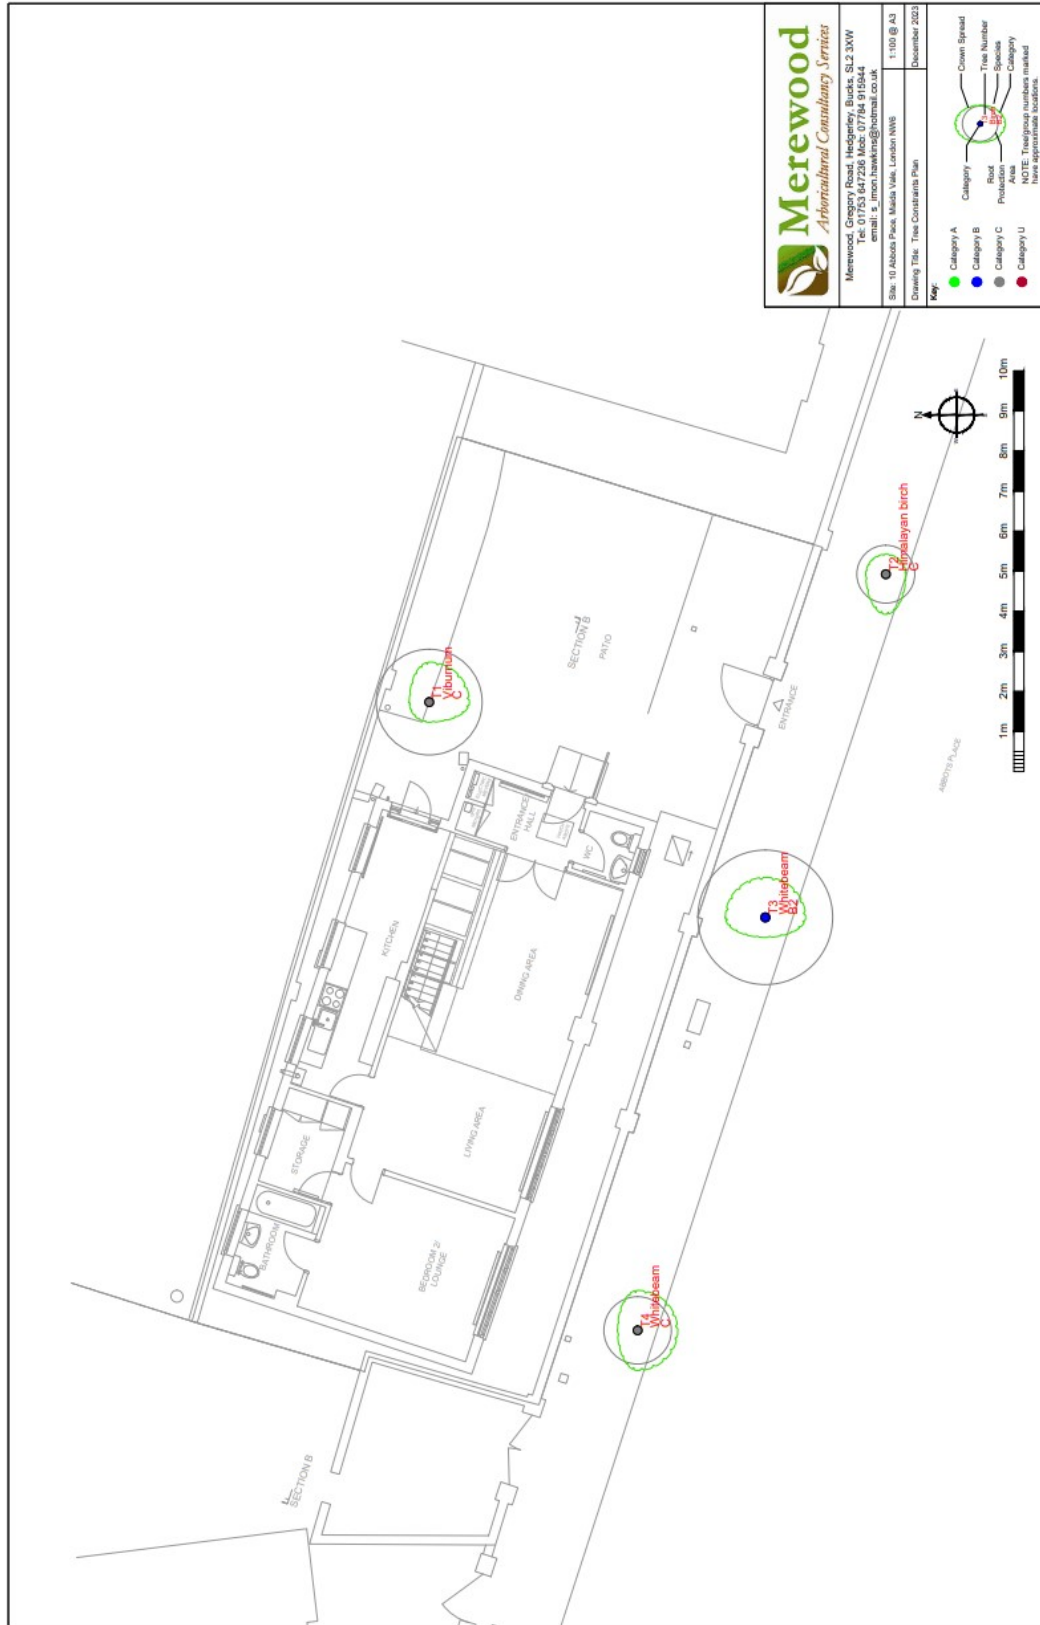
Plan of Tree Constraints

Tree no	Species	Height	Stem diameter	Crown spread				Physiological condition	Structural condition	Age	Observations/ Management recommendations	Life expectancy	Category
				North	South	East	West						
T1	Viburnum	4	110	0.5	1	1	0.5	G	G	M	A mature shrub	40+	C
T2	Himalayan birch	6	60	0.5	0.5	0.5	1	G	G	Y	Newly planted tree	40+	C
T3	Whitebeam	7	140	1	1	1	0.5	G	G	M/A	Established street tree	40+	B2
T4	Whitebeam	4	70	0.5	1	1	1	G	G	M/A	Establishing street tree	40+	C

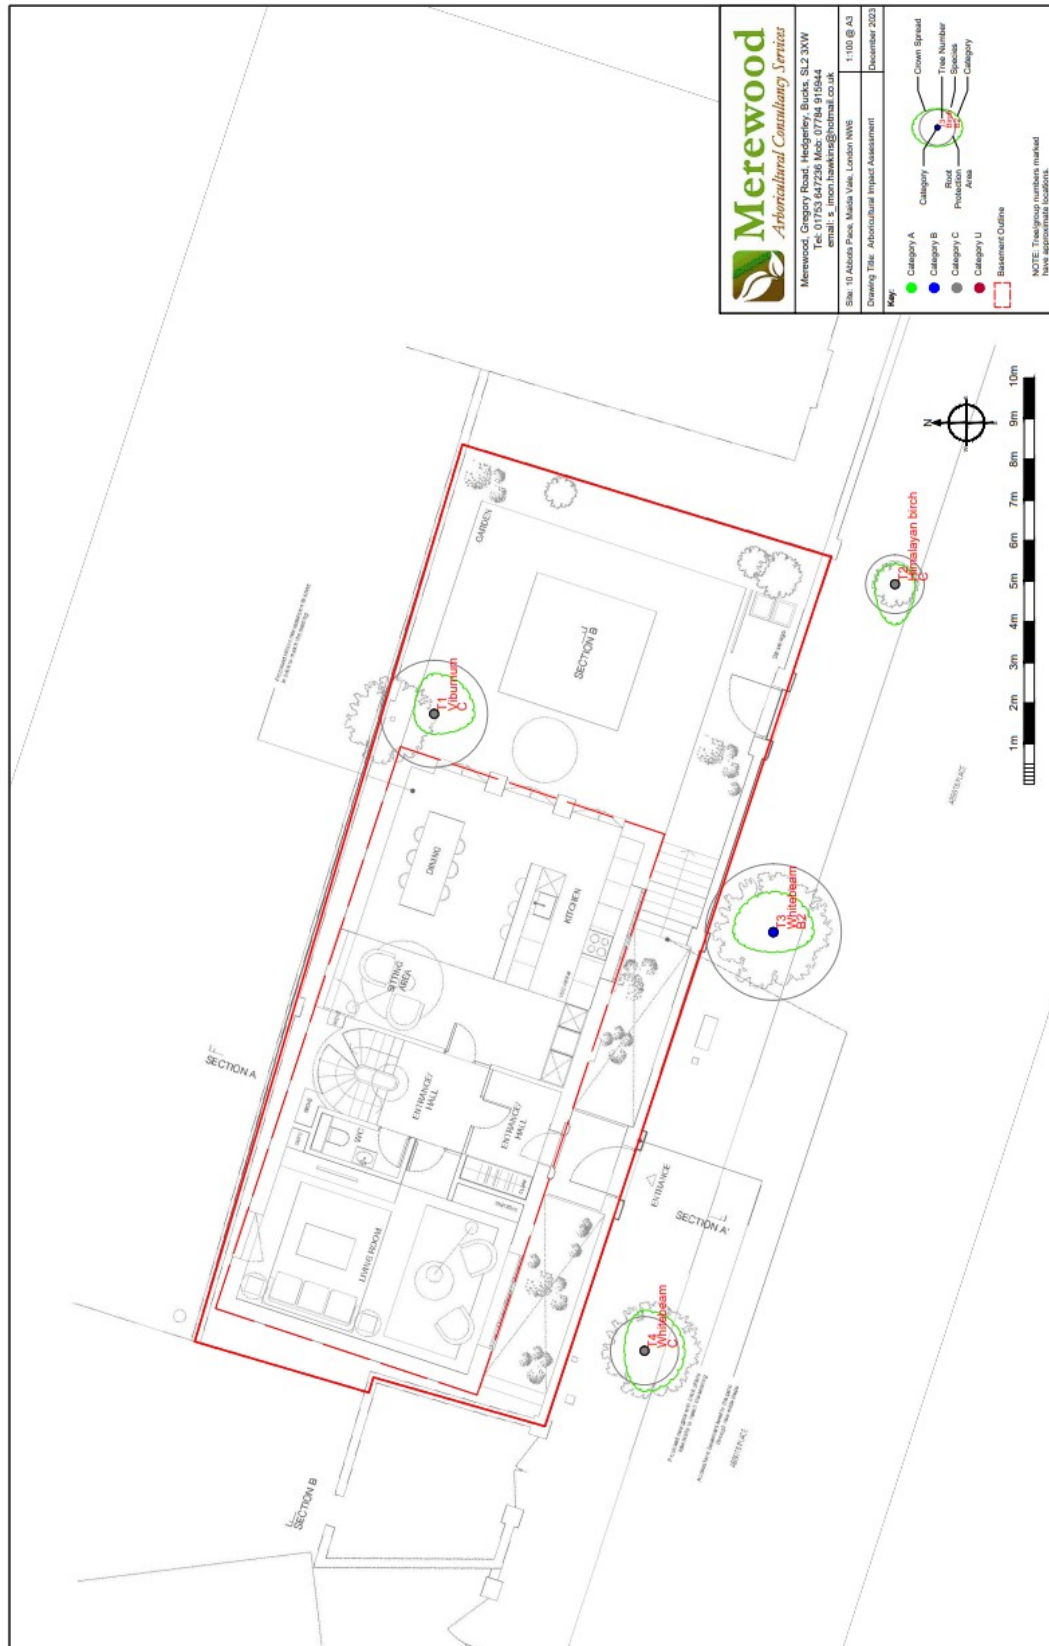
Impact Assessment Plan

- 4.4.1 The excavation work required to create a new basement will centre on the patio area to the east side initially, and from there further excavation work will take place internally.
- 4.4.2 The excavations required for the foundations of the new basement will remain outside the RPA's of the retained trees and will have no discernible effect on these trees.

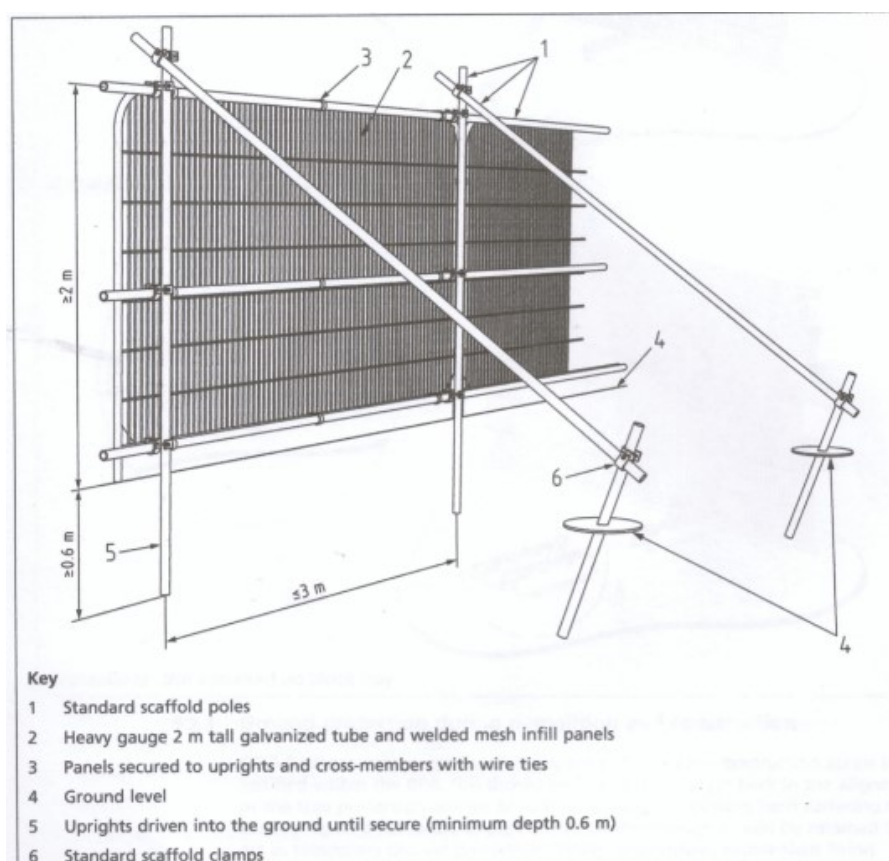
Fig. 1 Protective fencing in accordance with B.S. 5837

- 1.2.1 The tree protection plan (appendix 1) shows the line and position of the root protection fencing to be erected prior to any other works taking place on site.
- 1.2.2 The root protection fencing installation shall be approached from within the central working zone to avoid damage within the root protection area itself, in accordance with the recommendations of BS 5837/2012, illustrated by Fig. 1.

- 1.2.3 The fencing for the root protection zones shall be constructed of scaffold tube uprights (set at 3m intervals with diagonal braces driven securely into the ground). Thereafter 'Heras' type fencing shall be attached to the scaffold framework using either steel strapping or scaffold clamps. The fencing shall comply with the requirements of the British Standard B.S. 5837:2012 'Trees in relation to design, demolition and construction - Recommendations'.

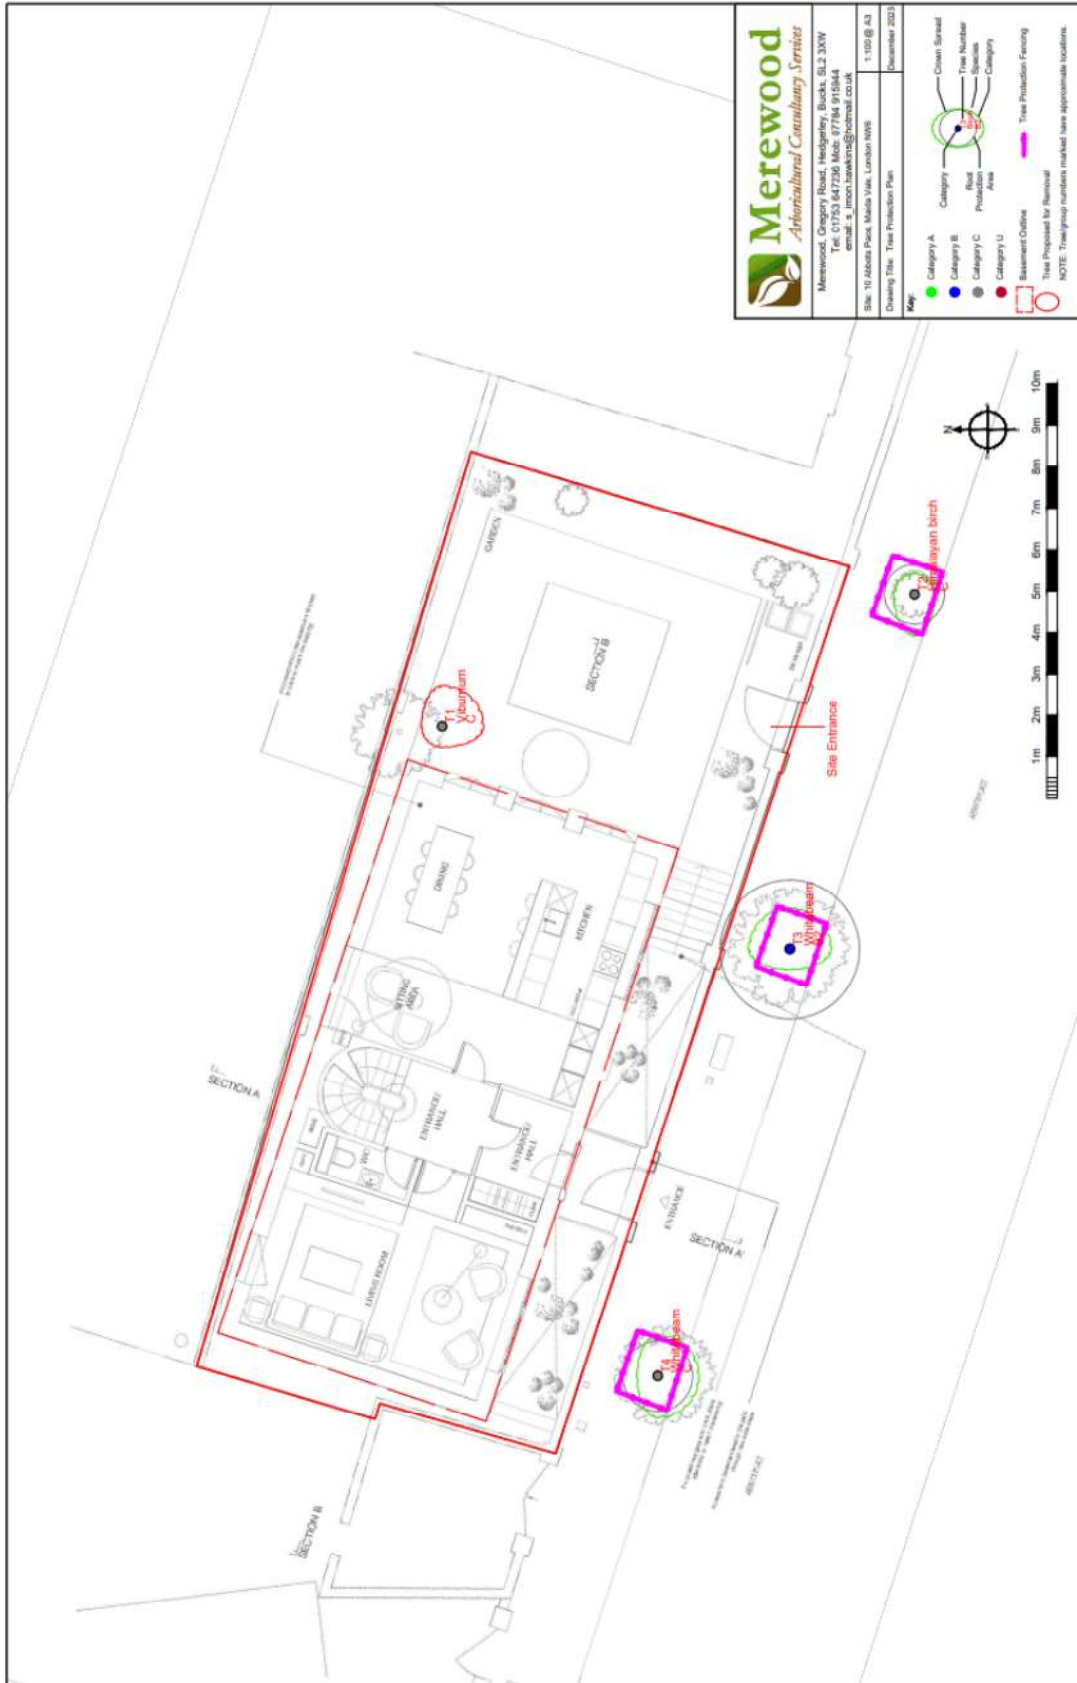
Tree Protection Plan

- 4.5.1 The movement of machinery (and pedestrians) in and out of and around a site has the potential to impact on the trees planted in the street. The tree protection plan (appendix 5) illustrates where protective fencing shall be erected prior to the commencement of the build to protect the street trees, whilst keeping the public highway open for pedestrians.

- 4.7.1 The proposed basement and infill extension can be built without any discernible effect on the significant trees on and adjacent to the site, provided the fencing detailed by the tree protection plan is properly installed around the trees.
