Our reference: T52
4th October 2023

Construction works adjacent to London plane tree at 72 Albert Street, London, NW1 7NR
Tree protection plan and arboricultural method statement

Site: 72 Albert Street, London, NW1 7NR	1:50@A3
Plan - Tree Protection Plan	Oct 2023

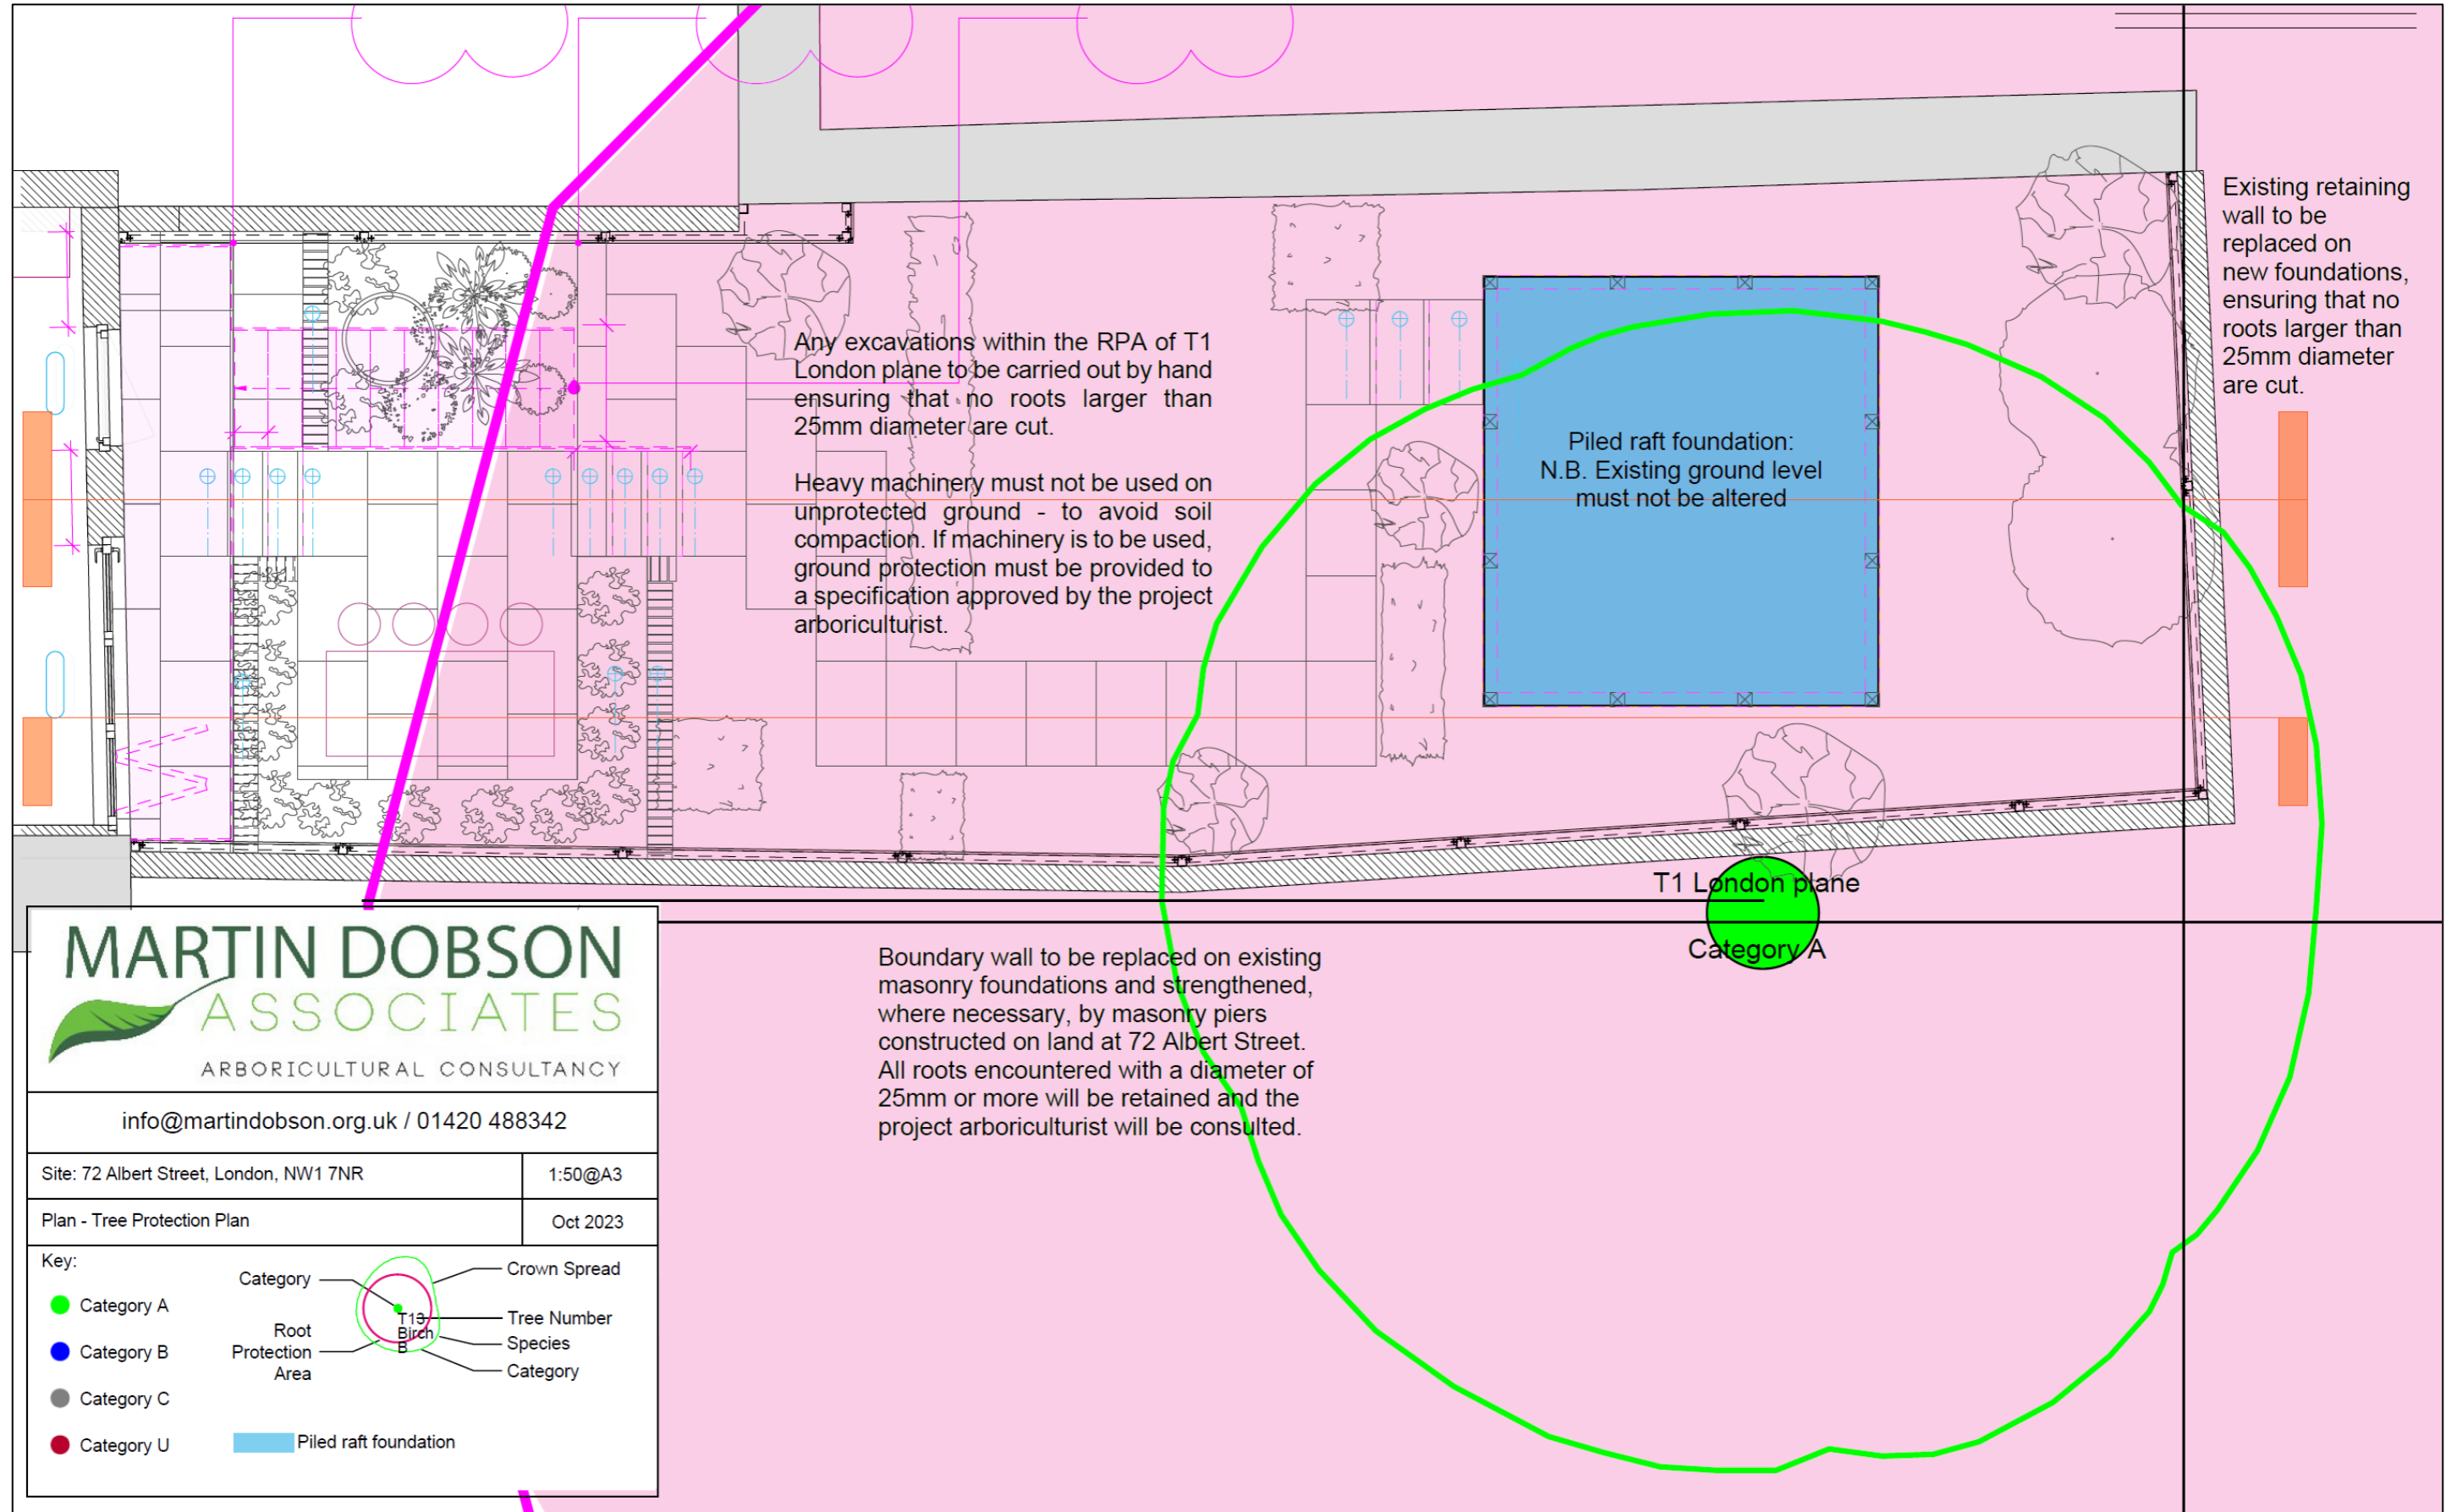
APPENDIX 1 – Tree Protection Plan

T1 London plane
Category A

Any excavations within the RPA of T1 London plane to be carried out by hand ensuring that no roots larger than 25mm diameter are cut.

Heavy machinery must not be used on unprotected ground - to avoid soil compaction. If machinery is to be used, ground protection must be provided to a specification approved by the project arboriculturist.

Piled raft foundation:
N.B. Existing ground level must not be altered

Existing retaining wall to be replaced on new foundations, ensuring that no roots larger than 25mm diameter are cut.

Boundary wall to be replaced on existing masonry foundations and strengthened, where necessary, by masonry piers constructed on land at 72 Albert Street. All roots encountered with a diameter of 25mm or more will be retained and the project arboriculturist will be consulted.
