ARBORICULTURAL IMPACT ASSESSMENT REPORT FOR:

The Hoo

17 Lyndhurst Gardens

Ref: JDL/17LDG/AIA/02f

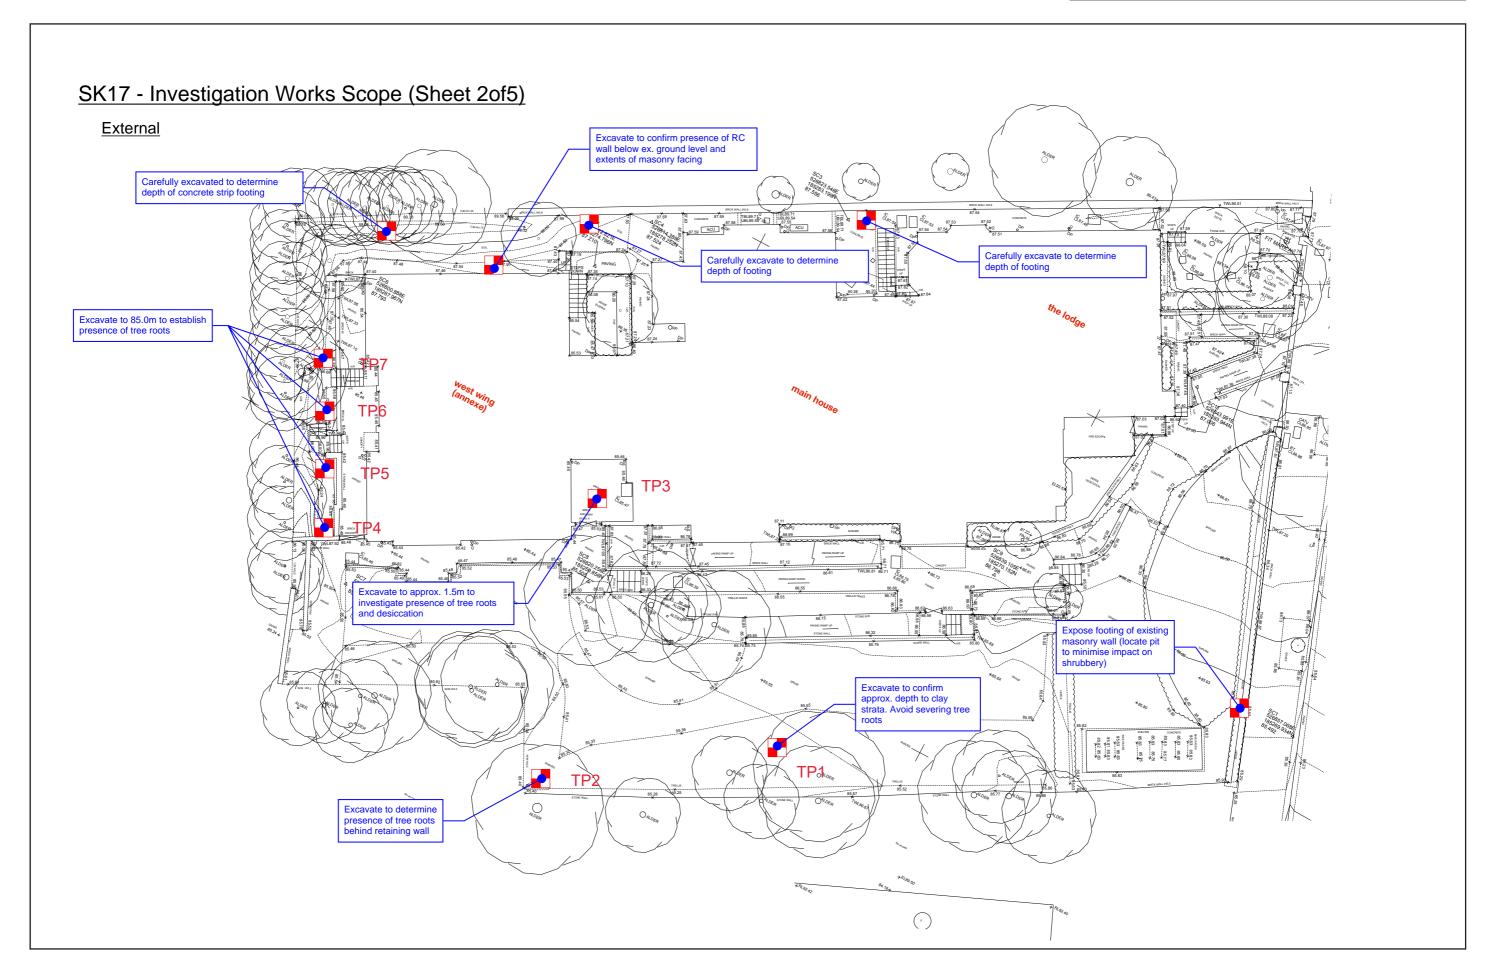
TP1 – Mixed brick rubble to approx. 100mm depth; potentially old paving. Soil beneath. Frequent fibrous roots

observed <10mm dia. Single severed root of 18mm dia

TP2 - Pit initially found to contain mixed brick rubble to approx. 100mm depth; potentially old paving. Soil

beneath. Frequent fibrous roots <10mm dia. Pit subsequently deepened to the foundation depth of the adjacent

boundary wall:no roots of any significance were observed within the visible extents of the pit. A portion of the

from below the foundation of the wall. The pile of spoil adjacent to the excavation was a mix of top soil and

TP6 - Concrete to approx. 100mm depth then soil below. Single root observed approx. 100mm dia, infrequent

TP7 – No pit found/dug at location

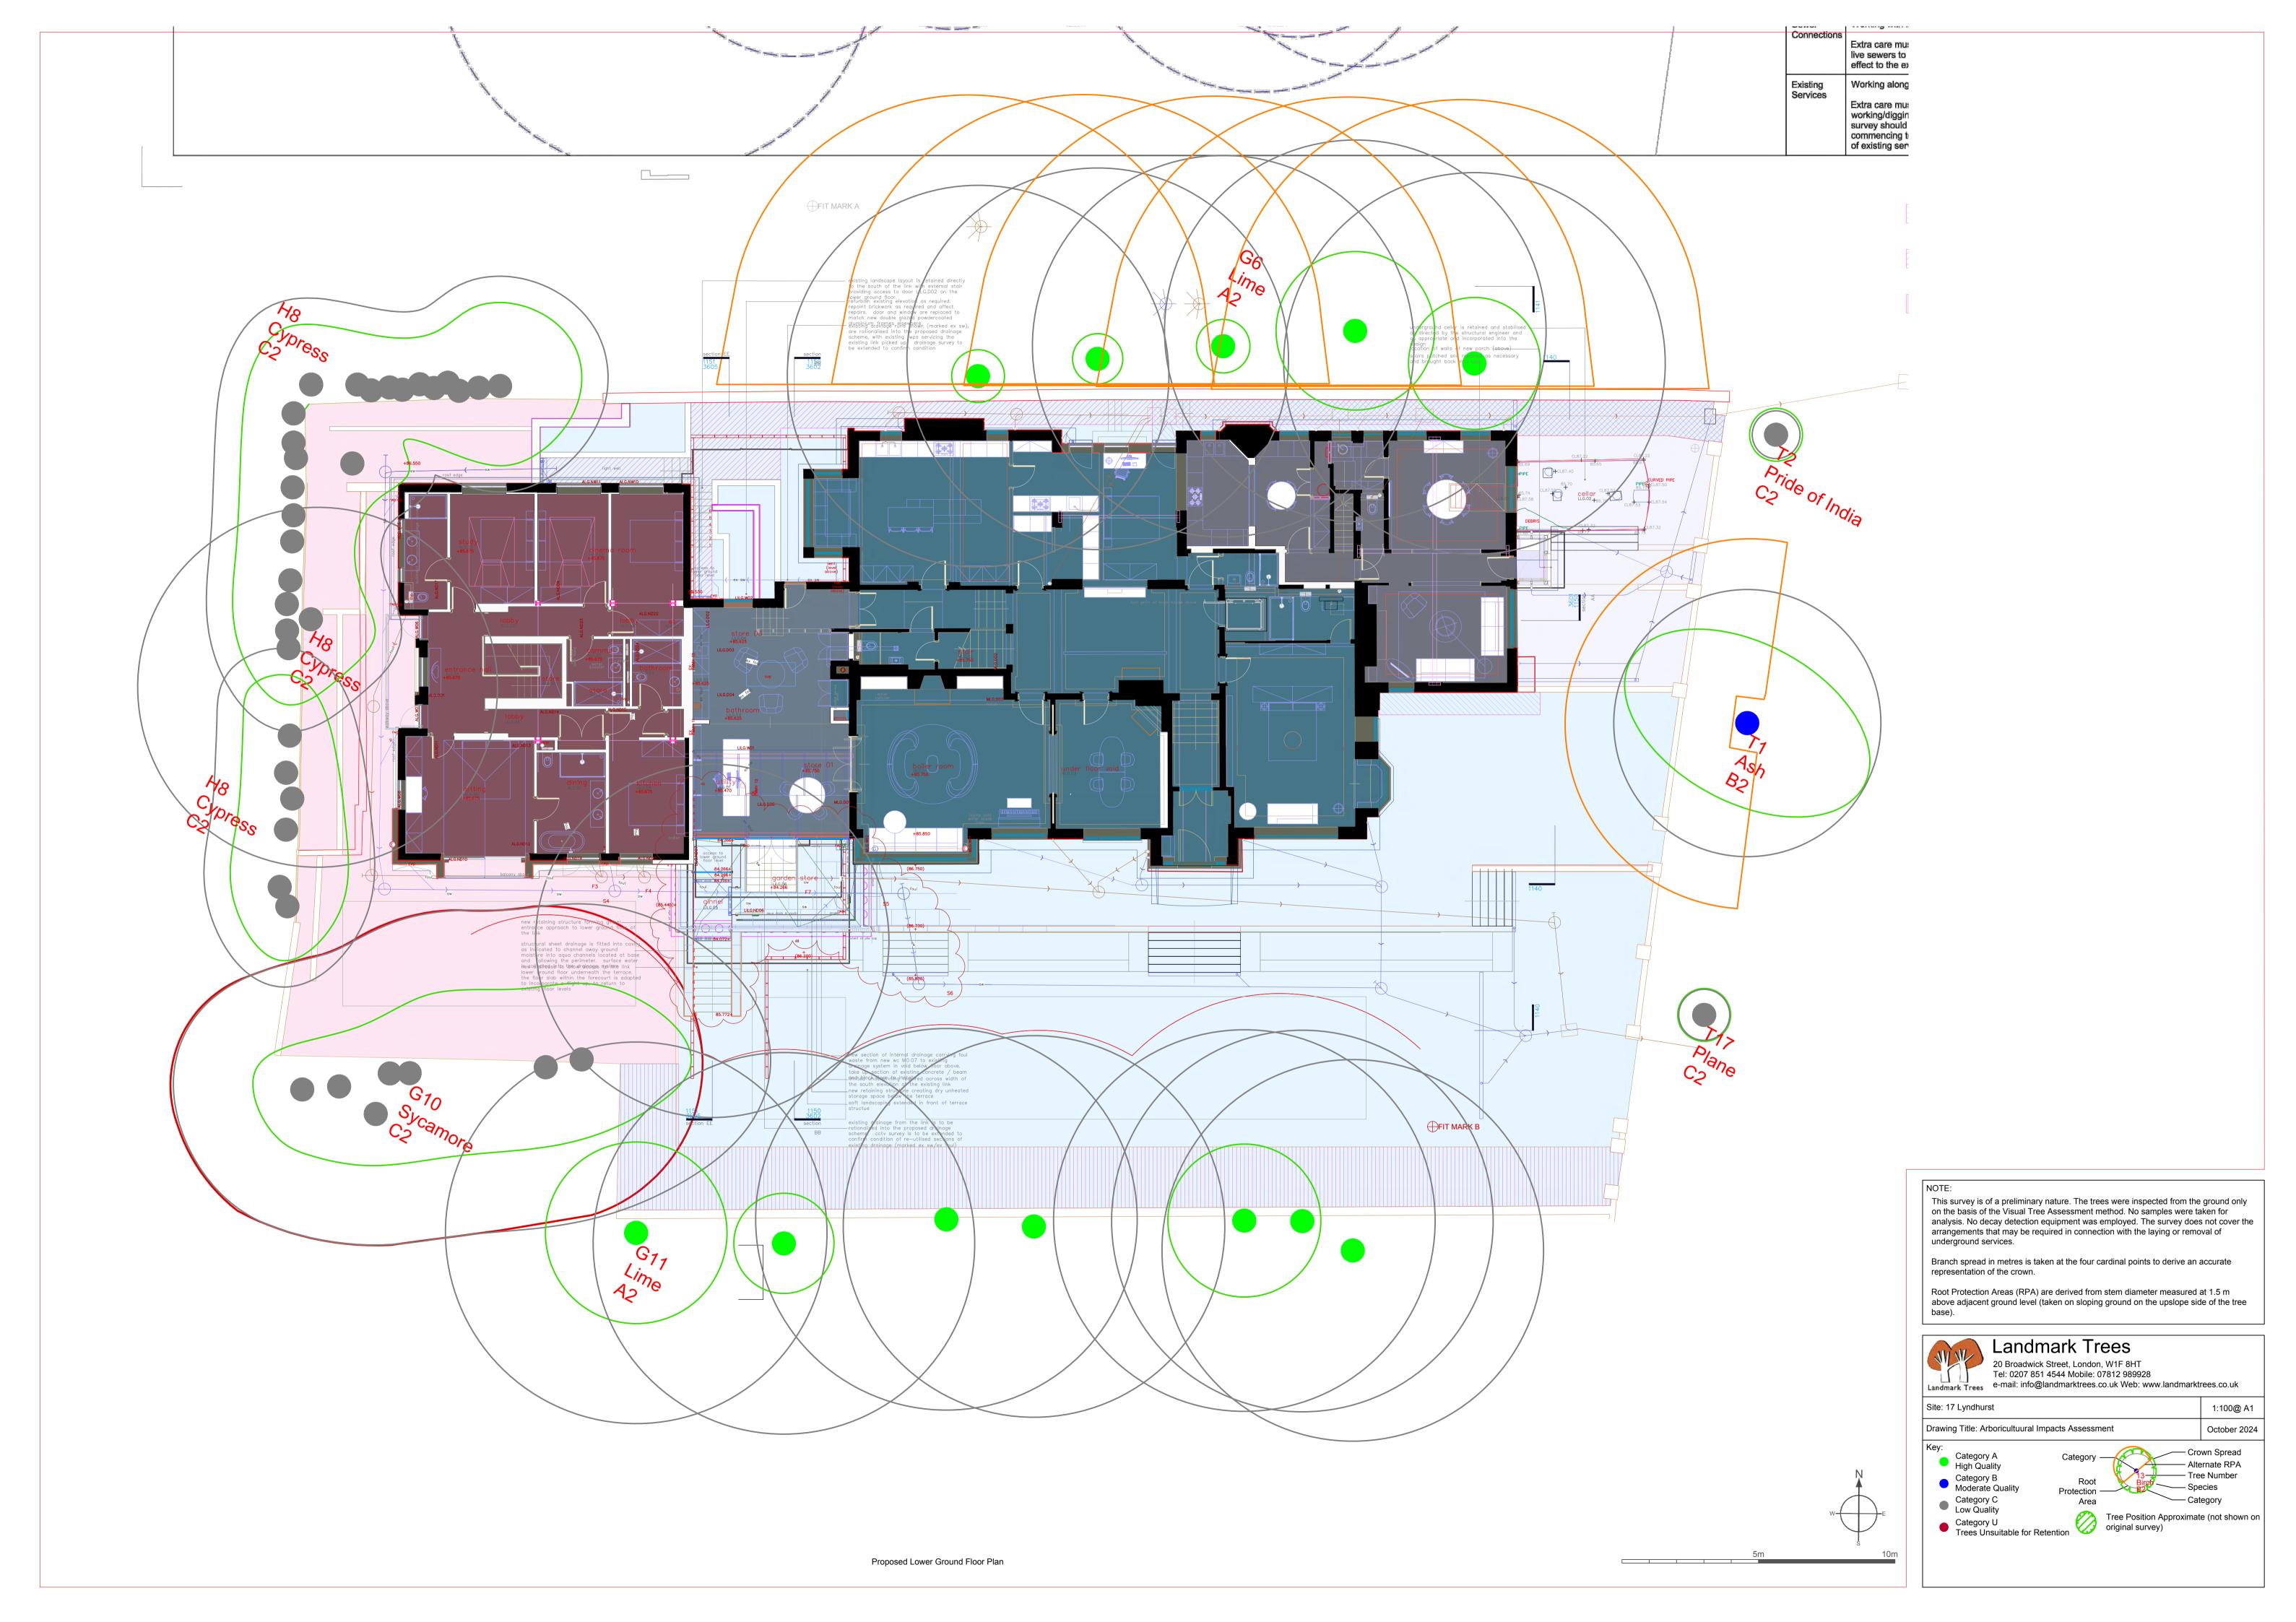
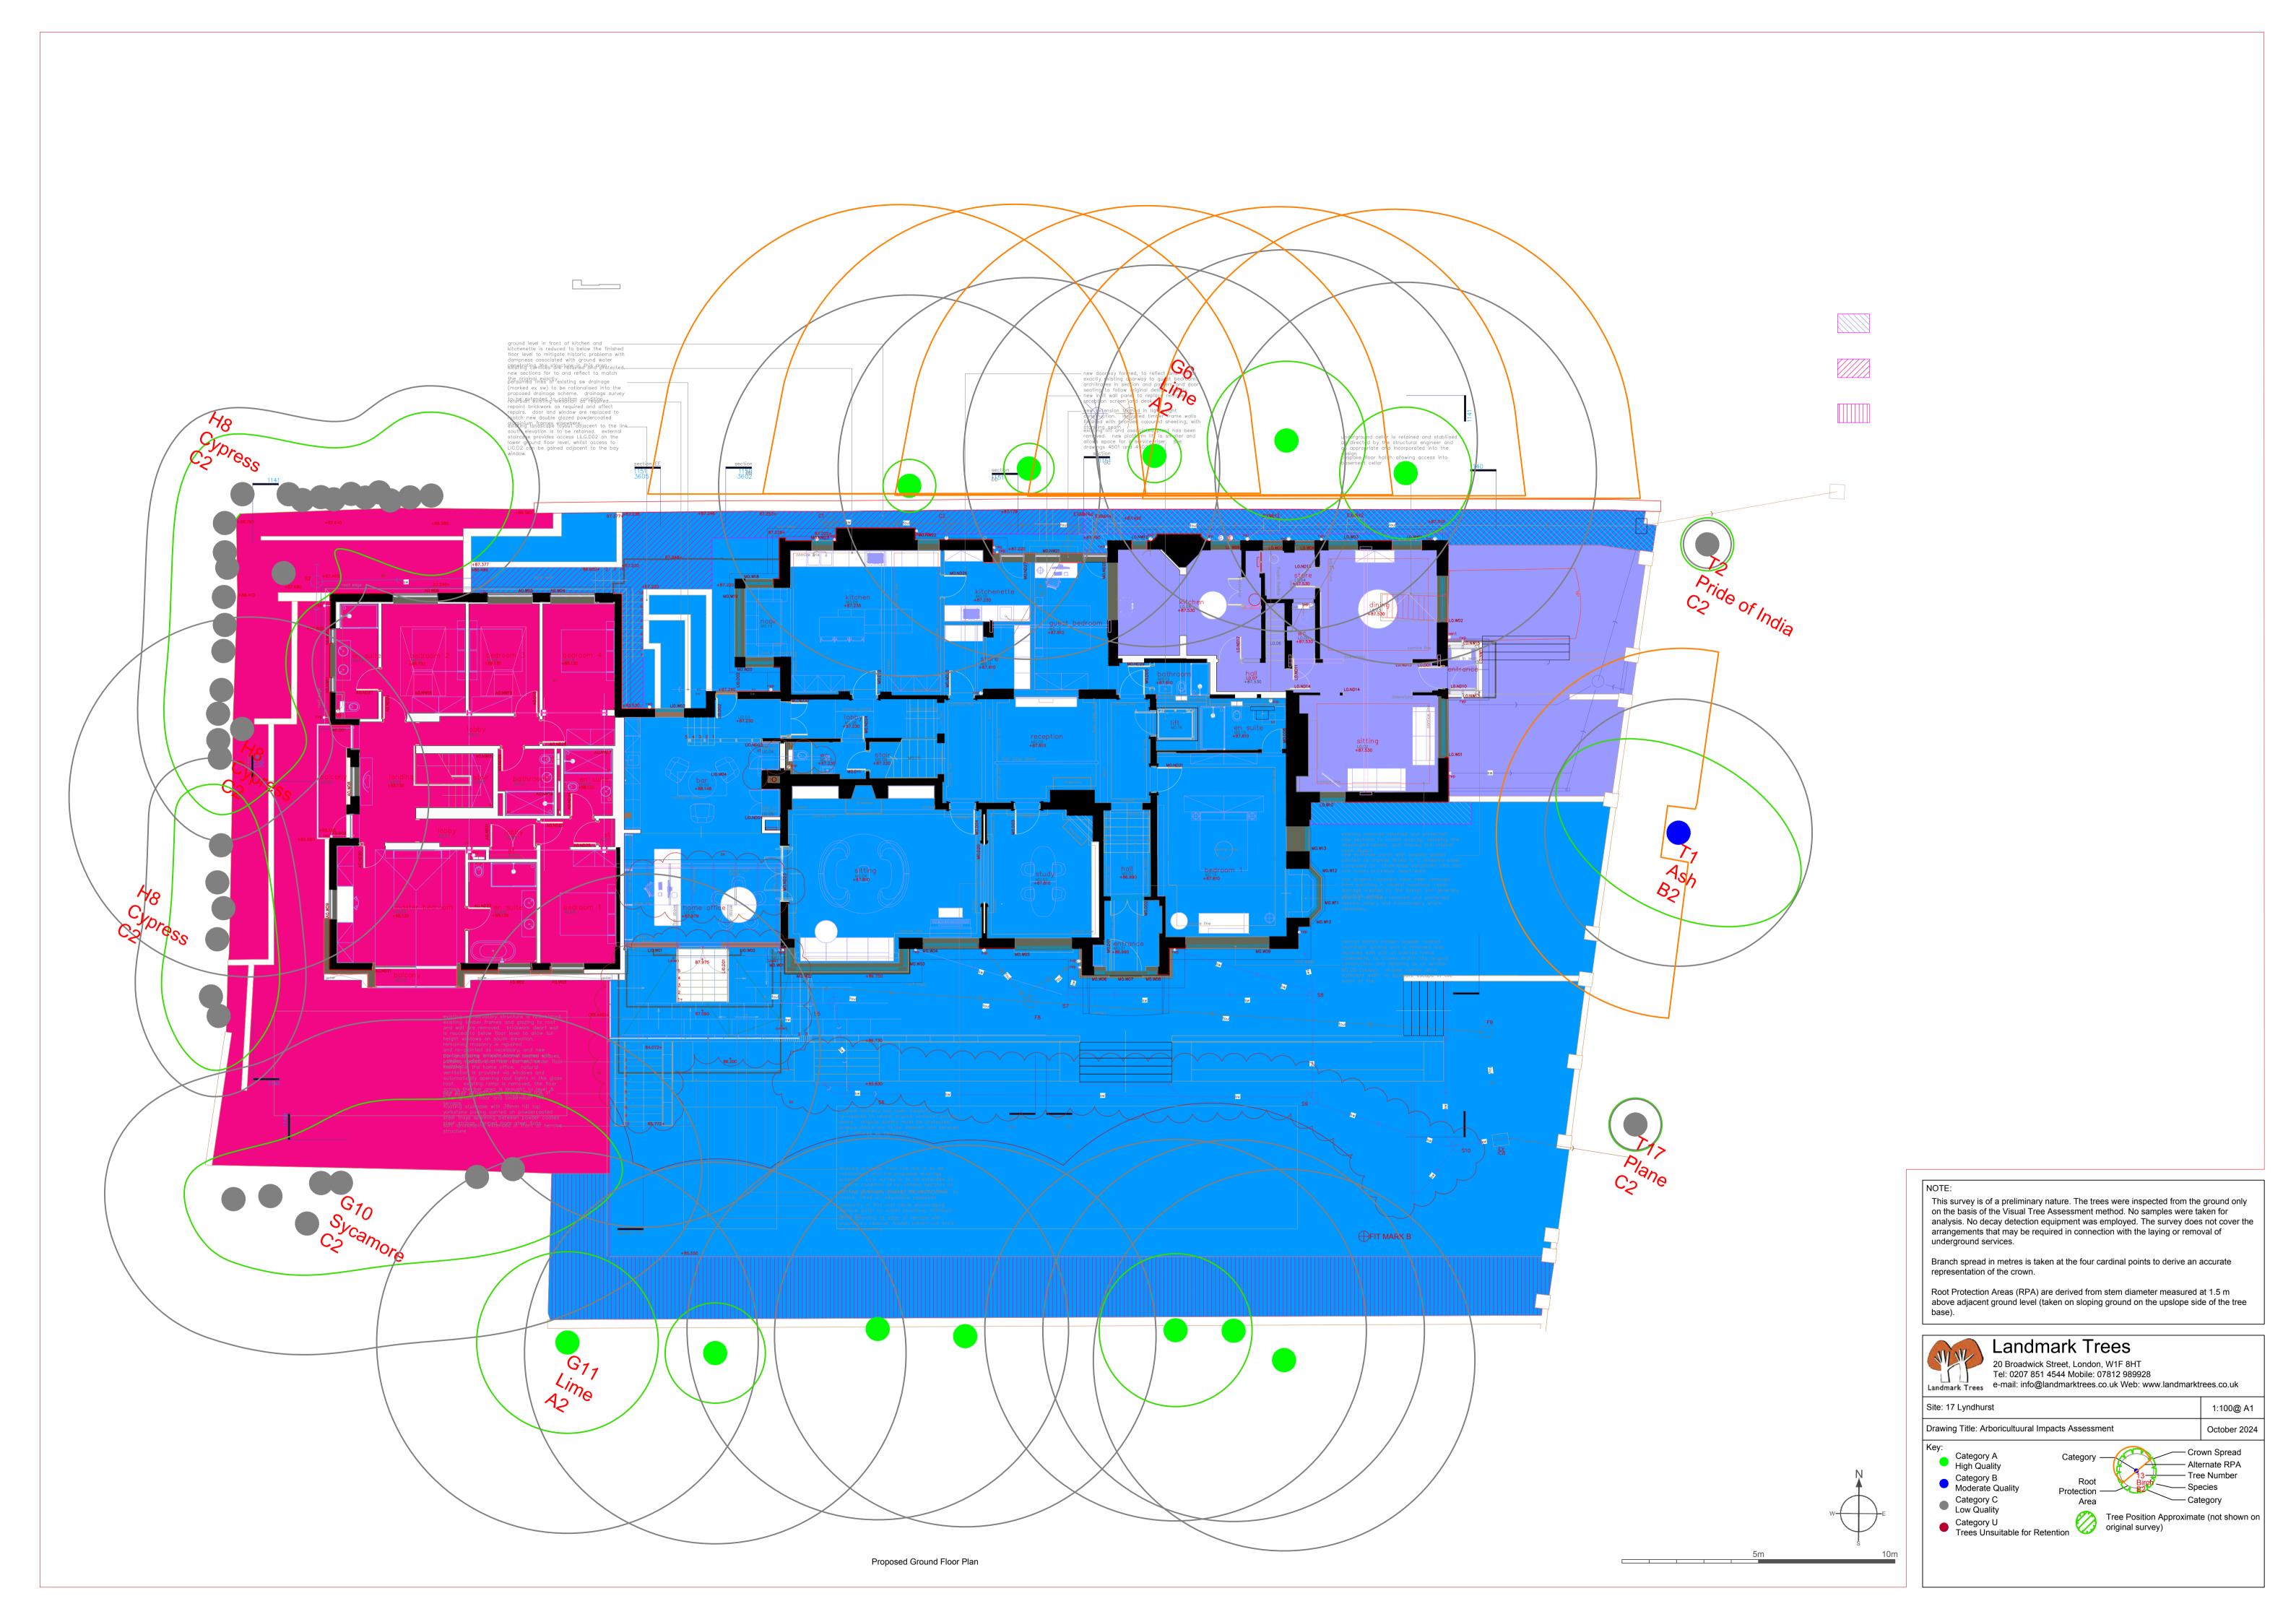
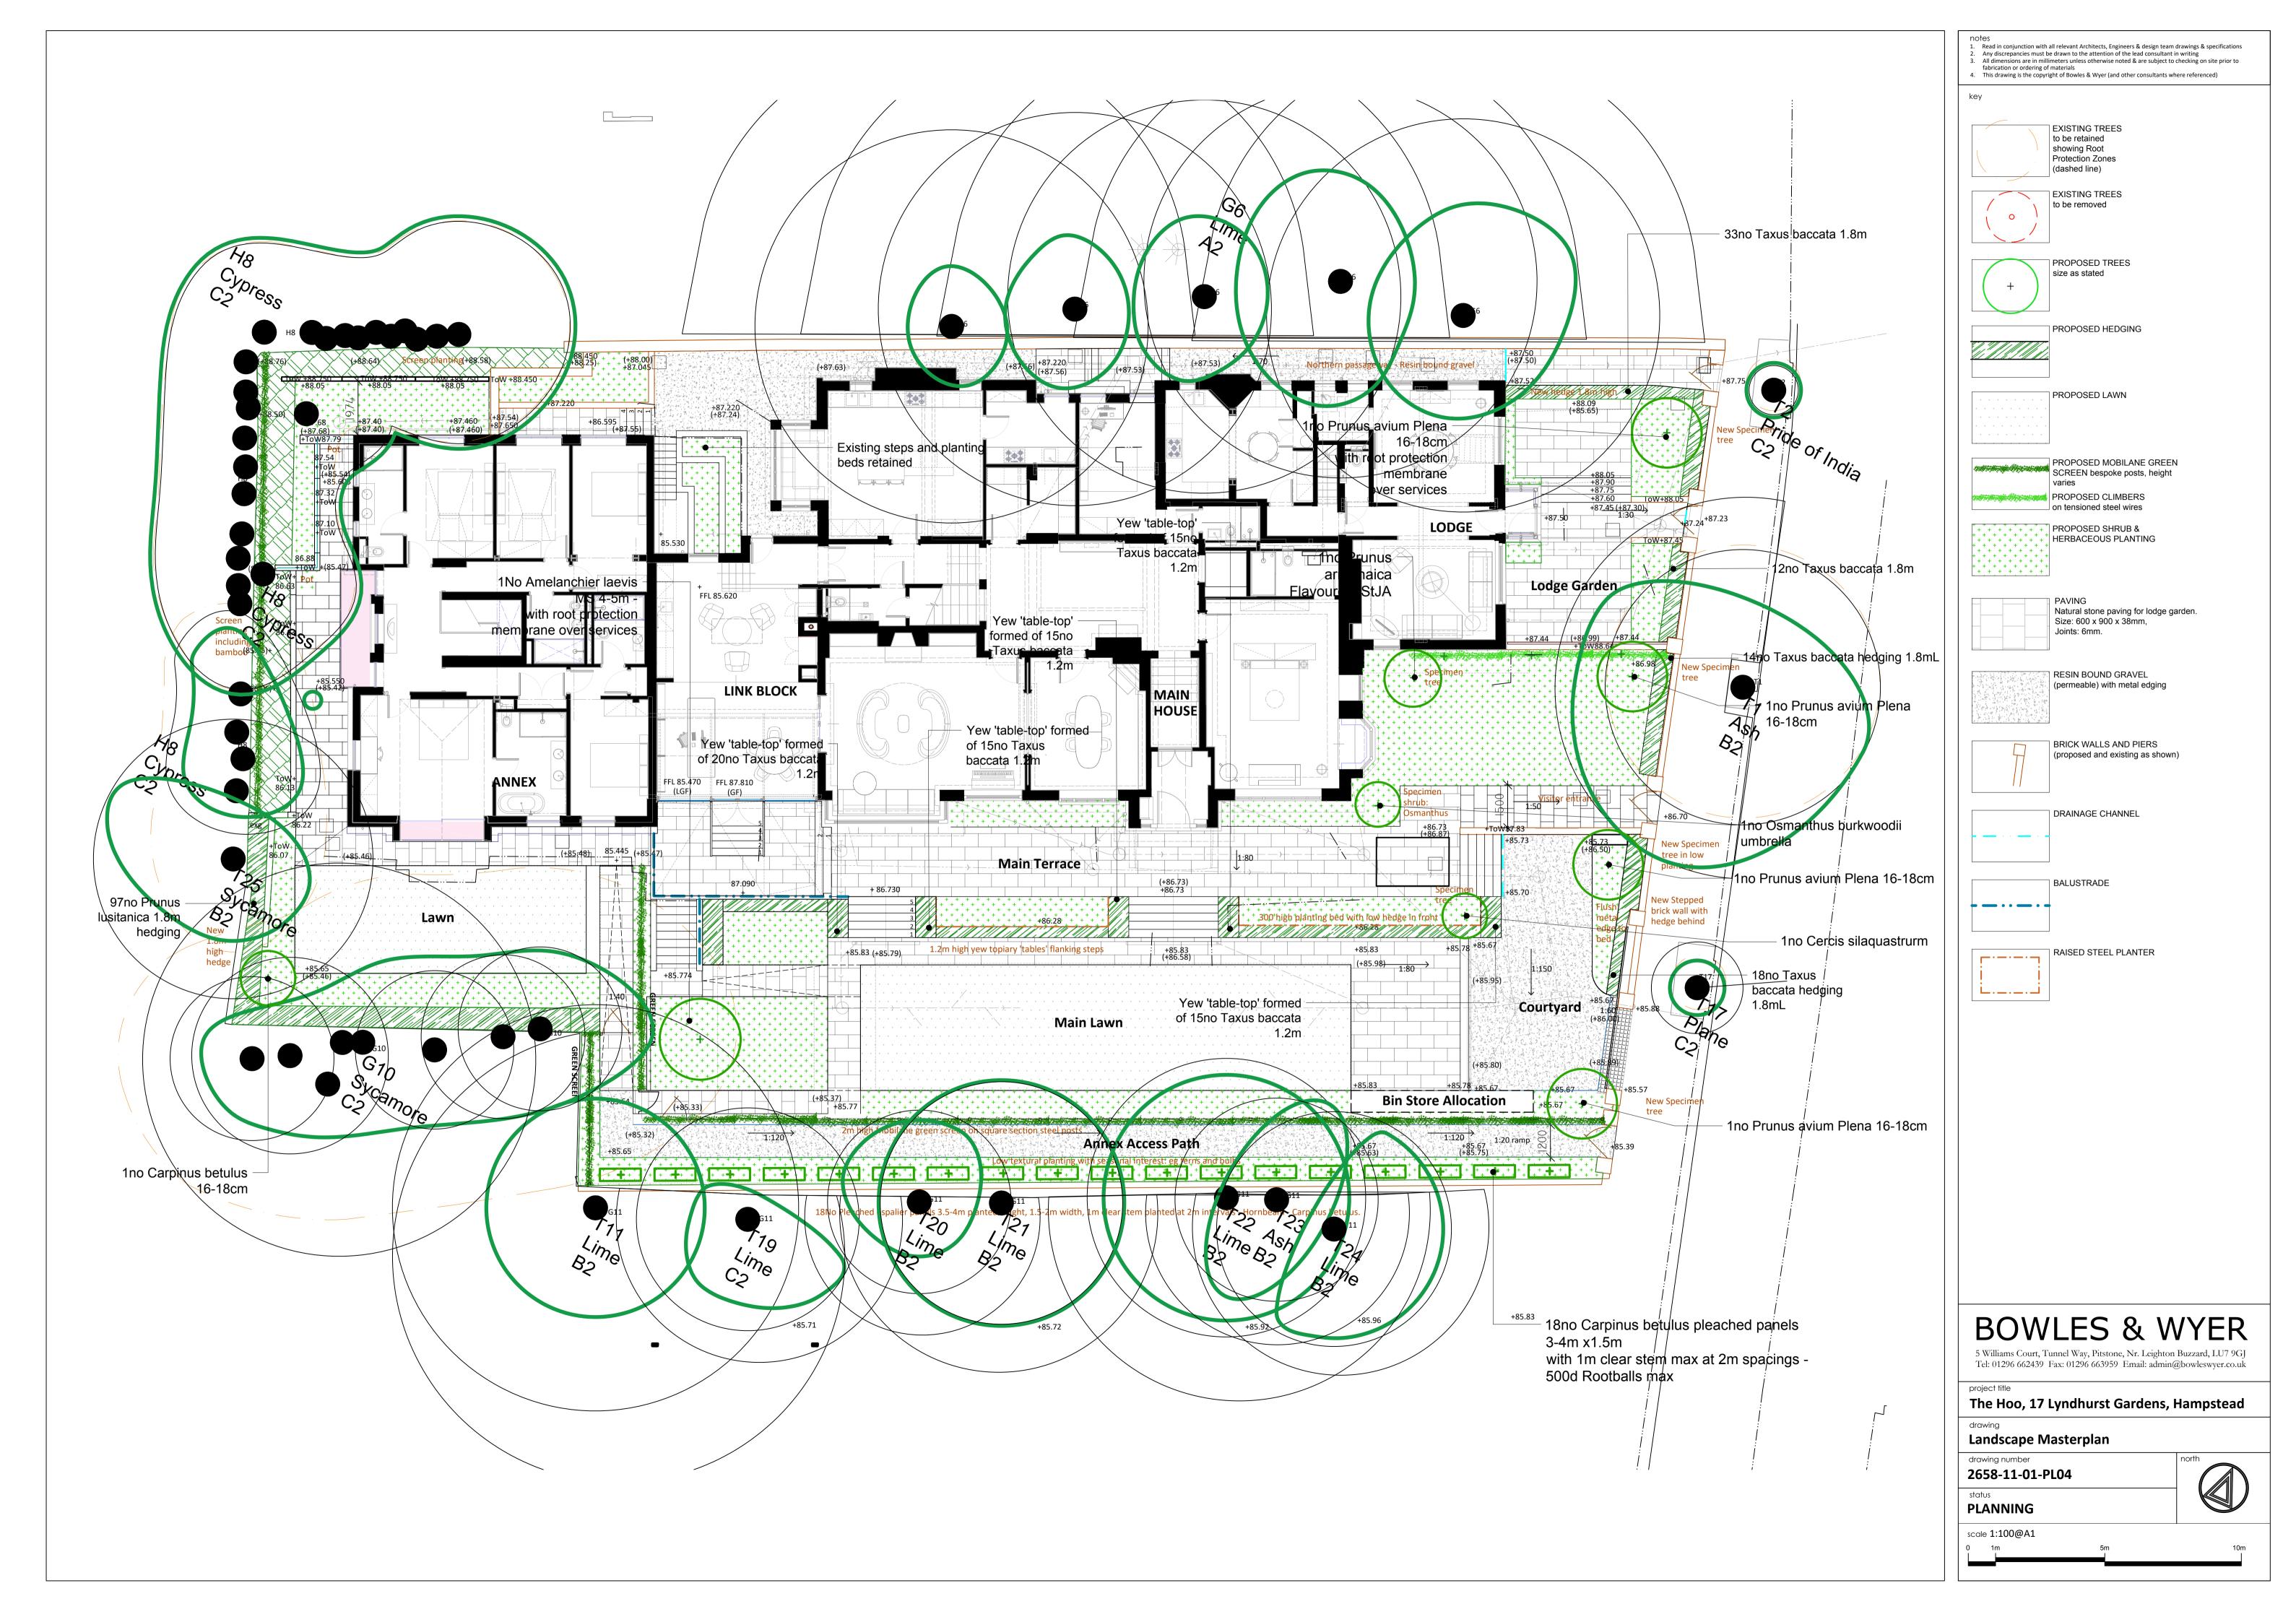
PLAN 2

- 6.1.1 These amended proposals introduce no new loss of canopy cover or RPA encroachments compared to those already consented.
- 6.1.2 For ease of reference the only potential impacts arise from the proposed retaining wall adjacent to H8 Leyland cypress and the provision of new hard surfacing within the modified RPA of T1. With regard to H8, trial pit findings have shown that significant roots could be affected by the construction of the retaining wall and we therefore recommend that flexibility of piling position is built into the finished design. Potential impacts to T1 can be readily mitigated through the use of a no-dig construction methodology. Site monitoring will be essential to ensure this is the case and that piles avoid significant roots in ongoing inspection pits prior to placement.

- 6.3.2 The proposed retaining wall to the rear of the site will though require flexibility of design and arboricultural supervision in the placement of foundations within the 'RPA' of the off-site conifer hedge, H8, to avoid damaging significant roots.

- 6.3.3 The paving encroachments to T1's RPA will require a no-dig construction technique, using a cellular confinement system with no fines aggregate for the sub-base. The degree of encroachment means that a permeable paving surface (e.g. gravel or block paving) is required. The finished section is likely to be up to 150mm above grade, depending on final specification, which will need to be factored into the overall finished site levels. The cellular confinement system with a temporary hard surface (e.g. road stone) can be used for site access during construction and the surface material replaced on completion of construction.
