Our Ref: CAS / 25536

### Re: External inspection to Derby Lodge, Wicklow Street, London. WC1X

#### Block :- 85 - 102 Wicklow Street.

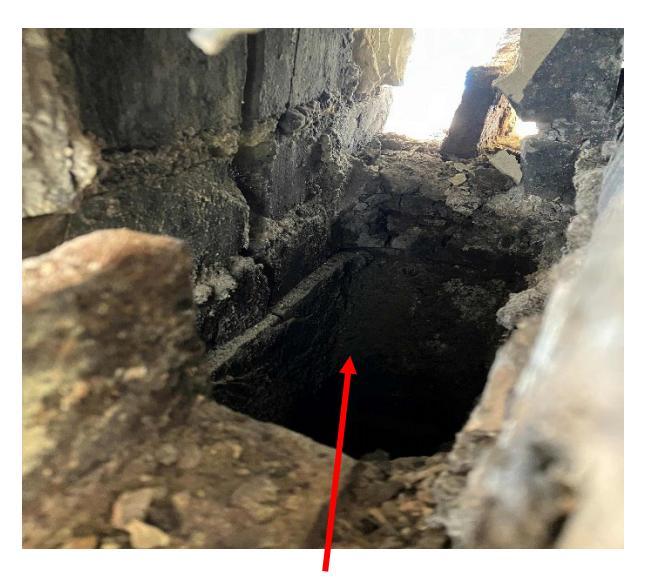
The piers are formed from solid construction as originally thought. The pier is hollow. The • pier is constructed from 102mm brickwork. We believe that they are hollow down to the ground floor.

## Void within the pier.

- The split pattress plate cannot be repaired. They need to be removed and replaced as soon as possible.
- The cracked brickwork will need to be removed and replaced. To replace the brickwork and pattress plates the remaining sections of the piers need to be propped and supported.
- We recommend that remedial wall ties are installed within the piers to tie them together.
- The concrete padstones under the feature steel arches cannot be repaired as the reinforcement within them is severely corroded and the cracks pass through them. The integrity of them cannot be guaranteed. They need to be recast in mass concrete incorporating a bracket to support the base of the steel arches.

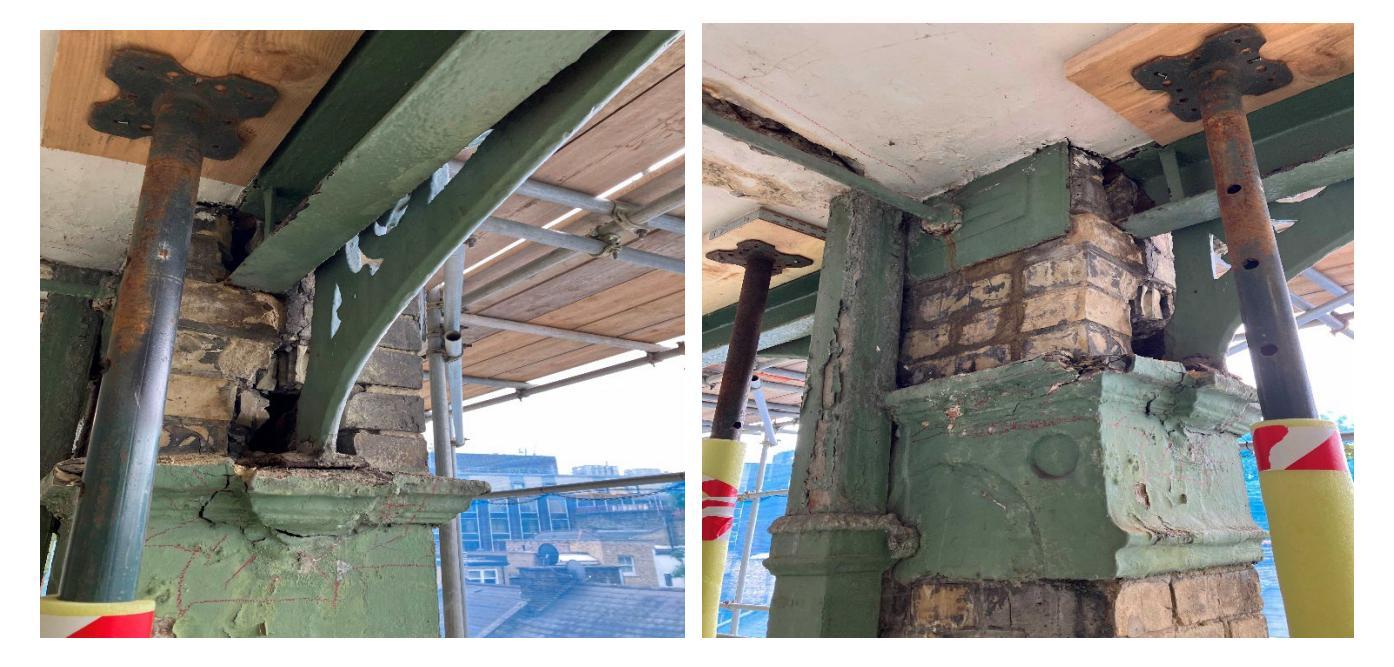
Cracked concrete under the steel arch. Corroded steel arches. The concrete is formed from clinker concrete with steel reinforcement which has corroded (see picture below from neighbouring block)

Corrosion to steel arches to be removed with a wire brush and repainted with zinc rich paint to prevent further corrosion.

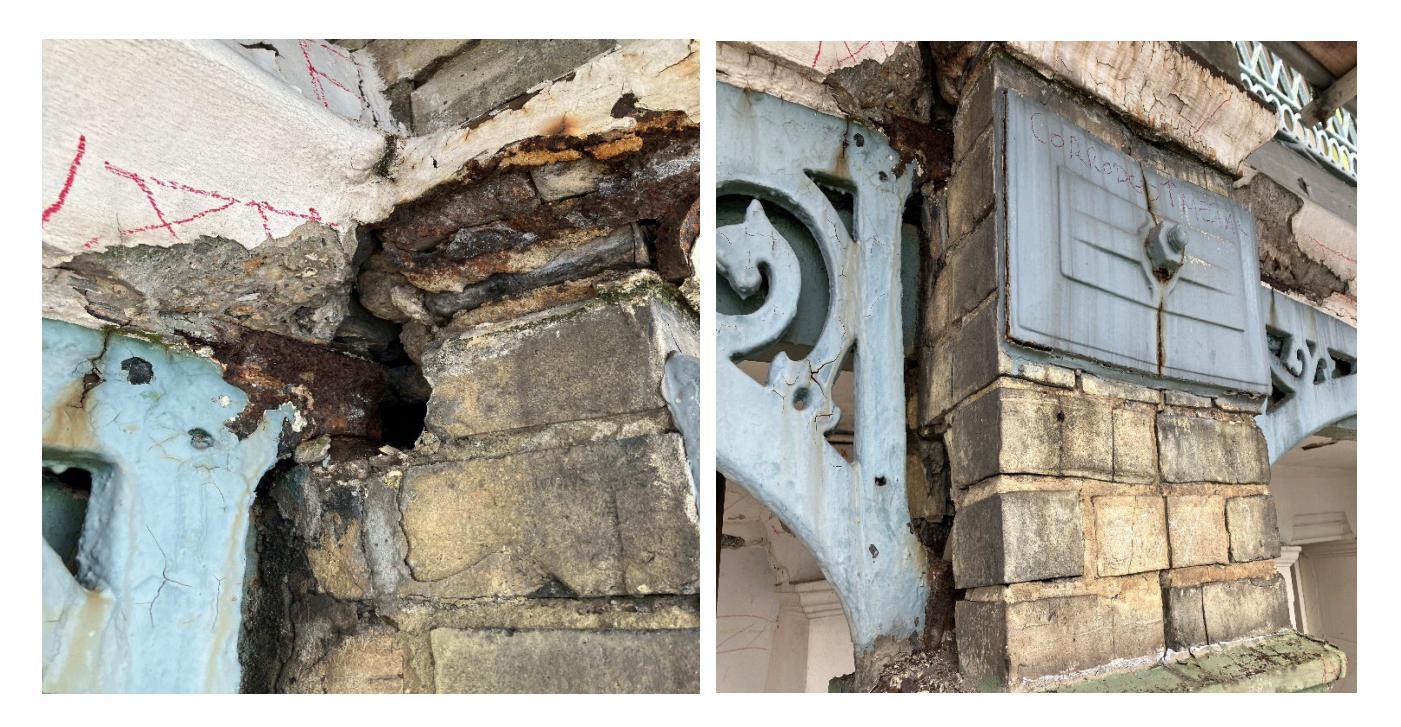
Corroded steel arches.

Distorted brickwork and cracked pattress plates.

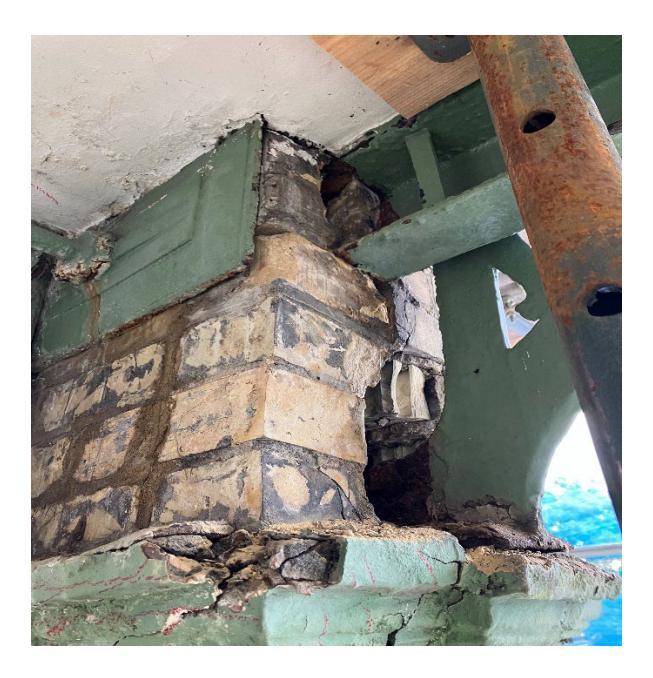
• The ends of steel channel which was exposed (under the fifth floor landing) was bearing 100mm onto the brickwork. The end of the PFC is corroded.

Concrete cast into the web of the beam. End of beam is corroded along whole length of its bearing where it has not been treated / painted.

- The beams which support the edge of the landings may be able to be repaired, i.e. remove surface corrosion with a wire brush and re treat the steel with a zinc rich paint. The existing lead paint may be covering severe corrosion. Each beam to be checked on a case-by-case basis. However, if the piers are going to be taken down and reconstructed it will be easier to install a new beam which is galvanised and painted to suit.

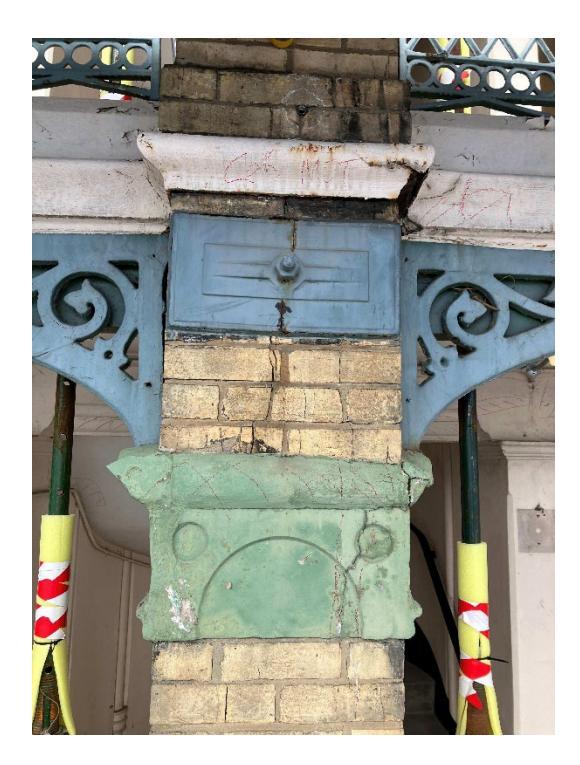
• The brickwork behind the split pattress plate on the fourth floor has cracked and is distorted. The plate needs to be replaced and the brickwork behind it needs to be reconstructed.

Failed Patress plates cracked brickwork (underside of fourth floor)

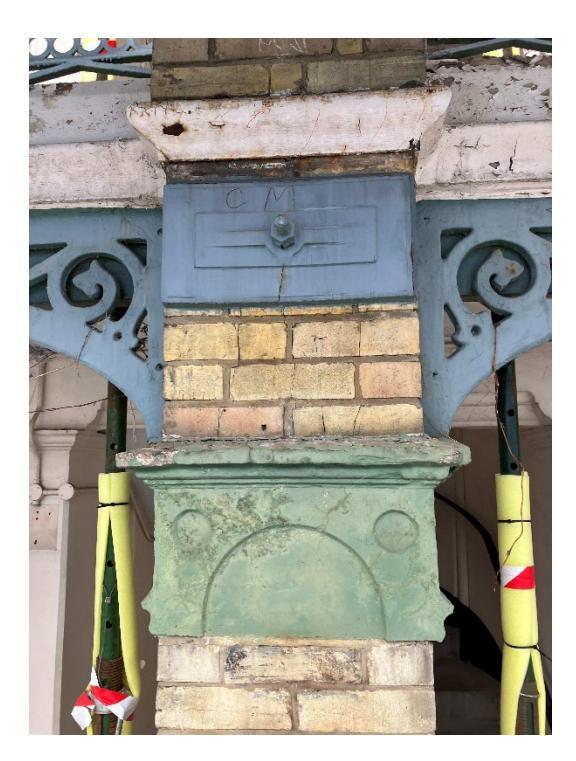
Patress plates is starting to fail cracked brickwork (underside of 3<sup>rd</sup> floor)

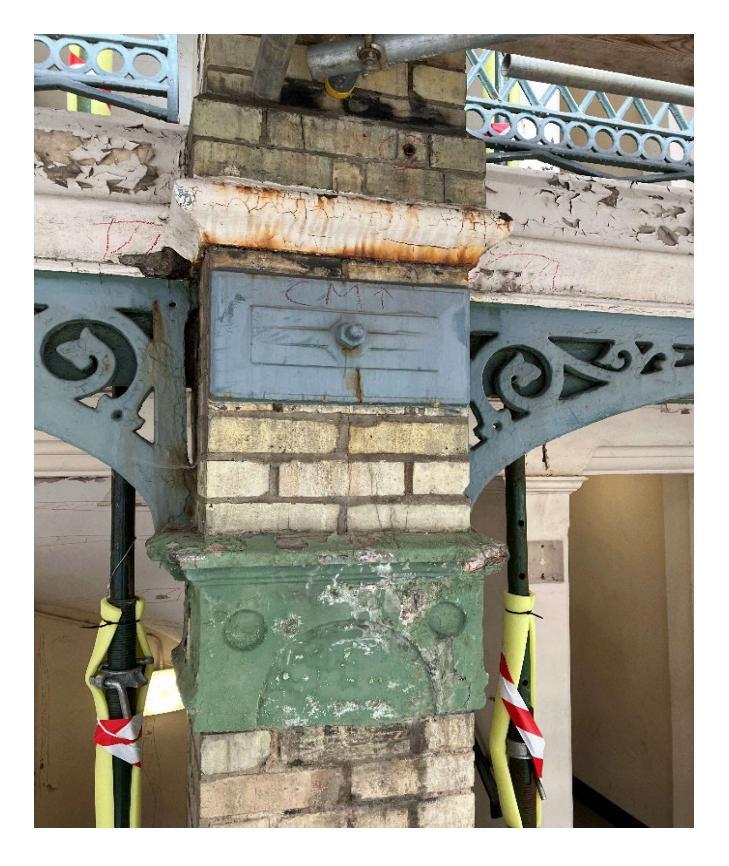
Patress plates is starting to fail cracked brickwork (underside of 2nd floor).

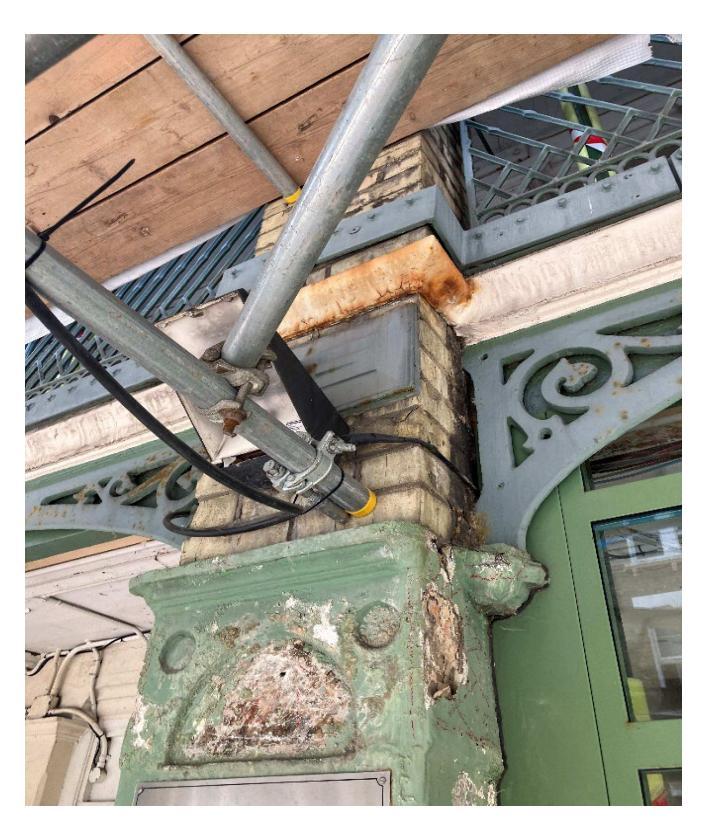
Pattress plates are starting to fail. Cracked concrete supporting feature arch.

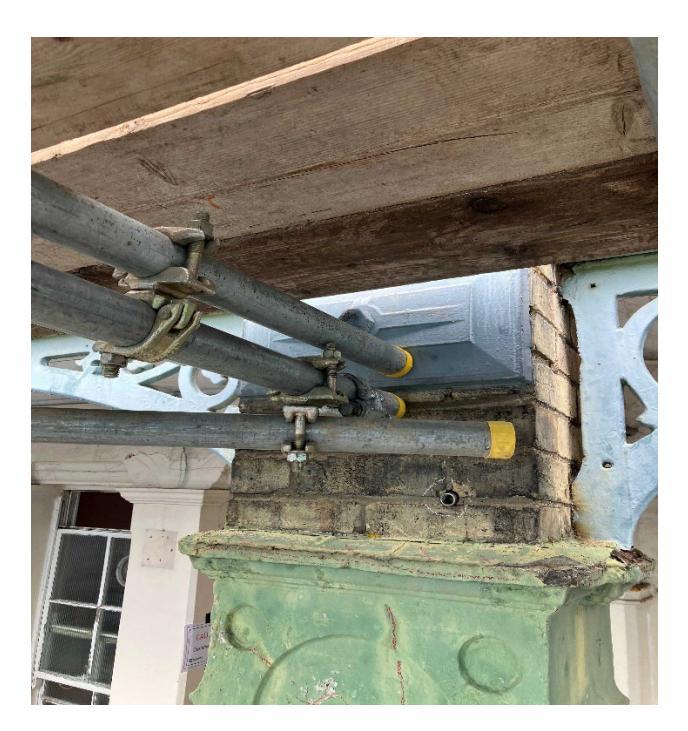
Pier under roof. Pattress plate condition is adequate. Corrosion to steel arches evident and cracking to padstone which could as this stage be repaired.

Ends of corroded beams & steel arches to be cleaned and treated to prevent further corrosion. If they are not treated the beams will lose their structural integrity and the brickwork around them will crack as the beams expand due to the corrosion.

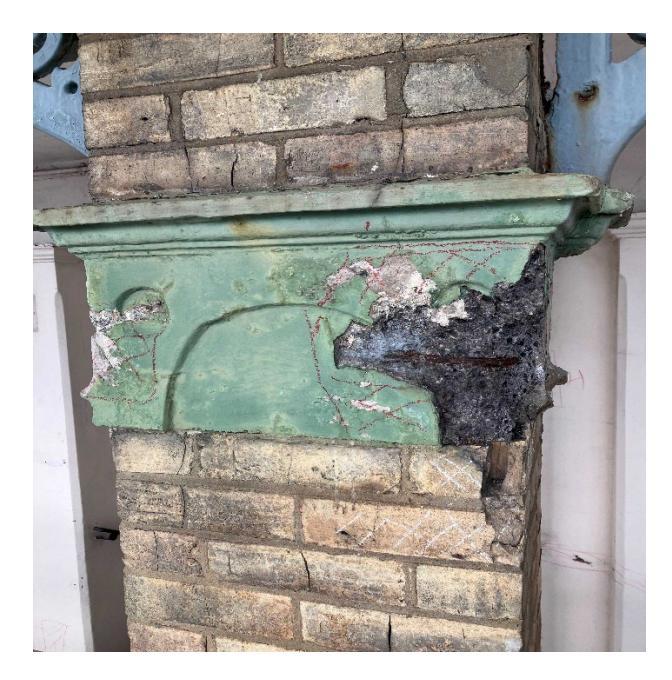
Cracked padstone and brickwork under the fifth floor landing.

Padstone under the fifth floor landing to be replaced to ensure the load is transferred down the column. This could be repaired with Sika products; however, we believe that it will need to be replaced within five years if it is repaired.

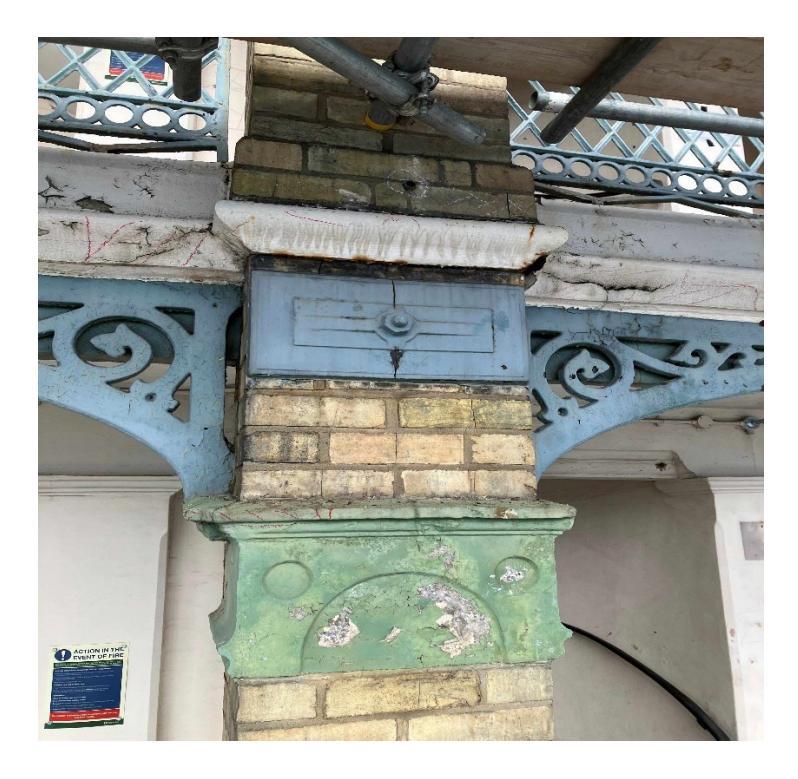
Cracked padstone and brickwork under the fourth floor landing.

Padstones with minor cracking can be repaired with Sika Products. If the cracks is greater then 25mm or down to the reinforcement within them we recommend the padstone is replaced.

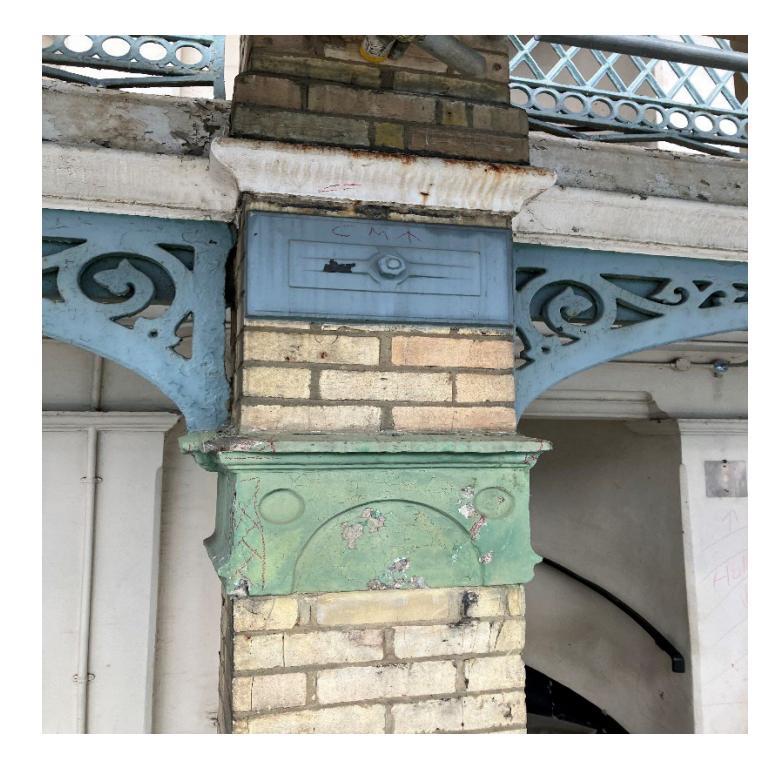
Cracked padstone and brickwork under the third floor landing.

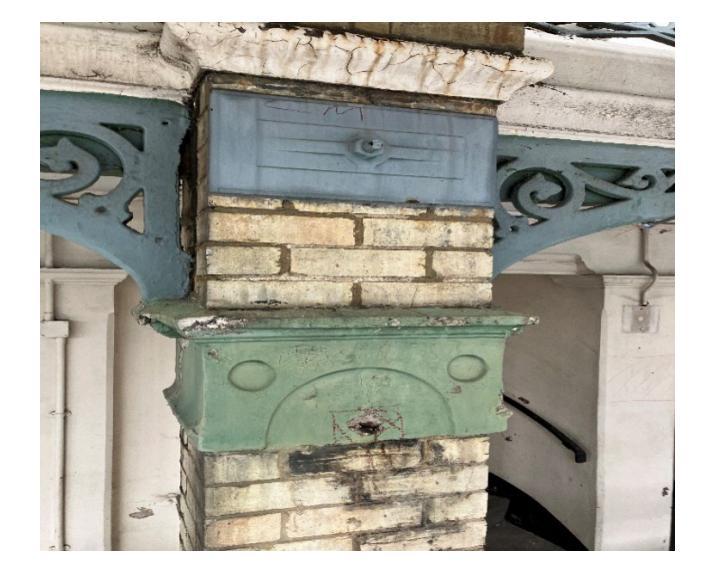
Second floor landing. No major defects on the day of visit.

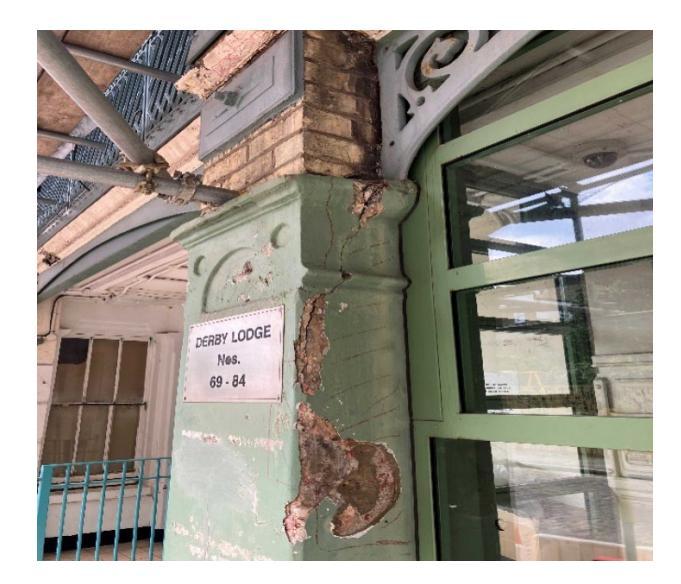
Repairs required to base of column.

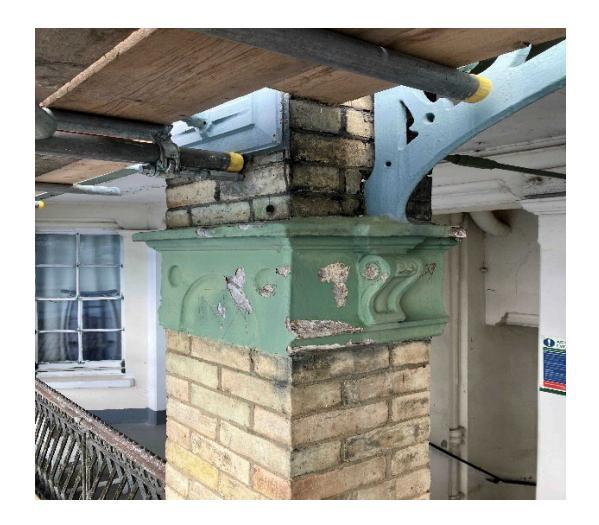
Pier under roof. Minor corrosion to pattress plates. Brickwork in good condition.

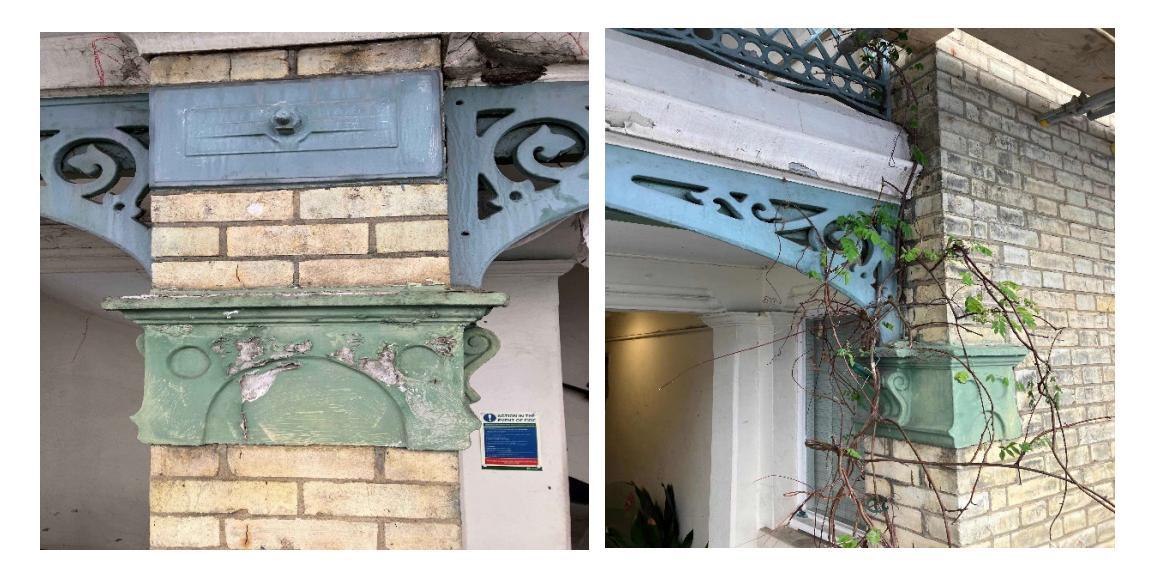
Cracked padstones under the fifth floor landing. Remove vegetation.

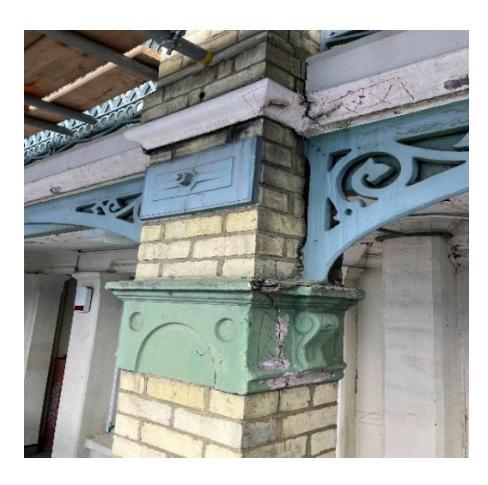
Cracked padstones and split pattress plate under fourth floor landing.

- Cracked / heavily corroded pattress plates to be replaced before they fail and lead to further structural damage to the piers.
- Ends of corroded beams & steel arches to be cleaned and treated to prevent further corrosion. If not, they will continue to corrode. The beams will lose their structural integrity and the brickwork around them will crack as the beams expand due to the corrosion. Each beam will need to be checked due to the water ingress down the structure.

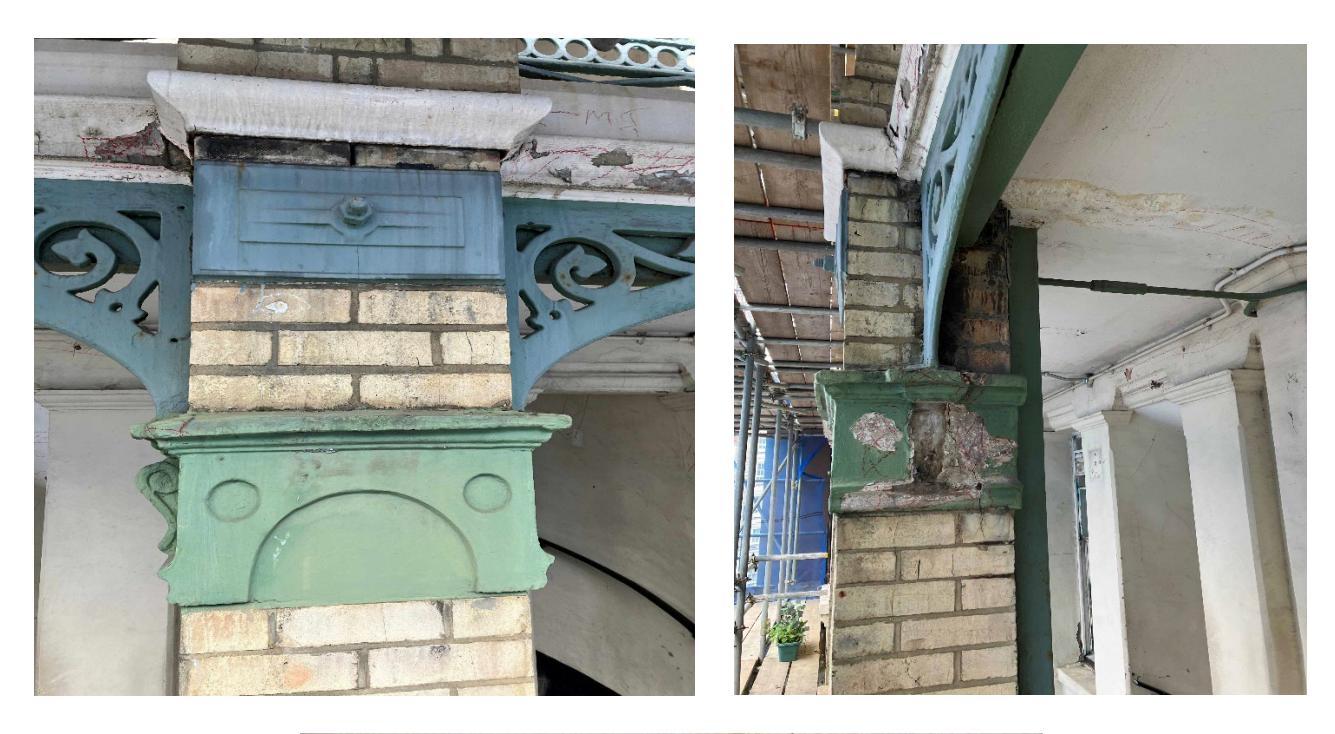
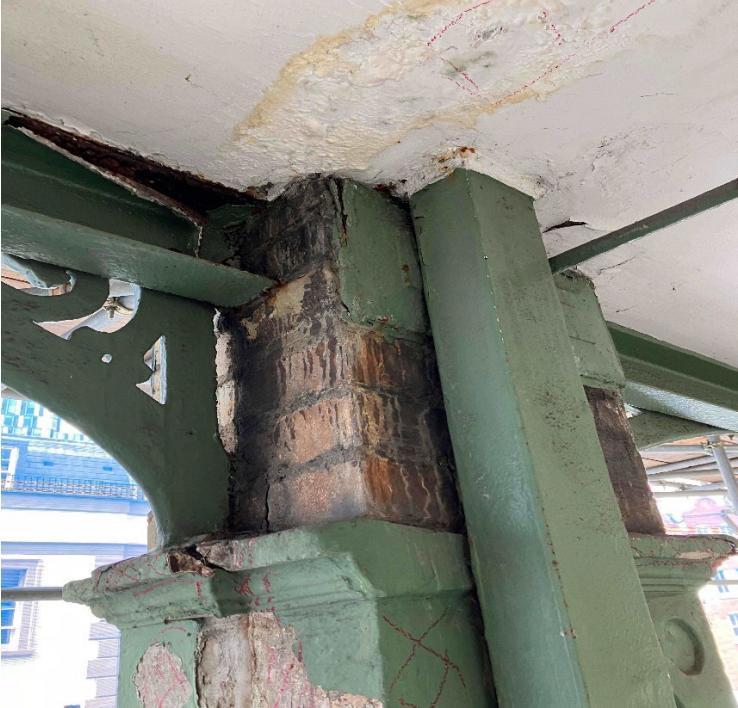
Plate is corroded and the padstone has cracked under third floor landing. Severely corroded steel beam due to water ingress down the column.

- Drainage to landings to be rectified to ensure surface water drains away from the building and not into the landing structures / piers. This is the main cause of the deterioration within the steel pattress plates and beams.

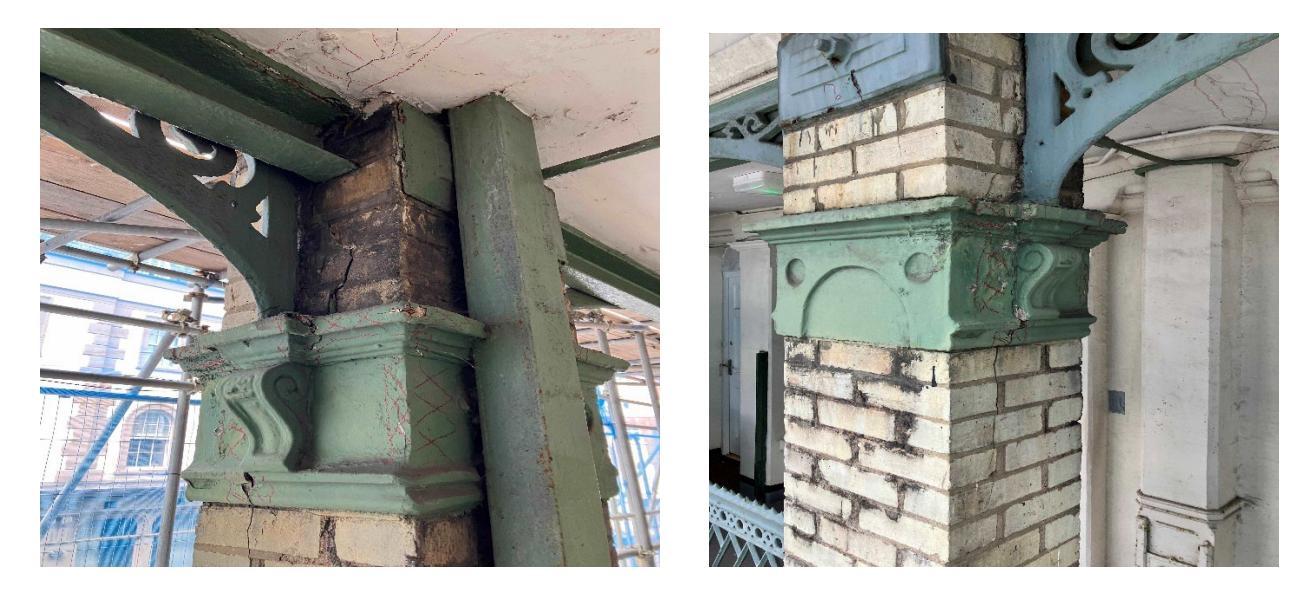
Corroded plates split brickwork under the second floor landing.

- Cracked brickwork to be replaced and remedial wall ties to be installed to tie the piers together. Helifix can be used a temporary fix, but they will not be a long term solution. We cannot guarantee how long they will last or when the cracks will re appear.

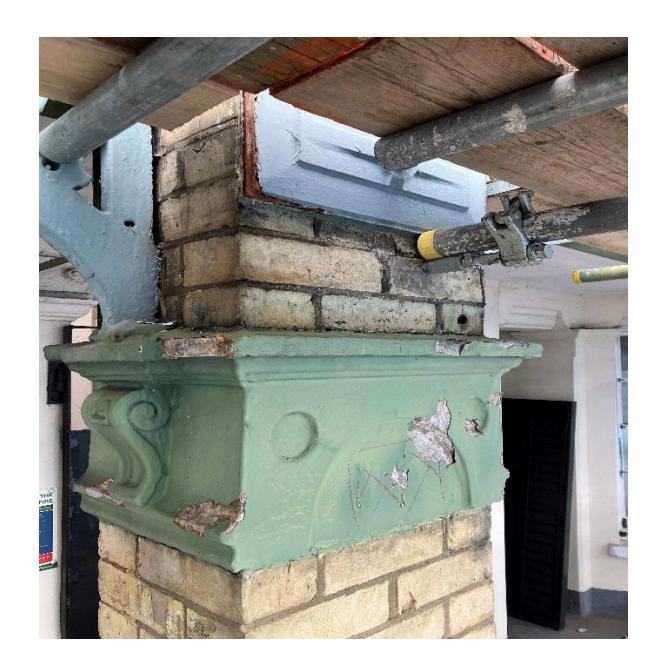
Pier under roof level. Corroded pattress plates.

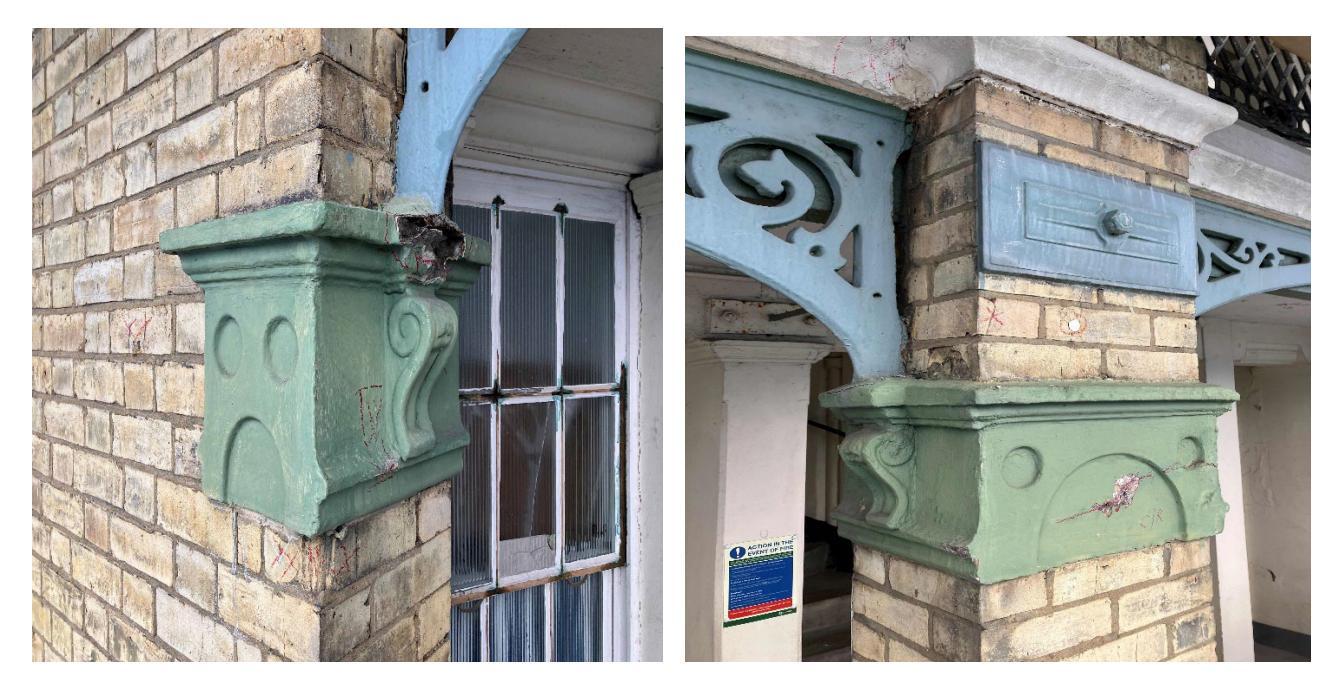
Cracked padstones under the fifth floor landing.

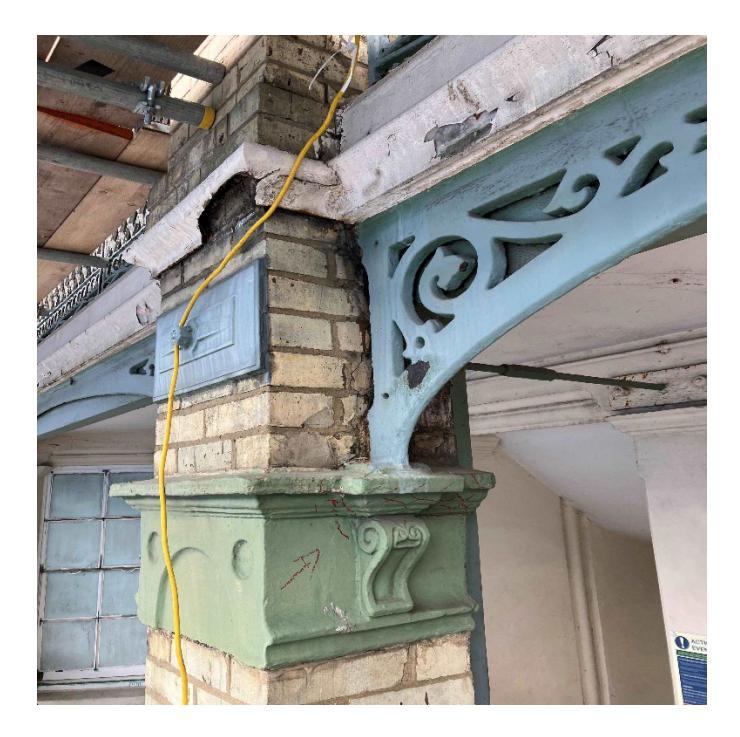
Signs of water ingress under the fourth floor landing

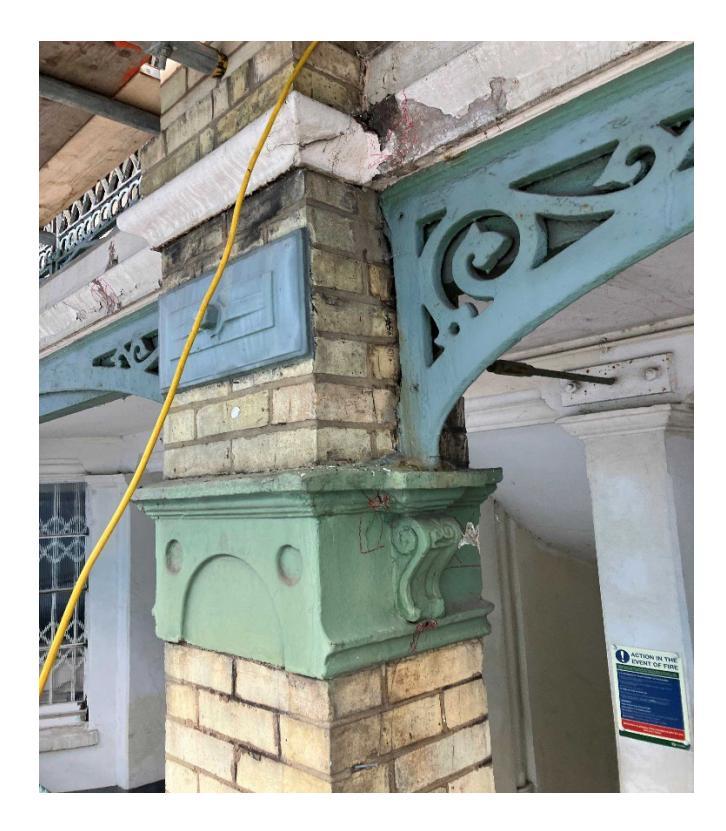
No major issued under the third floor landing.

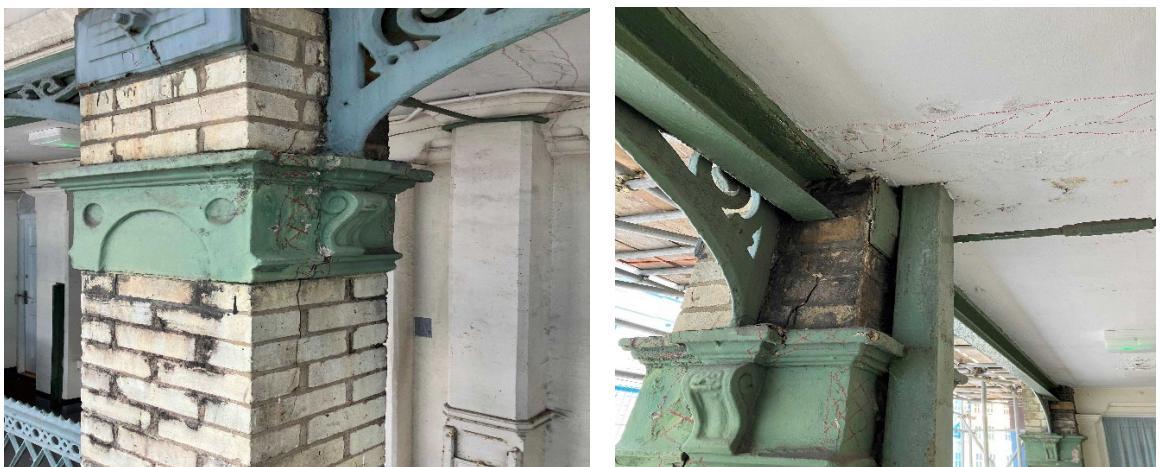
Cracked brick work and concrete padstone under the second floor landing. Patress plate is starting split.

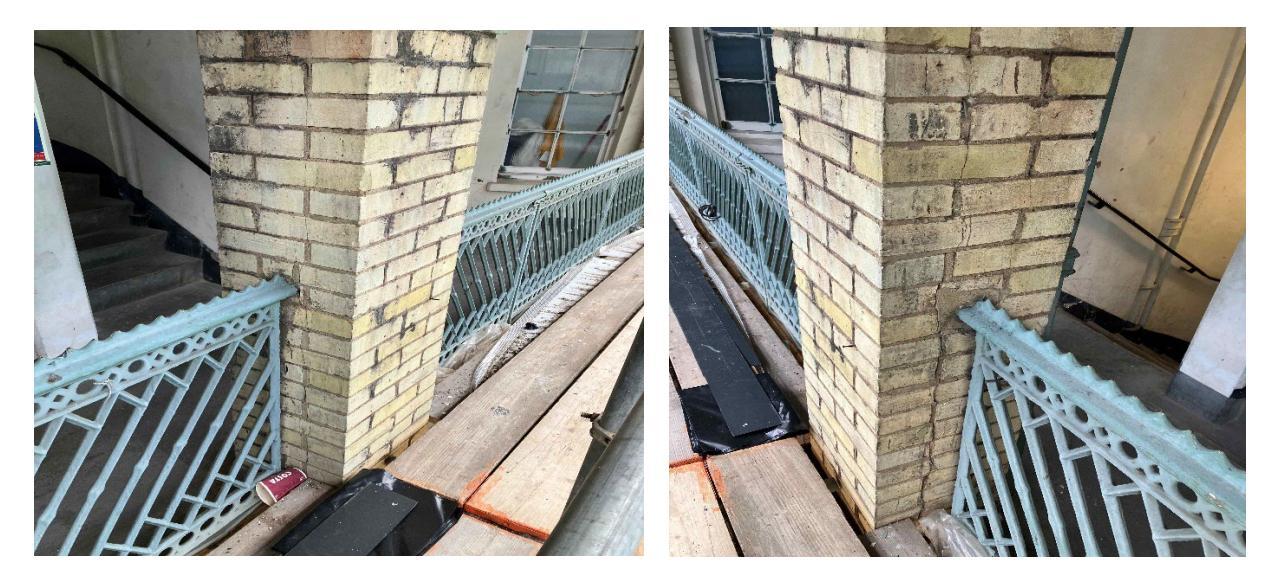
Brickwork to the piers at first floor level has cracked.
