Our Ref: CAS / 25536

20th March 2023

Re: External inspection to Derby Lodge, Wicklow Street, London. WC1X

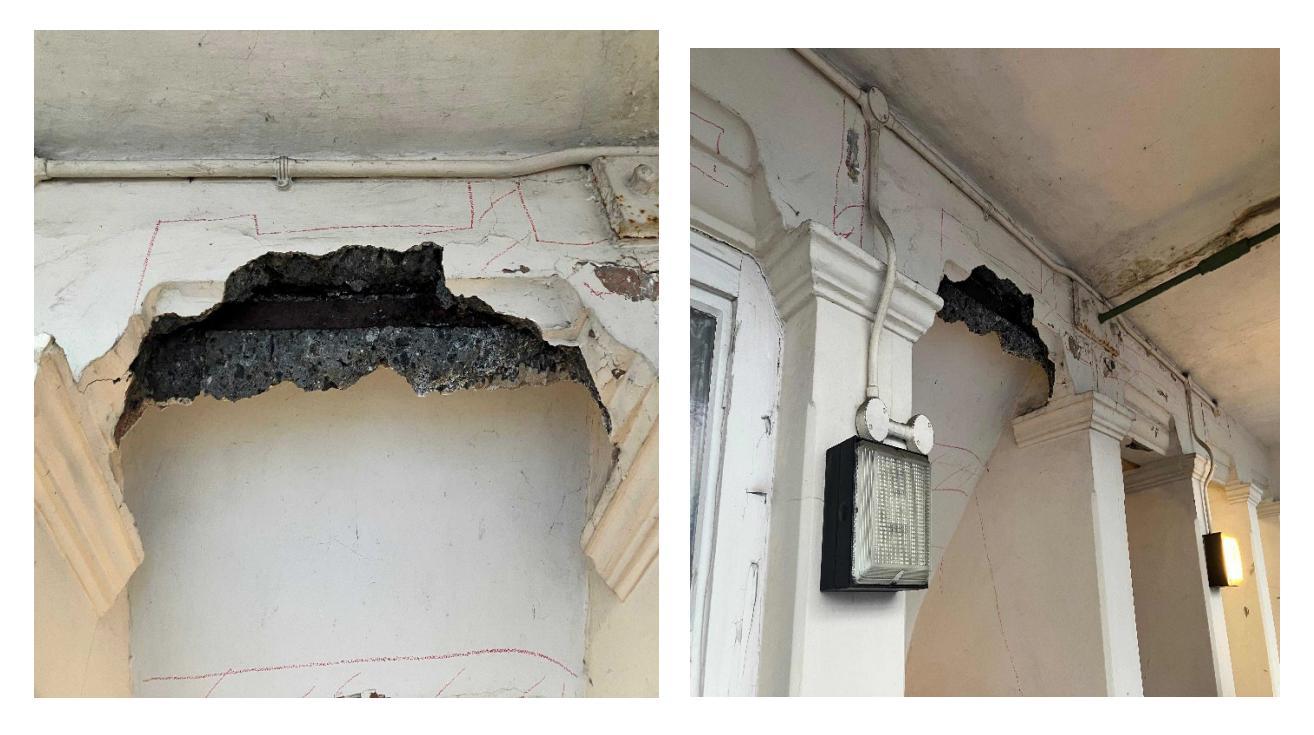
- The clinker concrete forming the lintels over the staircase and external landings has spalled and no longer bonded to the steel reinforcement. The streel reinforcement is corroded.

Concrete lintel over the opening to the staircase.

- The beams over the staircase and landings to the flat entrances cannot be repaired with Sika (or similar products). In our opinion the clinker concrete lintels need to be removed and replaced with concrete lintels.

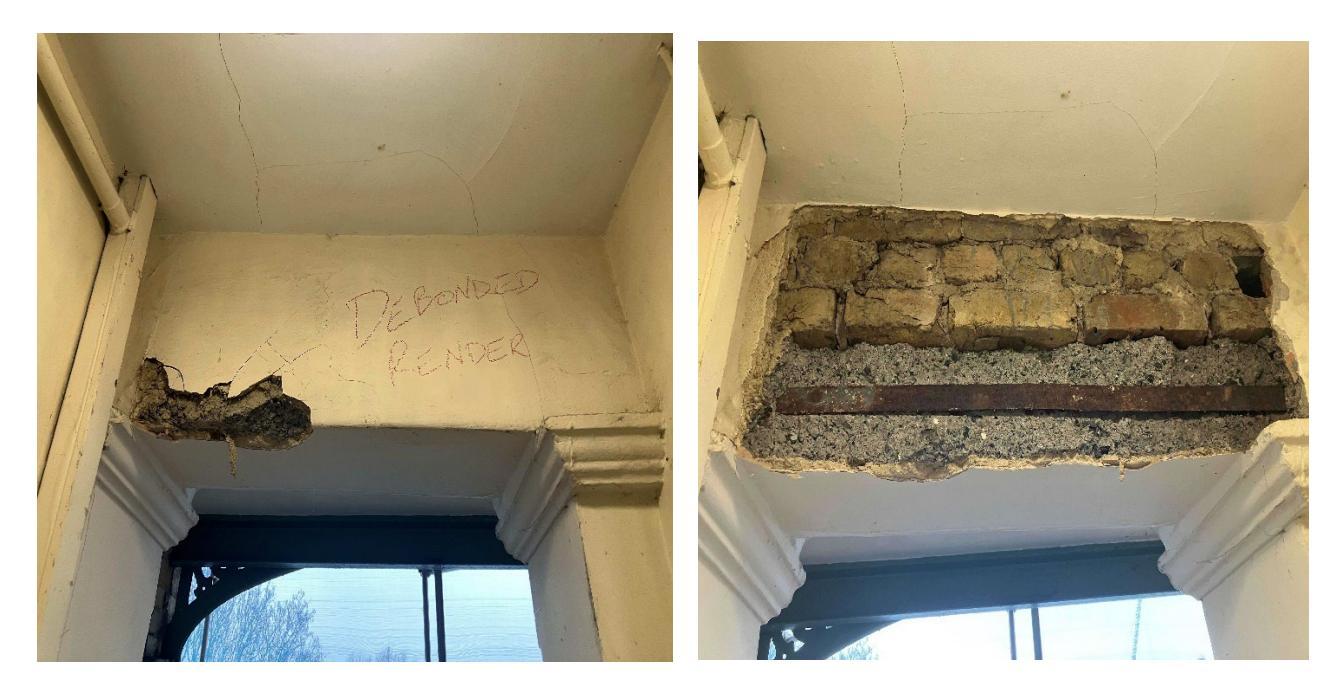
Clinker concrete lintel. (external landing to flat entrances).

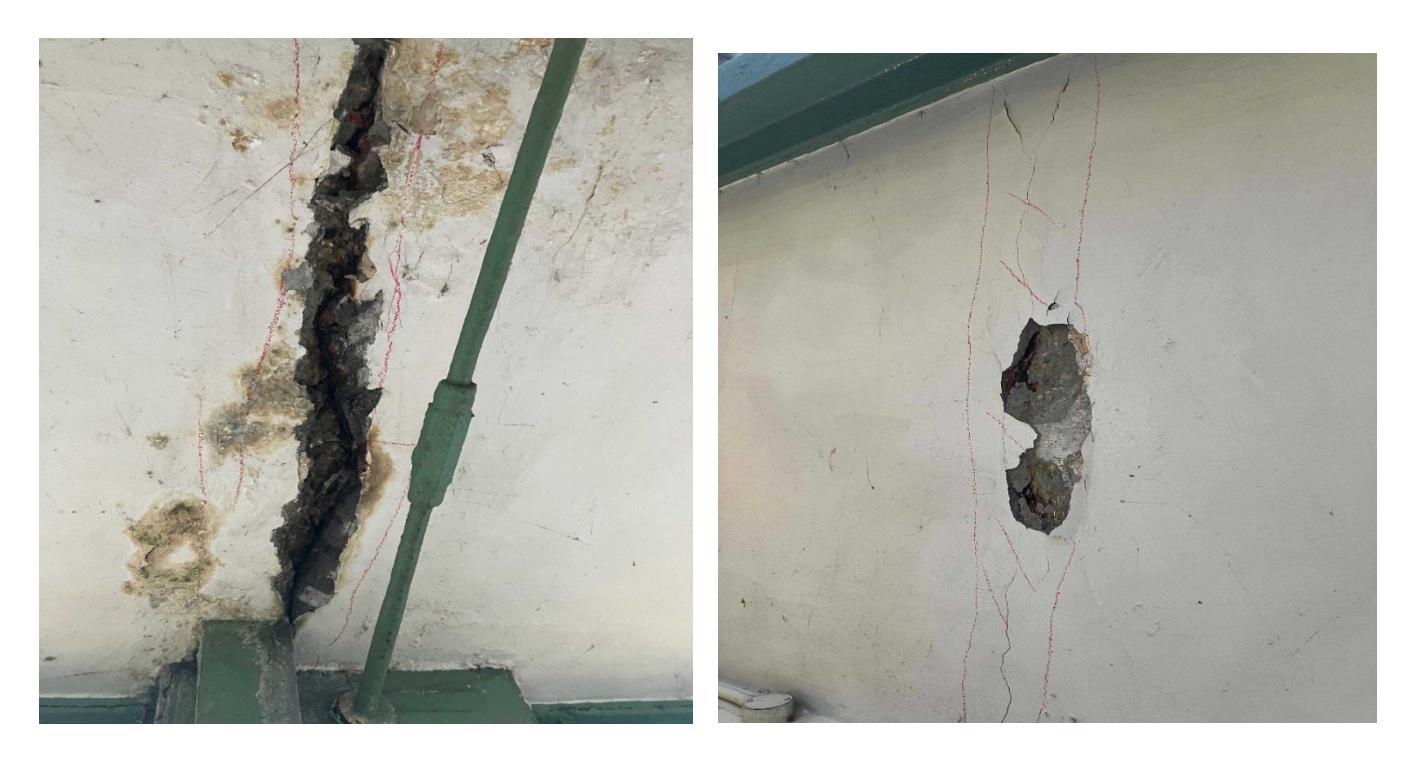
- We found evidence of previous repairs to the underside of the landings. We do not know when they were carried out. The cracking to the underside of the landings is inconsistent.

Signs of previous repairs to the landing structures. Reinforcement varies. Concrete is not clinker in some areas.

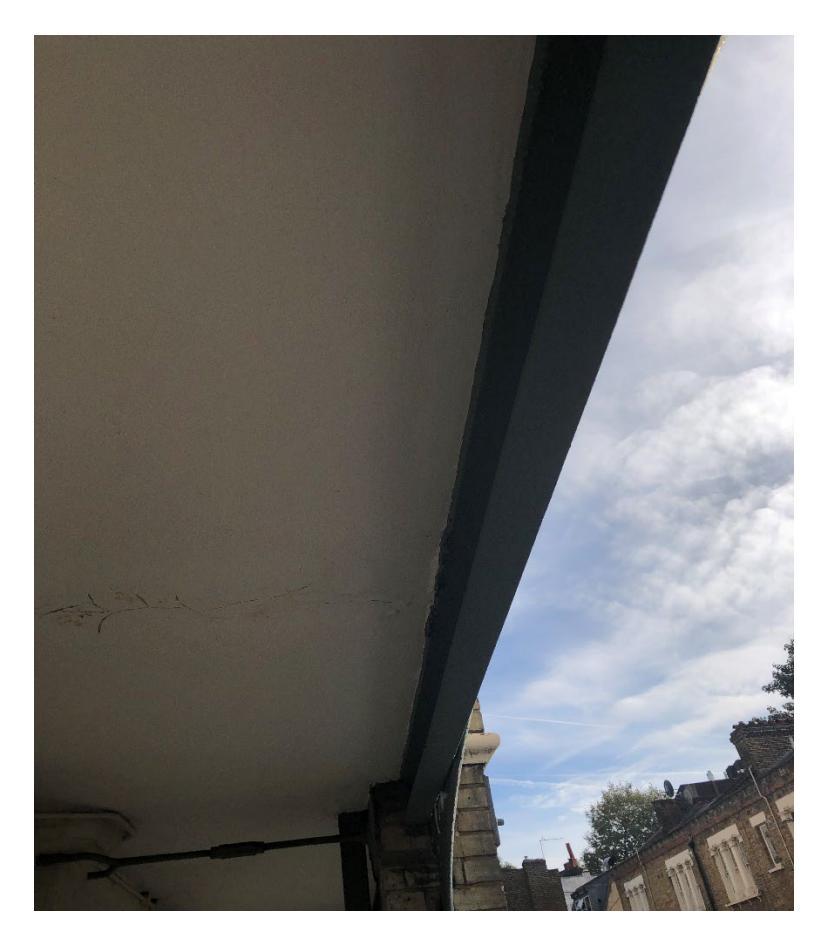
Cracking to the underside of the slab is not consistent. This may be down to previous repairs.

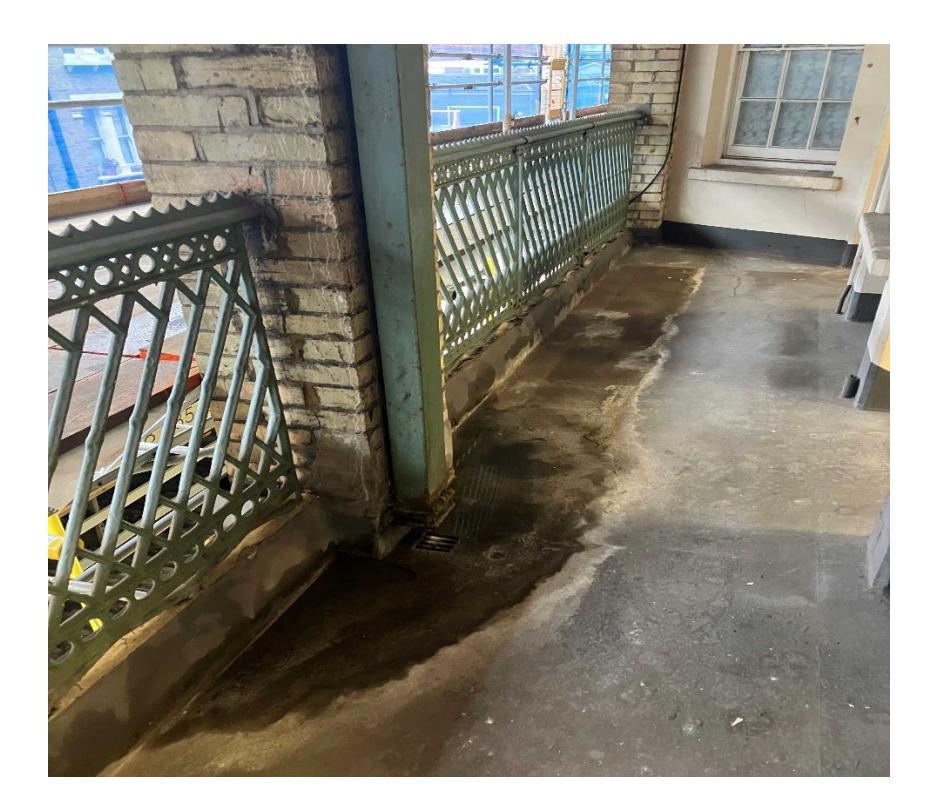
- It had been raining the night before our visit. We could see that the surface water was not draining away from the landings. The water is seeping into the landing structures. We believe this is the main cause of the deterioration to the landing structure.

Surface water pooling on the landings. It is not drawing away. The water is percolating into the landing structure.

- The waterproofing applied to the top of the landings needs to be re-laid so the surface water drains off the structure. We recommend that the drains are cleaned / repaired as required.

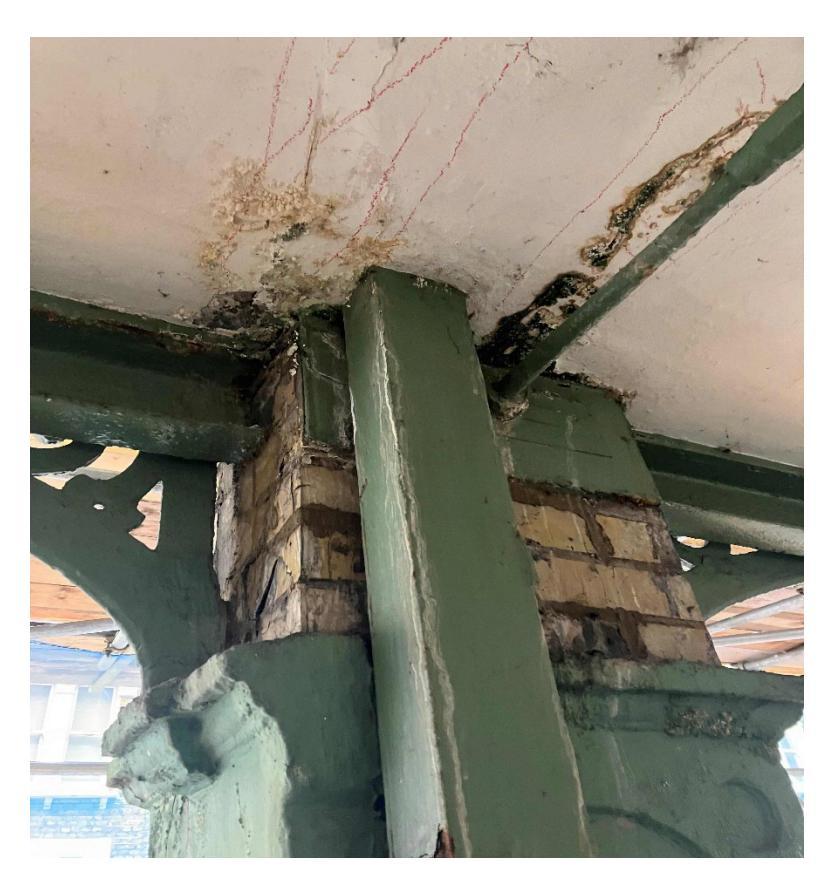
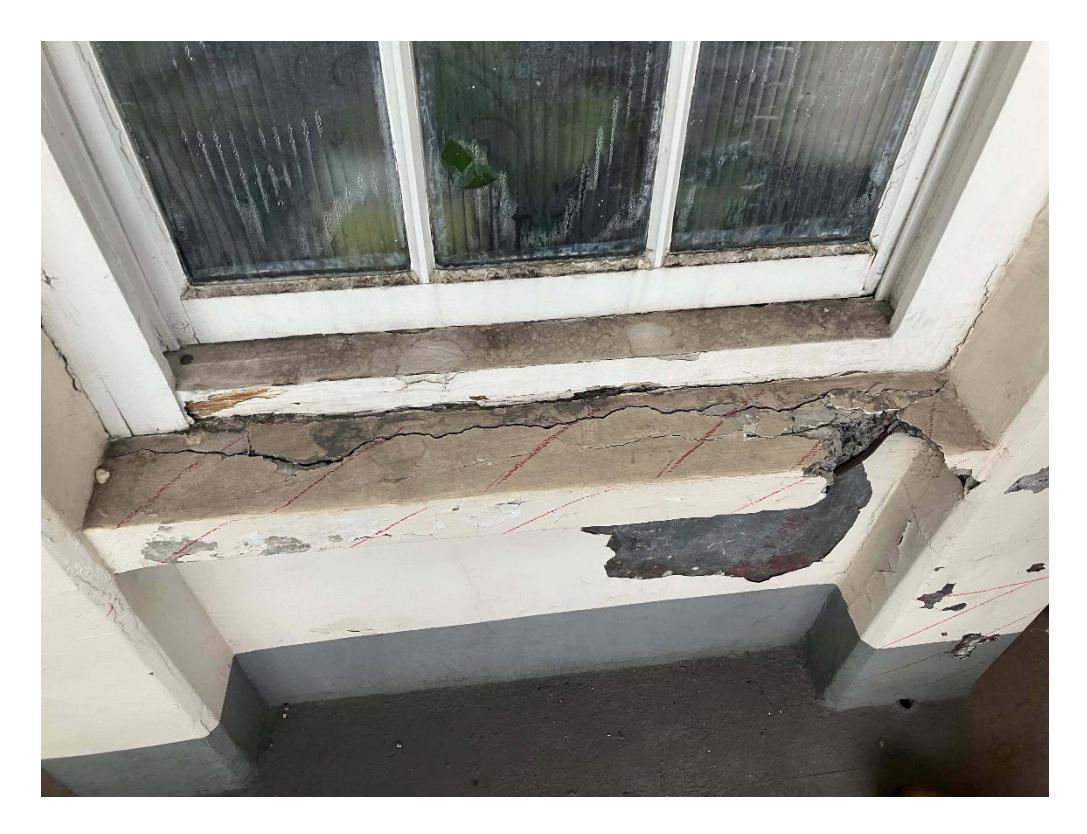
- Some of the brickwork within the columns had cracked, this will need to be replaced.
- Concrete forming the windows sills has cracked. Reinforcement has corroded.

Cracked concrete forming the windowsills.
