Arboricultural Design & Consultancy

TPO TREE WORKS APPLICATION

The Lodge
North End Avenue
London
NW3 7HP

AS/MF/0231/24

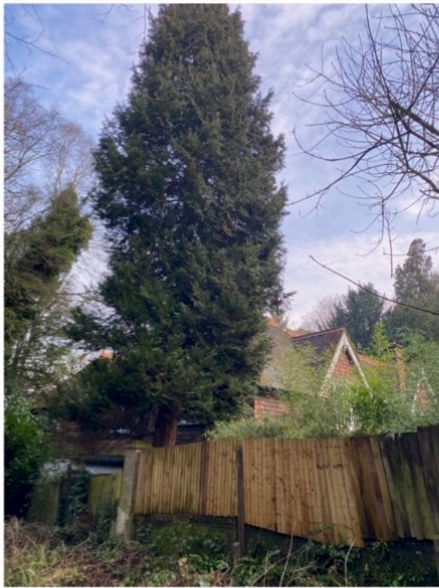
- (i) Inappropriate location of tree at 3m distance from property with crown overhanging the property
- (ii) Location within raised retainer with potential for structural damage at very close proximity to property
- (ii) Crown cannot be managed for species without causing detriment to the amenity value and aesthetic appearance of the tree
- (iii) Incongruous form within the Hampstead Conservation Area setting and also being within / adjacent to Hampstead Heath
- (iv) Robust replacement strategy which shall deliver a treescape for the property for the long term with improved canopy cover and biodiversity value

Tree T1 as viewed to north east
within raised retainer against west
elevation of property

TREE WORKS SCHEDULE			
Tree No.	Common Name	Tree Works	Reasons for works
T1	Lawsons cypress	Fell to ground level and grind out stump Provide replacement planting - minimum 12-14cm girth Standard tree (location and species to be confirmed in writing)	To facilitate replacement planting

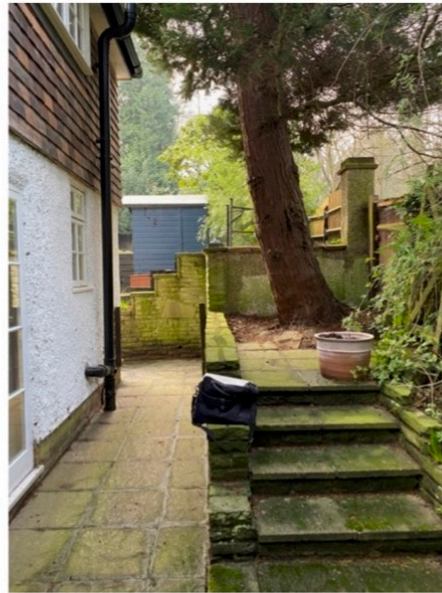
Tree T1 as viewed to south
within raised retainer
