UNIT 1 LOWER GROUND FLOOR:

FOUND HERITAGE MATERIALS - PROPOSALS

2001 - Proposed Plan - Lower Ground Floor - Former Bank  
uNIT  
1  
1 : 50

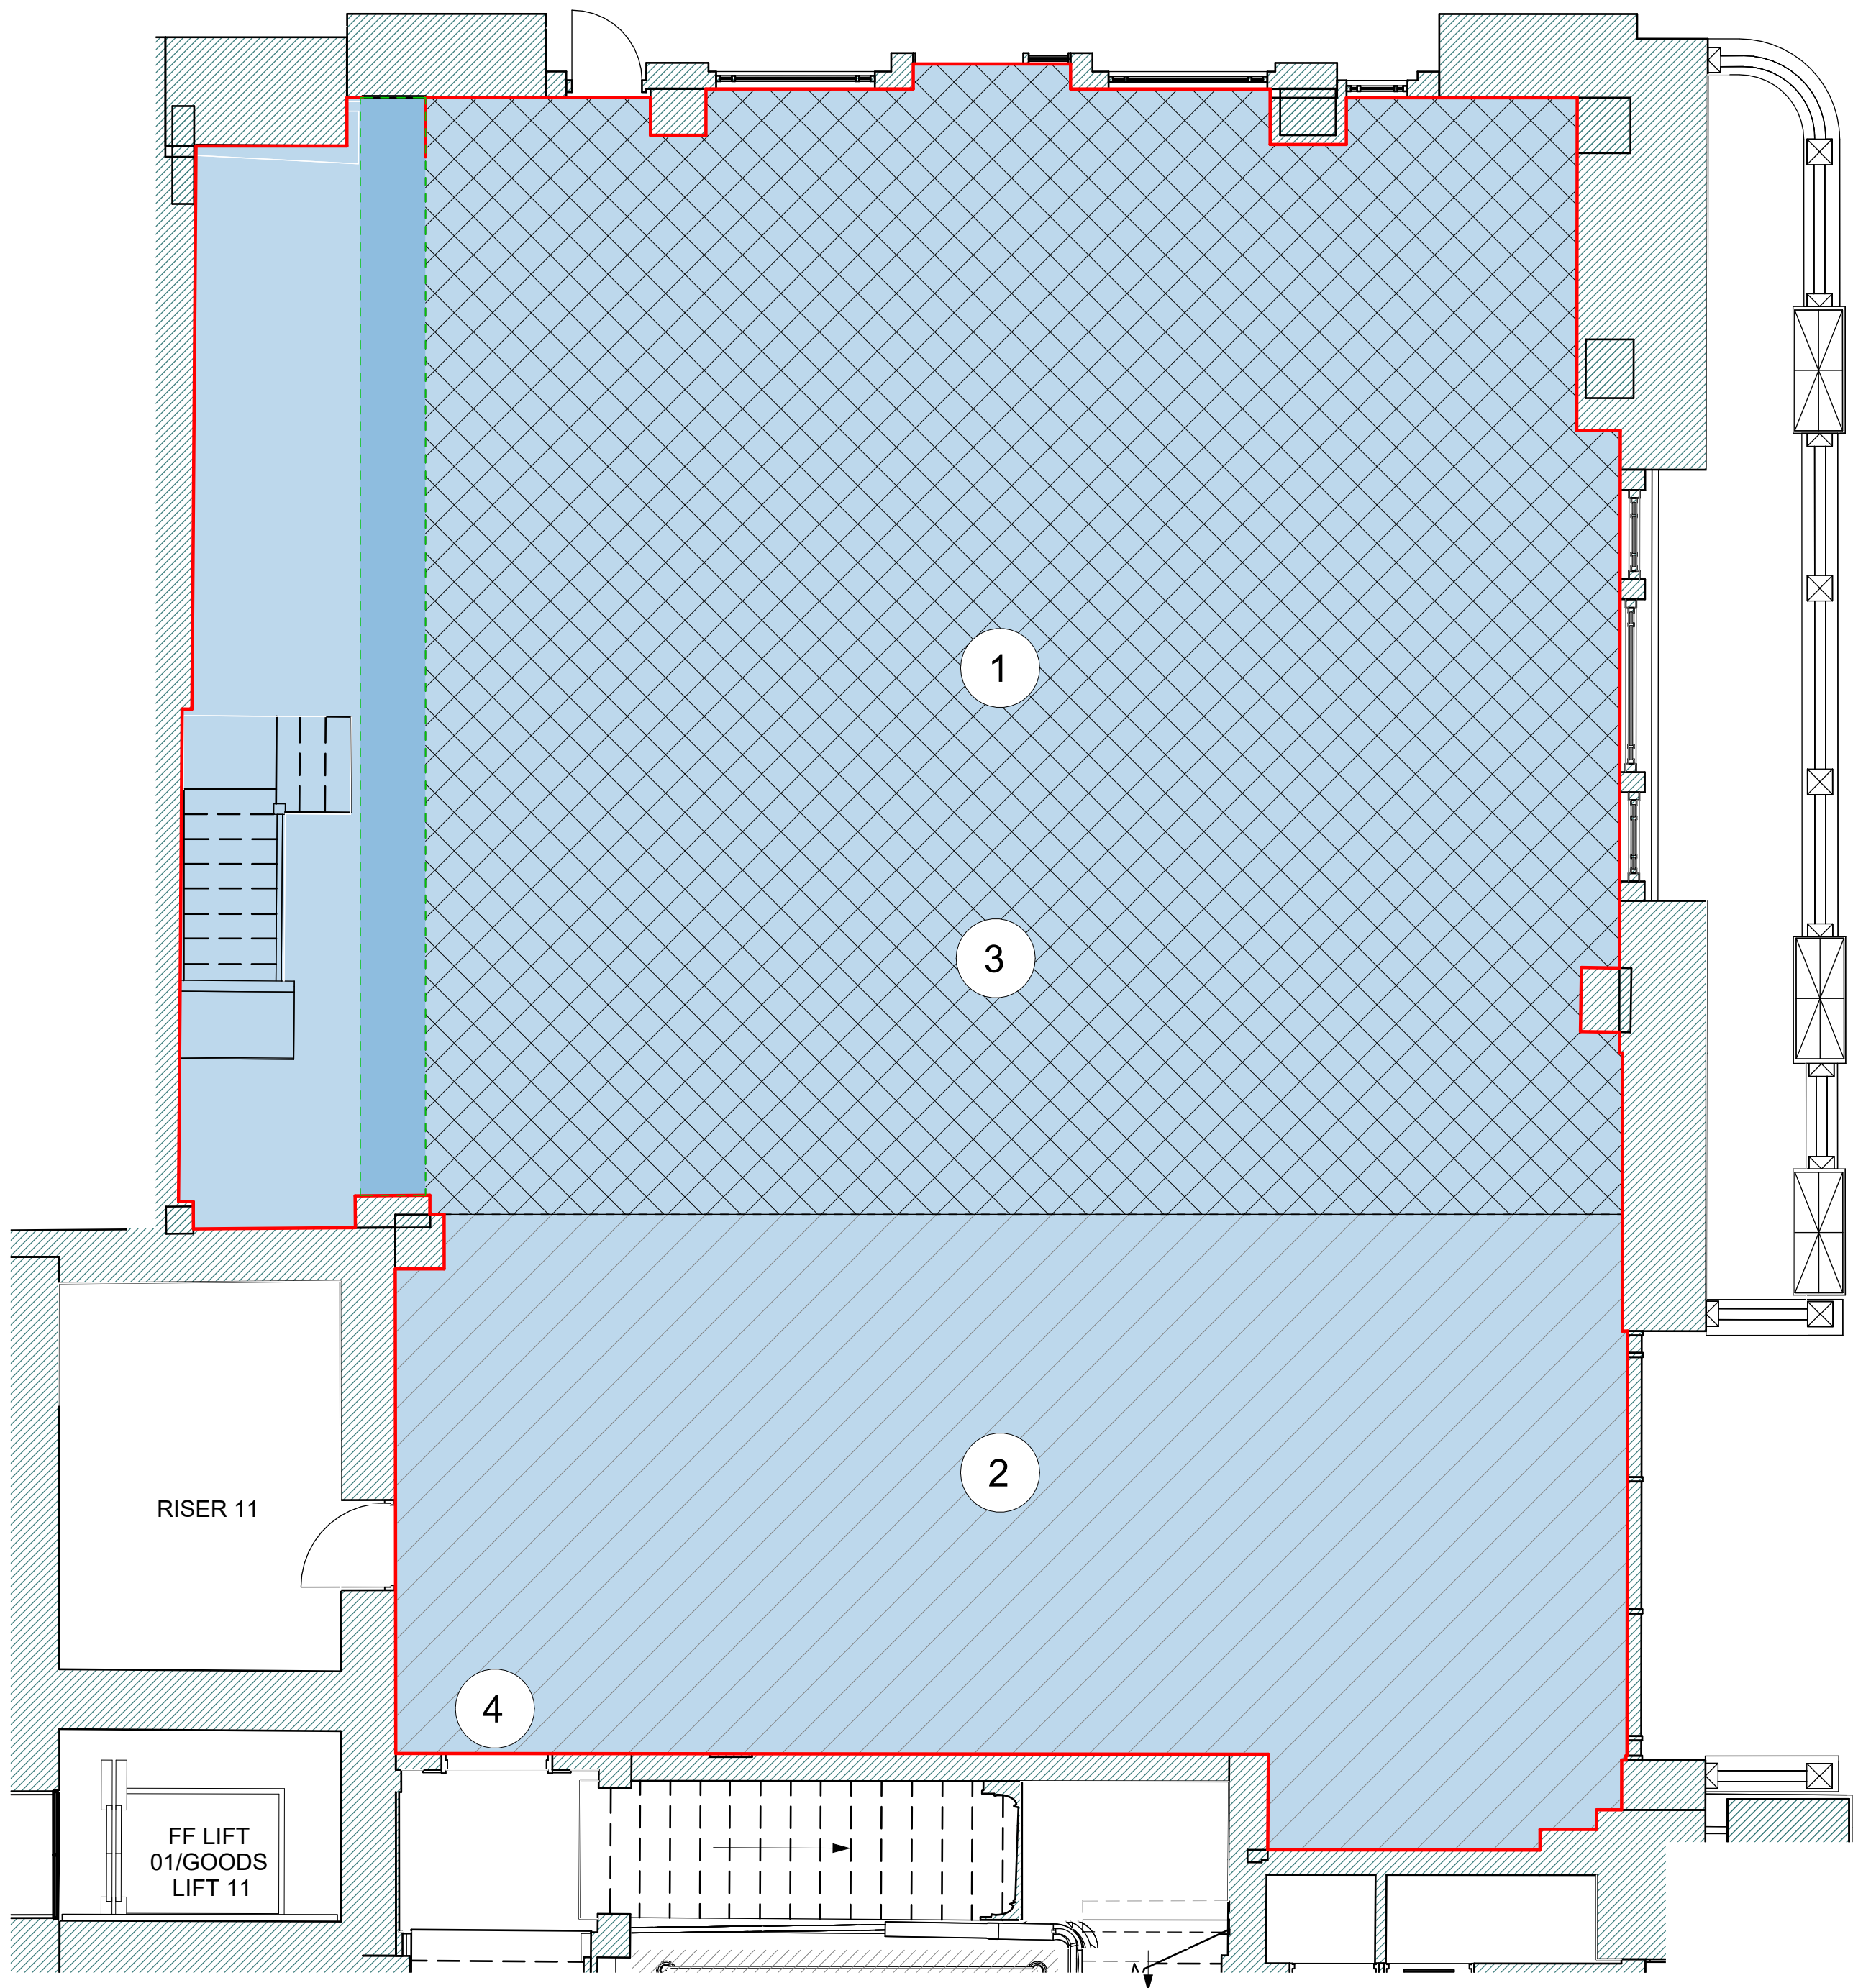
- HIGH LEVEL HERITAGE CEILING**, - IN FAIR CONDITION.  
TO BE REPAIRED AND MADE GOOD USING PROPOSALS ESTABLISHED BY CONDITIONS SURVEY CARRIED OUT AS PER PRINCIPLES BELOW.
- LOW LEVEL HERITAGE CEILING** - IN VERY POOR CONDITION.  
TO BE MADE SAFE AND ENCLOSED WITHIN A NEW SUSPENDED PLASTERBOARD CEILING USING PROPOSALS ESTABLISHED BY CONDITIONS SURVEY CARRIED OUT AS PER PRINCIPLES BELOW.

- FLOOR** - EXISTING PARQUET FLOORING IS IN VERY POOR CONDITION AND HAS DELAMINATED IN NUMEROUS AREAS ESPECIALLY WHERE LATE ADDITION FLOOR TRUNKING AND CONTAINMENT WERE PREVIOUSLY INSTALLED AND IS CONSEQUENTLY NOT FIT FOR PURPOSE. THE REMAINING PARQUET FLOORING IS TO BE REMOVED AND NEW LEVELLING SCREED IS TO BE APPLIED TO THE FLOOR SLAB SUITABLE FOR FUTURE SR2 APPLICATION (E.G. VINYL) BY A FUTURE TENANT - REFER TO SEPARATE REPORTS AND SUPPORTING HERITAGE STATEMENT.

- LOCATION OF ORIGINAL CONNECTING DOOR TO MAIN CIRCULATION – THIS HAS BEEN LOCATED BEHIND PLASTERBOARD WALLS AND HAS BEEN PREVIOUSLY SCREWED SHUT. TO BE LEFT IN PLACE AND RECORDED. OVER BOARDING TO BE REPAIRED AND MADE GOOD TO REESTABLISH REAR WALL.

AREA OF HERITAGE CEILING AT HIGH LEVEL (SEE NOTE 1)

AREA OF HERITAGE CEILING AT LOW LEVEL IN POOR CONDITION (SEE NOTE 2)

EXTENT OF EXISTING POOR CONDITION PARQUET FLOORING TO BE REMOVED TO ACCEPT NEW LEVELLING SCREED (SEE NOTE 3)

THESE CEILINGS ARE TO BE SURVEYED USING THE FOLLOWING PRINCIPLES TO ESTABLISH NECESSARY REPAIR METHODOLOGY:

- THE CEILING CONDITION WILL BE REVIEWED AND CHECKED VIA A VISUAL SURVEY. THIS WILL ASCERTAIN THE GENERAL CONDITION OF THE CEILING AS WELL AS OF ANY DEFECTS (E.G. DELAMINATION, NIB CONDITION, FRIABLE PLASTER, MOVEMENT IN THE CEILING, CONDITION OF PLASTER WADS, CONDITION OF FIXINGS USED, ETC).

- LOCALISED PHYSICAL HAND PRESSURE TESTING WILL ALSO BE USED AS DEEMED APPROPRIATE.
  - STRUCTURAL ENGINEERING ADVICE MAY BE REQUIRED DEPENDING ON THE CONDITION THAT IS FOUND, TO ASCERTAIN THAT THE CEILING IS SAFE FROM COLLAPSE AND ALSO TO CONFIRM THE FIXING METHODOLOGY FOR THE PROPOSED SECONDARY CEILING THAT IS PROPOSED TO ENCLOSE THE LOWER CEILING.

- THIS VISUAL INSPECTION WHERE POSSIBLE WILL BE CARRIED OUT VIA THE EXISTING OPENINGS TO THE CEILINGS AND COULD MAKE USE OF ENDOSCOPE CAMERAS IF REQUIRED.

- IT IS POSSIBLE THAT ASBESTOS IS LOCATED ABOVE THE CEILING VOID - THIS MAY LIMIT THE EXTENT AND TYPE OF REPAIR. THIS IS TO BE NOTED BY THE SPECIALIST SUB CONTRACTOR AND ANY OPERATIVES AND ALL NECESSARY PRECAUTIONS / METHODOLOGY 'S PUT IN PLACE.

- PROPOSALS FOR REPAIRS WILL THEN BASED ON THE FINDINGS, E.G. REPAIR OF OPENINGS AND CONSOLIDATION WORKS MAKING USE OF TECHNIQUES SUCH AS SCREWS AND WASHERS / COUNTER LATHING / STEEL STRAP WITH WIRE AND WASHERS ETC.
