Arboricultural Survey, Impact Assessment and Method Statement

30 Elsworthy Road,
London,
NW3 3DL

File Ref: ASIAMS151.1

Ross Fountain Dip. Arb L4 (ABC)
15.09.22

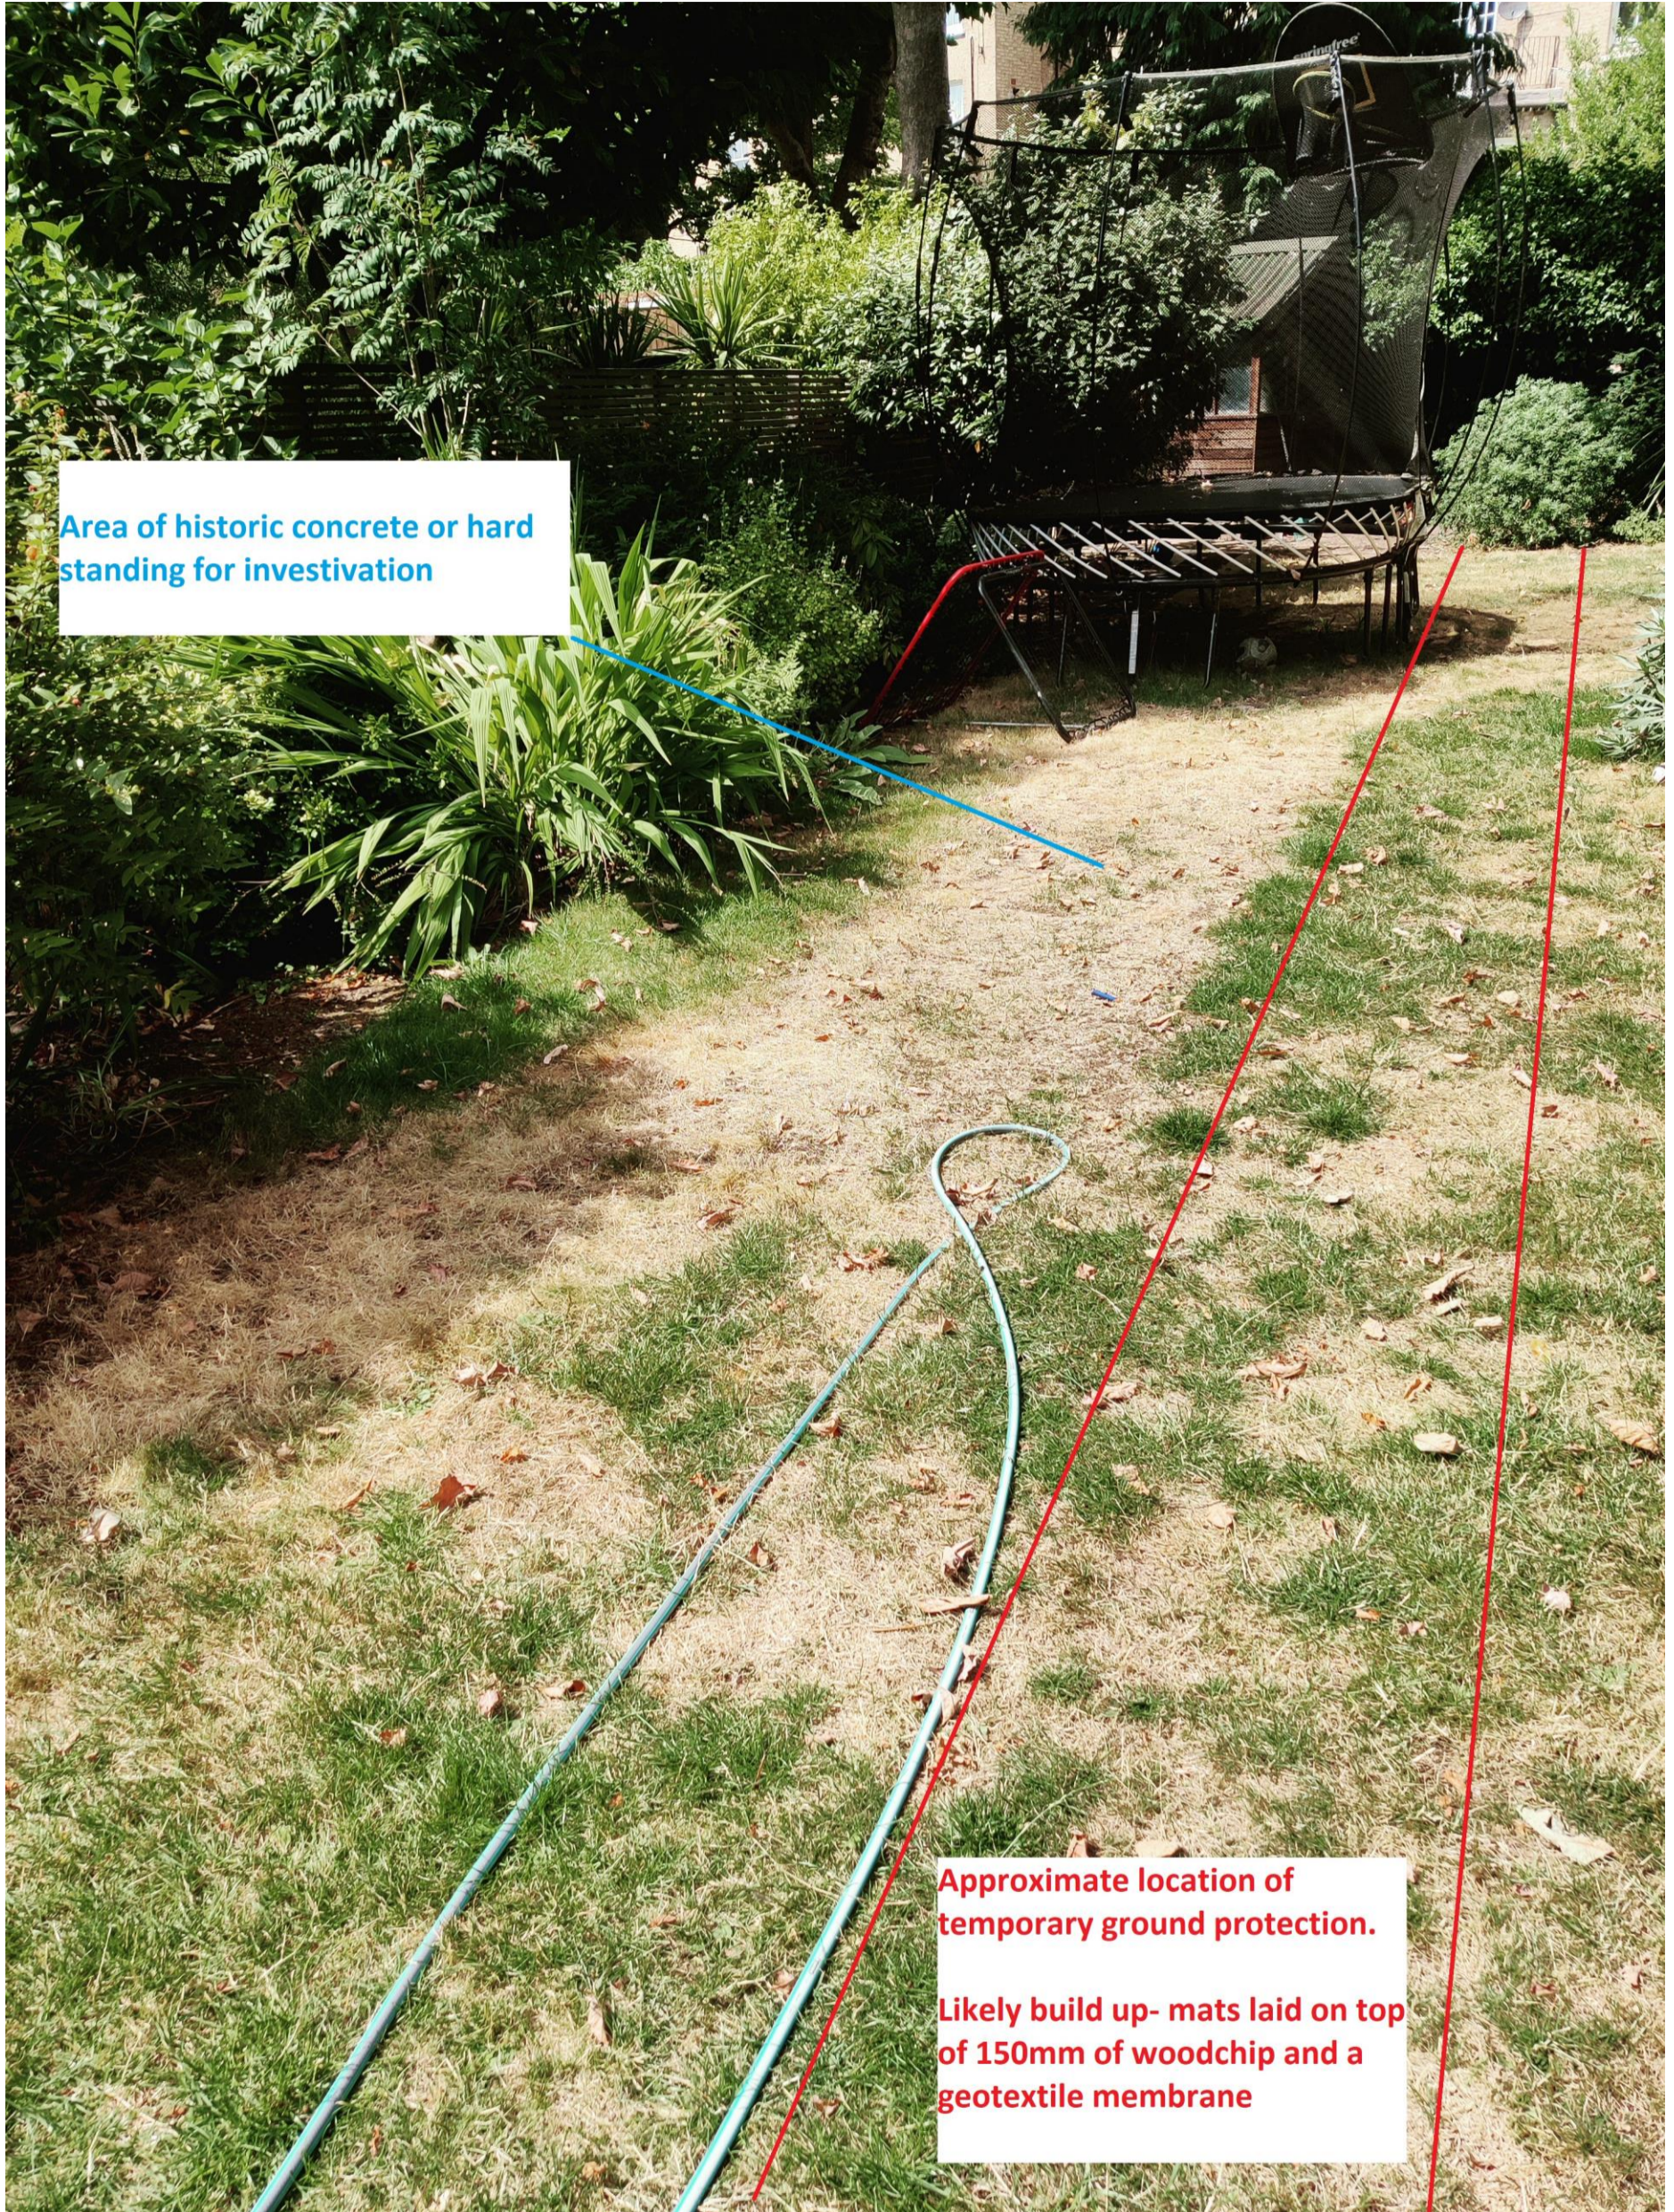
Picture 1- showing approximate location of temporary ground protection and area of historic concrete or hard standing

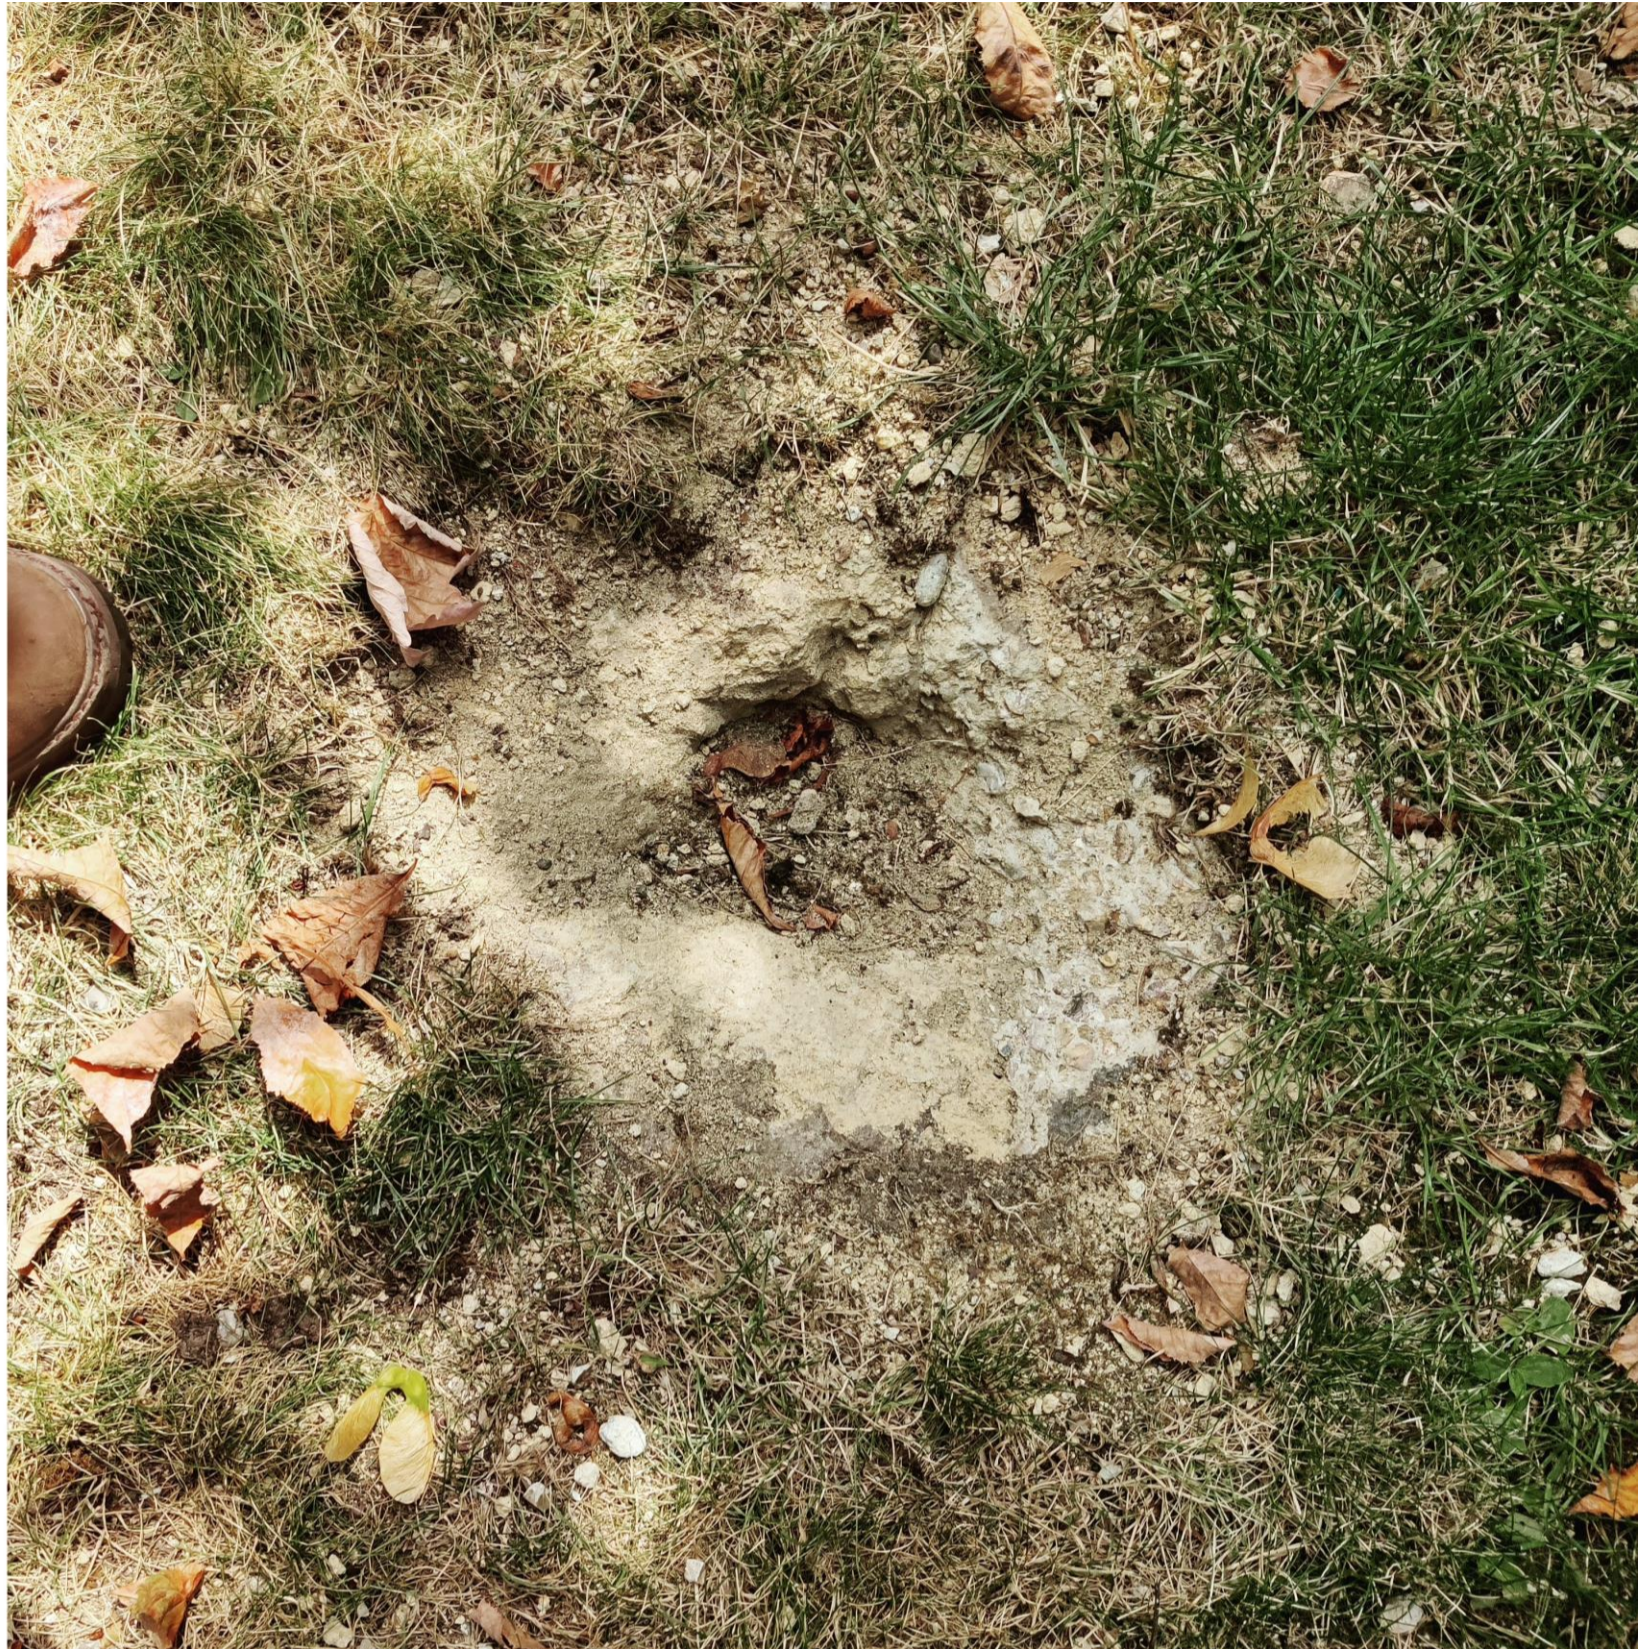
Picture 2- showing historic concrete or hard standing within the lawn

5.3.2.2 If rooting activity is discovered and exposed in the removal of the concrete slab the AC should be contacted. In this case soil and mulch may be required to be applied to the area to avoid root damage occurring. Any exposed roots should temporarily be covered with hessian and kept damp to avoid desiccation or any sudden changes in temperature, see **5.4 Prohibitions and precautions within RPAs**.

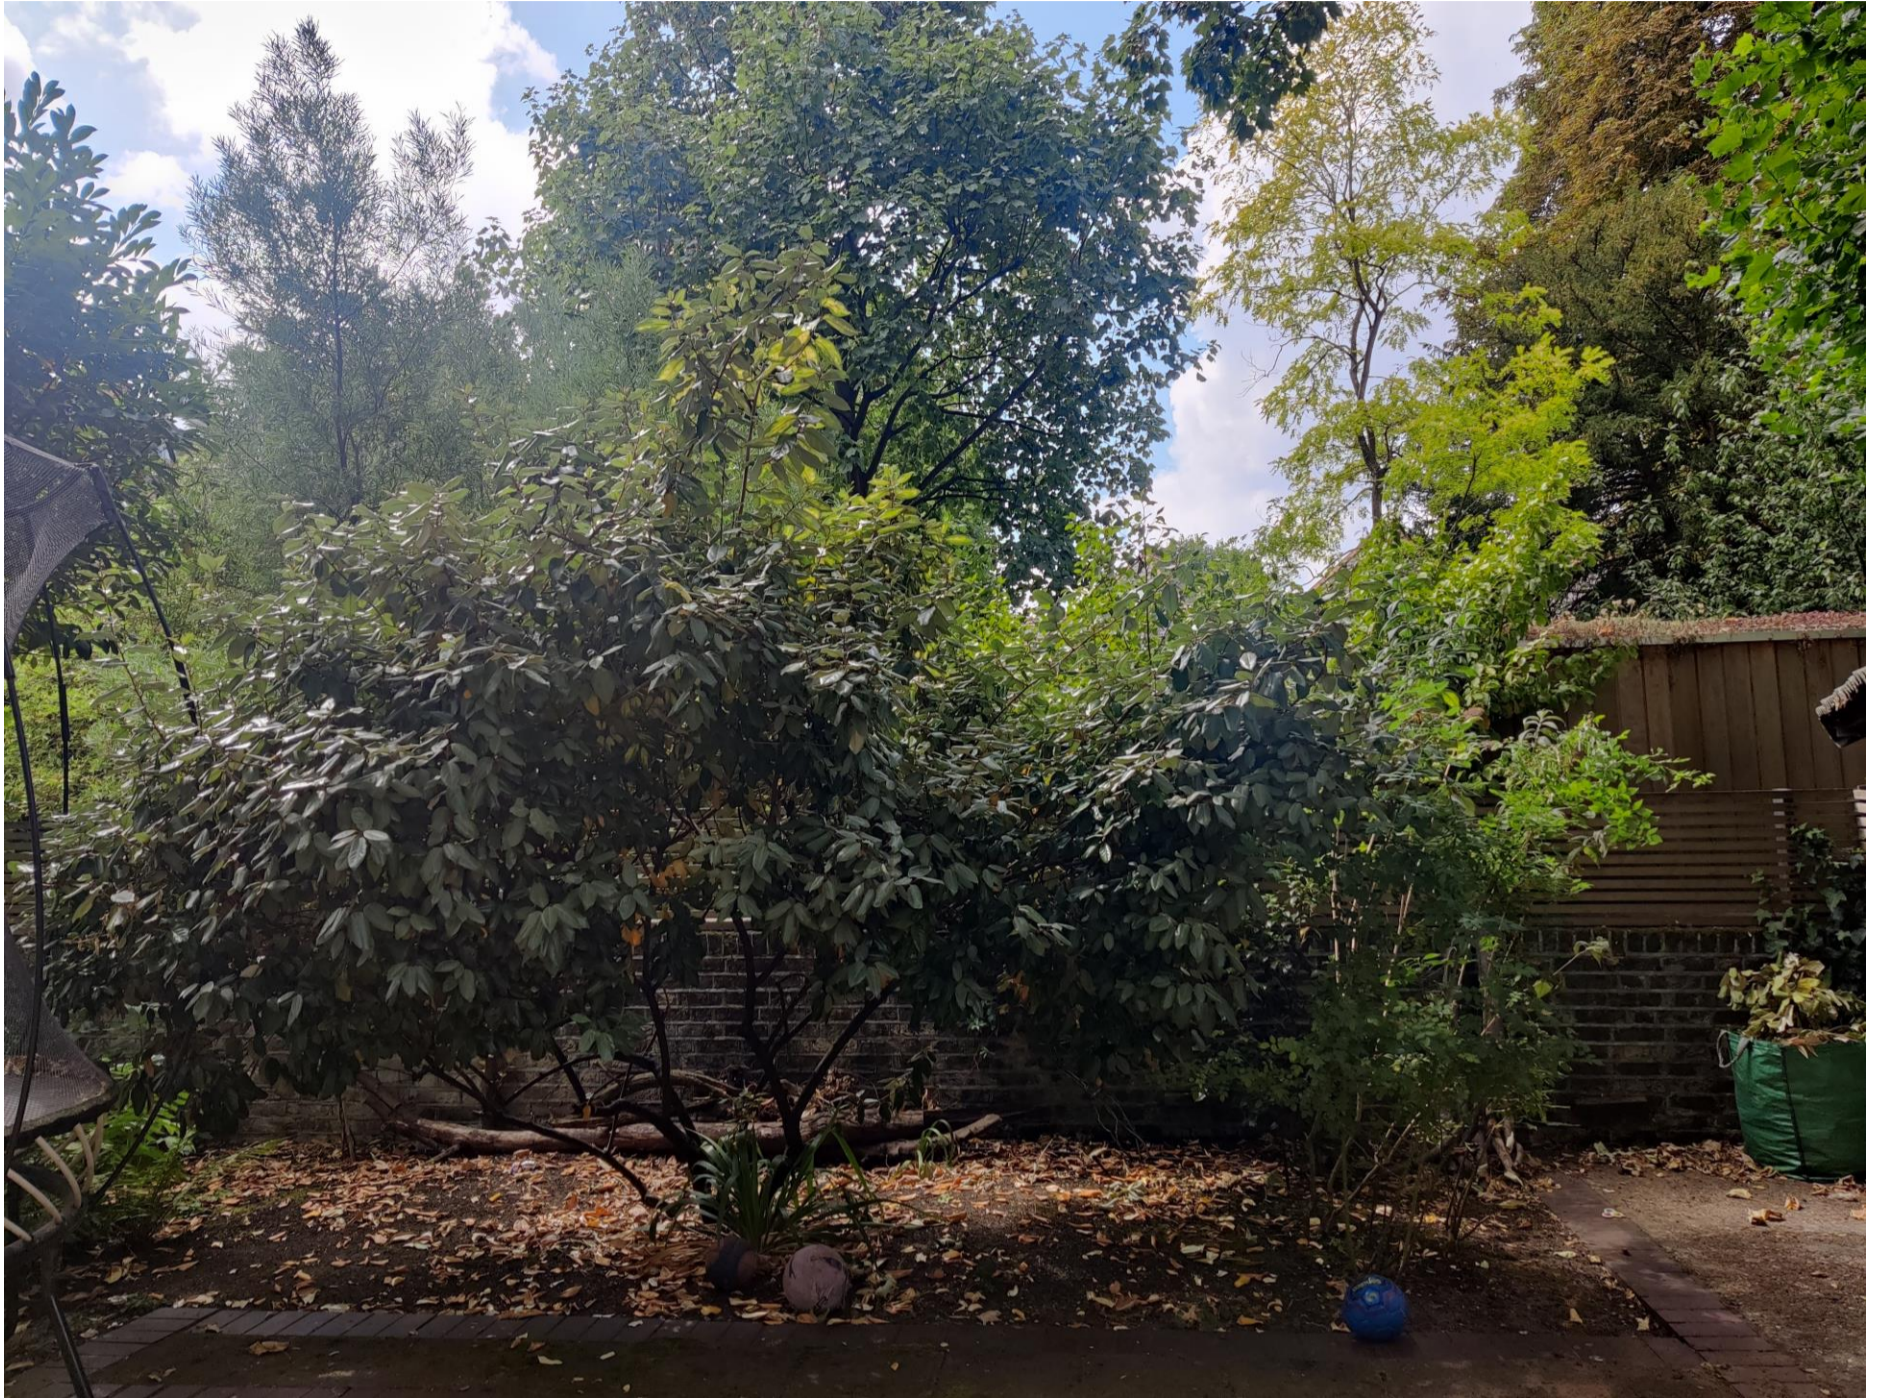
4.4.1.2 Some removal or relocation of small, young woody plants listed in G001 are necessary to enable the proposed development. This is to enable locating the studio. See picture 3 in the appendix. The plants are young or small and are of low to moderate quality and their removal is insignificant in terms of visual impact and environmental impact and do not impact the character of the area. As the plants are young and small, they can be readily replaced. This is advised over relocation except for the camelia and rose which are both very small plants. In general replacement is preferable in comparison to relocation due to the potential damage caused to roots of retained trees that may occur in digging up enough of the transplanted root system for the plant to be viable in its new location.

Picture 3- showing G001, a group of small and young woody plants that need removing or relocating to enable the proposals

5.3.1 The removal of small, young woody plants within G001 should be carried out by felling and grubbing out (severing roots close to the trunk of the removed plant if necessary) or cutting to ground level and poisoning with ecoplugs where regrowth is likely. Though stump grinding is not expected given the size of the removed plants, this can be carried out if necessary. However, this should be minimised to around 5cm in depth and carefully localised to the specific stump removed, to avoid damage of roots of retained trees. Where small plants are to be relocated- such as the rose or camelia, a root ball containing earth should be carefully transported to a pre-dug square hole that is preferably located outside of RPAs of retained trees. Any roots outside the root and soil root ball should be cut cleanly with a sharp hand tool- such as secateurs. The root ball should be wrapped to avoid break up during transportation and planted in the pre-dug hole as soon as possible. The hole should be backfilled, avoiding excessive compaction and the plant watered liberally. If relocation within RPA is crucial, this would be possible however a trial hole would need to be carefully dug and plants relocated if rooting activity was found. Planting within an RPA would need to be monitored by the project AC and practices governed by the restrictions as set out in **5.4 Prohibitions and precautions within RPAs** of this report.
