# Planning Statement

Application for Discharge of Pre-Commencement Planning Conditions at 31 South Hill Park, Hampstead, London, NW3 2ST

Issue Date: 24/01/25

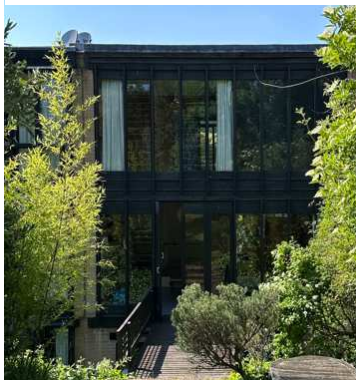
- The condition of the existing external timber elements is not suitable for preservation due to the level of decay and distortion.
- The existing external timber elements have been later painted with an impervious paint, which prevents moisture evaporating naturally and has further contributed to the extent of decay. Removing this would require dismantling and planing down the painted finish which would change the profiles of the timber and could make reassembly unfeasible.

Figure 3 - 2024 Site photo with later painted boards and over cladding at the eaves

Based on the condition survey of the front and rear timber facades and timber bridge by Six Heritage (on 7<sup>th</sup> November 2024) our proposal is for the complete replacement of these timber elements with new Iroko tropical hardwood.

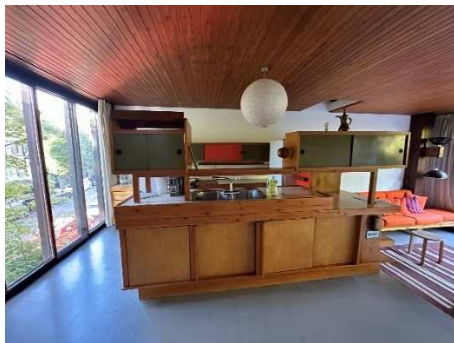
Figure 5 - Kitchen long elevation with swing doors at low level and raised sink worktop

- **Worktop height:** The existing Formica worktop height, excluding the area around the sink, is currently very low (830mm including a 70mm thick worktop.) This is not only difficult from an ergonomic perspective but makes it impossible to fit a standard oven or fridge under the existing worktop height (as these would require a worktop height of 900mm minimum).

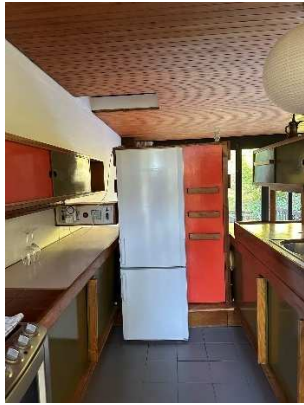
Figure 6 - Full height fridge which does not fit comfortably in cupboard

- **Existing Fridge Freezer:** The original design, as noted on the original drawings, suggests a "Shelf for refrigerator" that is clearly too small to accommodate any modern fridge freezer units. A large full height fridge freezer has subsequently been awkwardly installed which is clearly detrimental to the original design intent of the kitchen. By increasing the height of the worktop, it will be possible to install an under-counter fridge.

**6a. Fridge:** New freestanding fridge

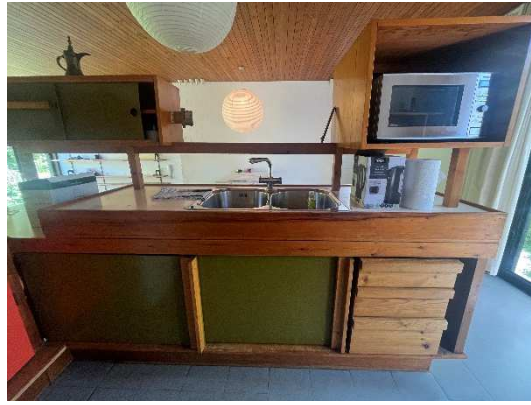
Figure 7 - Sink worktop. High level units have sliding doors or are open shelves. Low level sliding doors to cabinets and pull-out drawers RHS

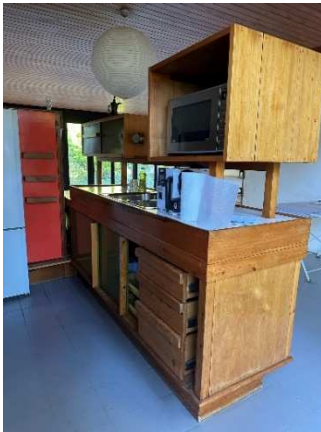
Figure 8 - Excessively large high-level unit for microwave

- **Cupboard above the sink:** There is a cupboard above the sink which is awkward in size and scale. We believe that this was a later, non-original addition, perhaps to accommodate a microwave.

**7. High level unit:** Unit to be restructured to match proportions of other units, including sliding door mechanism and handles to match existing. Existing timber to be reused where possible

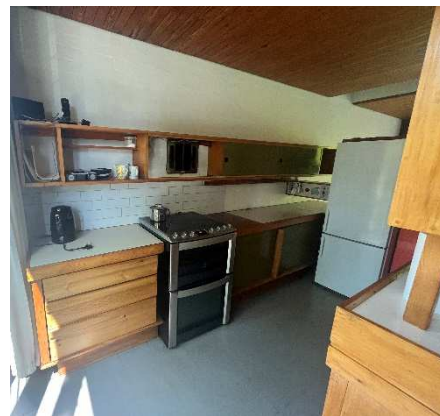
Figure 9 - Existing oven protrudes past worktop. Formica door fronts use sliding mechanisms.

**2. Oven:** New integrated oven (600mm h x 600mm w) to be installed within a new bespoke pine framed carcass to match existing. Pine infill panel to match existing installed below cooker.

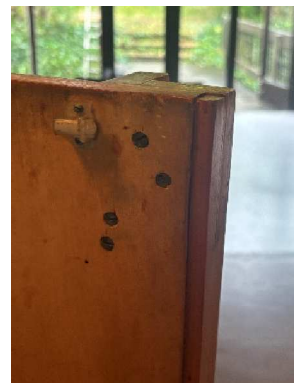
Figure 11 - Hidden screw fixings no aligned inside cupboards

- **Joints and connections:** The kitchen joinery uses both screwed and glued joints with timber dowels. Where joints/ screws are concealed within cupboards, or are out of site, the joints are haphazard and do not follow a setting out pattern. The exposed timber dowels on the high-level units are also unevenly positioned, do not align, and have patchy filler.

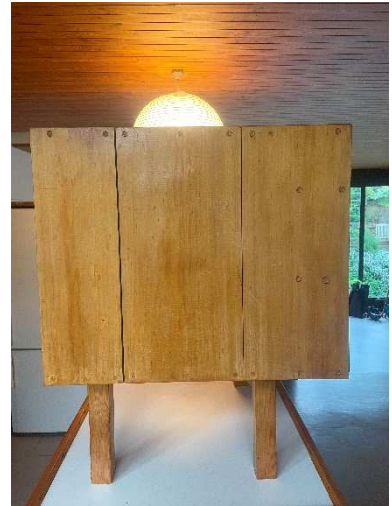
Figure 13 - Timber dowels do not follow a setting out pattern

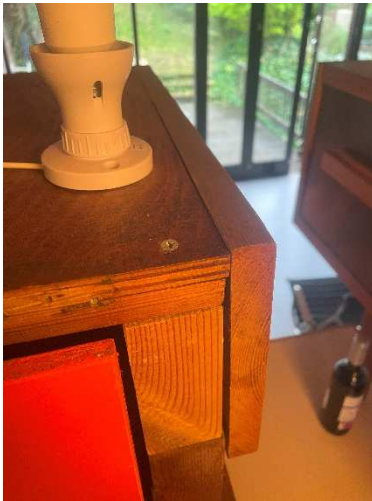
Figure 14 - Poor carpentry to end cupboard with fridge (to be adapted in proposals)

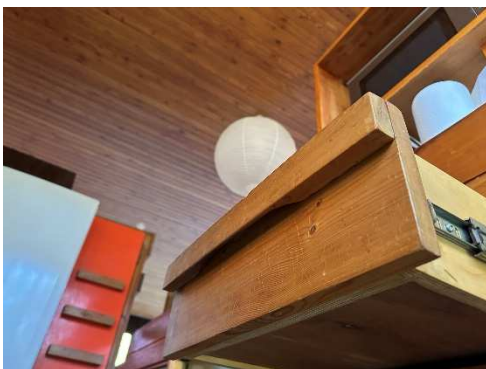
Figure 16 - Existing drawer fronts and handles from solid pine wood.

- **Finishing:** The varnish finish on the exposed solid pine drawer fronts is uneven and tired and would benefit from re-finishing with new clear varnish lacquer.

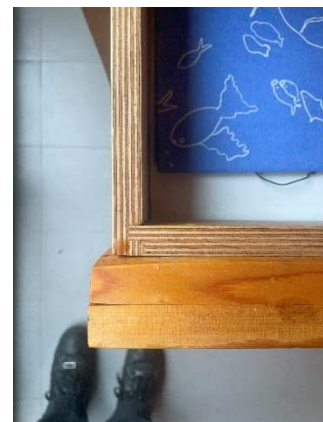
Figure 17 - Plywood pull out drawers

- **Drawers:** The internal birch plywood drawers appear to be a later addition to the kitchen and have more modern drawer mechanisms. The drawers can be retained, and new 'soft close' mechanisms installed to match existing.

**5. Drawers:** Drawer units to be retained and refurbished. All drawer mechanisms to be replaced. Removable 'slot in' plywood drawer organisers and interiors to be constructed to ensure a clean and functional internal arrangement of the drawers.
