16 Provost Road, London, NW3 4ST.

Structural Engineering Report relating to the proposed construction of a proposed gym/sauna in the rear garden of 16 Provost Road, London.

Version: Rev 1

Date: 28th January 2025

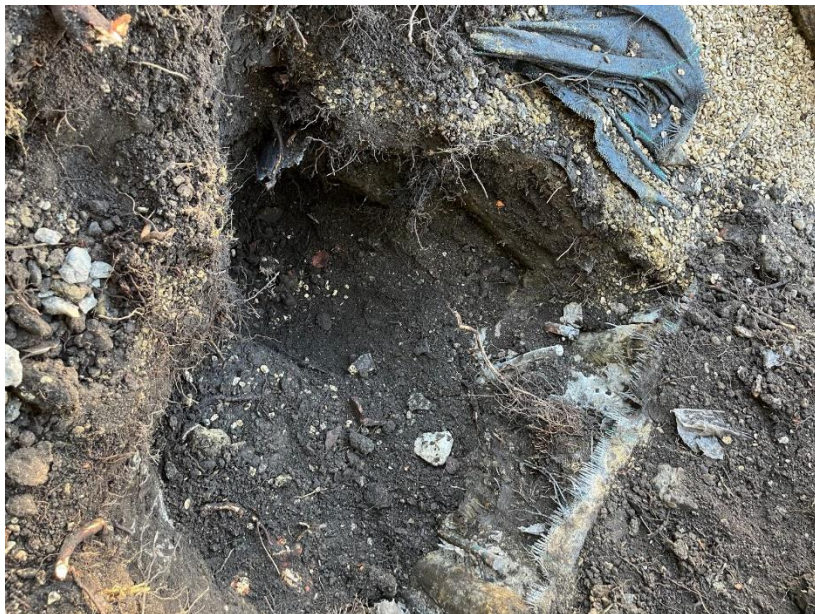
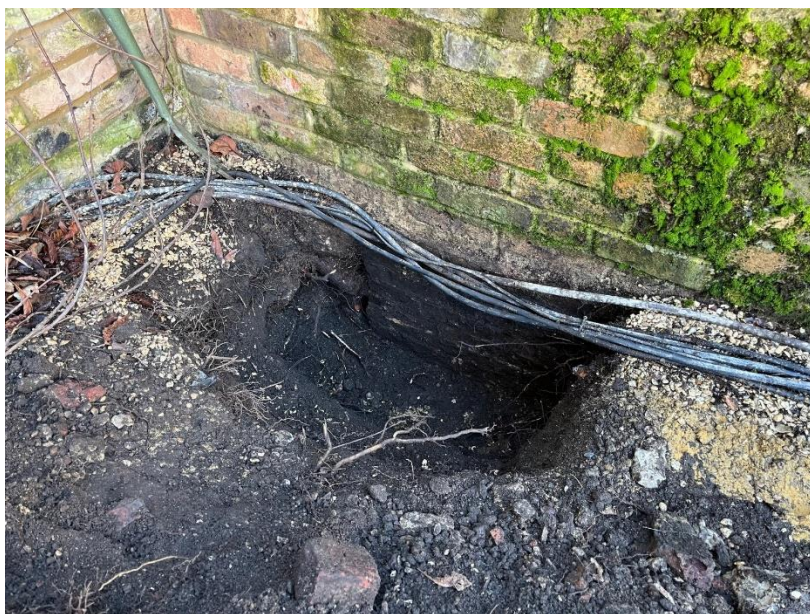
Appendix A Photographs of the Trial pits.

- 2.3 Trial pit 1 was located around 1.5 meters from the tree and was excavated to a depth of around 1.1 meters. A series of concrete bases that were around 400 mm in diameter and

around 500 mm deep were located. The tops of the bases were almost at ground level and they encased a series of 150 mm timber posts. The writer is of the understanding the timber posts supported a children's climbing frame that covered the space some years back and was removed.

- 2.4 Aside from the concrete bases, there was some sign of made ground in trial pit 1. The balance was firm black soil to the full depth of the excavation.

- 2.5 The second trial pit was located close to the existing rear wall and the adjoining neighbour's boundary wall showed. The base of the wall was around 900 mm below ground level and was founded directly onto the soil without any signs of corbelling. The upper there was some made ground and some tree roots associated with nearby shrubs that were installed when the earth build up was created.
