Arboricultural Impact Assessment

20 Church Row Hampstead London NW3 6UP

GD.241049.AIA

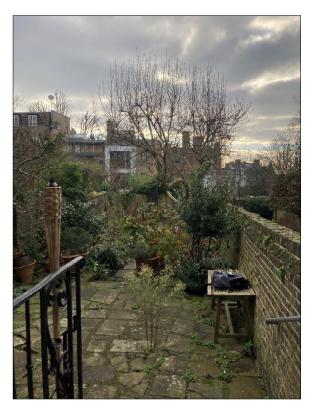
The approved scheme has been designed with the intention of retaining the Magnolia (T1), which is located within the rear garden of the site. This is a semi-mature tree featuring a prominent position and focal point within the garden.

Figure 3: Image showing the Magnolia tree (T1) as viewed from the main house looking down the garden

Tree Ref	Species	Schedule of Facilitation Tree Works
T1	Southern Magnolia <i>Magnolia</i> grandiflora	Carry out a maximum 1.0m lateral reduction of the northern crown to re-balance Carry out a selective thin of the regrowth to improve structure
T2	Japanese Maple Acer palmatum	Carry out selective pruning to limit encroachment over site boundary
T4	Common Elder Sambucas nigra	Carry out selective pruning back to site boundary
T5	Apple <i>Malus</i>	Carry out selective pruning back to site boundary

8.2.1 As the construction access will be required within the Crown spread of Magnolia T1 I recommend a bespoke 'tree protection box' is constructed around the main stem and scaffold limbs to prevent direct damage to the tree.

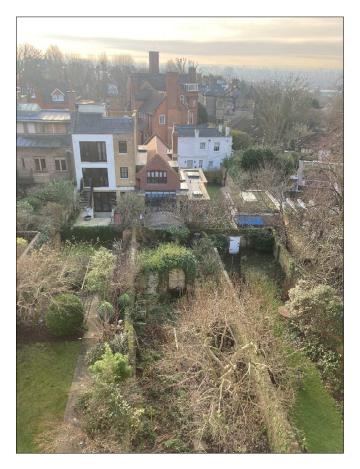
4.2.1 The existing garden consists of a patio area with a small garden path and steps leading to a redundant brick-built water feature. The garden predominantly comprises planting beds stocked with small shrubs and perennials.

4.3.1 The garden is set upon a number of levels to account for the gradient sloping north to south. The existing boundary treatment consists of a continuous retaining brick wall with the surrounding gardens at varying levels to account for the wider gradient of the local area.

Figure 4: Photo of rear garden as viewed from the top floor of the main house

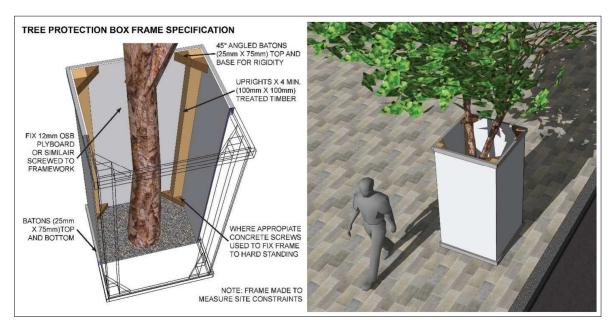
Figure 6: Illustration & Specification of Tree Protection Box (Reproduced from AECOM Limited Report)
