ARBORICULTURAL IMPACT ASSESSMENT REPORT
SITE: 13 Lambolle Road, NW3 4HS, Camden
CLIENT: c/o Exedra Architects

24th September 2024 EAS-205

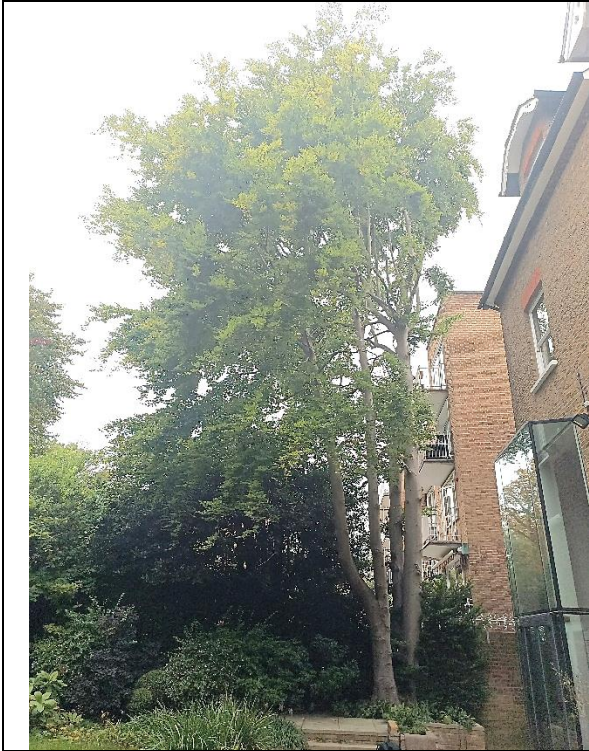
T1 – Common Beech

6.7 The dominant tree on the site is the large multiple stemmed Beech tree, T1, located on the northwestern corner of the rear garden close to and proximal to the residential building. Although seemingly healthy it has been subject to multiple pruning and management operations over the years, mainly to crown lift, deadwood and cut back branches from the adjacent buildings. Beech are not known to tolerate this kind of heavy crown management but although misshapen with three remaining leading stems no evidence of pathogenic fungal disease was observed and the crown was healthy in spite of its previous management regime.

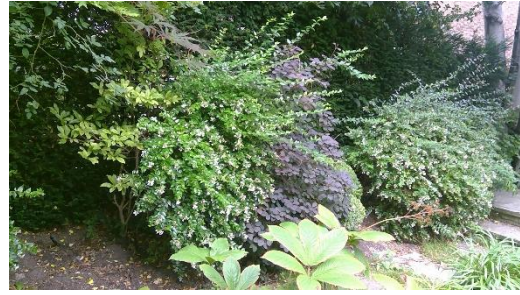
SG2 - Mixed species shrubs Abelia, Cotinus, Choisya, Box

SG2	Mixed species shrubs: Abelia, Cotinis, Choisy, Box	2	2	2	2	2	100	m/s	5	1	13	C2	Early Mature	10-19	0	Average form, shape and condition mixed shrub border. No significant recent crown management. Dense crowns, minor dead wood.	No works.	High risk zone	No response required	1
H1	Yew (Common)	3	1	1	1	1	70	m/s	2	1	3	C2	Semi-Mature	10-19	1	Average form, shape and condition boundary hedge. Dense crowns, minor dead wood. Garden hedge, managed - trimmed.	Annual trimming maintenance	High risk zone	3 - within 12 months	1

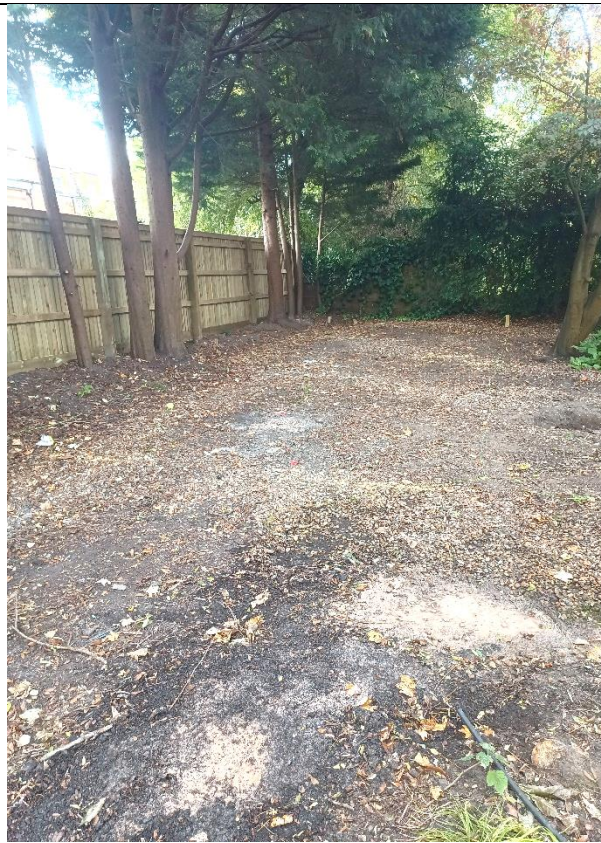
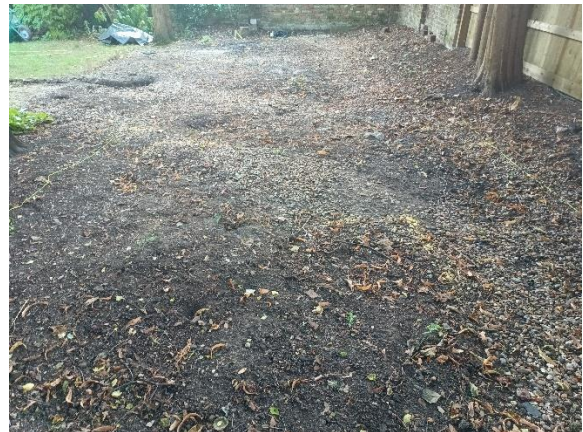
Location for proposed gym / garden room within the RPAs of adjacent Leyland Cypress

7.3.1 The minimal impact, 'no-dig' ground screw foundations proposed for the garden room, which, although within the RPAs of adjacent trees, will be located between pre-identified locations of tree roots where possible. Using a specialist contractor, they will scan the area of the garden room and identify the major tree root locations with a Tree Root Morphology Map (see figure 1 below). This will help inform the garden room construction team where they can place ground screw piles to avoid major tree roots as structurally possible.
