4 Prince Arthur Road

Design & Access Statement
London Borough of Camden

January 2025

Prepared by:
Roberts & Treguer Ltd.

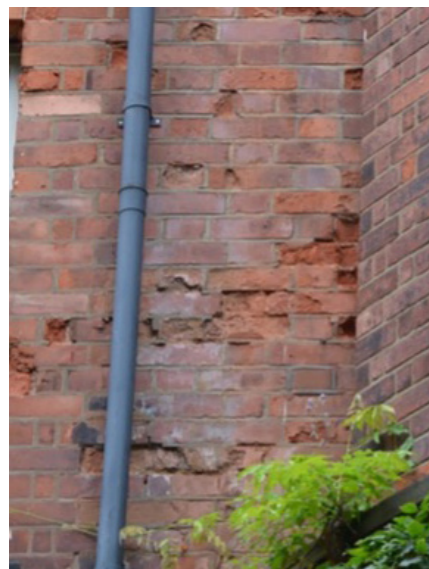
The external walls are constructed of red brickwork laid in Flemish bond. The bricks appear to be fairly standard Sussex Reds 228 mm by 108 mm by 68 mm. Some historic refacing and re-pointing have been carried out using poorly colour matched cement rich mortar with significant spalling to the brick facings.

Close up photo of damaged bricks that will need repairing.

Reclaimed Suffolk Reds will be pieced into replace defective bricks or render sections. Colour and texture to match existing.

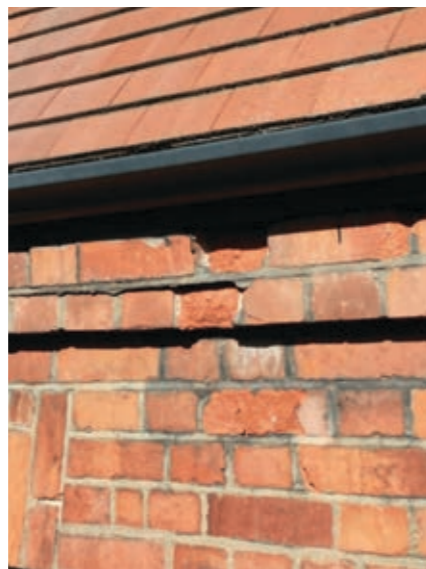
Detail of spalling masonry.

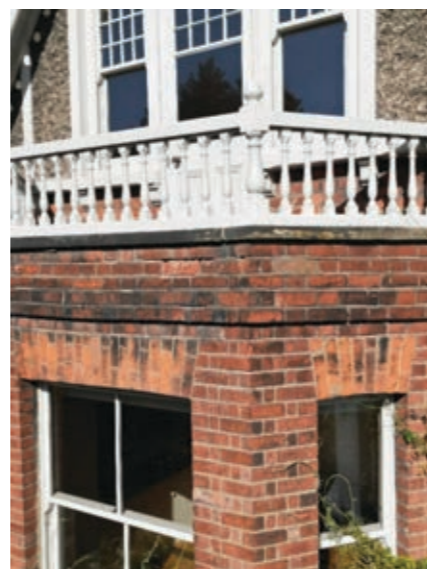
Detailing of open mortar joints.

Lime Mortar to be hand mixed to match local sand used in original samples of mortar visible down the street (shown above). The mortar selected will be breathable and hand troweled to match the pointing on the original walls.

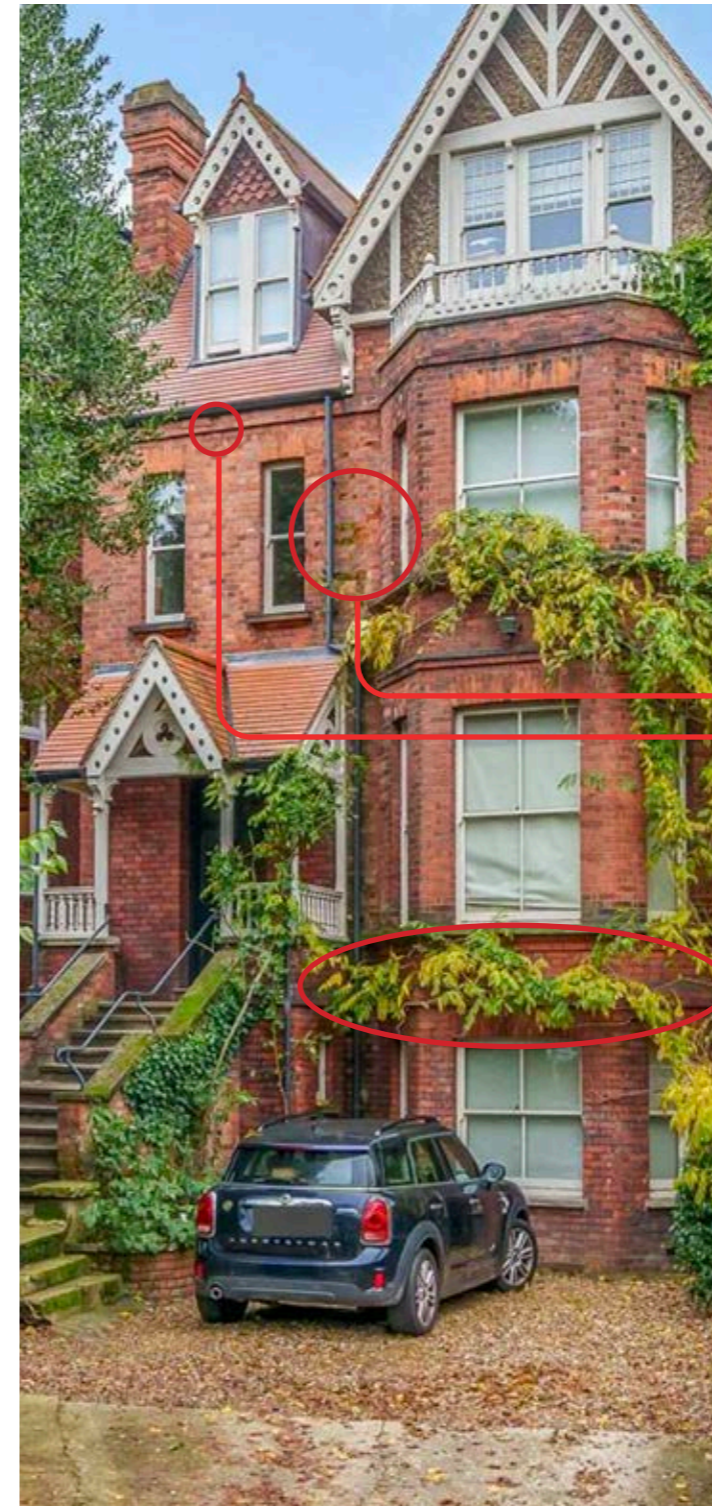
The house and neighboring property at 2 Prince Arthur Road are covered in foliage, primarily wisteria and jasmine. The wisteria also appears to be affecting the brickwork.

Damage and spalling of brickwork and masonry.

Wisteria is growing on the front of the house. In October the climber's stem was severed between the ground floor and lower ground floor, and above this level should have completely died off by the time the works commence.

The wisteria will carefully be removed so that the underlying bricks and mortar and cement can be assessed and repaired.

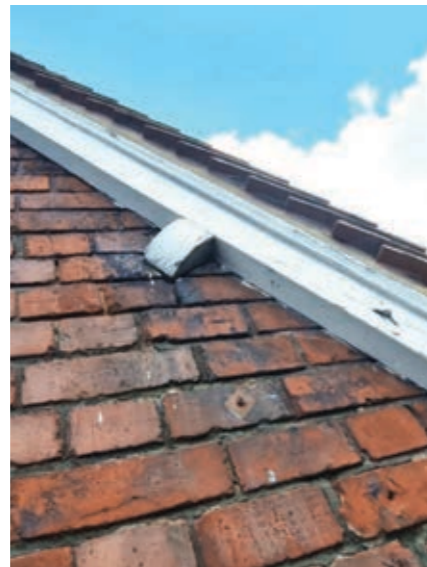
The veranda and eaves of the house are south facing, and the paint work is looking more tired than the rest of the house, with some sections of wood are exposed.

Detail of delimitation of decorative coatings and expansion of timber grain.

The decorative barge boards, external joinery and wooden windows will be repaired and redecorated. The woodwork and metal work will be painted in colours that match existing. The metal work is Exterior Satin Shaded White (Farrow & Ball 201) and the metal work is Exterior Satin Off-Black (Farrow & Ball 57). The wood storage cupboard and the electricity meter cover will be gloss black.

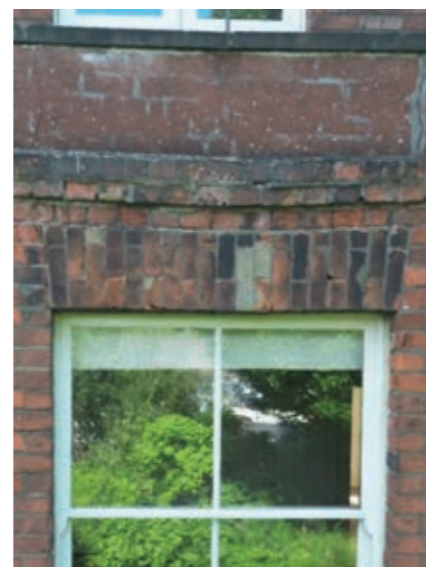
This lintel has dropped slightly, area requires repair and repointing.

Historic refacing repairs and vertical crack repairs are visible.

At the rear elevation, historic refacing repair has resulted to a vertical crack that has become visible. It will be repaired and repointed, without render.

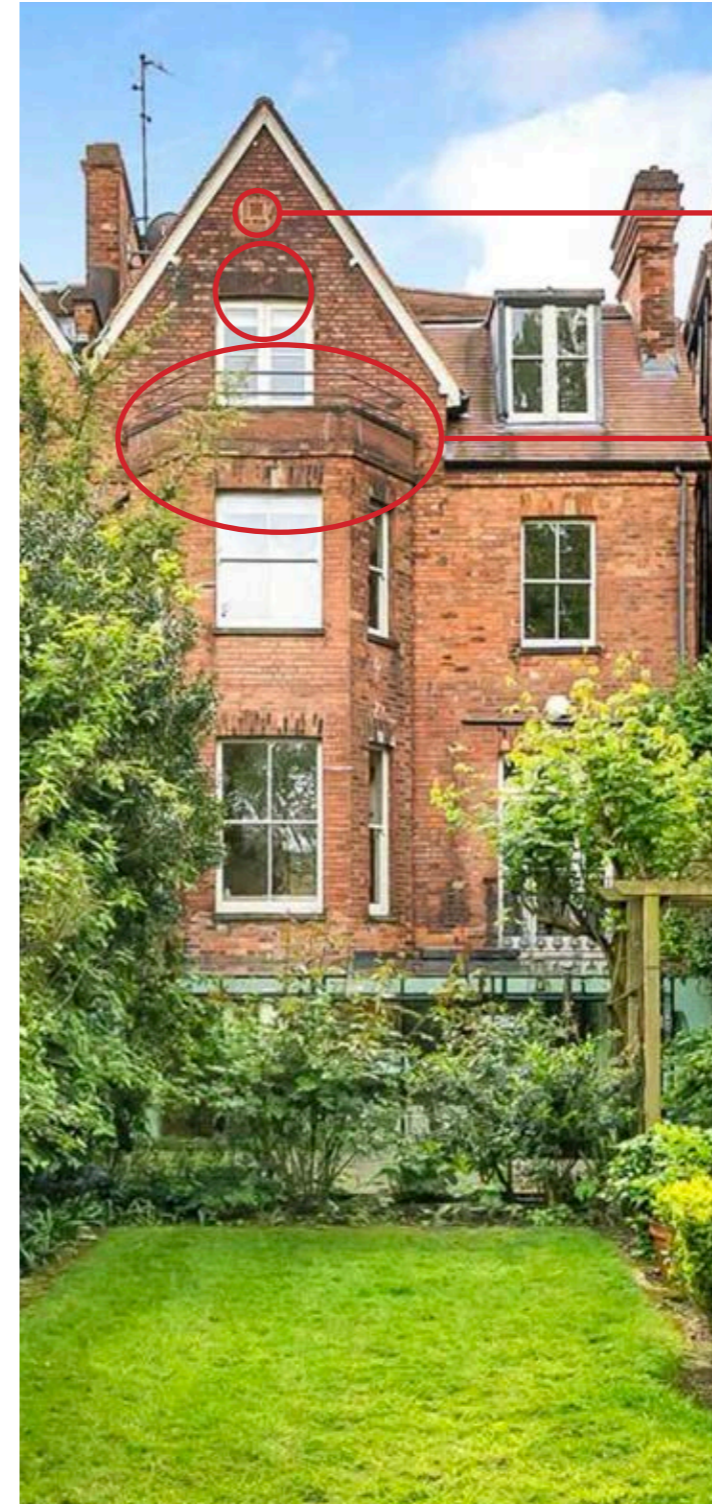
The air brick above the top rear window has been poorly patched to allow ventilation to the attic space.

The bricks below the top back bedroom veranda are partially rendered and in poor condition.

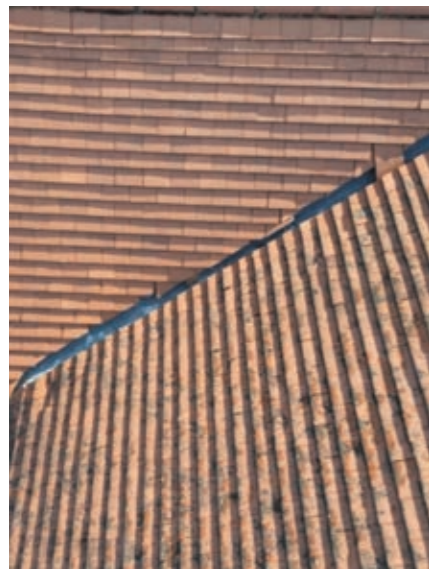
Close up photo of damaged roof tiles that will need repairing.

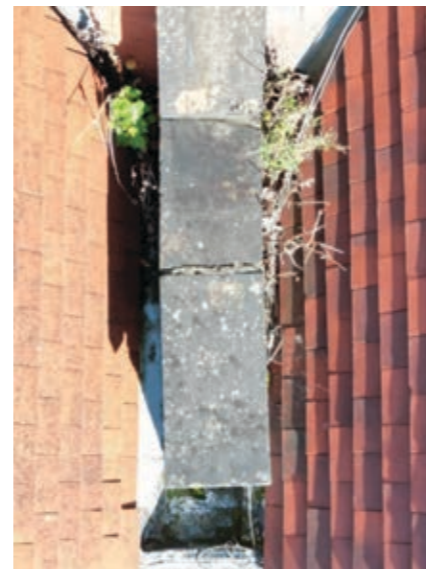
Detail of blocked gutter to the rear of the property, this requires clearance.

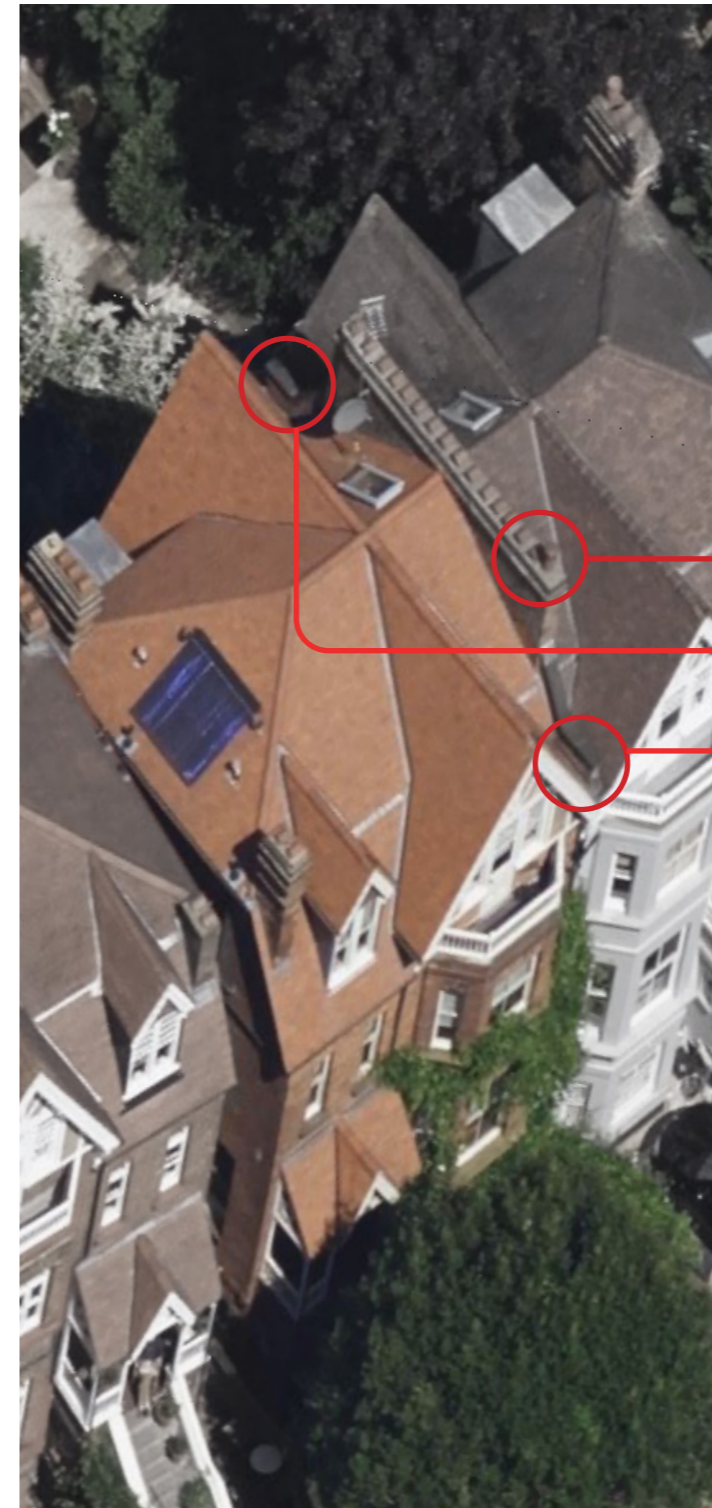
The roof valleys with the adjacent property are clogged with leaves, silt and vegetation. As a result there is damp in the top bedrooms. There is no access and regular maintenance is not possible.

Minor invasive plant has taken root to the top of the main shared chimney stack.

Existing silt and invasive plant growth from the valley gutters.
