Heritage Statement

10 Chalcot Crescent, London NW1 8YD

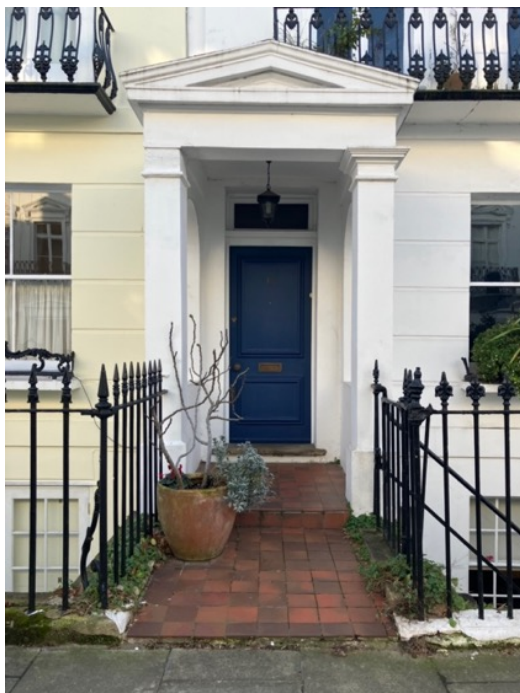
Front Entrance

At ground level the entrance portico and cast-iron railings remain in situ. The front entrance has been tiled in red quarry tiles. The kerb to the boundary railings has some damage at its edges. The ground floor sash window (WG.1) is original and in good condition. It has an extended cill with cast iron planter restraints, some of which are missing or damaged.

Modern quarry tiling will be removed and replaced with York stone in external areas.

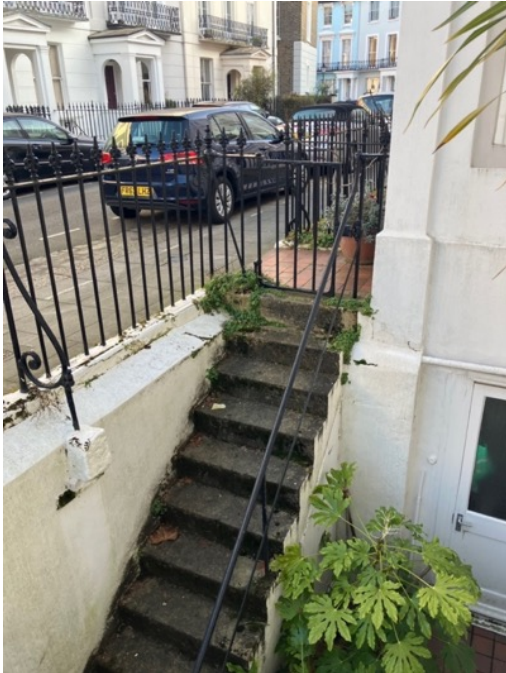
Concrete steps lead down to a lower ground level, with open area. The gate is missing post finials either side and the lock plate is damaged. The floor to the area has been tiled in red

Concrete steps down to open area

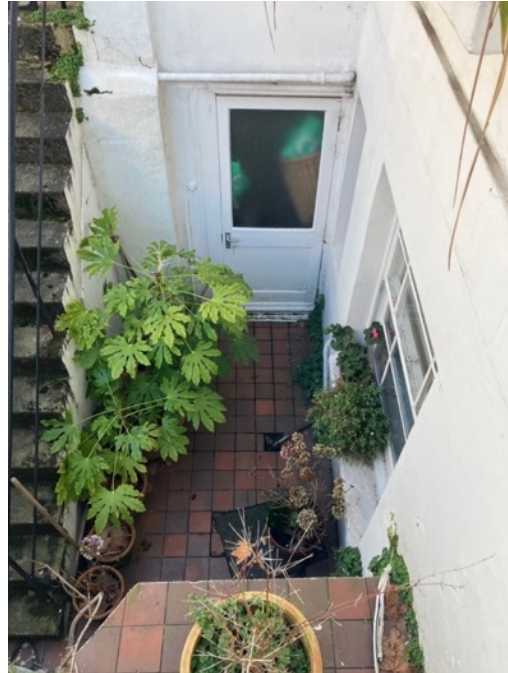
quarry tiles, as has the top of an open fronted bin store. Timber doors create under steps storage spaces.

Quarry tile finish and storage spaces

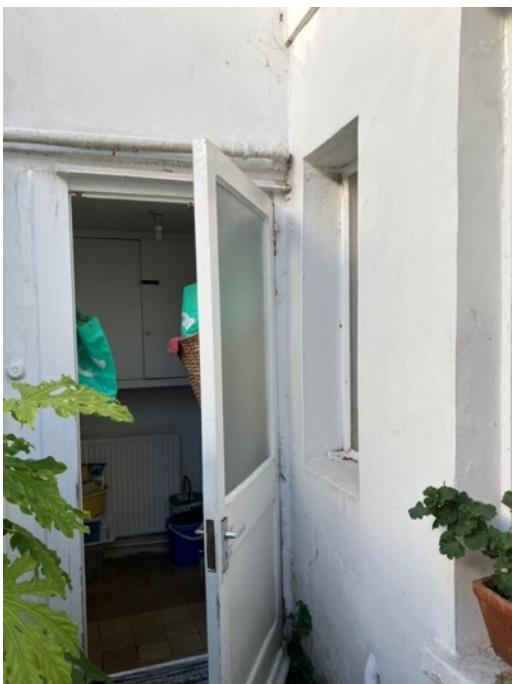
The external door into the lower ground floor (DB1) is a modern glazed timber door. Typically, this area has exposed and surface mounted incoming services and drainage.

Modern openings to area DB1 and WB3

- 4.1.7 The modern external door DB1 from the front area will be replaced with a solid 4 panel door to a pattern matching period detail. It will be painted black.

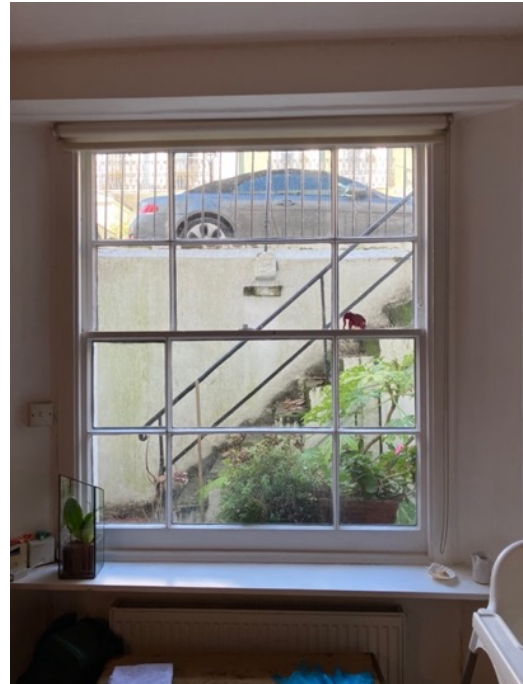
The original sash window (WB1) is intact and in good condition. An additional window has been inserted into the wall, a single fixed glass panel, possibly mid-century (WB2).

WB1 original sash (with modern cill)

- 4.1.8 Window WB1 will be overhauled and secondary glazing fitted internally. Externally fixed metal bars are proposed, to a simple design as typical for security in such locations. Both these additions are reversible and required to upgrade the thermal performance and security of the property.

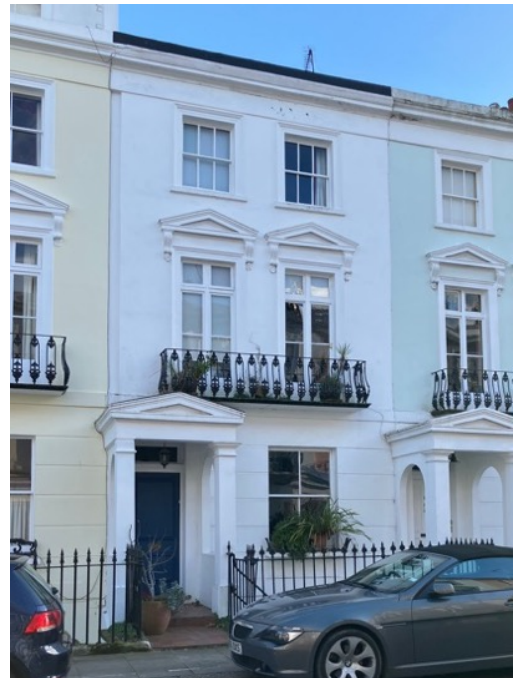
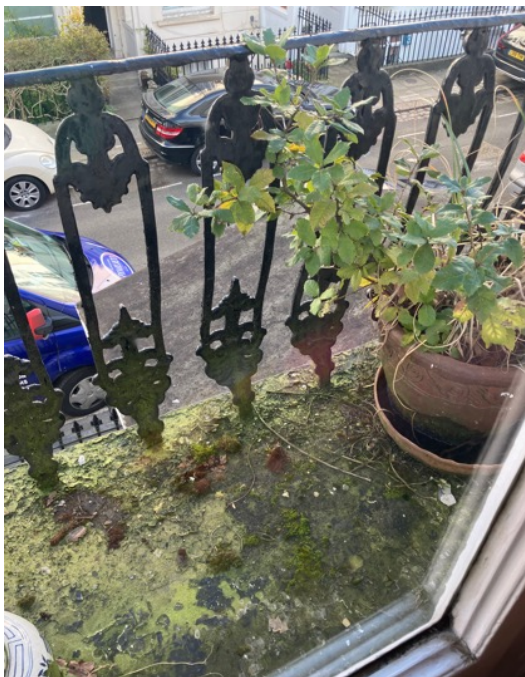
At first floor are paired casement French windows with fanlights over and pedimented surrounds (W1.1 & W1.2). These have one fixed and one opening door. W1.1 has top hung fanlights, whereas W1.2 has fixed fan lights. The fanlights are in good condition but the casement doors have significant water damage and rot along the panels, lower frame and cills. The casement doors open onto a cantilevered balcony with cast iron decorative balustrade. The underside of the balcony has an exposed joint and the surface has extensive mould and water damage.

Balcony and casement condition

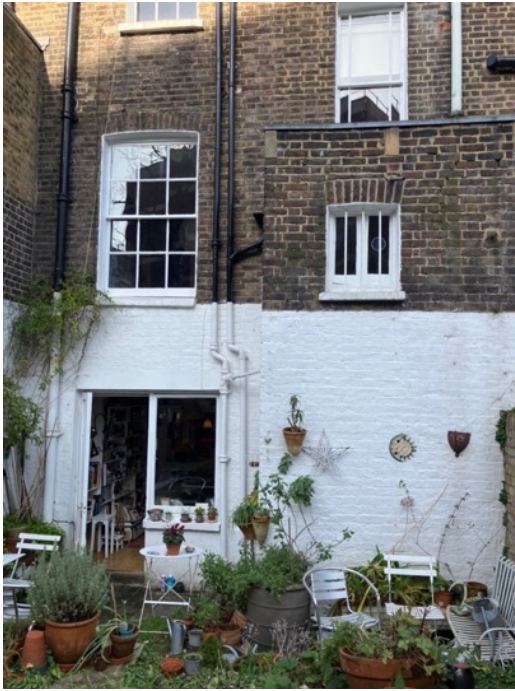
Lower ground DB2 & WB3

At lower ground floor all the openings have 20th century doors and windows. DB2 is glazed door giving access into the garden, with an adjacent fixed window (WB3).

- 4.1.9 DB2 and WB3 will be removed and replaced with a high performance minimal aluminium pivot door. This is considered a suitable location for a sympathetic modern design, to visually connect with the garden, provide maximum daylighting and thermal efficiency. The opening is not visible from the public realm and set back behind a high boundary wall on all sides of the garden.

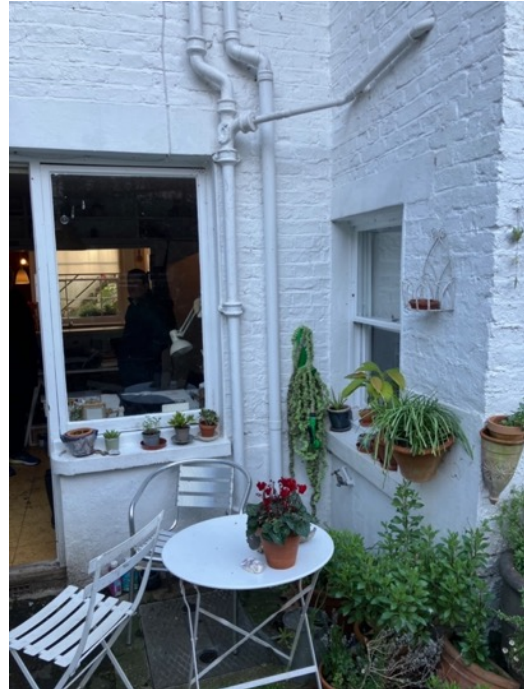
On the closet wing is a modern sash within an original opening.

WB3 and closet wing window WB4

- 4.1.2 The internal window opening in the spine wall will be infilled with brick and plastered to reinstate the historic plan and character of each separate room.
- 4.1.3 The modern windows WB2 and WB4 will be removed and infilled with brickwork. The opening WB2 on the front elevation will be rendered and painted to match the stucco. Window WB4 will be infilled to retain the cill and the outline of the previous opening.

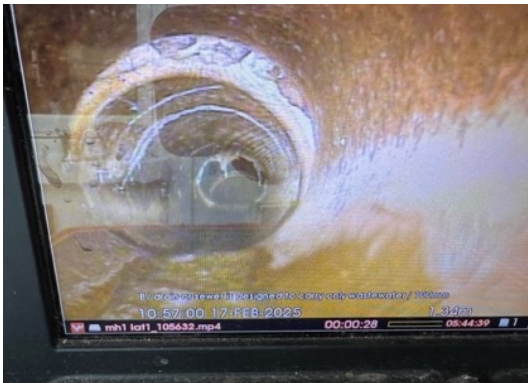
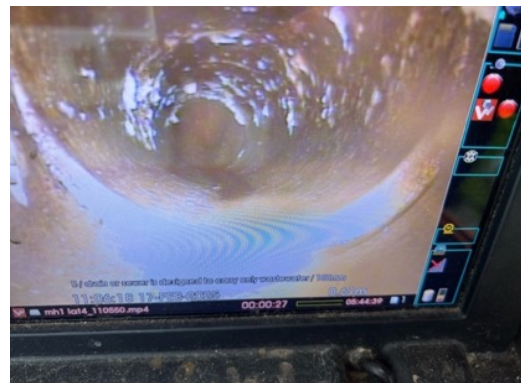
The property has been previously damp proofed, although this is has now failed with damp penetration recorded and visible on all external and party walls. The floor is damp and the extent of the issue is difficult to assess without intrusive investigation, as it has been finished with ceramic or cork tiles throughout.

A CCTV camera survey of the drain running back to front under the floor has evidenced damage to the clay combined drainage pipes. Sections of pipe present displacement and at least 2 cracks, with consequent leakage below the slab.

Because the drainage pipes are leaking, not enough running water is penetrating through the drain and it has become partially blocked at the front, which could mean the ground is saturated below the slab. Therefore, the ground floor slab and drainage system needs to be replaced.

- 4.1.1 It is vital for the long-term sustainability and protection of the property that the problems associated with the underground drainage, ground slab and damp proofing are addressed and resolved.

The drainage survey has identified fractured and misaligned sections of pipe work which need to be removed and re-laid to function. The ground slab is uneven, damp and its construction and history of any remedial works is unknown. It is therefore proposed to remove the drain and slab and reinstate both to existing levels but with robust damp-proofing and insulation to meet current building regulations. This will not affect the footings or neighbouring properties.

Likewise, damp-proofing to the walls was undertaken decades ago and has failed. This has led to water damage to joinery, plaster and finishes. It is proposed to renew the damp proofing to the spine wall, party and external walls. This will be SIKA type wet plaster system, installed by a reputable company, with long established experience in working with listed buildings.

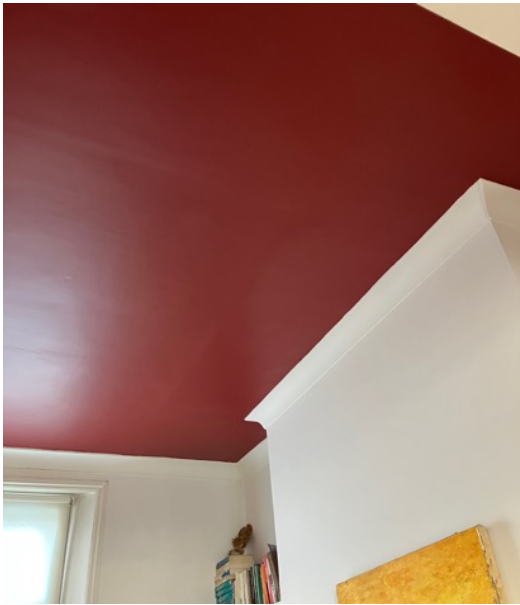
The cornices at 1st floor are different, with the original in the front room and a modern cornice in the rear. This has most likely come about by the rear room ceiling being replaced in the past. The front ceiling shows signs of movement, with unevenness and cracks.

Ceiling and cornice rear room

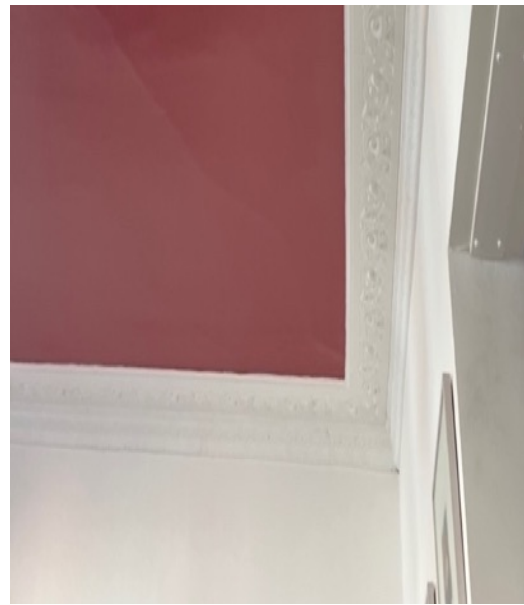
Ceiling and cornice front room

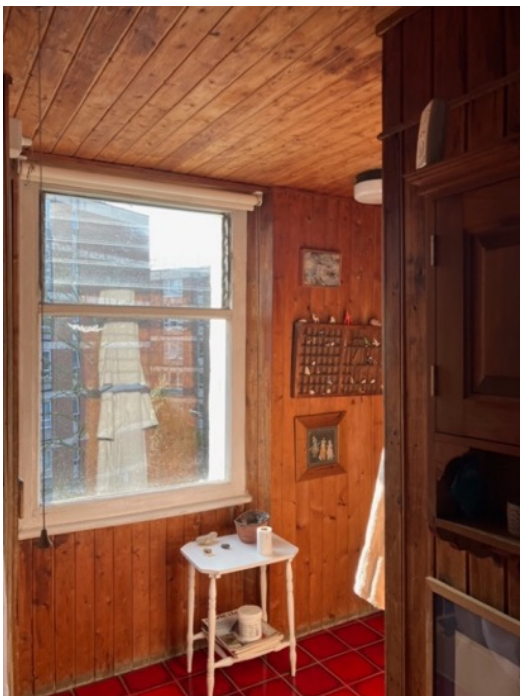
The second floor has seen historic alterations to the rear room, having been converted into sauna. The original window and door were removed and all walls and ceilings lined with pine boarding and the floor finish in ceramic tiling. A glazed screen and door were added to the top landing to create a lobby.

Sauna and modern window W2.3

- 4.4.1 This floor is to be designed as a bedroom with ensuite. The sauna, all fixtures and fittings will be removed, including D2.1 (a flush modern door) and the glazed lobby at the top of the stairs. The opening for D2.1 will be infilled with timber stud and plasterboard and skirtings reinstated.

- 4.4.3 The modern louvred sauna window will be replaced with a period detail sash window 6 over 6 pattern to match the other existing.
- 4.4.3 The sagging and unstable bedroom ceiling is proposed to be removed and replaced.

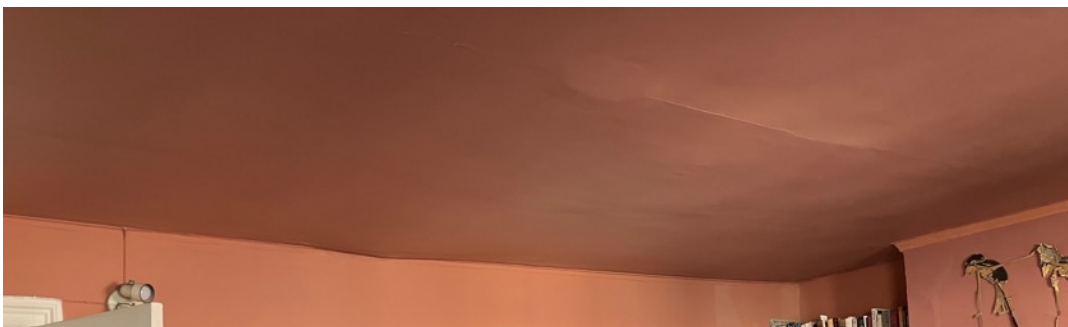
Second floor front bedroom ceiling

The bedroom ceiling shows significant damage, is very uneven, sagging and with a central crack running its entire length. A further stress point can be seen in the middle of the spine wall, with a dip in the ceiling underneath the valley gutter above. The roof's timber structure will be investigated when the concrete roof tiles are removed and repaired where necessary and the existing ceiling needs to be replaced.

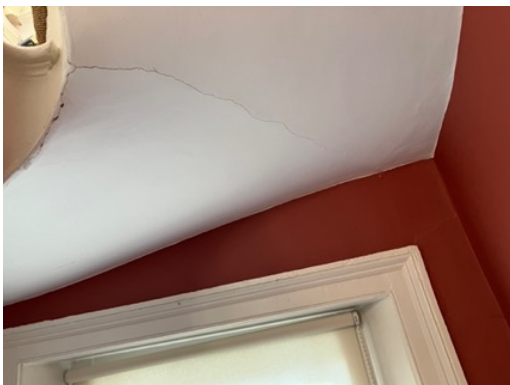
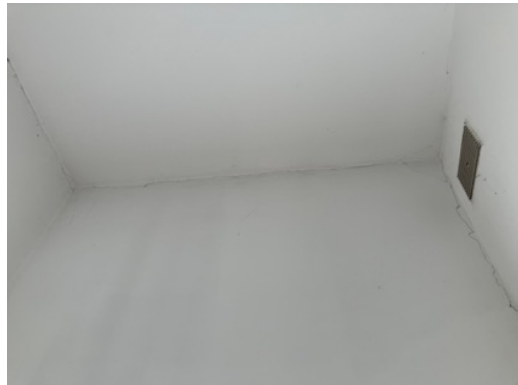
The original staircase is intact from lower ground to second floor. The strings, handrail and balusters are in good condition. There is a slight fall inwards to the staircase and cracks can be seen on the underside of the staircase windows and where the stairwell meets the rear wall, which will be repaired.

Movement cracks on the staircase
