11 Cannon Lane

Structural Statement to support the repairs to the existing masonry wall

This statement is to support the Listed Building Consent application for the Grade II listed structure at 11 Cannon Lane. The works broadly include the structural repair to the existing wall on the North-East side of the site, adjacent to the historic entrance to the Old Parish Lock Up.

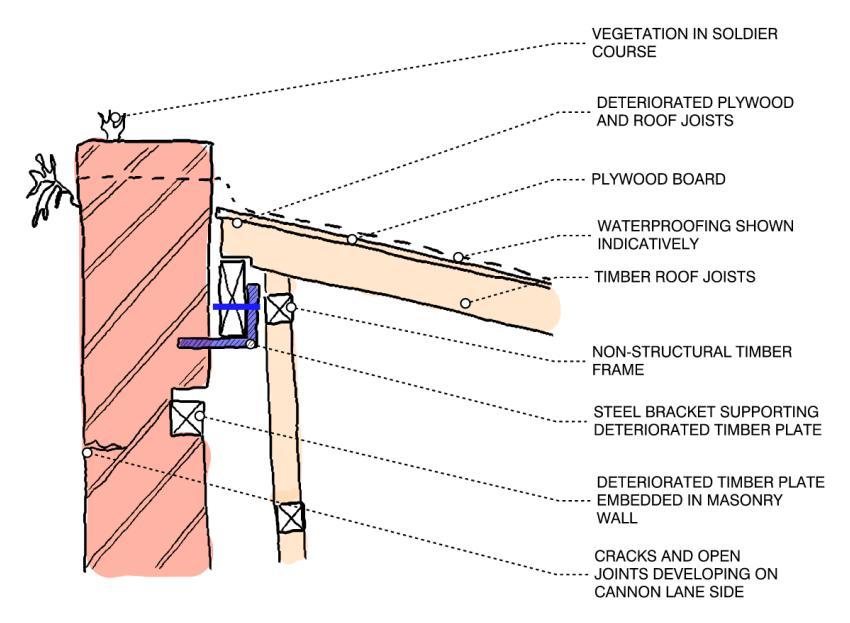
Figure 1 – Existing Structure Sketch

The existing roof over the 'art studio' is a modern roof formed from timber joists at approximately 600mm centres spanning from the Cannon Lane historic wall to the existing masonry wall within the property. The roof is boarded using plywood sheeting. At the bearing on the side closest to Cannon Lane, the joists bear on to a timber plate which is supported on steel brackets which are embedded in the masonry. Refer to Figure 1 for a summary of the existing structure at this bearing.

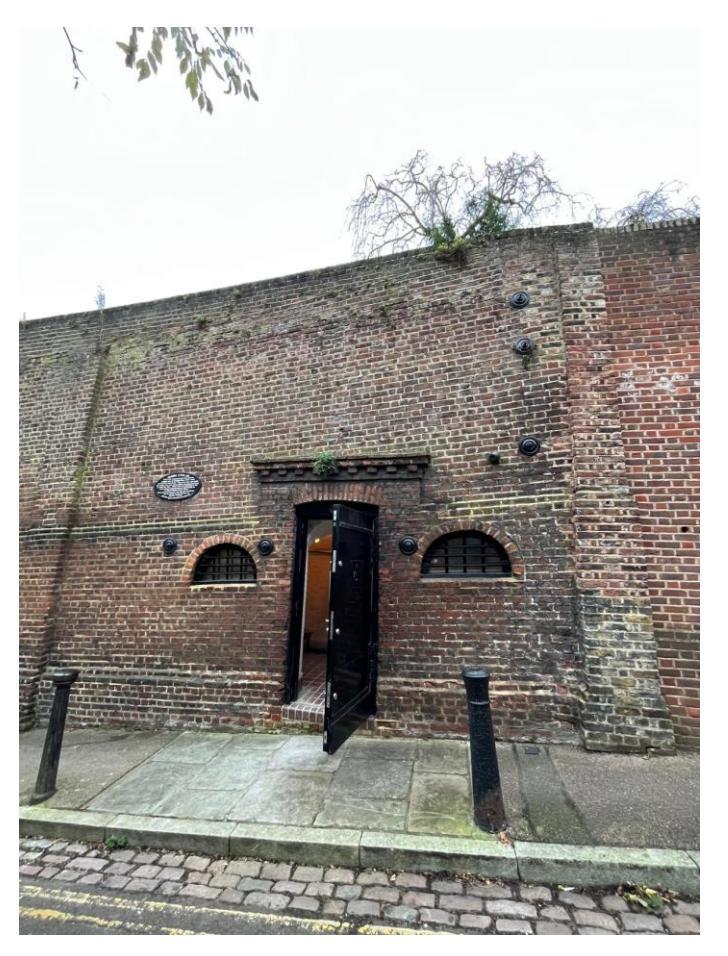
Photo 01 – External wall

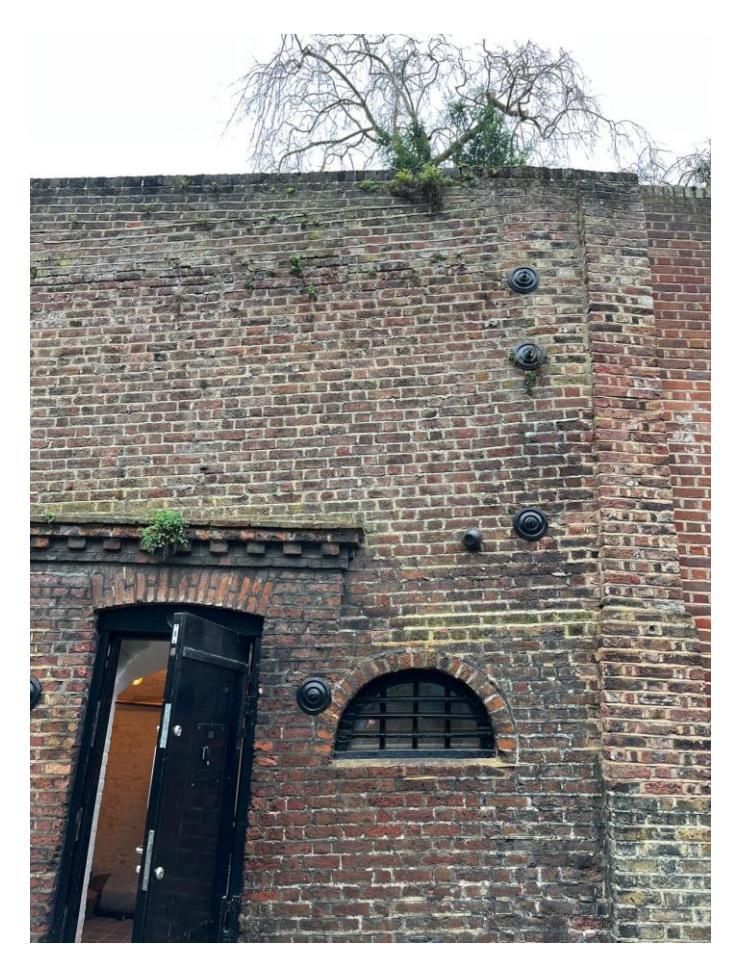
Photo 02 - External wall, North side

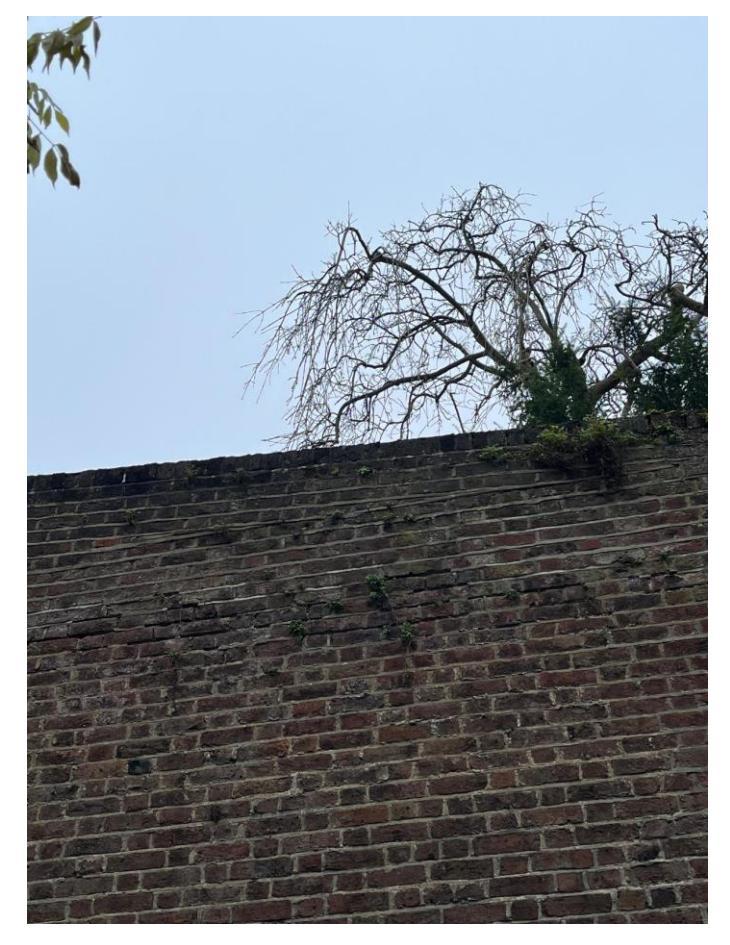
Along the historic wall bearing and around the roof drainage points, there are signs of significant water ingress, and the timber joists and boarding has deteriorated. In a number of cases the joists appear to be partially propped on the timber partition that has been constructed in front of the masonry wall. During site visits, the historic brickwork wall has been noted as damp, and a number of existing embedded timber plates have also deteriorated. Externally, there is vegetation growing at parapet level and there are signs of distress in the brickwork, such as the opening of the joint approximately 1m from the top of the wall.

The source of water ingress appears to be through the top of the parapet wall itself, where the existing joints between bricks have deteriorated as well as through the possible failure of the waterproofing layer between the wall and the roof. This has led to the deterioration of the existing timber structure, both in the roof and wall. Due to the location of the embedded timbers in the existing wall, it appears that their deterioration may have led to the top of the parapet pivoting about this point and leaning inwards, opening the joint in the brickwork wall on the external face.

Photo 03 – External wall opening of joints and missing mortar

- The deteriorated embedded timbers are to be sequentially removed and infilled with brickwork, to match existing, with lime mortar
- Loose or cracked brickwork in the top of the wall is to be re-consolidated. Loose or open joints are to be repointed with a suitable lime mortar
- The roof structure is to be replaced. The roof is to be suitably tied into the existing walls to transfer loads and effectively restrain the tops of the walls

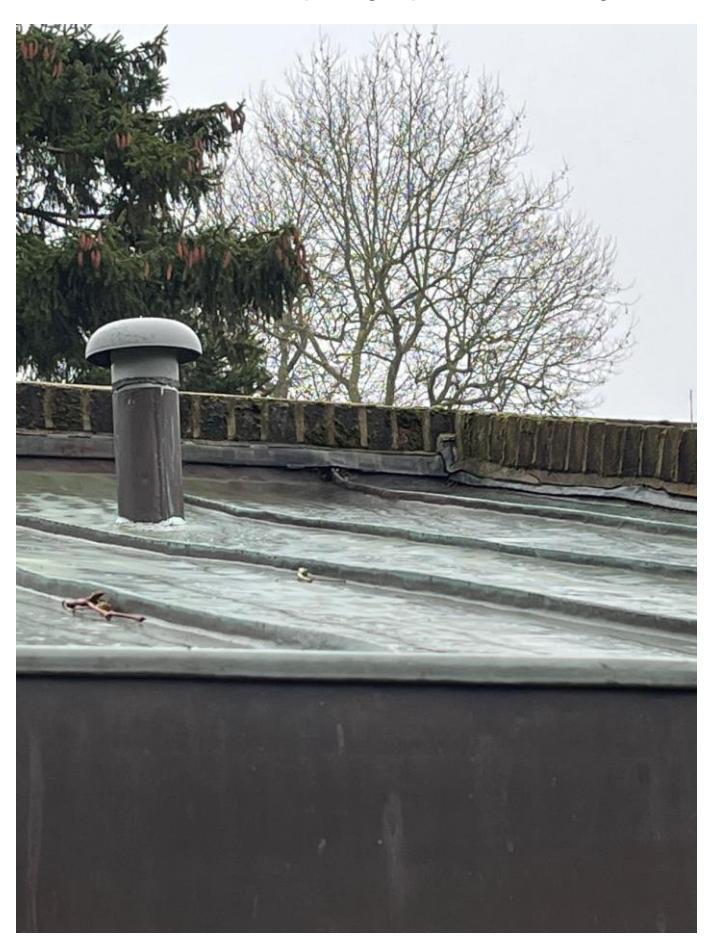
Photo 04 – Soldier Course over Art Studio

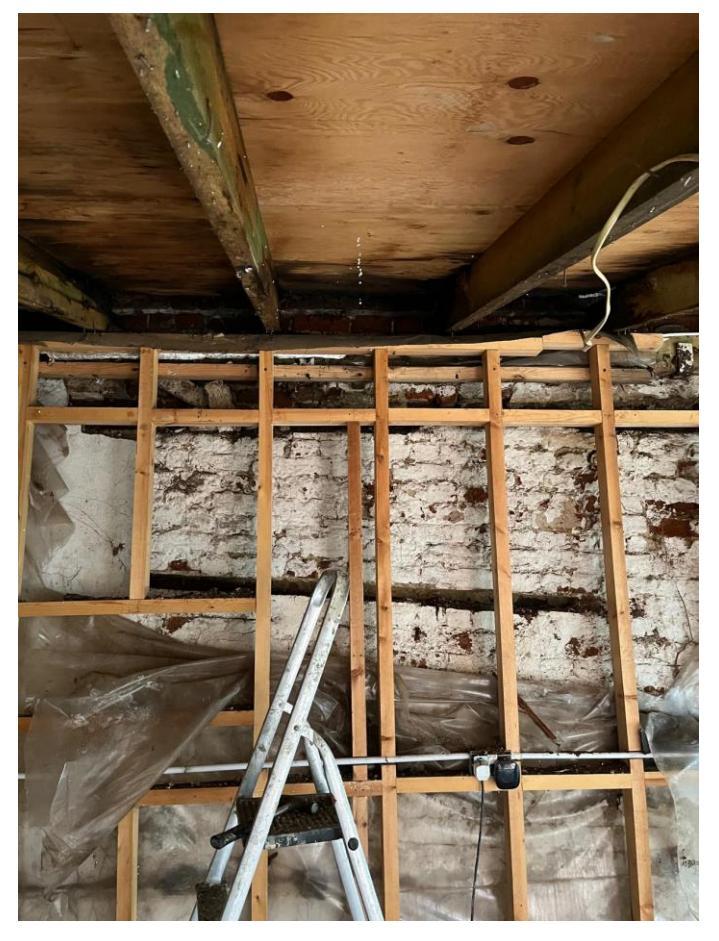
Photo 05 - Internal Wall showing missing embedded timbers

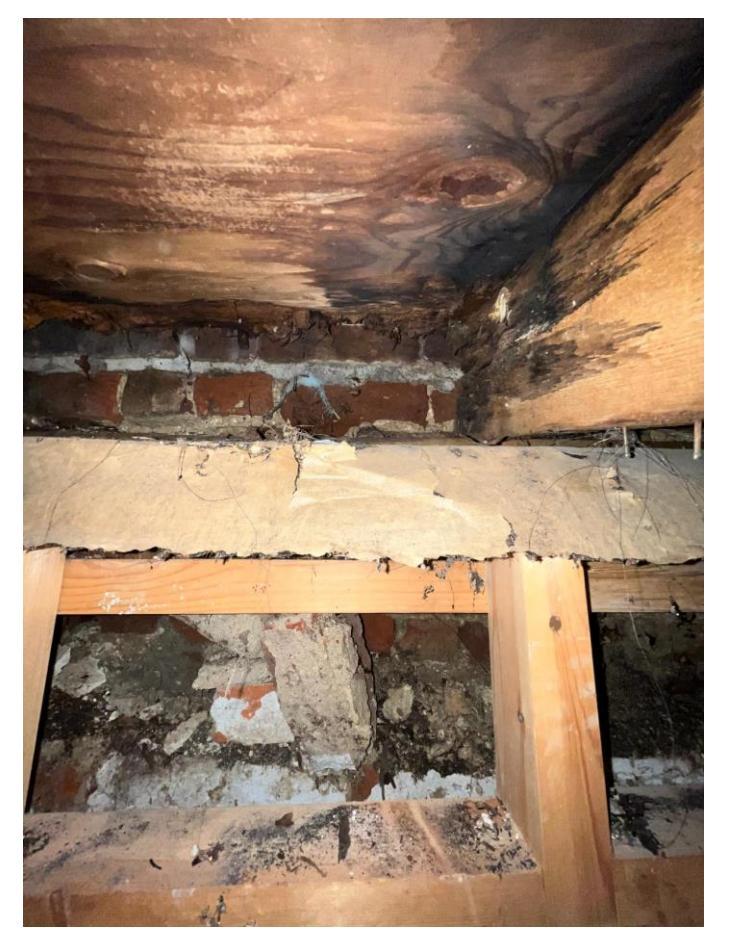
Photo 06 - Roof joist bearings and poor condition masonry

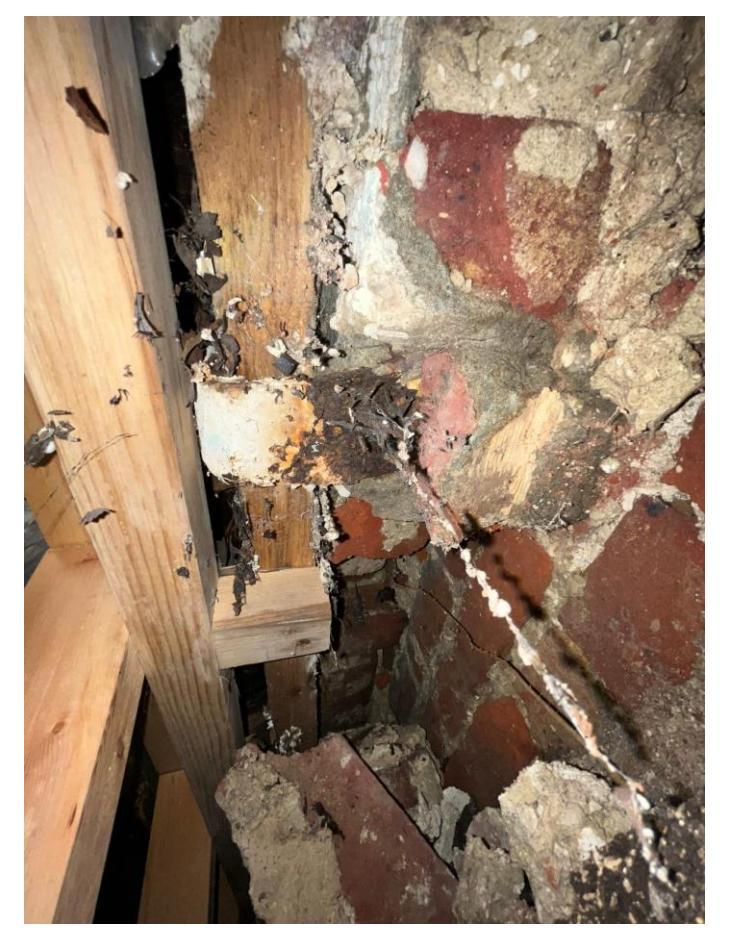
Photo 07 - Roof joist bearing and steel brackets

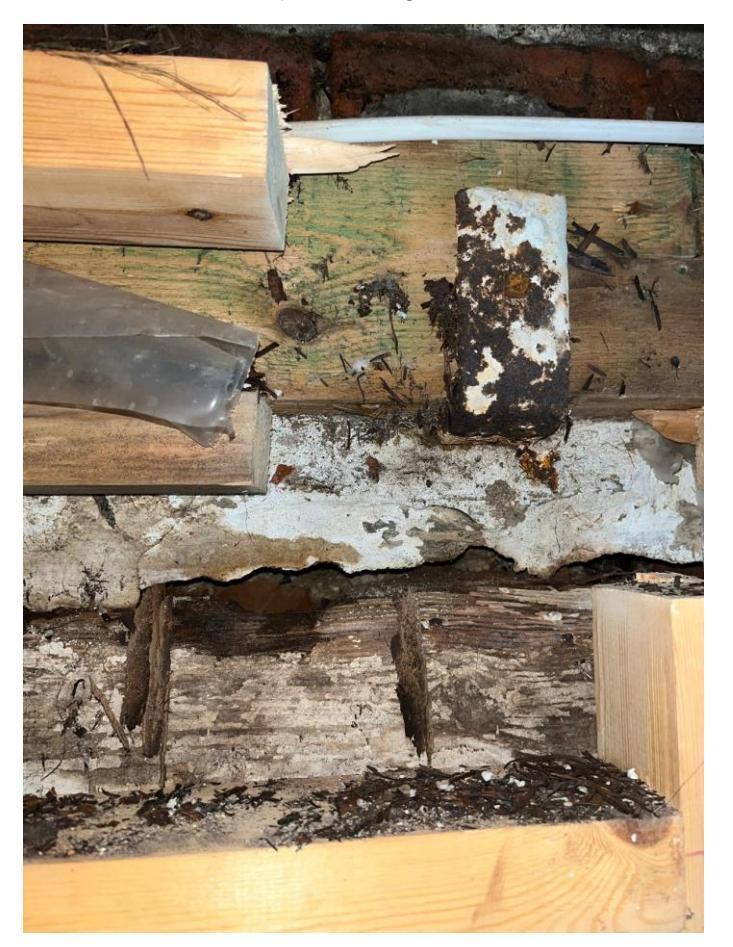
Photo 08 – Modern timber wall plate and historic embedded timber plate below

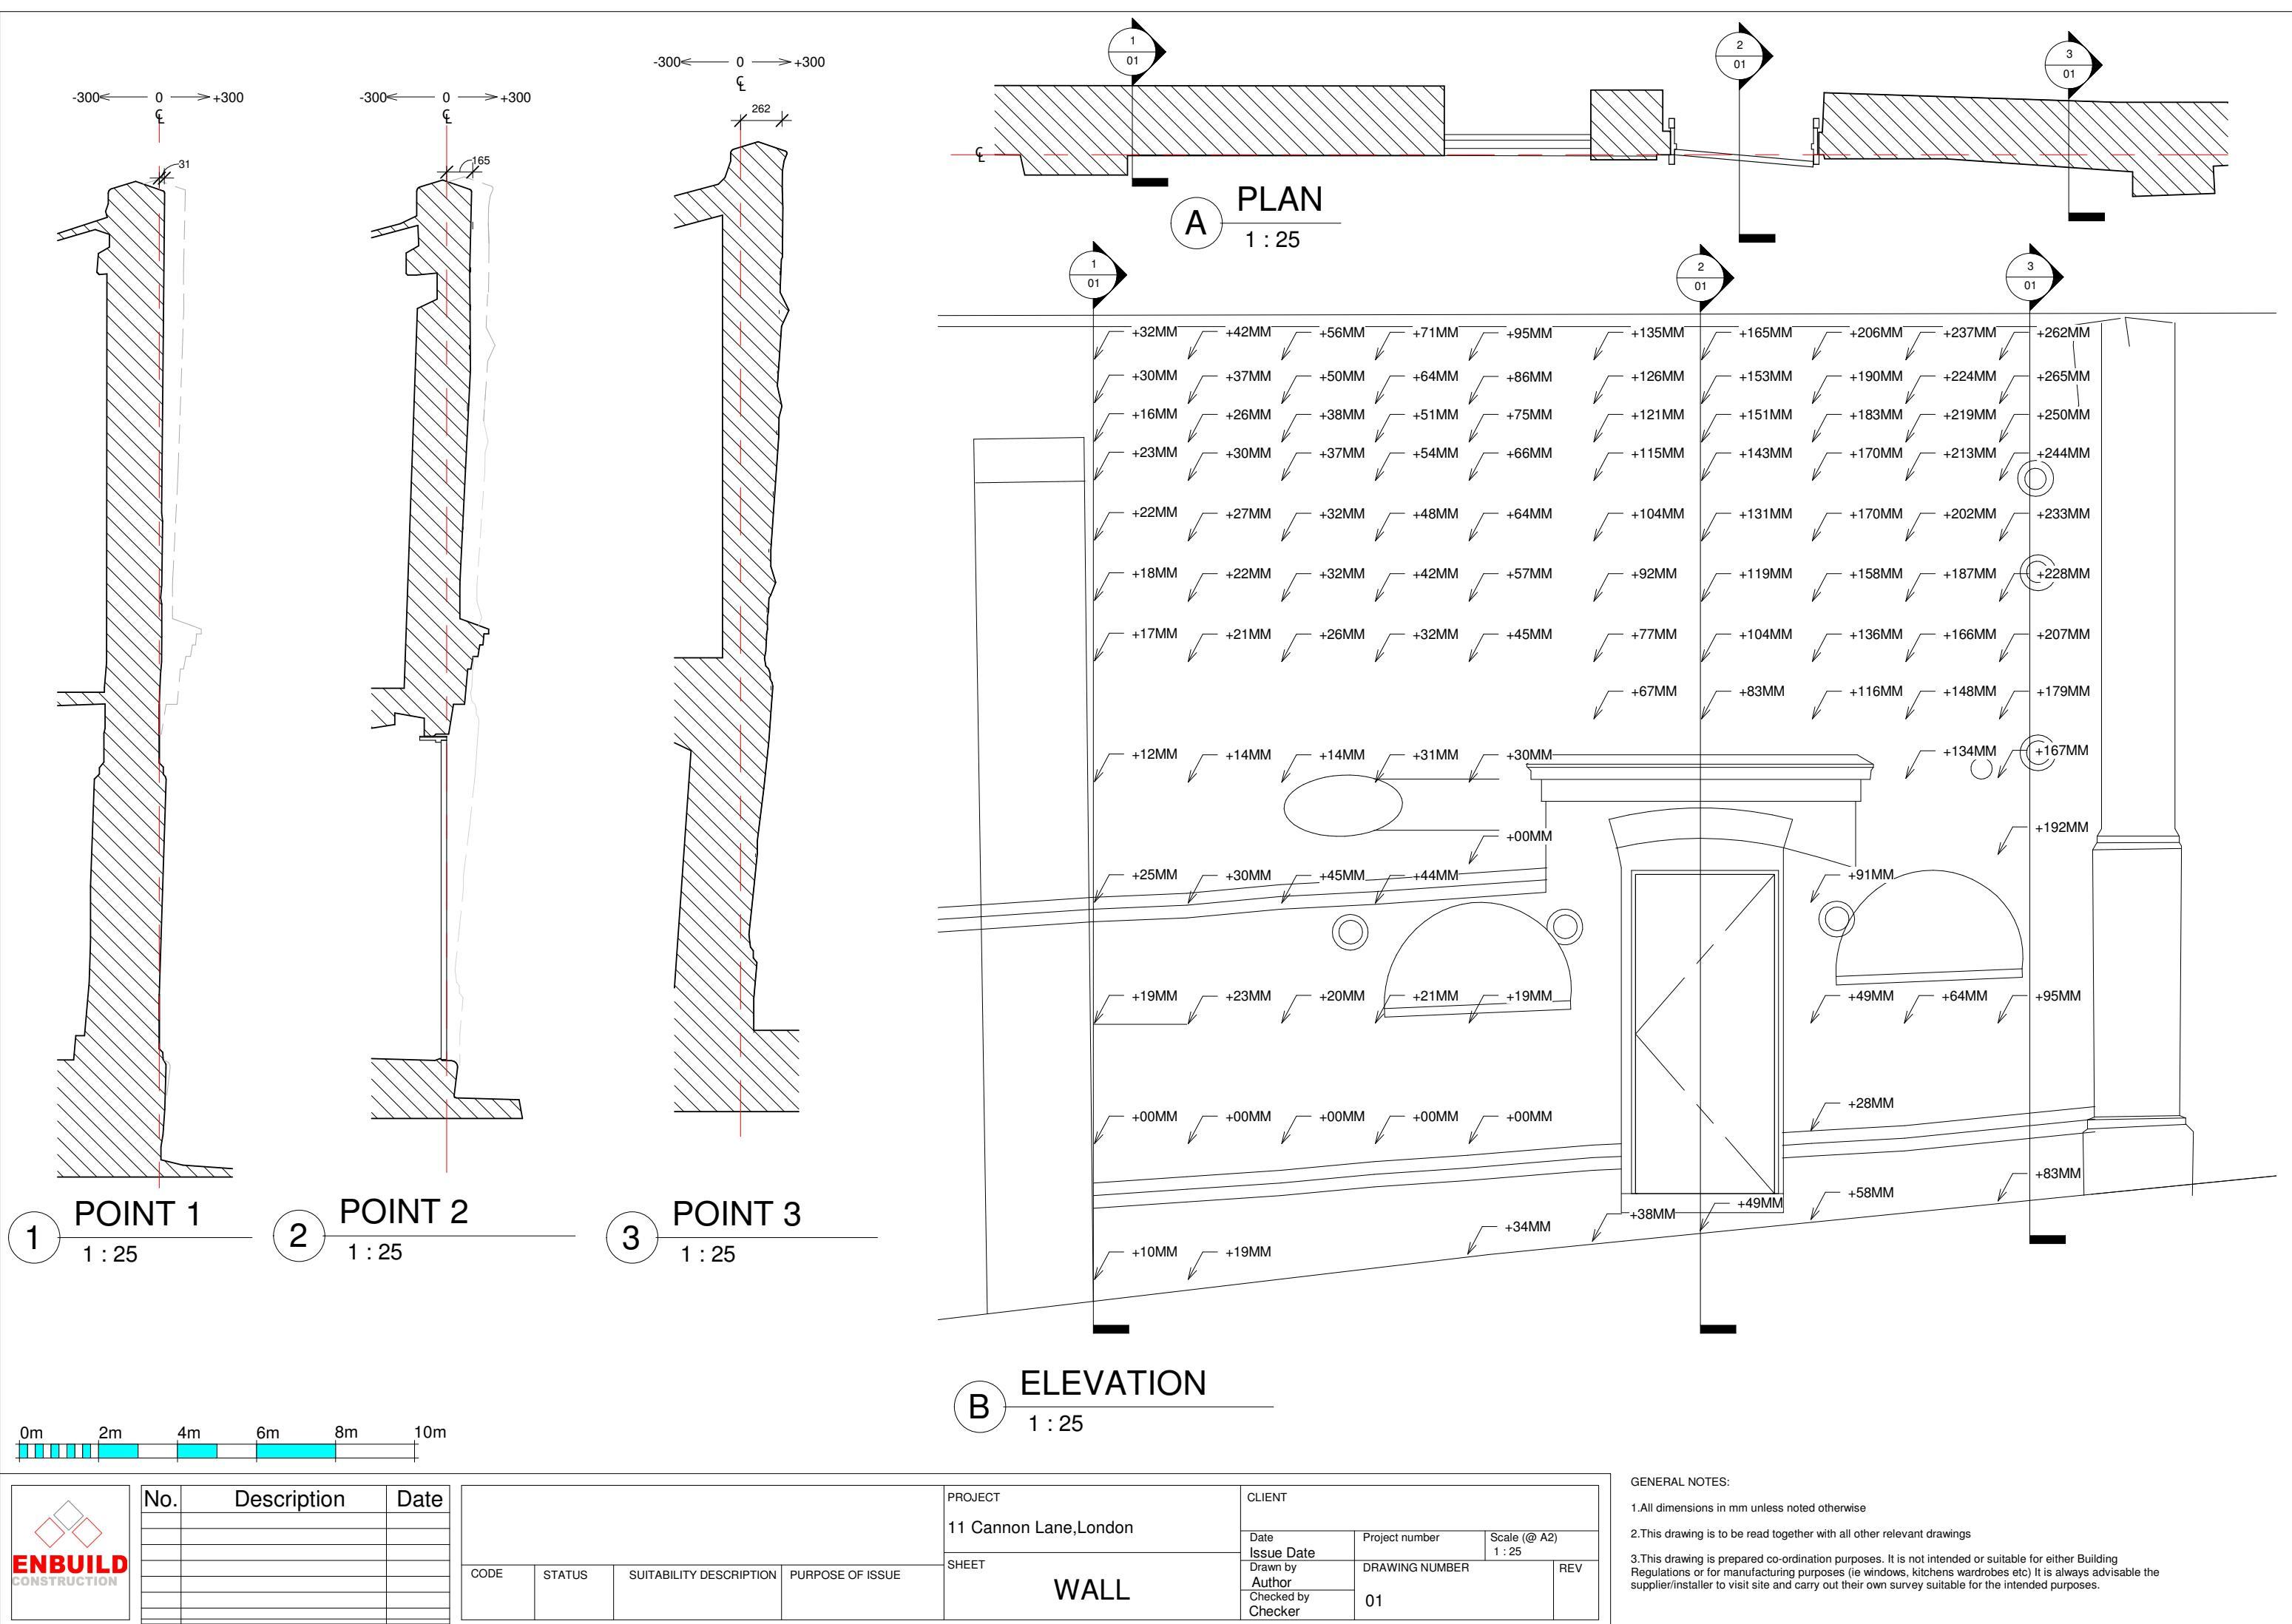
Appendix B Verticality Survey

A verticality survey was undertaken in February 2025 to confirm the extent of lean of the wall. The results of this are attached in Appendix B. This survey highlights that the wall leans most at its northern side and gradually reduces toward the south. The overall outward lean of the wall is assumed to be historic and the wall is now tied back with the use of pattress plates. The inward pivot, assumed to be from the wall hinging around the missing/deteriorated embedded timbers noted earlier, is slightly prominent in point 2 of the survey.
