26 Rosslyn Hill London – NW3

Structural Survey

Date:	04/02/2025	Prepared by:	TS	
Reference:	1031-rep-003	Checked by:		
Filename:	1031-rep-002-P1-visual survey.docx			
Revision:	P1	Status:	PRELIMINARY	
Revision Date:	04/02/2025			
Revision:				
Revision Date:				
Kiosque Ltd, 20-22 Wenlock Road, London, N1 7GU				
t. 020 3740 0745 – e: mail@kiosque.co.uk

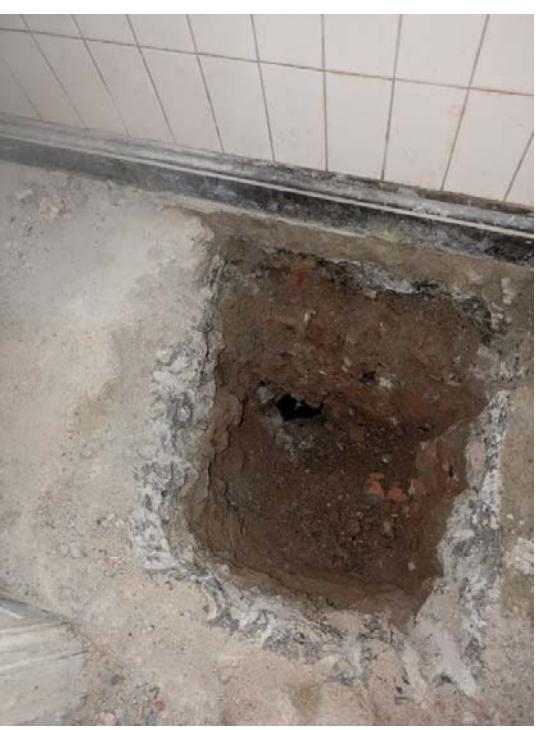
- Trial pits were dug prior to the survey in rooms LG #1 and LG #2 to ascertain the depth and profile of the foundations. The findings are described in Appendix 2 of this report.
- Water was present at the bottom of trial pit 1.
- The foundations typically consist of the brick wall sitting on a concrete footing bearing on a clay sub-strata.
- Foundations to the side external wall in room LG #1 are only 800 mm deep.
- To the rear of the property the external wall foundations in the toilet area consists of the brick wall bearing directly onto the sub-soil with no concrete footing at the depth of 0.5 m. At this location, locally, a 900 mm void under the wall was noted. This void could be an underground cistern, well or chamber. No lintels or concrete beams were installed, and the external wall was bearing directly above this void with no apparent support locally.

Void under foundation

- A void under the foundations was noted in the rear lower ground floor toilets, with the brick wall bridging over the void with no lintel of reinforced concrete beam. This shall be investigated further. The void shall be filled with concrete and local underpinning of the foundation shall be carried out to ensure the wall above bear on sound ground.

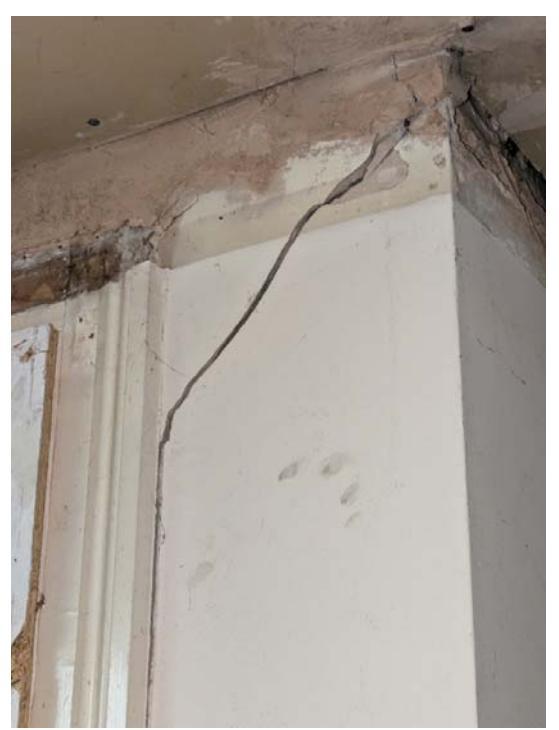
- The foundations to the bay windows and to the side wall appeared to be shallow and less than 1.0 m deep. This is typical of some properties of this period and type of construction where bay window foundations are shallower than the main foundations. This might lead to differential settlement and cracks appearing around bay window. Consideration for underpinning the bay window as part of the new building redevelopment shall be given.

Crack in wall adjacent to bay window

- Where structural cracks where observed, local stitching of the walls shall be carried out by inserting stainless steel reinforcement bars (eg Helifix bars) within the brick joints.

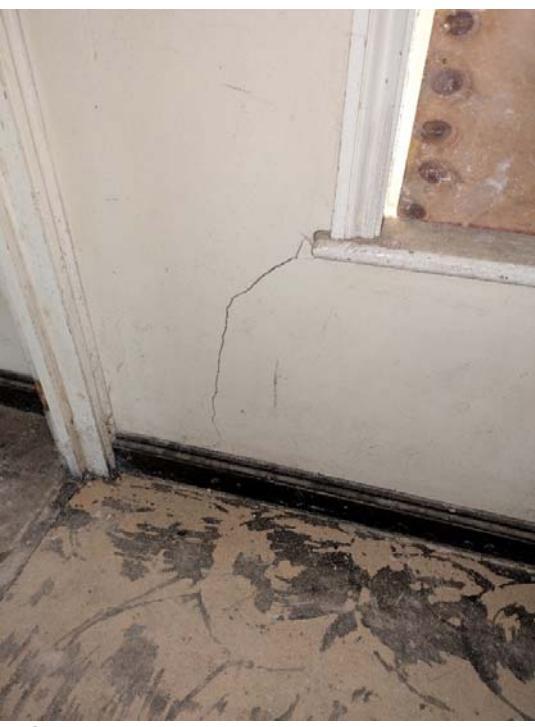
Crack adjacent to window in top landing

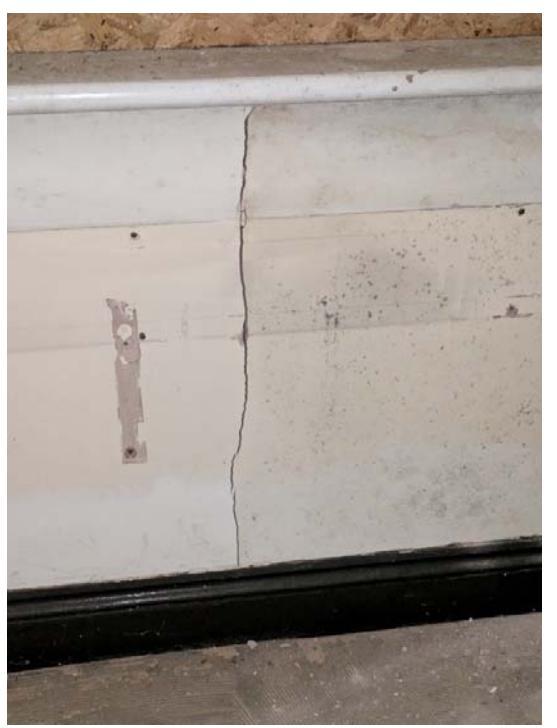
Crack under window in rear rooms

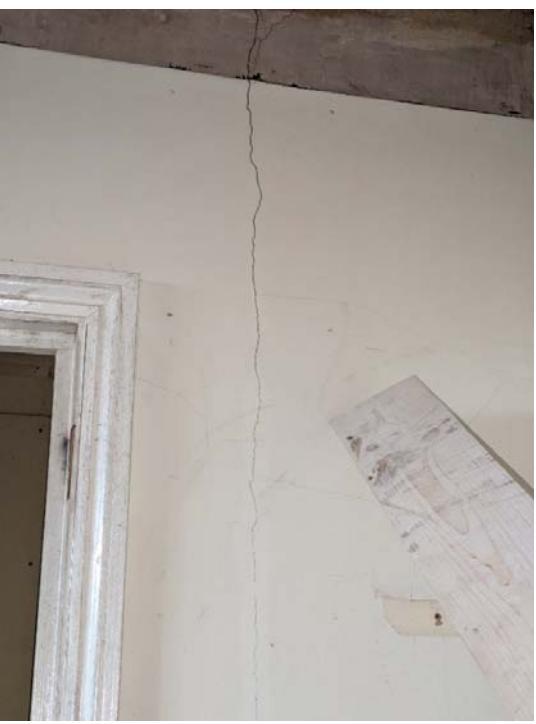
Crack in wall in rear room at first floor

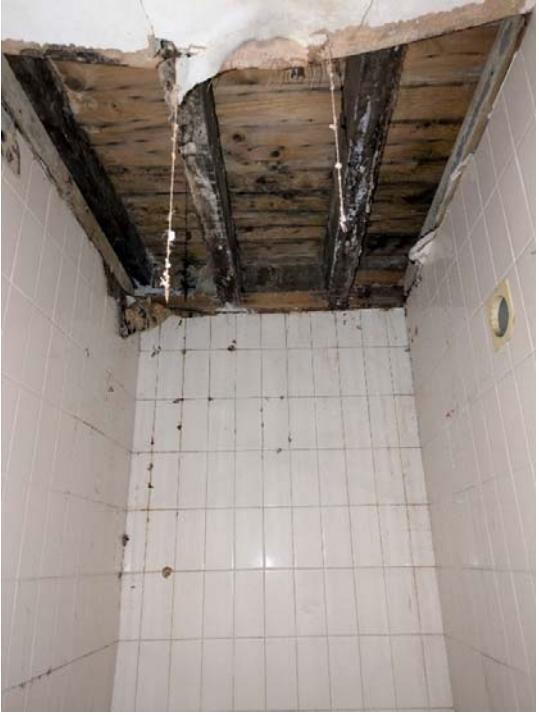
- A high level of dampness, fungal growth and local decay was noted. We suspect that once all ceilings and floor boards will be removed a more widespread problem of timber dampness and decay will be uncovered. Consequently, we will recommend that during the future development the timber joists are replaced throughout the floor.

Fungal growth in timber

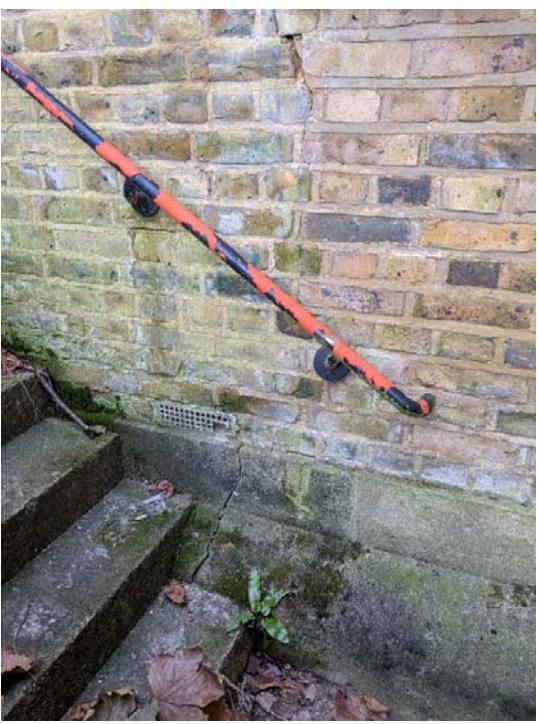
- Cracks and movement in walls were noted in some external walls (front wall and rear wall). These cracks would indicate that differential movement has occurred at foundation level. In addition to repairs and strengthening the walls (eg installation of Helifix bars in masonry joints to bond walls junction together) local underpinning of the foundation shall be considered.

Crack in external wall
