Our Ref: CAS / 25536

## Re: Derby Lodge, Wicklow and Britannia Street, London. WC1X

## Block :- 85 - 102 Wicklow Street.

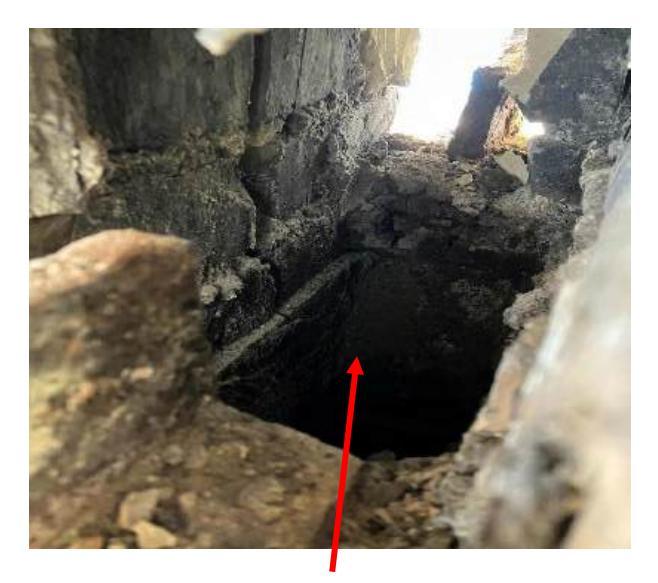
The central piers are not formed from solid construction as originally thought. The pier is • hollow. The pier is constructed from 102mm brickwork. We believe that they are hollow down to the ground floor.

Void within the pier.

After much consideration we recommend that the central piers are taken down and reconstructed on each block as detailed on our drawing 25536 / 04. This is to ensure that the structure will last another 50 + years.

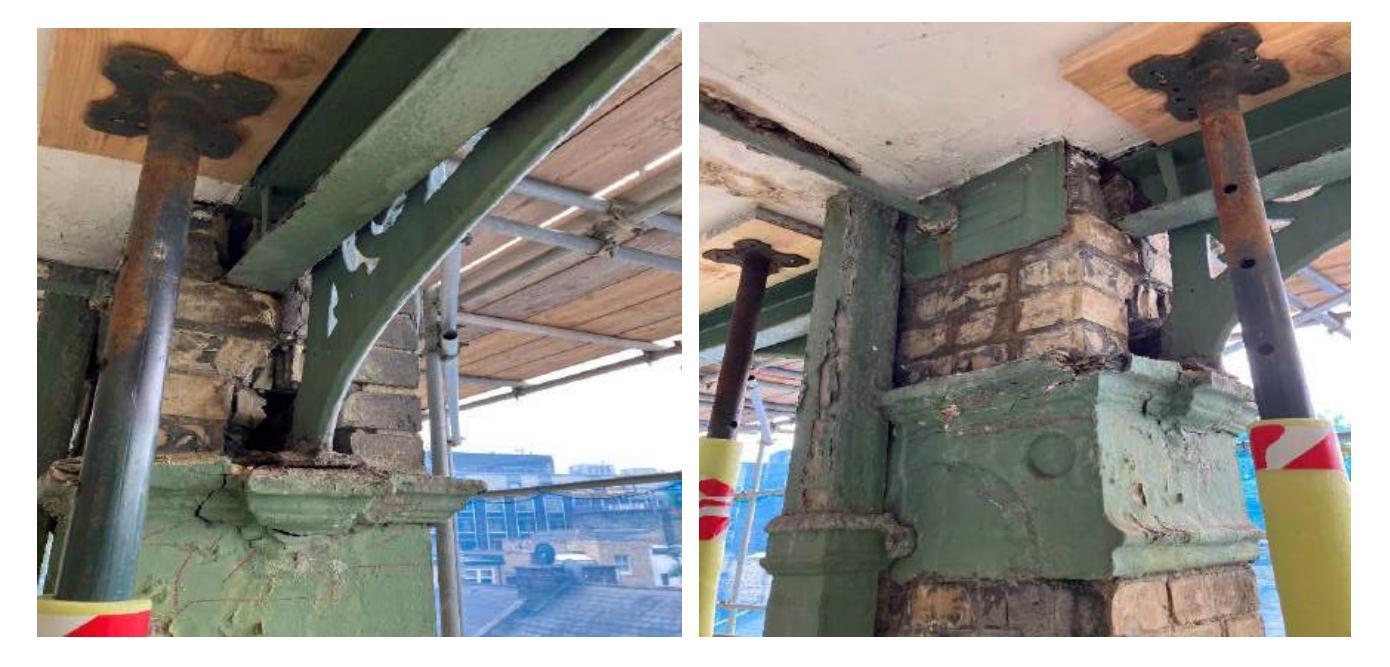
- The concrete padstone which has the rendered feature to it is not solid across the area of the pier.
- The concrete corbels out to support the base of the steel arch. The base of the steel arch only bears onto brickwork approximately 25mm. The steel arch is supporting the edge of roof over the fifth-floor landing. The arches on the lower floors are not supporting the landings as the steel channels have been added into the structure. The top of the arch is tied into the pier. The concrete has cracked in various locations. The ends of the arches where they bear onto the structure are corroded.

Cracked concrete under the steel arch. Corroded steel arches. The concrete is formed from clinker concrete with steel reinforcement which has corroded (see picture below from neighbouring block 69 - 84)

The concrete padstones within the piers have been cast from clinker concrete. To our knowledge they are part of the original structure and are approximately 160 years old. The reinforcement within the padstones has corroded and caused the concrete to crack / fail. The clinker concrete has come to the end of design life.

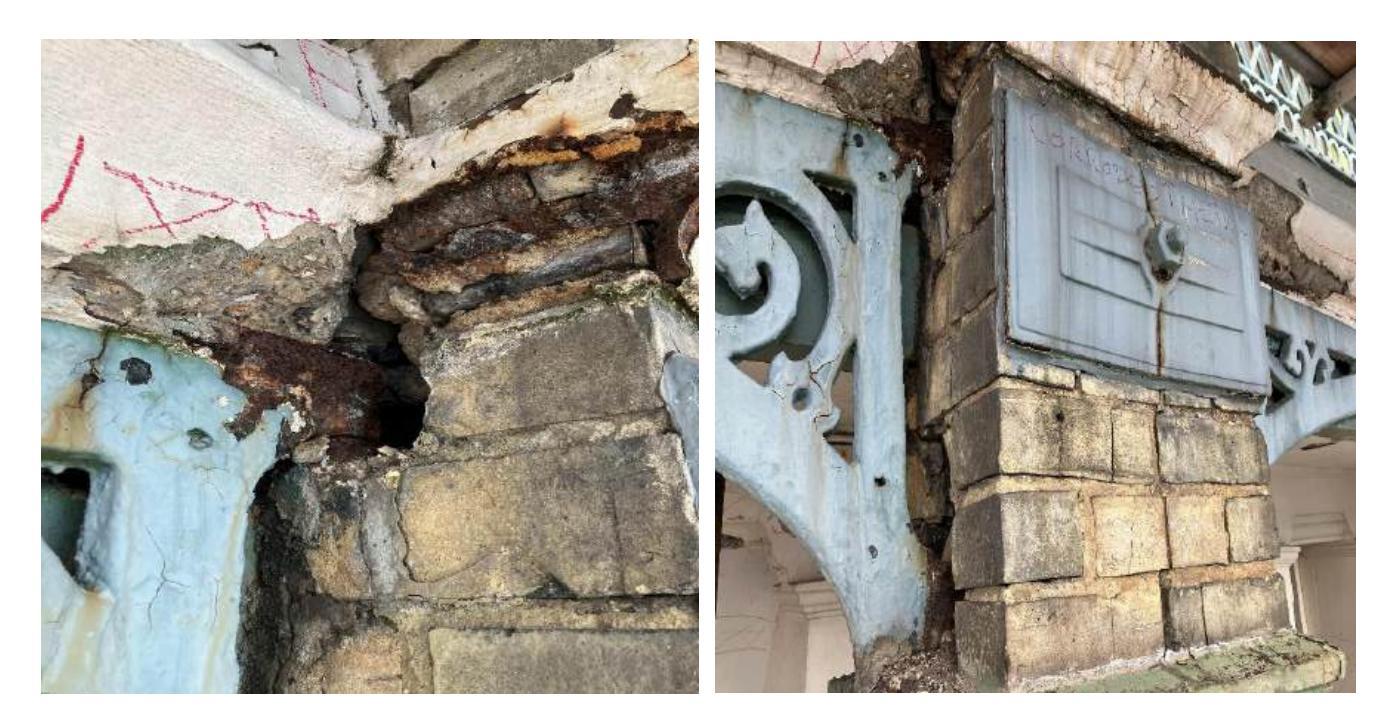
Corroded steel arches.

Distorted brickwork and cracked pattress plates.

We believe that the pattress plates have failed / failing have cracked due to following variations in temperature causing them to the expand and contract and them not being galvanised to prevent them from corroding. We do not know what grade steel the existing plates are.

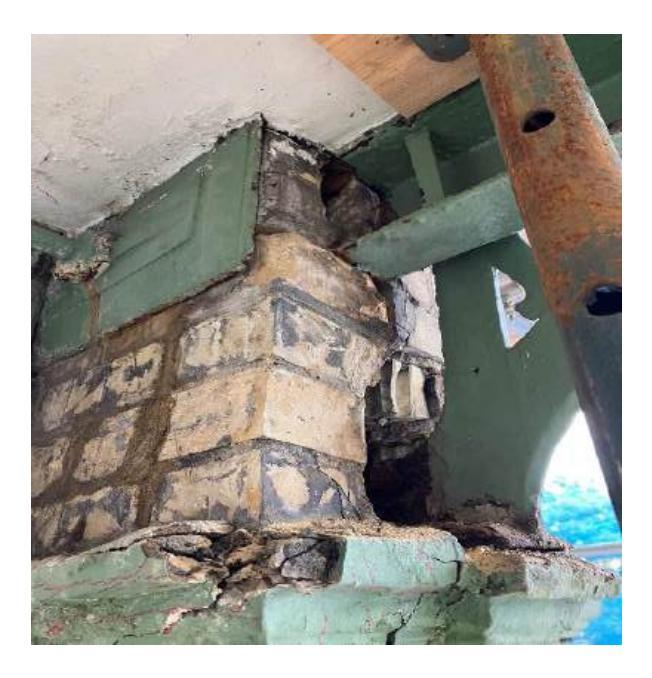
• The ends of steel channel which was exposed (under the fifth-floor landing) was bearing 100mm onto the brickwork. The end of the PFC is corroded.

Concrete cast into the web of the beam. End of beam is corroded along entire length of its bearing where it has not been treated / painted.

The PFC beams are not part of the original structure, we believe that they were installed to provide support to the edge of the landing. The PFC beams are no galvanised. As water has run down the inside of the piers the ends of the beams have corroded.

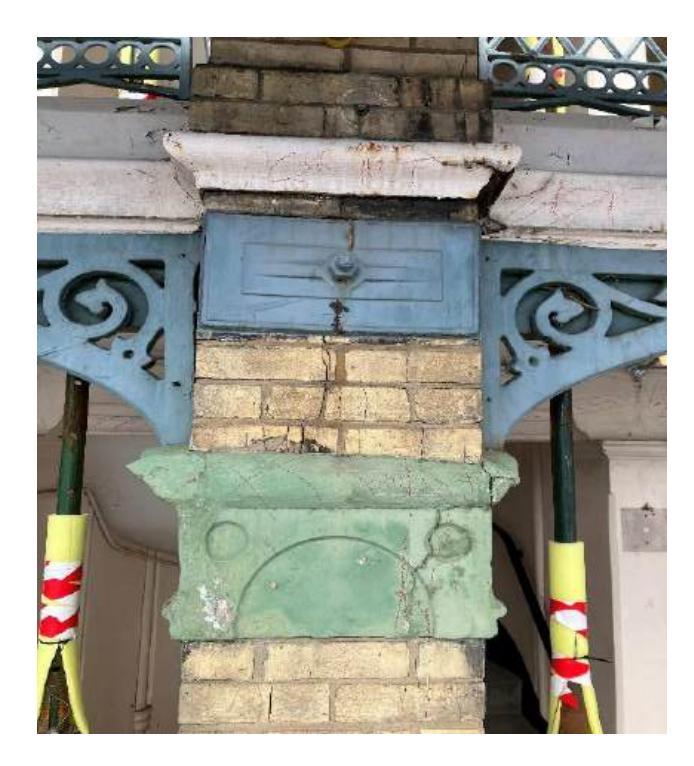
• The brickwork behind the split pattress plate on the fourth floor has cracked and is distorted. The plate needs to be replaced and the brickwork behind it needs to be reconstructed.

Similar defects are noted at lower level down the structure.

Failed Patress plates cracked brickwork (underside of fourth floor)

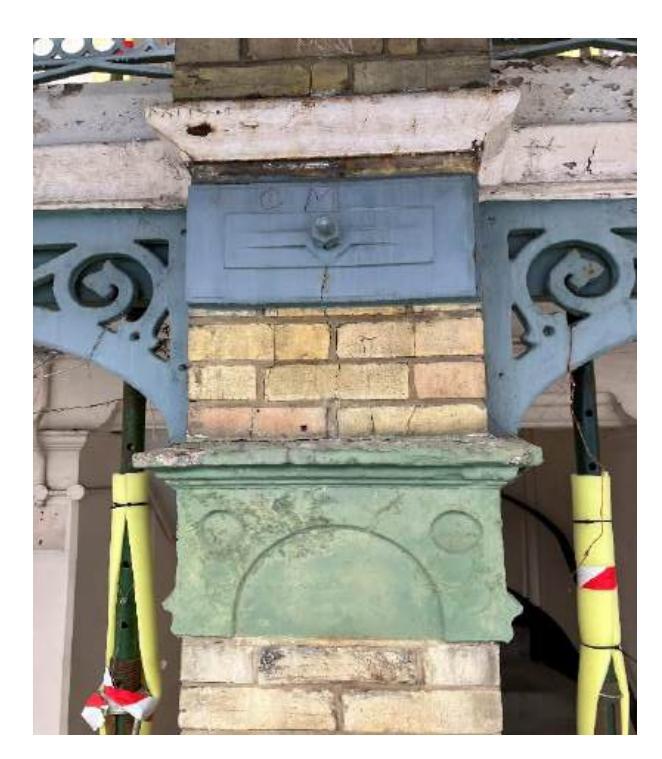
Patress plate is starting to fail cracked brickwork (underside of 3<sup>rd</sup> floor)

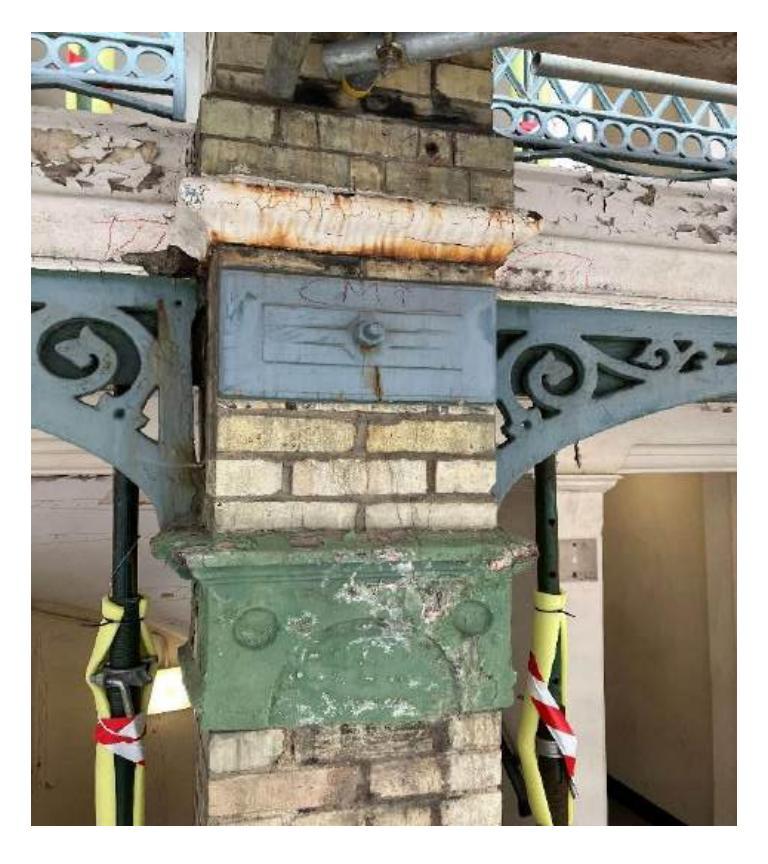
Patress plate is starting to fail cracked brickwork (underside of 2nd floor).

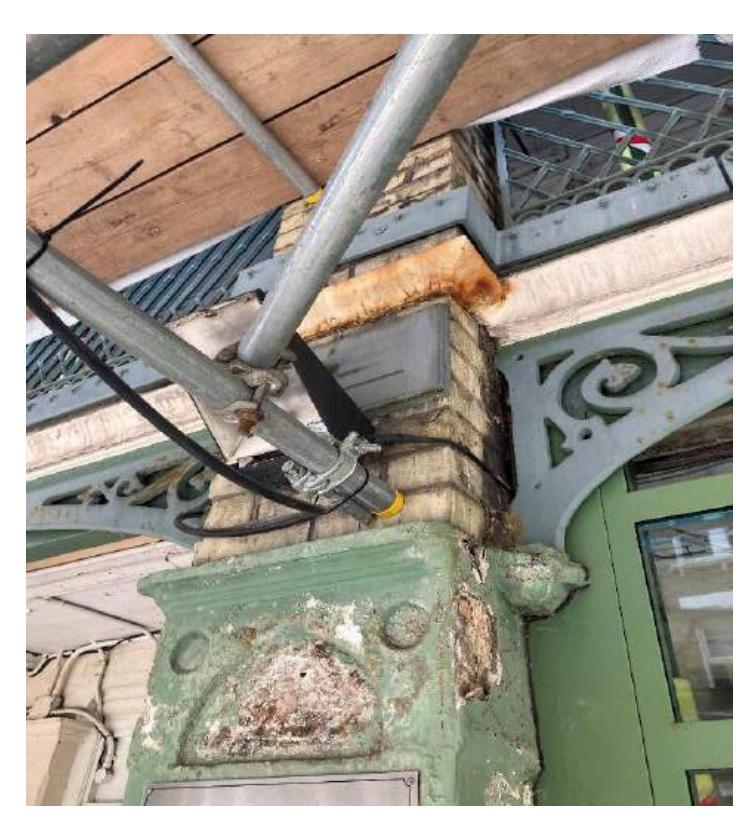
Pattress plates are starting to fail. Cracked concrete supporting feature arch.

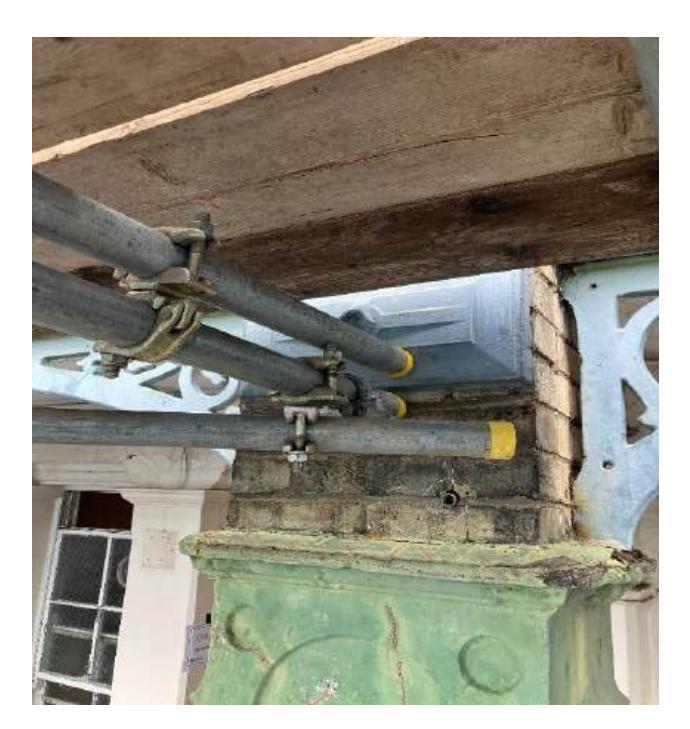
Pier under roof. Pattress plate condition is adequate. Corrosion to steel arches evident and cracking to padstone.

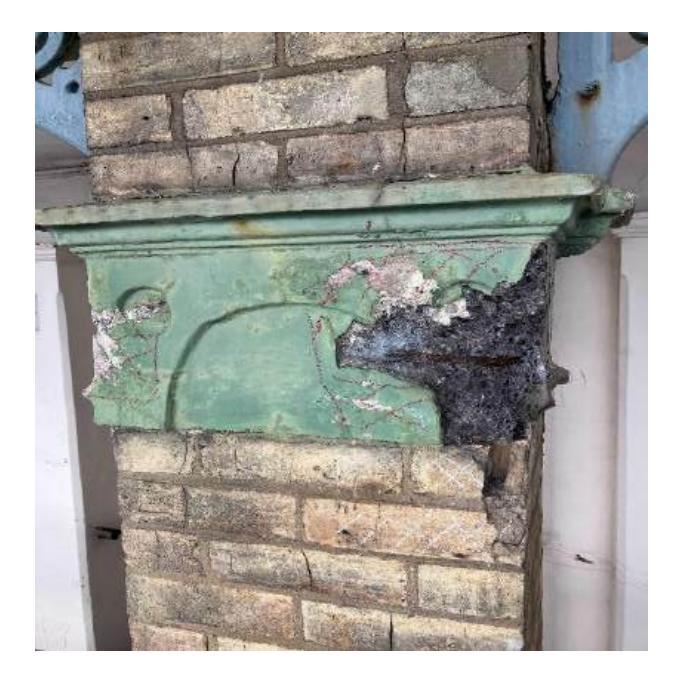
Cracked padstone and brickwork under the fifth-floor landing.

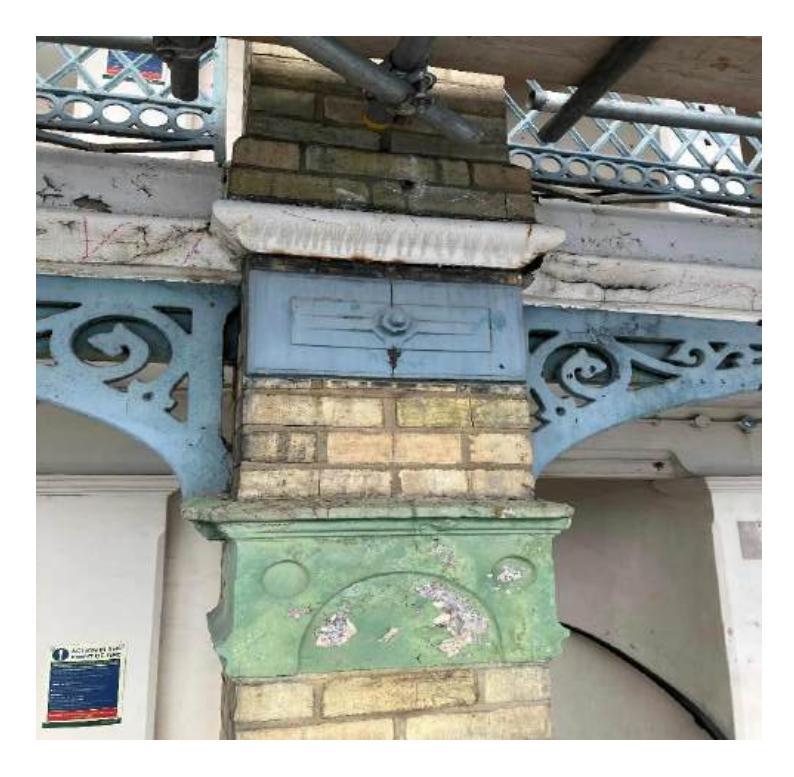
Cracked padstone and brickwork under the fourth-floor landing.

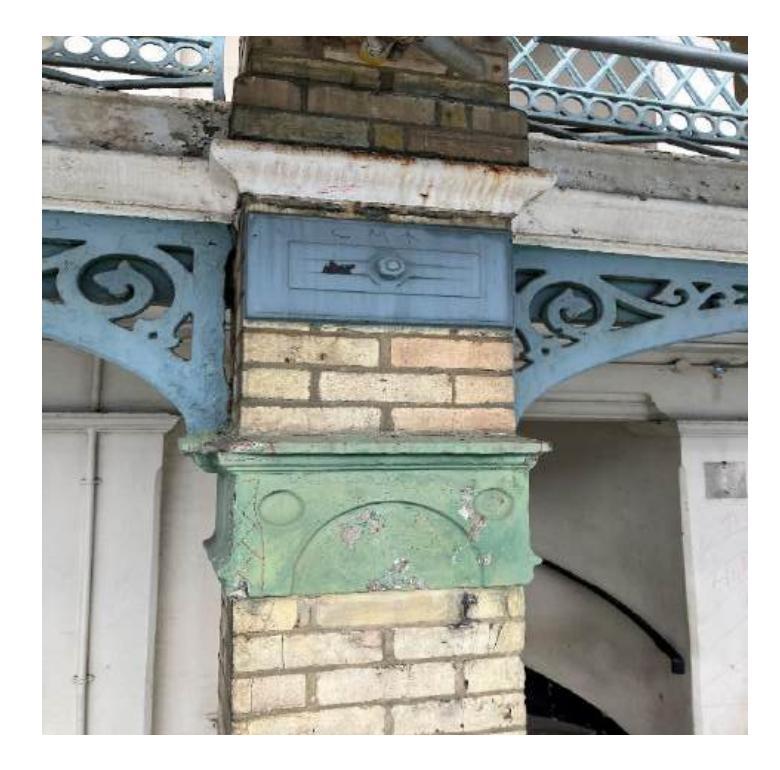
Cracked padstone and brickwork under the third-floor landing.

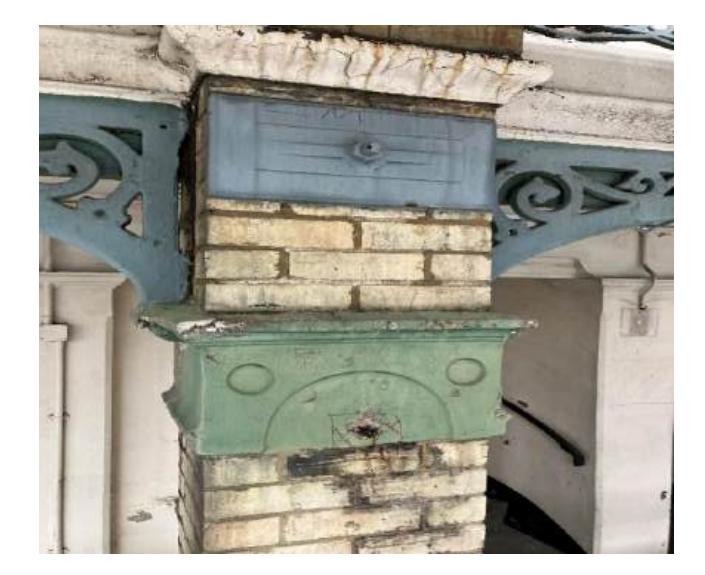
Second floor landing. No major defects on the day of visit.

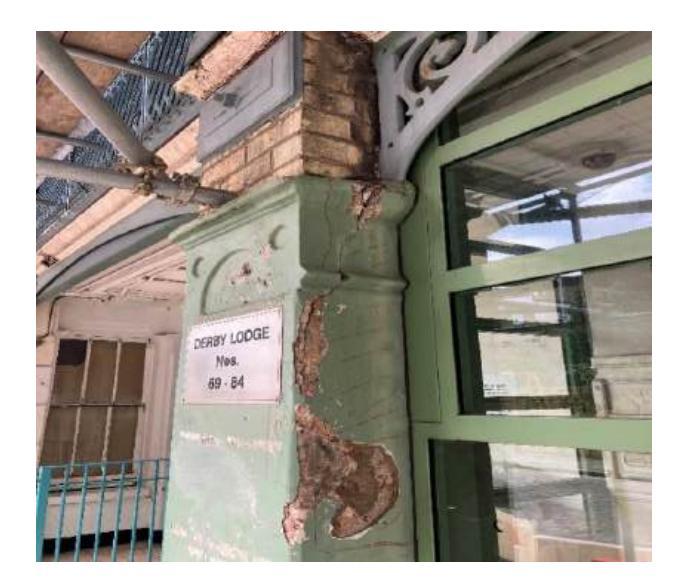
Cracked padstone and masonry at ground floor level.

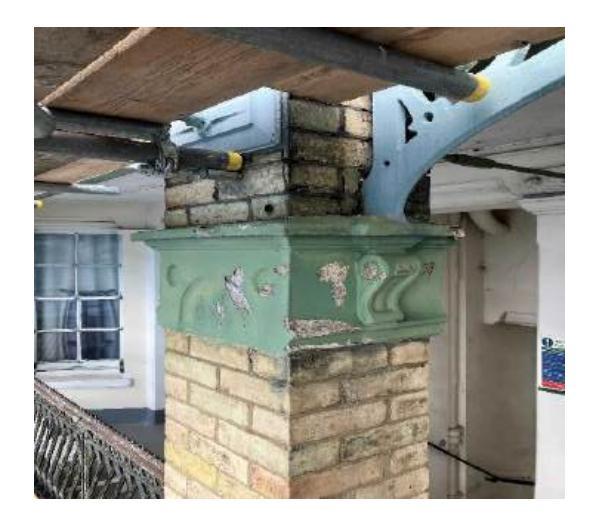
Pier under roof. Minor corrosion to pattress plates. Brickwork in good condition.

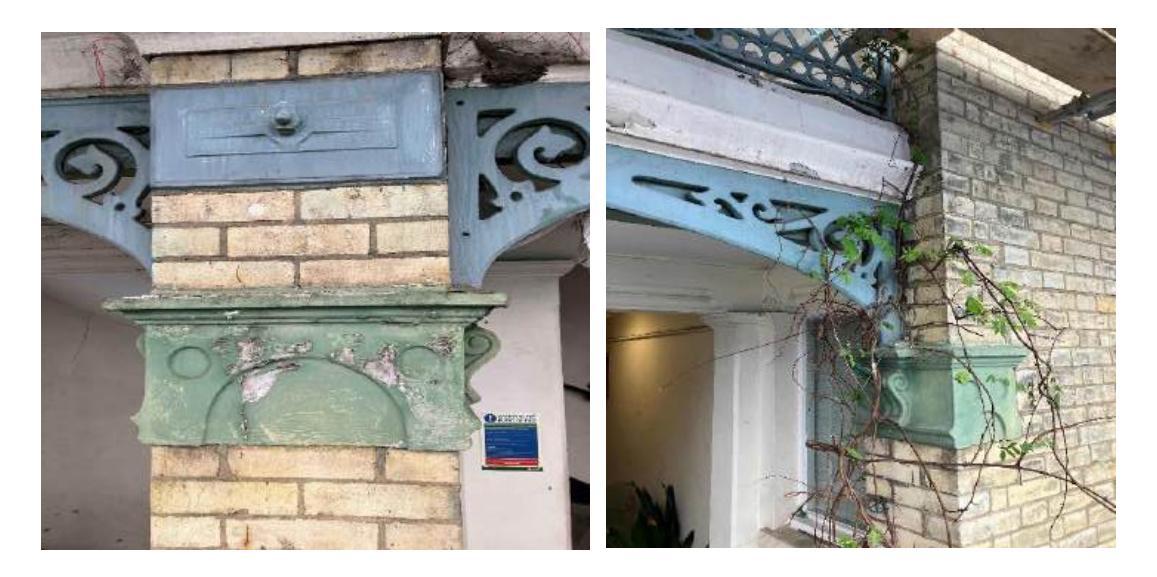
Cracked padstones under the fifth-floor landing. Remove vegetation.

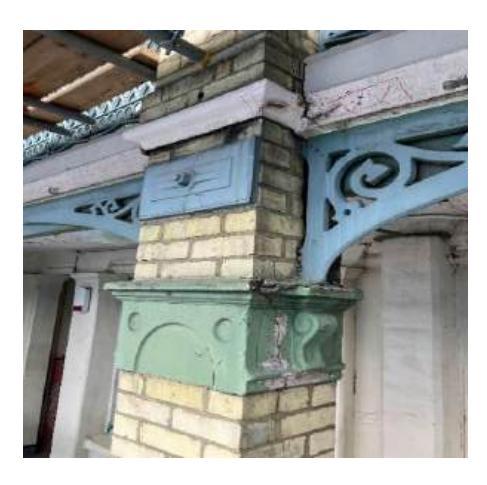
Cracked padstones and split pattress plate under fourth floor landing.

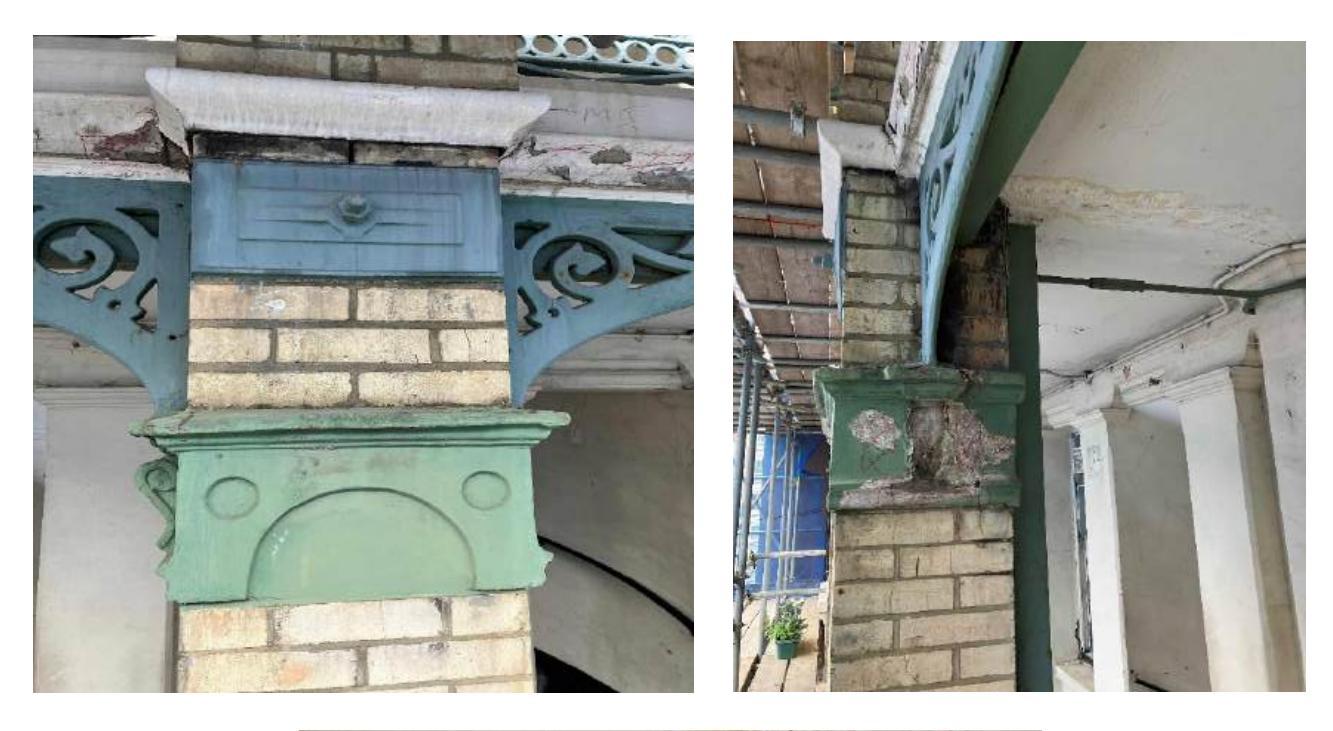
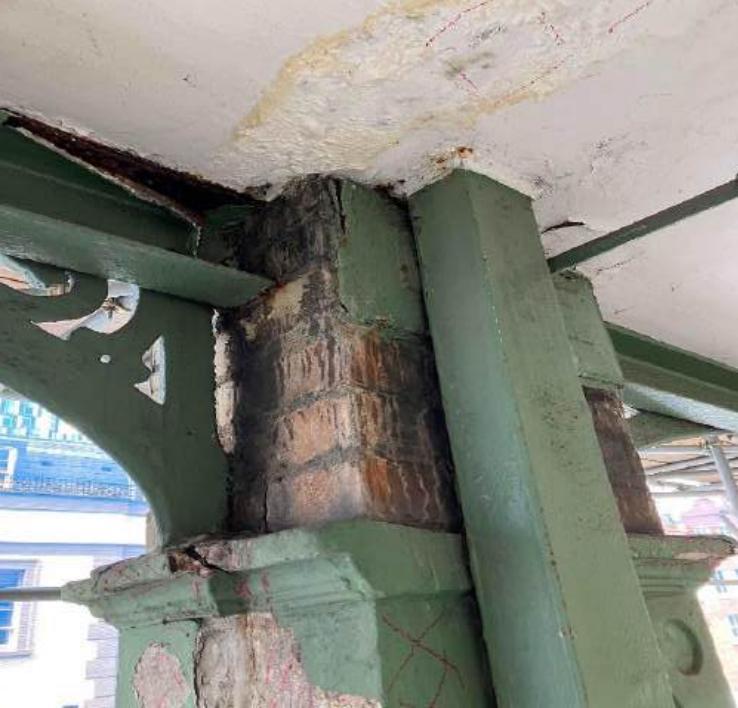
Plate is corroded and the padstone has cracked under third floor landing. Severely corroded steel beam due to water ingress down the column.

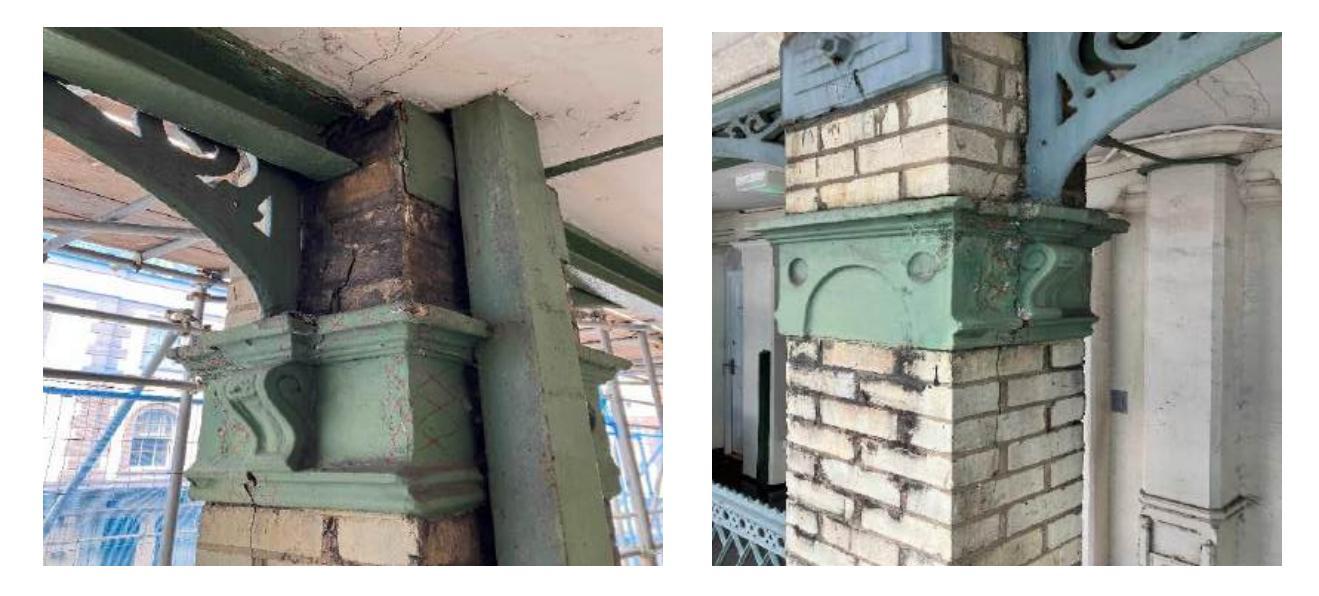
Corroded plates split brickwork under the second-floor landing.

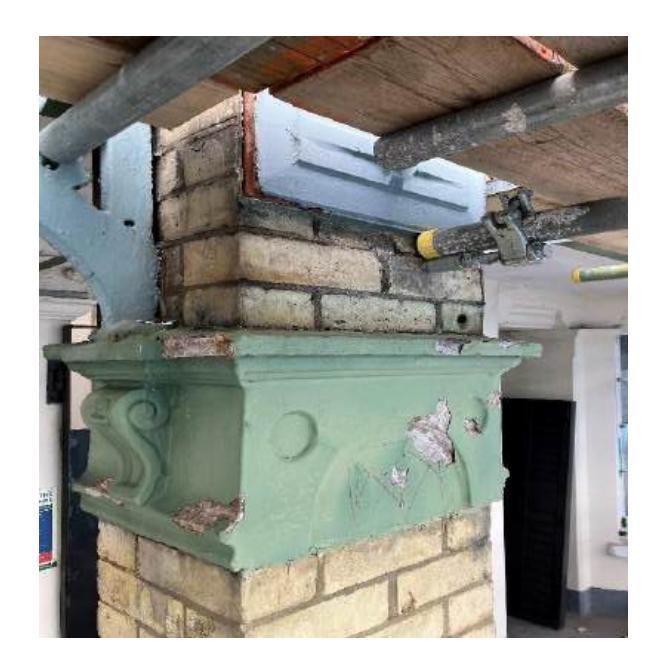
Pier under roof level. Corroded pattress plates.

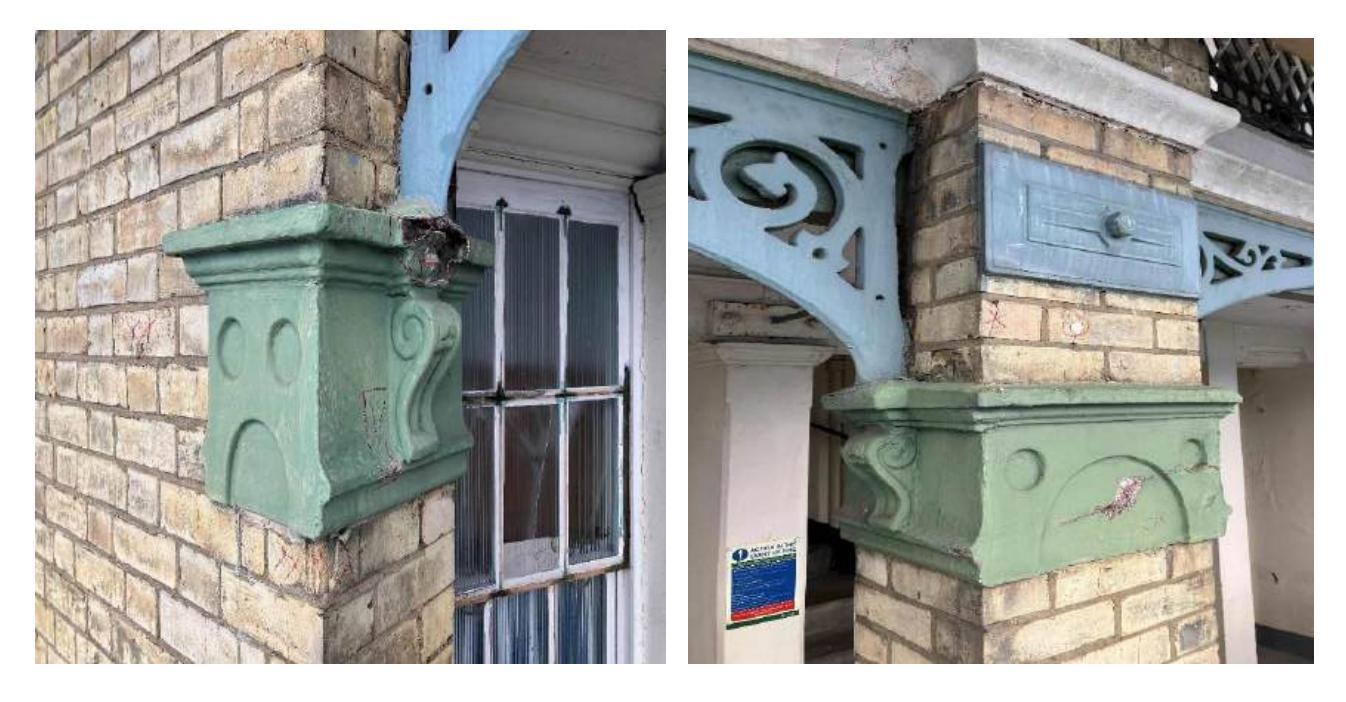
Cracked padstones under the fifth-floor landing.

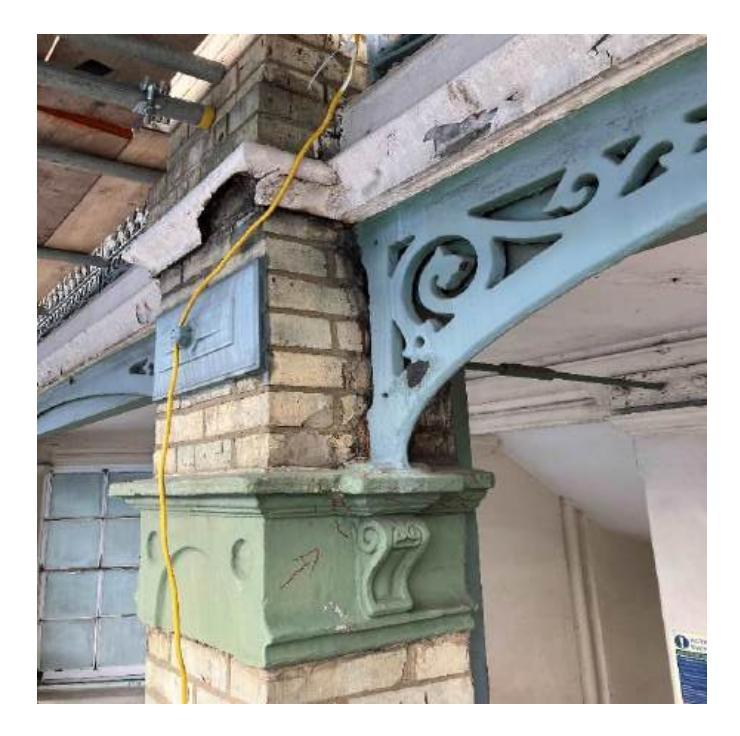
Signs of water ingress under the fourth-floor landing

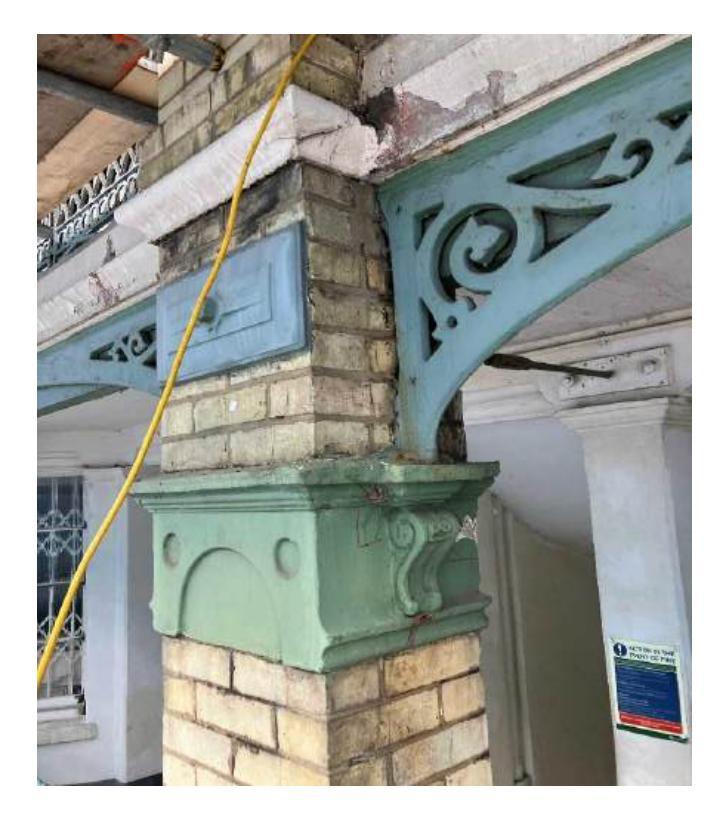
No major issued under the third-floor landing.

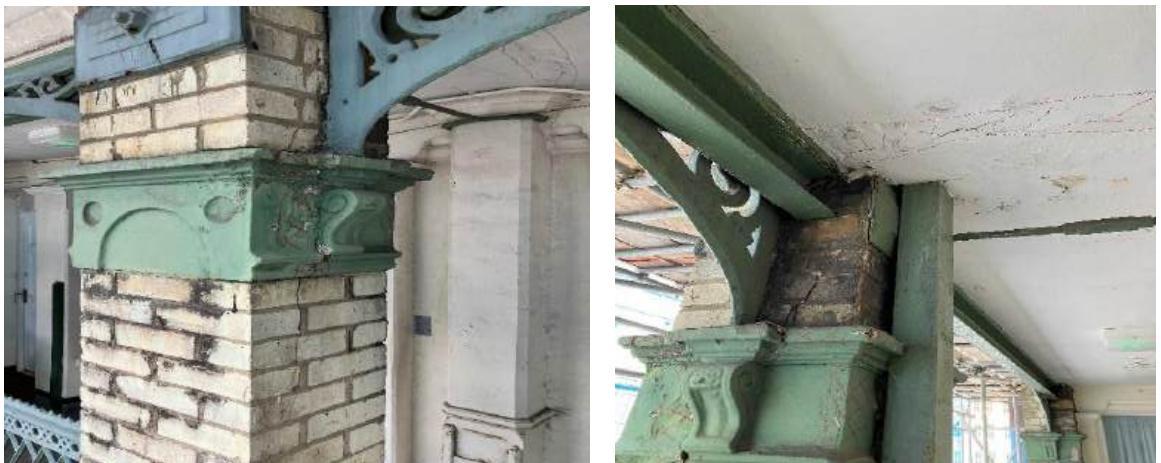
Cracked brick work and concrete padstone under the second-floor landing. Pattress plate is starting split.

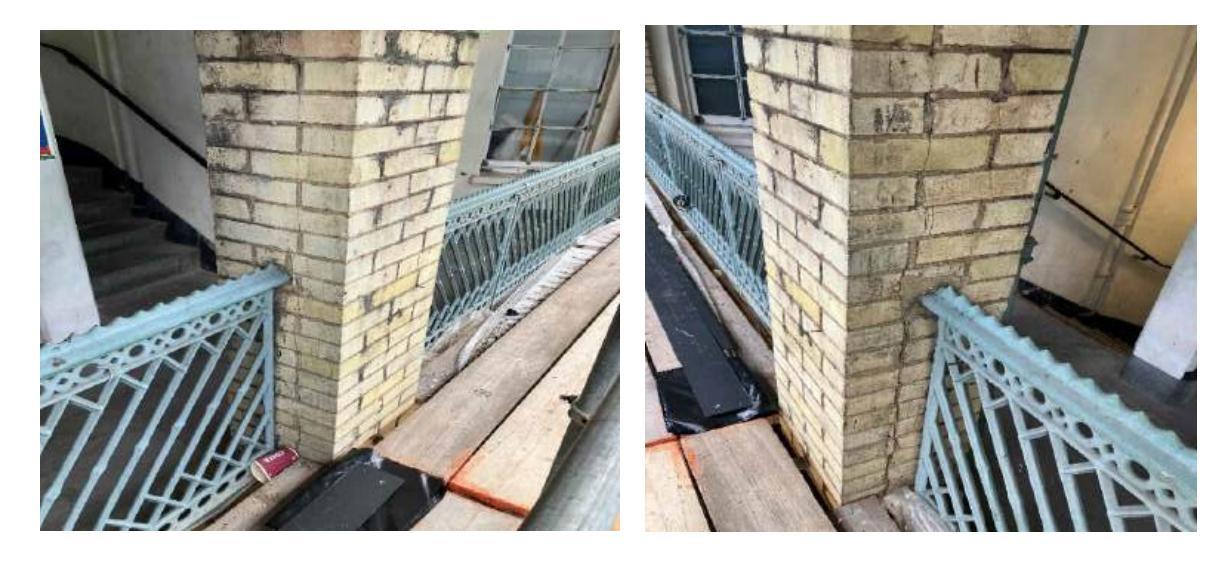
Brickwork to the piers at first floor level has cracked.

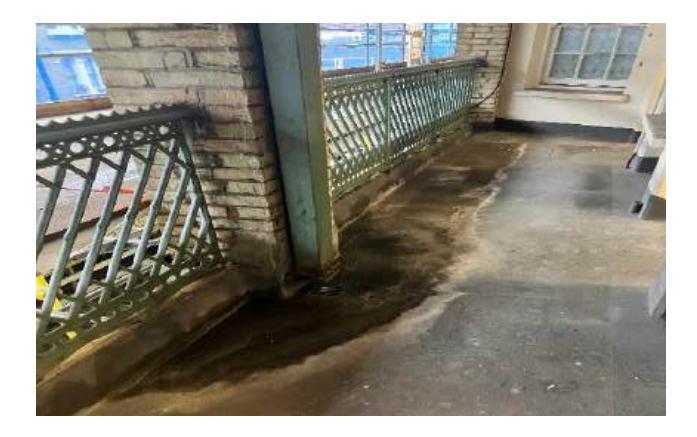
The rainwater from the landings does not drain away from the structure via the rainwater pipe which is set behind the masonry pier. As a result of this water has run down the inside and outside of the piers. This has increased the corrosion of the landing beams, the deterioration of the of the clinker concrete padstones, pattress plates and brickwork. See picture below :-
