19 Charterhouse Street

Project No. 23-52

Drainage Strategy Report DMAG-2352-DSR March 2025

Produced for Farrview Limited

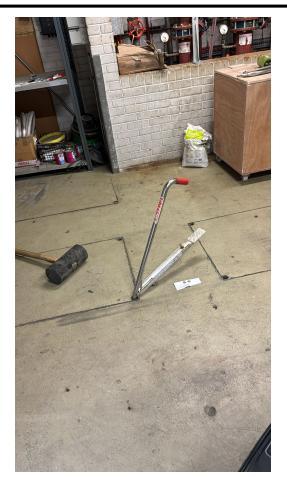
Unable to lift cover lids (1)

It is recommended that the seized covers are replaced for maintenance purposes and the remaining pipes are surveyed.

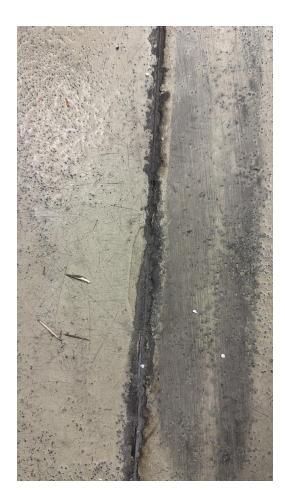
Unable to lift cover lids (3)

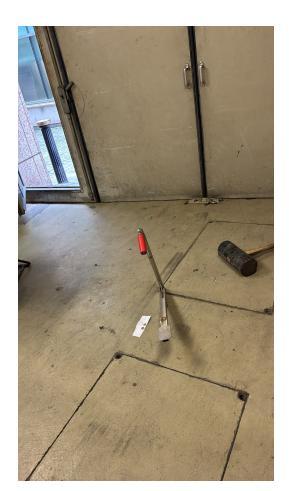
Unable to lift cover lids (5)

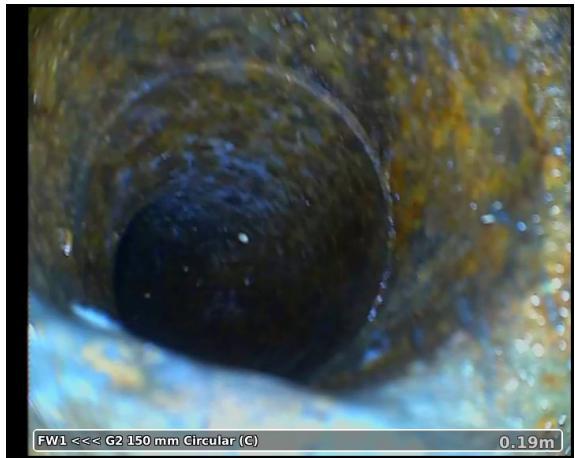
G2X_2c3c6d0d-94d4-48ad-a8a1-30fb1e76f51e_20240314_08 3125_845.jpg, 00:00:08, 0.19 m Surface damage, corrosion products from 12 o'clock to 12 o'clock, rust

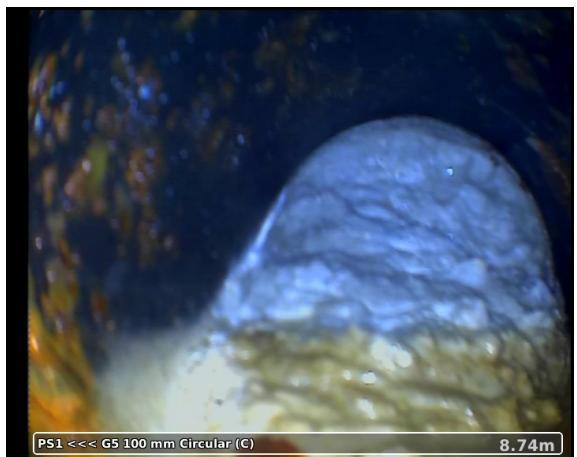
G5X_6594ff58-c8d0-4b1c-a4c2-c6b85e141af2_20240314_08 4652_165.jpg, 00:01:12, 8.74 m Finish node, gully, reference: G5, PIPE NOT IN USE

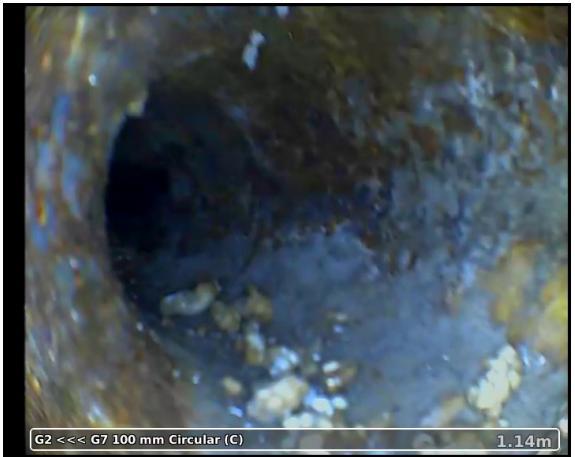
G7X_b453e101-1ac8-4560-a09f-3b2f80ce0565_20240314_09 3823_988.jpg, 00:00:15, 1.14 m Surface damage, corrosion products from 12 o'clock to 12 o'clock, rust

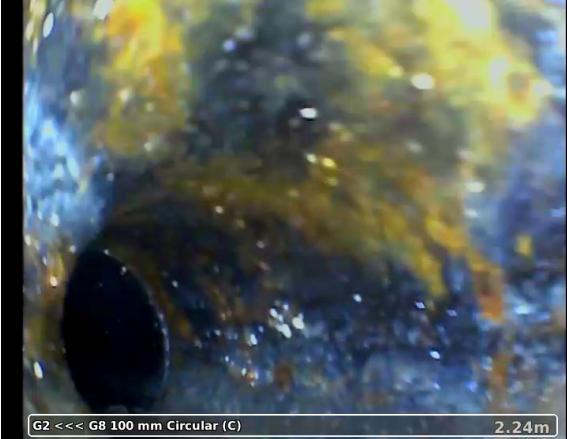
G8X_83a088b8-ce63-4d3a-b8c8-9b50ea16ae07_20240314_0 94508_379.jpg, 00:00:23, 2.24 m Surface damage, corrosion products from 12 o'clock to 12 o'clock, rust

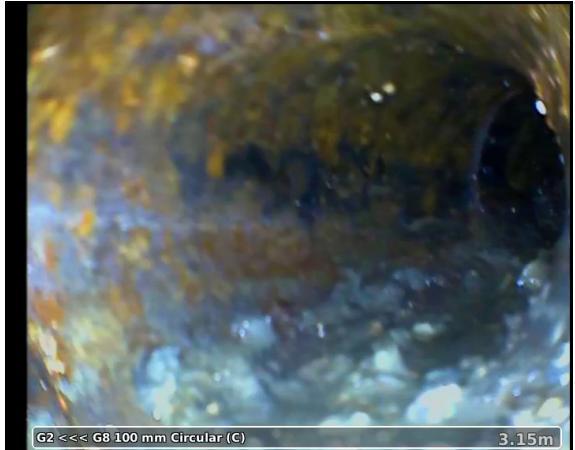
G8X_d0807cb3-b38c-4035-ac9b-d24c8175ca0c_20240314_0 94533_498.jpg, 00:00:30, 3.15 m Surface damage, corrosion products from 12 o'clock to 12 o'clock, rust

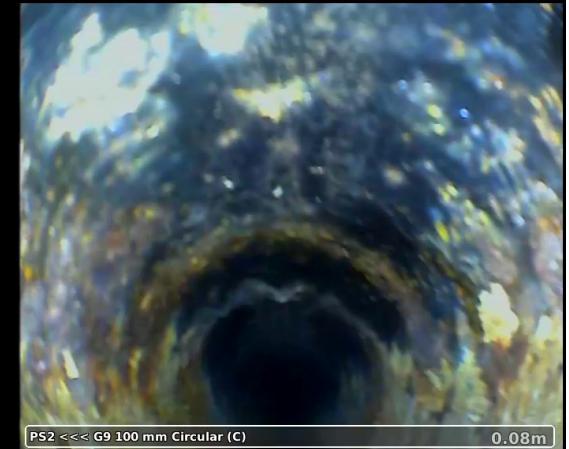
G9X_bbf66fca-f3a6-431e-9a01-8af7f25f75ff_20240314_11061 2_365.jpg, 00:00:14, 0.08 m Surface damage, corrosion products from 12 o'clock to 12 o'clock, rust

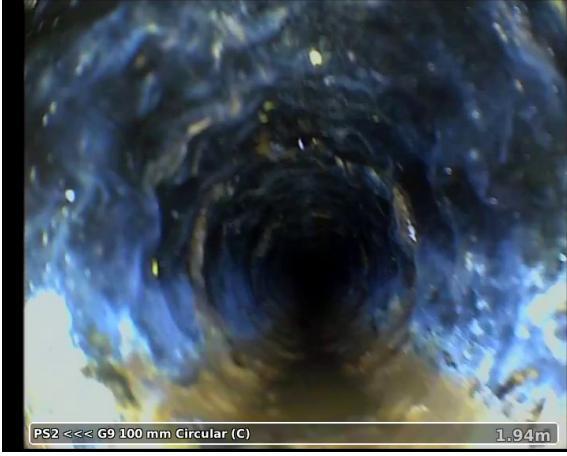
G9X_c87ebb54-ef2c-4d79-8511-708484e769f9_20240321_09 3238_249.jpg, 00:00:20, 1.94 m Attached deposits, other from 12 o'clock to 12 o'clock, 5% cross-sectional area loss, start, rust

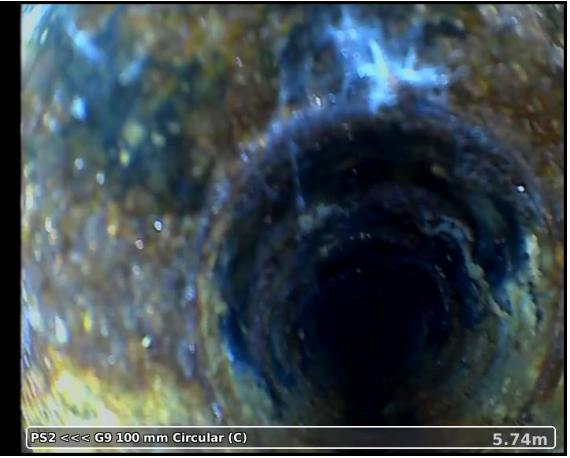
G9X_8e3582c3-deff-42cc-8898-58a5fccdcbdd_20240314_110 730_871.jpg, 00:00:45, 5.74 m Surface damage, corrosion products from 12 o'clock to 12 o'clock, rust

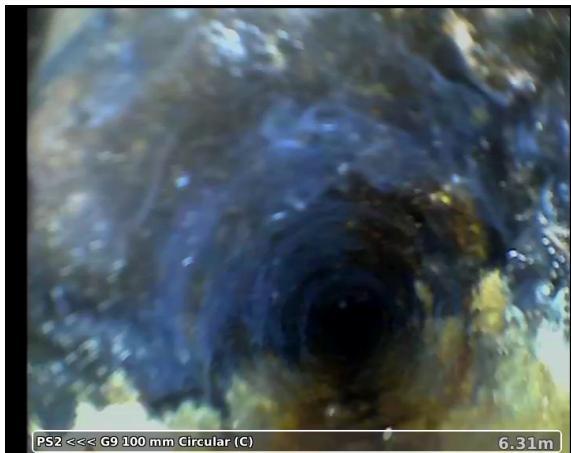
G9X_43383c32-8394-47ce-9e7b-188e0f4e54ac_20240314_1 12414_050.jpg, 00:00:49, 6.31 m Surface damage, corrosion products from 3 o'clock to 9 o'clock, start, rust

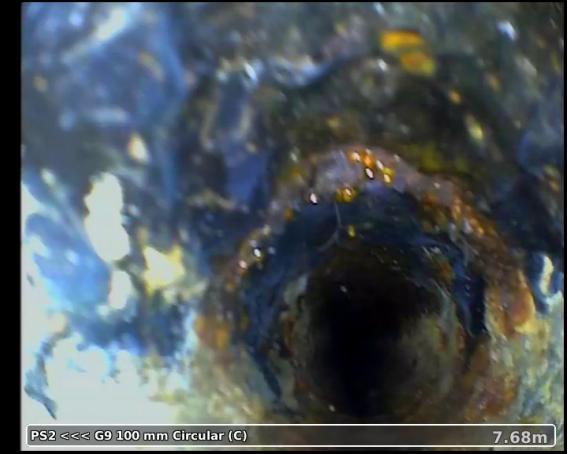
G9X_ec861d1f-6ea2-4040-ae0e-7495884a3066_20240314_1 13418_970.jpg, 00:00:55, 7.68 m Attached deposits, other from 3 o'clock to 9 o'clock, 5% cross-sectional area loss, start, rust

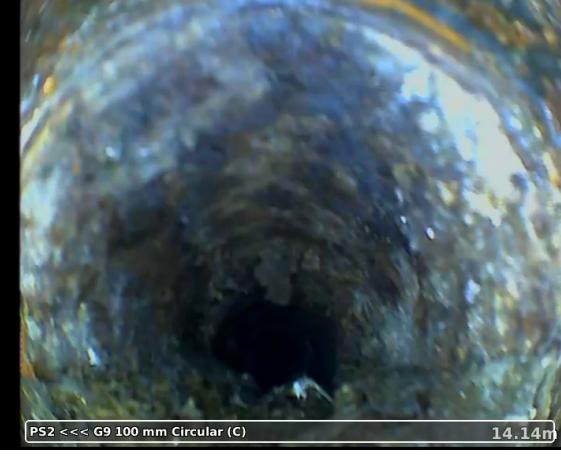
G9X_8ba8ea85-0c82-4a51-9dce-dd1f8d41a8f3_20240314_11 2845_495.jpg, 00:01:38, 14.14 m Attached deposits, other from 12 o'clock to 12 o'clock, 15% cross-sectional area loss, rust

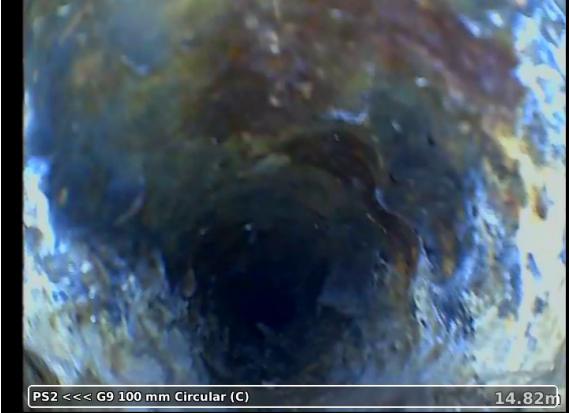
G9X_1836089f-fa55-4f23-86d8-3ead5427c59d_20240314_11 3444_049.jpg, 00:01:48, 14.82 m Attached deposits, other from 3 o'clock to 9 o'clock, 5% cross-sectional area loss, finish, rust

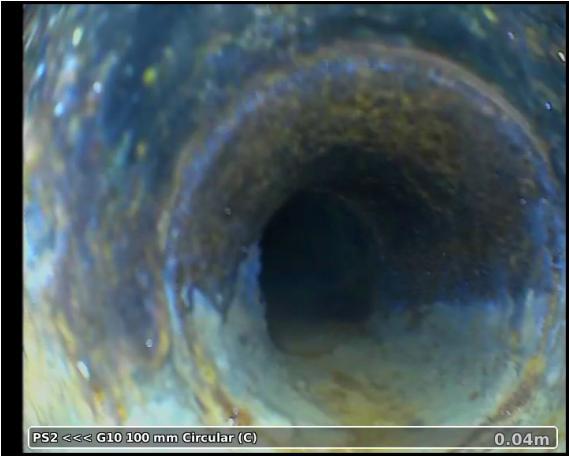
G10X_b4ab0cd9-77e9-4ed6-9eaa-721a4bf0d418_20240314_ 114651_698.jpg, 00:00:13, 0.04 m Surface damage, corrosion products from 12 o'clock to 12 o'clock, rust

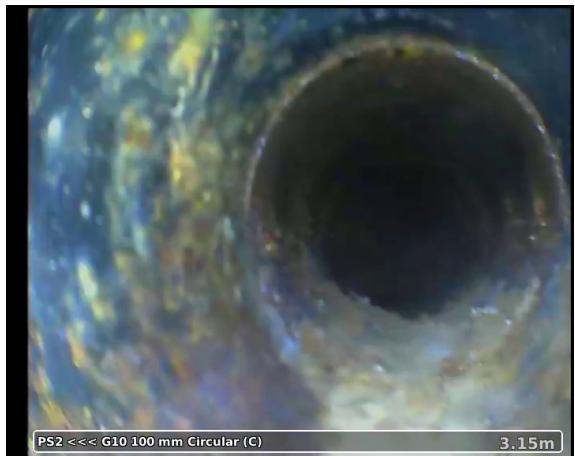
G10X_a13f95ad-a369-429d-922a-e6cce53b631a_20240314_ 114259_751.jpg, 00:00:30, 3.15 m Attached deposits, other from 4 o'clock to 9 o'clock, 10% cross-sectional area loss, rust

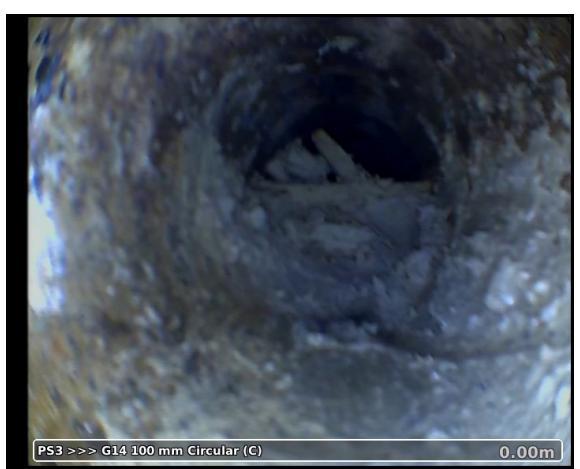
G14X_138b4686-fe15-44a5-9236-90f6b4b6ff48_20240314_1 30634_433.jpg, 00:00:07, 0.10 m Settled deposits, coarse, 75% cross-sectional area loss

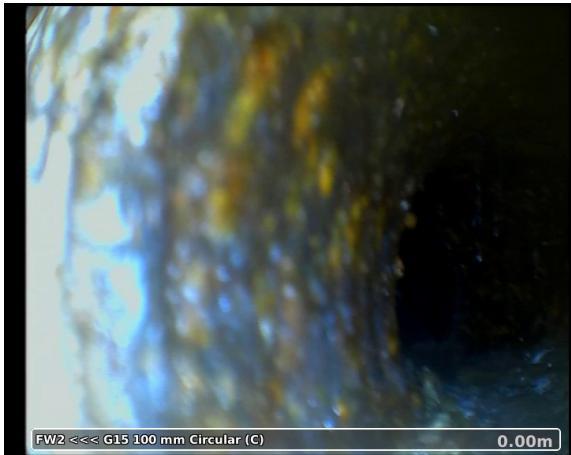
G15X_271d15ad-0d33-4f7f-805c-a734677c1be1_20240314_1 32510_254.jpg, 00:00:05, 0.00 m Surface damage, corrosion products from 12 o'clock to 12 o'clock, start, rust

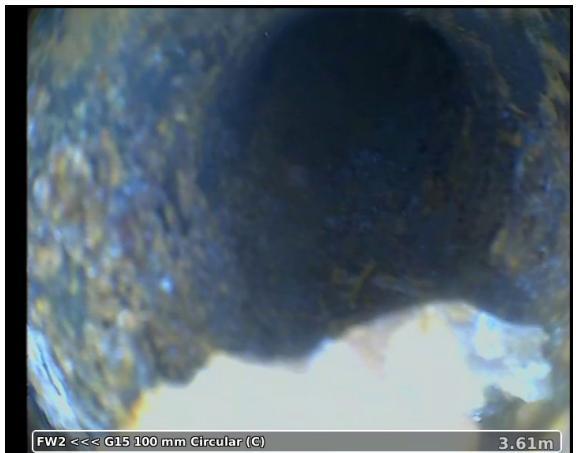
G15X_8c06bd60-837e-42c6-a65d-4e23570d614e_20240314_ 132539_547.jpg, 00:00:29, 3.61 m Surface damage, corrosion products from 12 o'clock to 12 o'clock, finish, rust

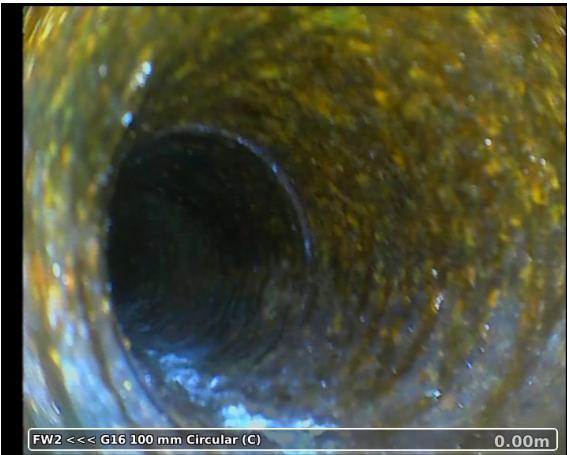
FW2AX_73906fd4-1a7b-4e96-89f6-7d1fb7850fde_20240314_ 132706_402.jpg, 00:00:05, 0.00 m Surface damage, corrosion products from 12 o'clock to 12 o'clock, start, rust

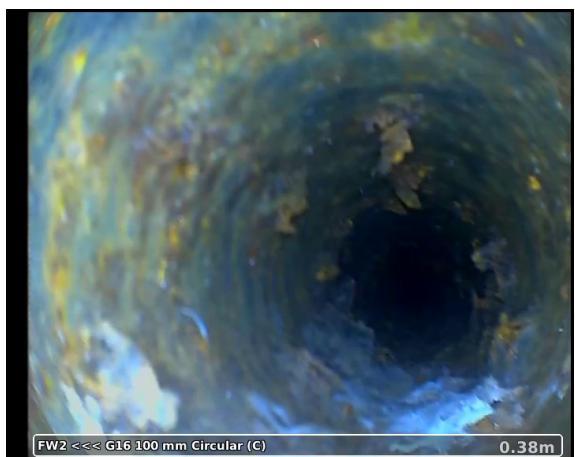
FW2AX_3fb2f957-fe54-4334-ab2d-8aaf3fe52ab6_20240314_ 132941_966.jpg, 00:00:08, 0.38 m Attached deposits, other from 12 o'clock to 12 o'clock, 10% cross-sectional area loss, start, rust

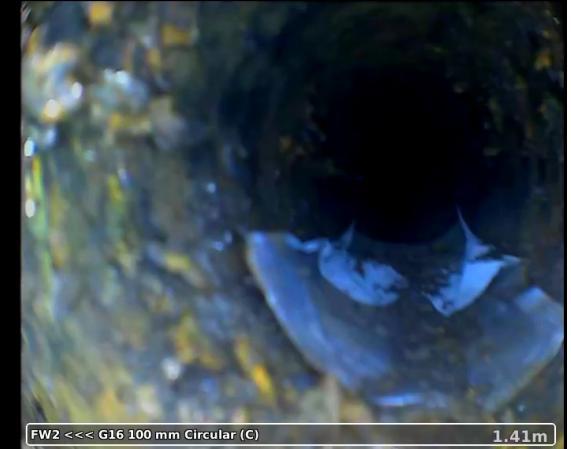
FW2AX_c7d75daa-197d-48a8-ae77-da34bc505241_2024031 4_133042_900.jpg, 00:00:14, 1.41 m Attached deposits, other from 12 o'clock to 12 o'clock, 10% cross-sectional area loss, finish, rust

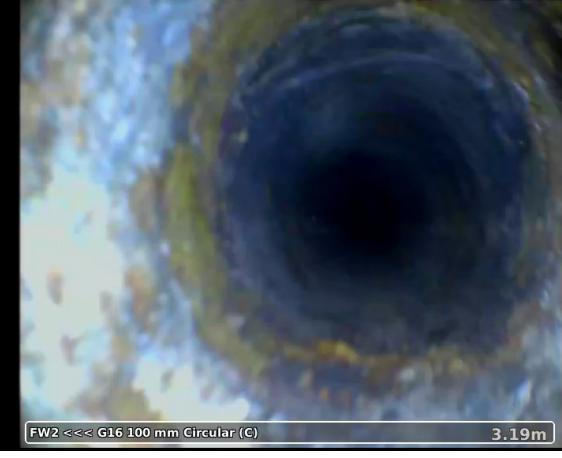
FW2AX_08eee839-7aea-4334-bfbf-1d07fd118a9a_20240314 _132751_519.jpg, 00:00:21, 3.19 m Surface damage, corrosion products from 12 o'clock to 12 o'clock, finish, rust

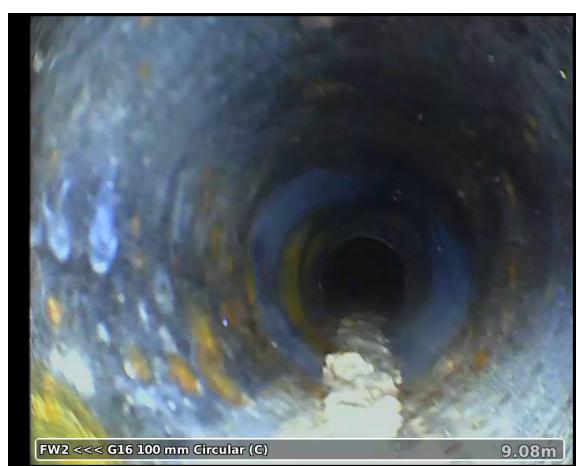
FW2AX_4ae88d00-d077-4593-9070-d29bf6cff742_20240314 _132850_958.jpg, 00:00:43, 9.08 m Settled deposits, coarse, 5% cross-sectional area loss

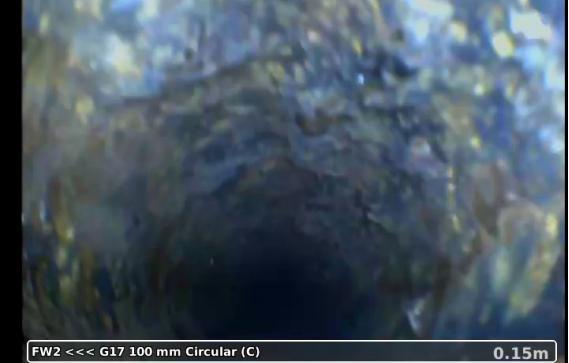
G17X_327645fe-7bd0-45c8-94bf-8f2375d4ff41_20240314_13 4043_615.jpg, 00:00:07, 0.15 m Attached deposits, other from 12 o'clock to 12 o'clock, 5% cross-sectional area loss, start, rust

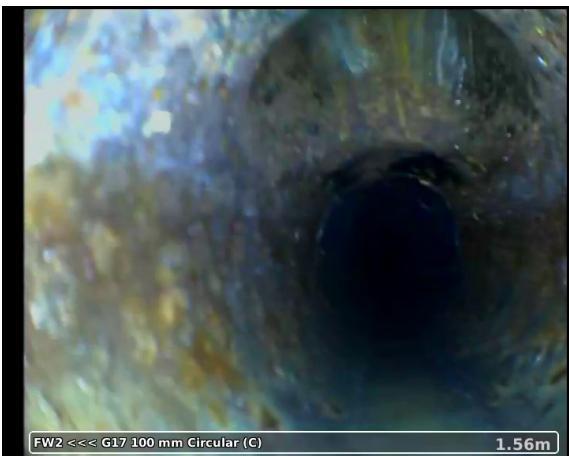
G17X_d9cadae8-3f81-41ed-867d-e246e5e47963_20240314_ 134120_228.jpg, 00:00:14, 1.48 m Attached deposits, other from 12 o'clock to 12 o'clock, 5% cross-sectional area loss, finish, rust

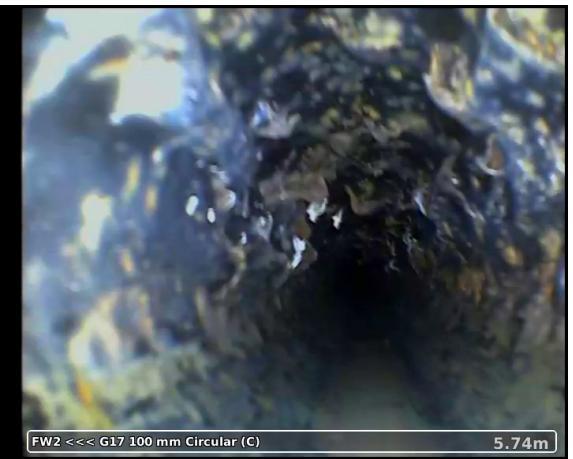
G17X_65ca1d92-2dcb-4d60-ac8e-b786008c2b4d_20240314_ 134850_883.jpg, 00:00:34, 5.74 m Deformed drain or sewer, 15%, start

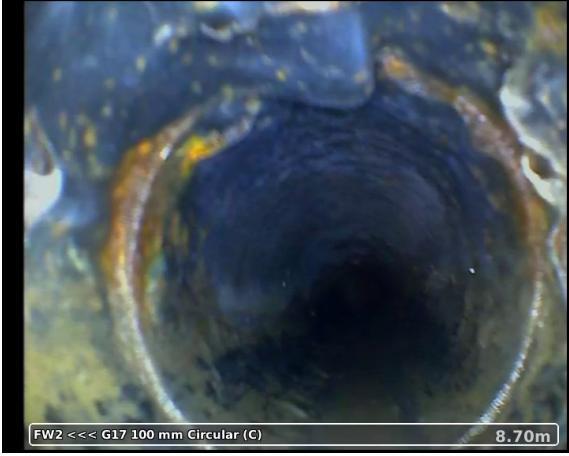
G17X_01c36cf5-79e7-4e58-90ac-06e73b206184_20240314_ 134914_611.jpg, 00:00:48, 8.70 m Deformed drain or sewer, 15%, finish

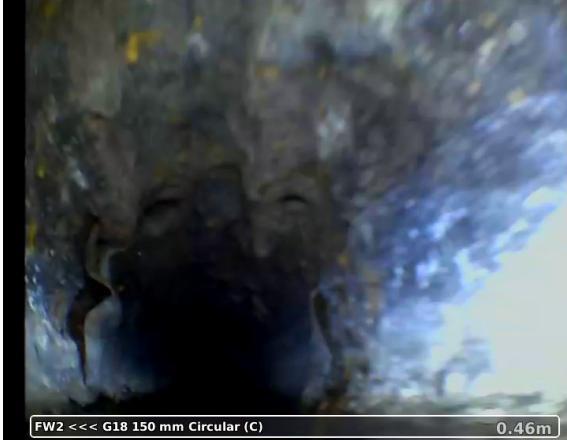
G18X_1e4720c3-80c9-4bd2-a2fe-ad7183785ebe_20240314_ 135259_222.jpg, 00:00:07, 0.46 m Attached deposits, other from 12 o'clock to 12 o'clock, 10% cross-sectional area loss, start, rust
 FW2 <<< G18 150 mm Circular (C)</th>
 2.20m
