CTC Reference	e: 15081	Report Date: 08/09/202	22					
Client: Client Ref:	Rafael Monroy n/a							
Property:	104 Haverstock Hill, London, NW3 2BD	Local Authority: LB Cam	den					
Mortgage Len Reference: N/	Mortgage Lender: Reference: N/A							
Scope of Report: To survey and assess a large holm oak and other vegetation in the front garden of 104 Haverstock Hill and determine whether it could potentially affect the property; specifically to assess the risk of damage or injury to persons or property. This includes indirect damage due to clay shrinkage subsidence by the abstraction of soil moisture or direct damage by mechanical failure of the physical action of aerial parts or the roots.								
Consultant:Bruce BlackmanQualifications:BSc Landscape Management, ISA Certified Arborist, City and Guilds Arboriculture LANTRA PTIQuality Checked:Bruce Blackman BSc, Cert Arb, LANTRA PTI,

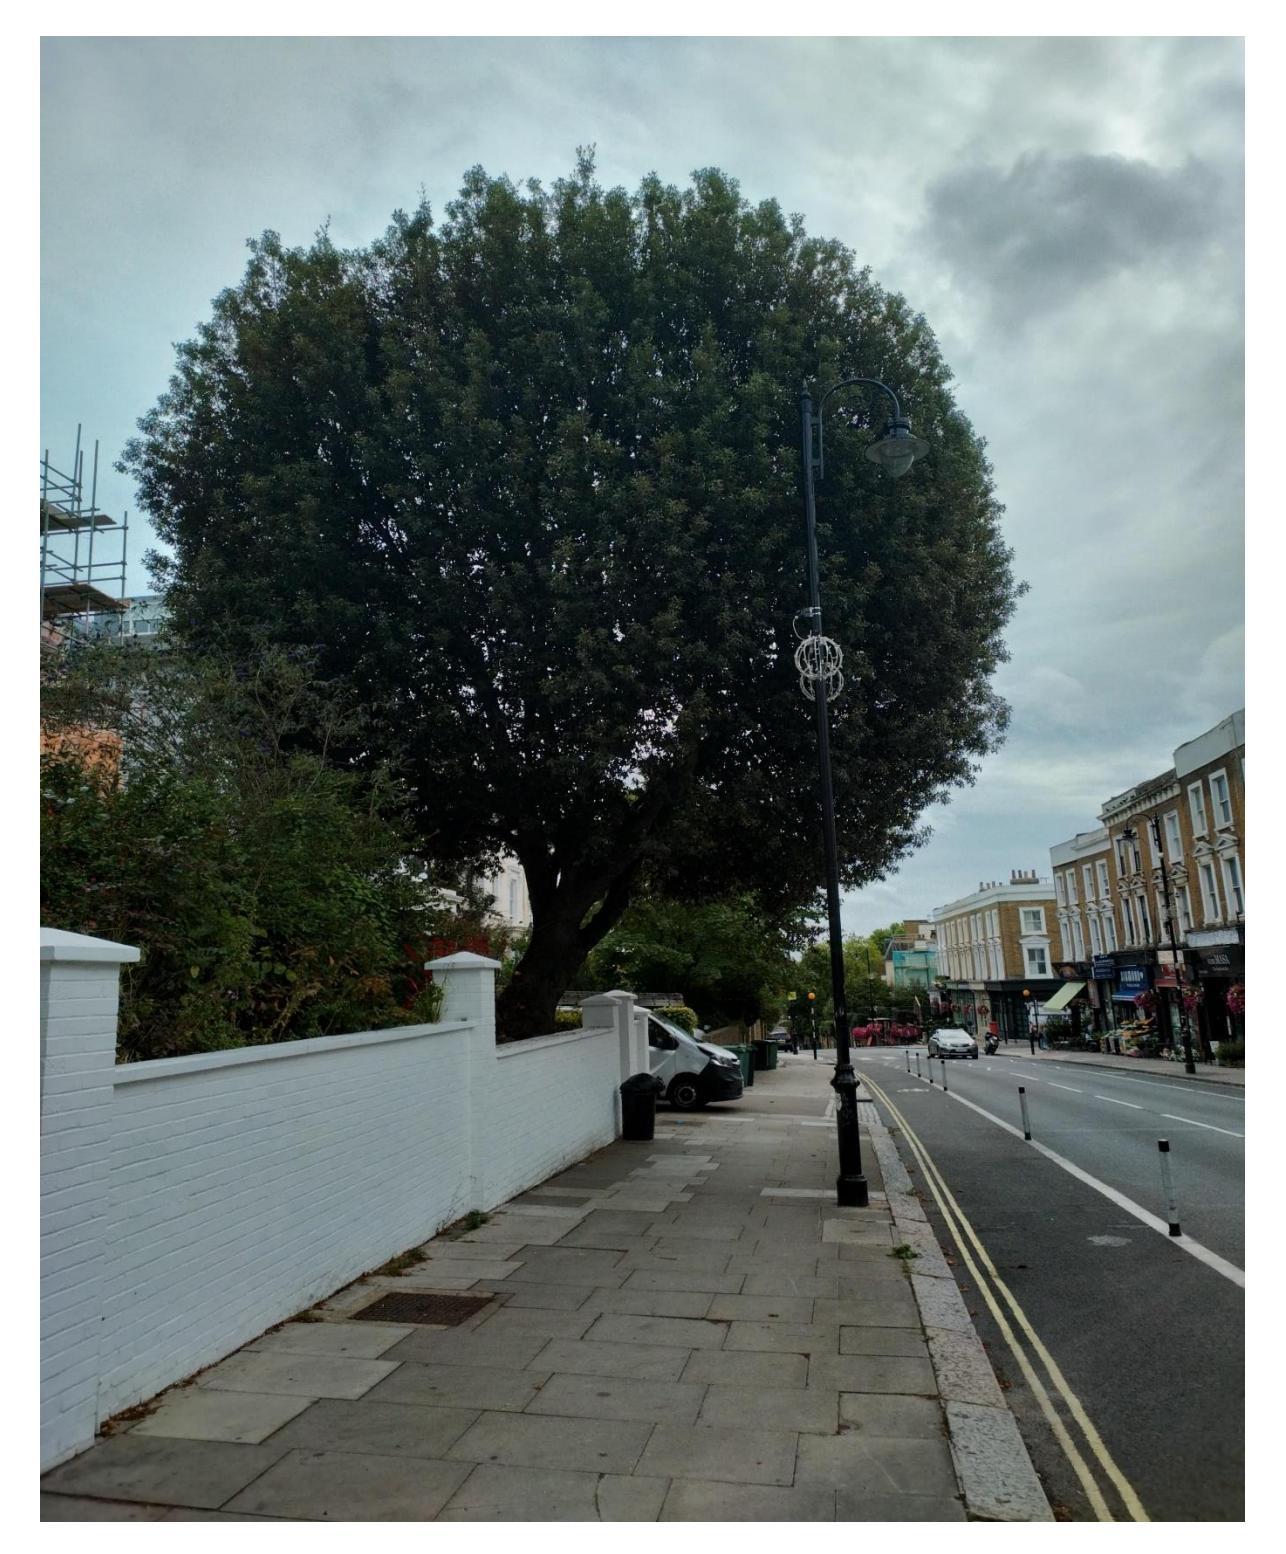
<u>Photo 1</u> – T73 Holm oak

Tree No.	Species	Age Class	Approx. Height (m)	Dia. (DBH)	Condition	Growth Potential	Dist. to Building (m)	
73	Holm oak (Quercus ilex) (Photo 1)	М	19M	62	Fair	Low	1230cm (house) 7cm (new wall) 360cm (gate pier)	
Targe	ets:	Road, wall, garden,						
Defe	cts:	Crown: to Stem: lea Roots: no	oo large for ining toward o defects vis	site, grov 1s road, sible,	ving into lig	ght,

Tree No.	Species	Owner- ship	Priority	Protection	Pruning Cycle (yrs)	Recommendation	Indicative cost
73	Holm oak	С	2	TPO	2	Crown reduce by 3m	£950
SG1	Mixed species	C	2	CA	1	Remove all shrubs within 2m of house. Trim remainder	£150
SG2	Mixed species	C	2	CA	1	Remove all shrubs within 2m of house. Trim remainder	£150
SG3	Mixed species	C	2	CA	1	Remove all shrubs.	£500

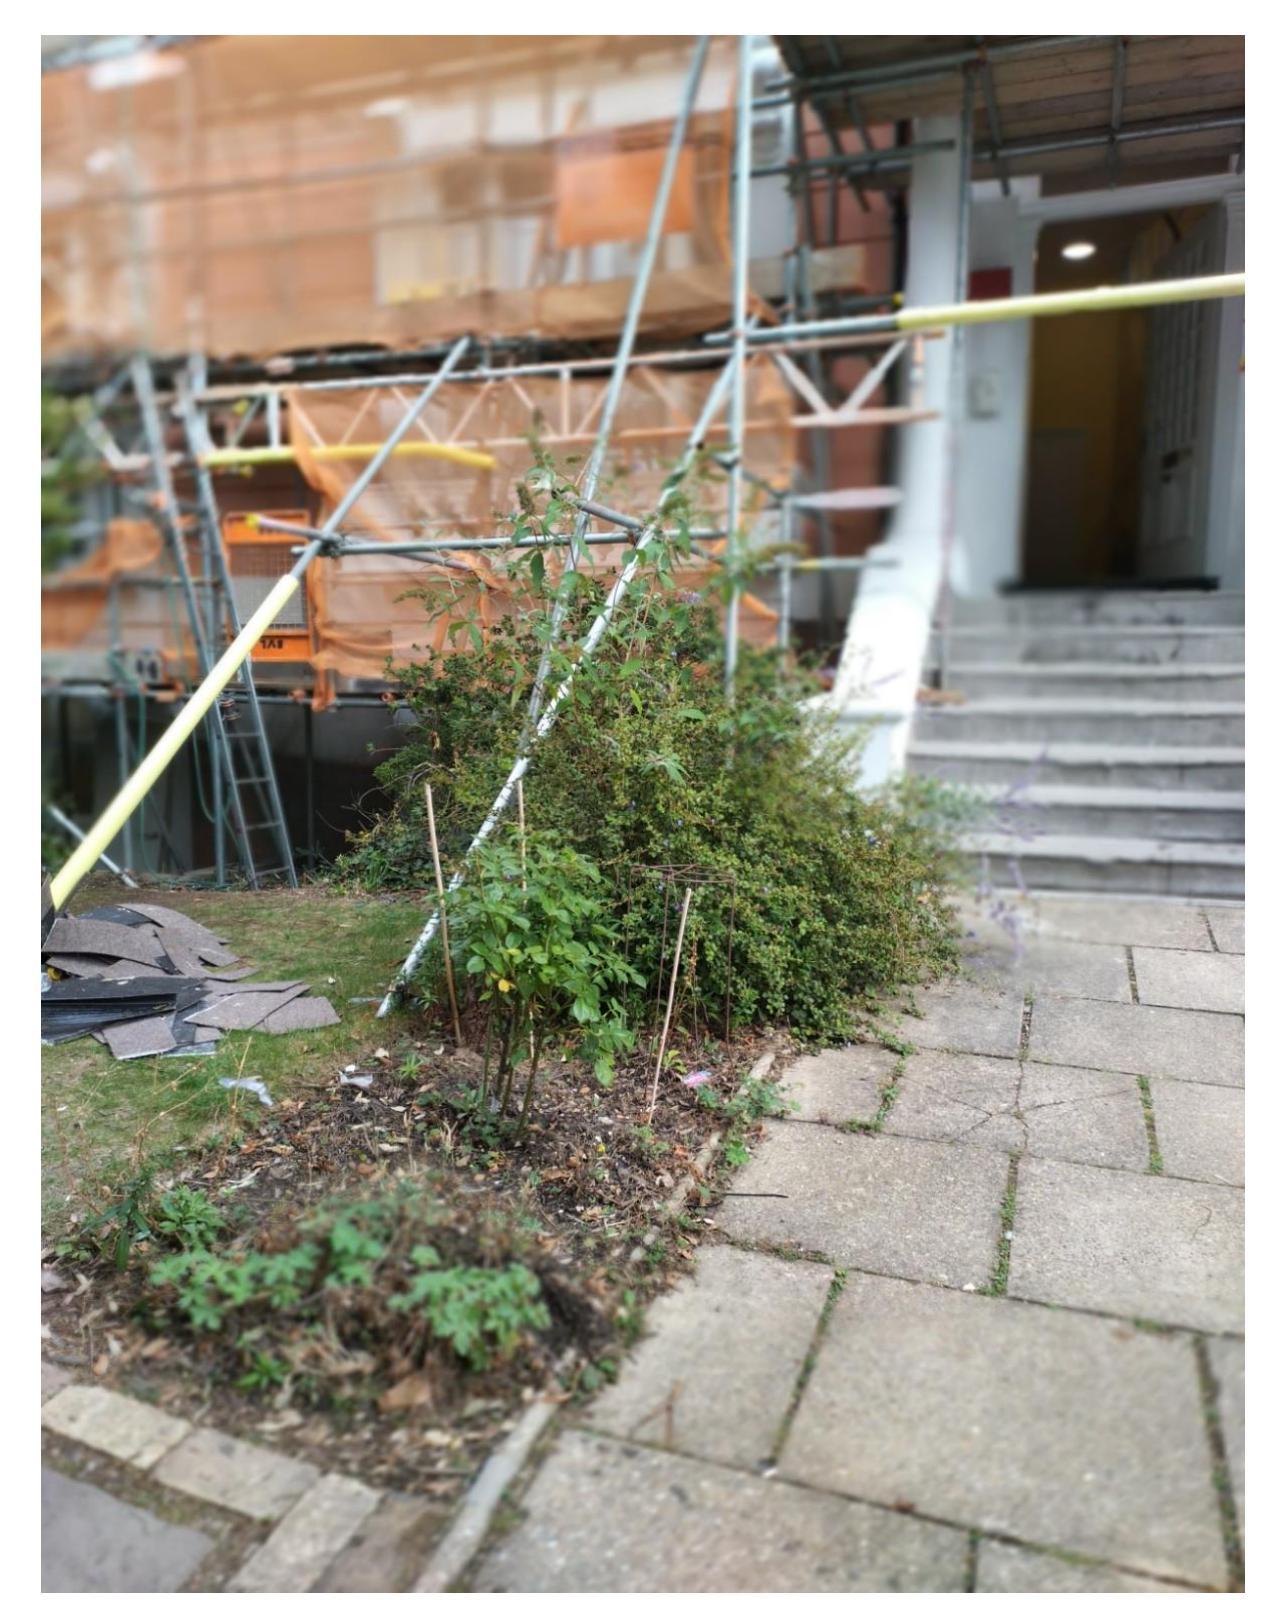
<u>Photo 2</u> – SG1

Tree No.	Species	Age Class	Approx. Height (m)	Dia. (DBH)	Condition	Growth Potential	Dist. to Building (m)
SG1	Mixed species (Hebe/ Euonymous/ Cotoneaster) (Photo 2)	М	1M	5	Fair	Medium	230cm (house)
Targets:		Road, wa	all, garden,				
Defects:		No defec	ts visible

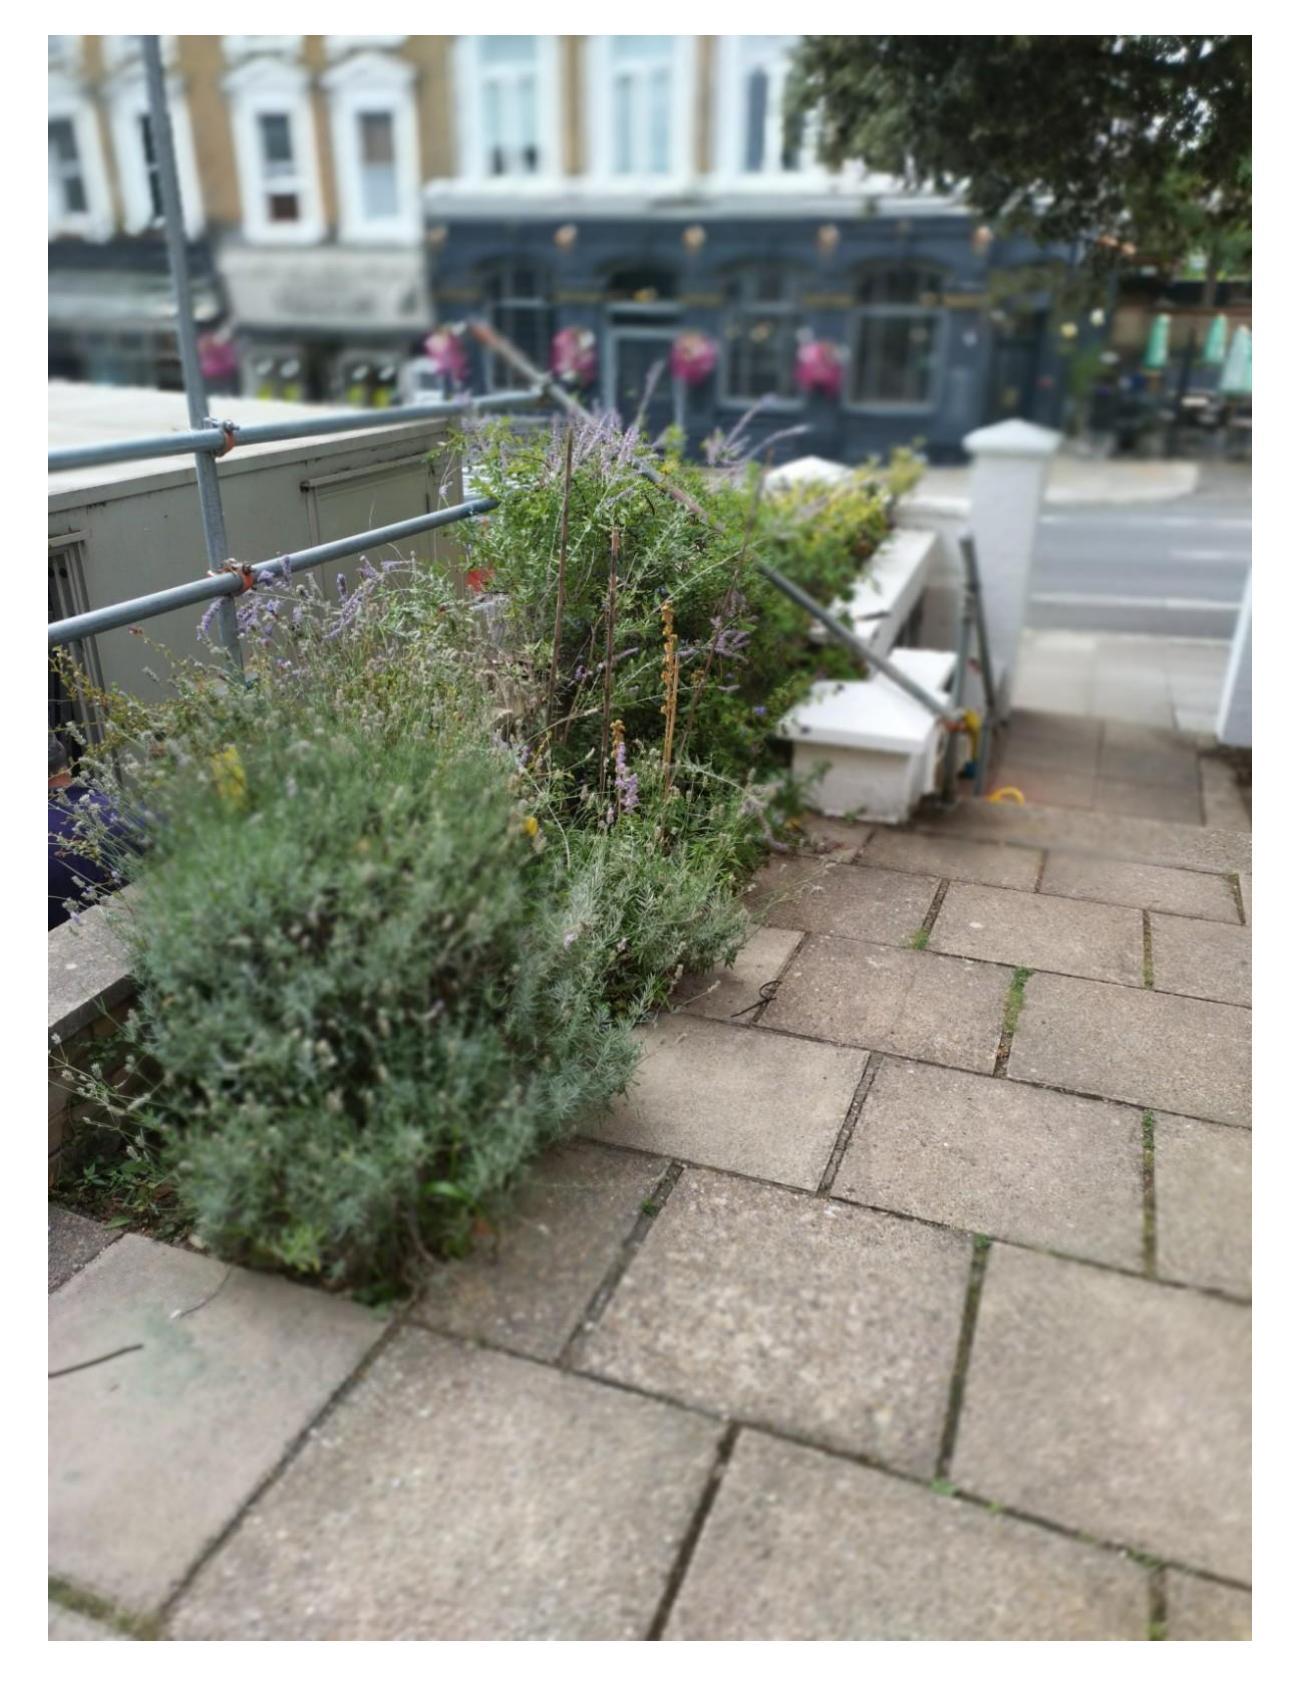
<u>Photo 3</u> – SG2

Tree No.	Species	Age Class	Approx. Height (m)	Dia. (DBH)	Condition	Growth Potential	Dist. to Building (m)
SG2	Mixed species (Lavender/ Euonymous) (Photo 3)	М	1.5M	5	Fair	Medium	520cm (house)
Targets:		Road, wa	ull, garden,				
Defects:		No defec	ts visible

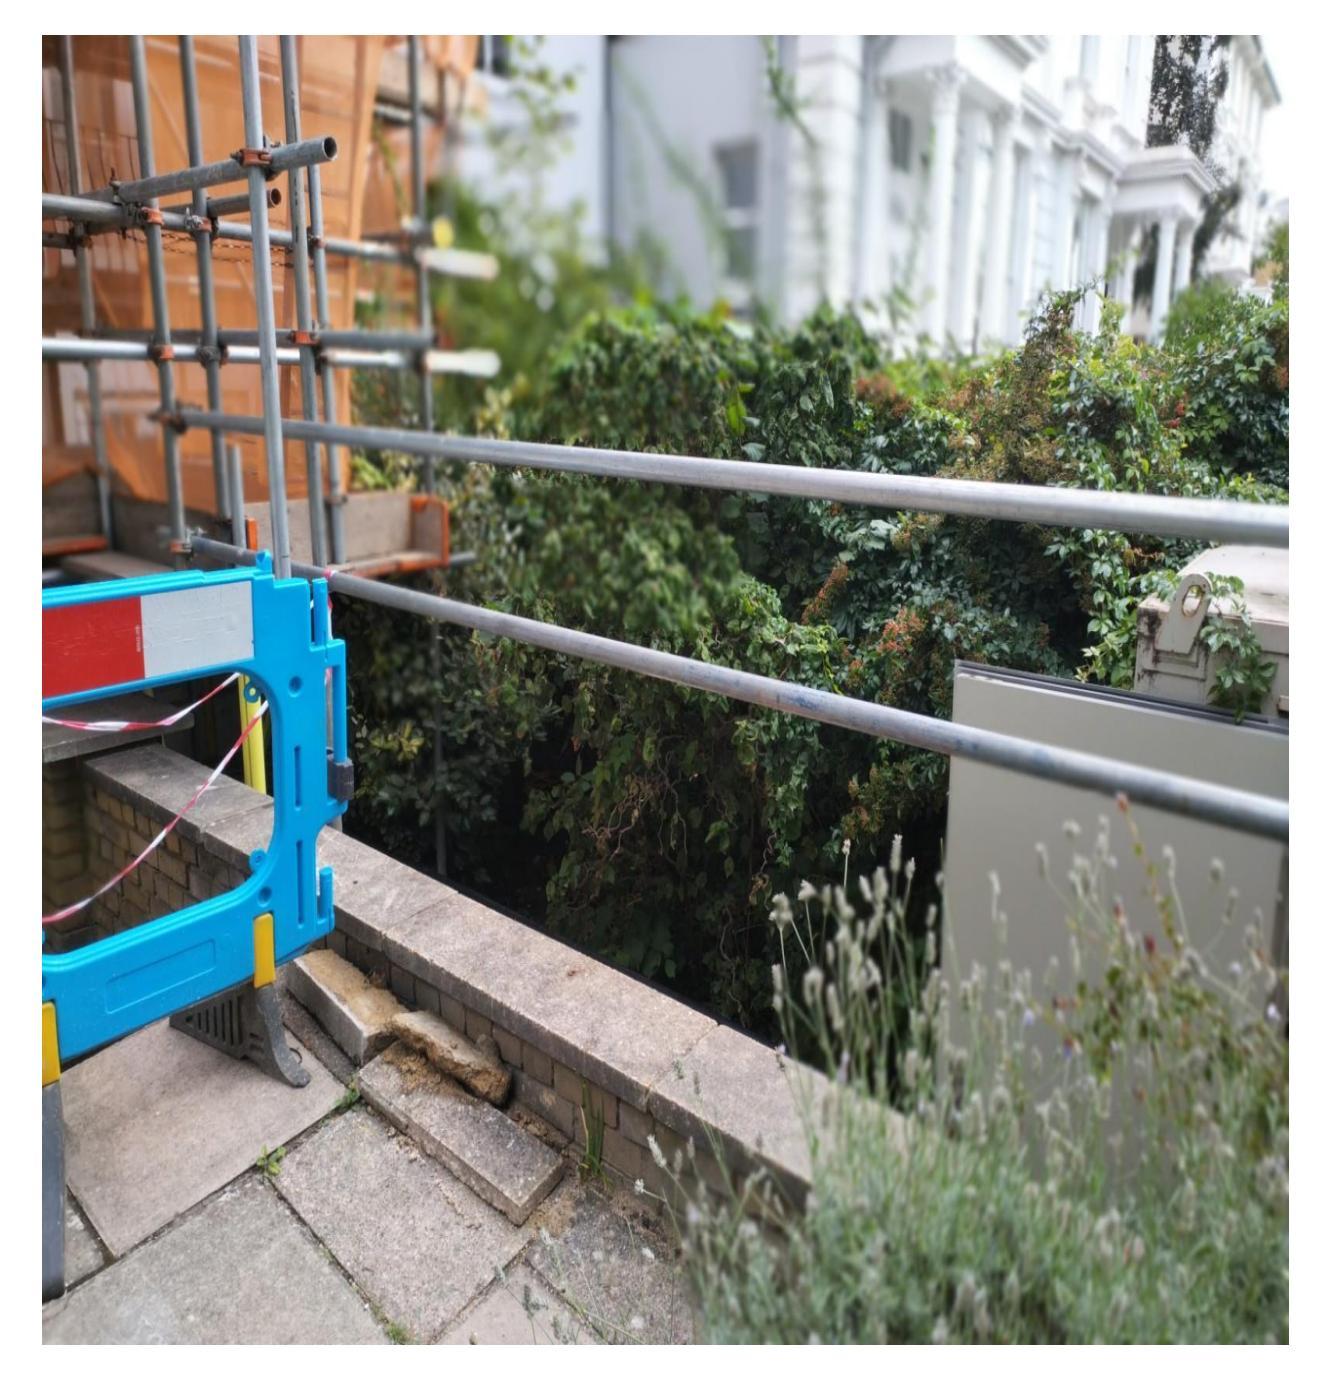
<u>Photo 4</u> – SG3

Tree No.	Species	Age Class	Approx. Height (m)	Dia. (DBH)	Condition	Growth Potential	Dist. to Building (m)	
SG3	Mixed species (Corkscrew hazel, Forsythia/ Mahonia, Ivy) (Photo 4)	М	3.5M	5-10	Fair	Medium	260cm (house)	
Targets:		Road, wall, garden,						
Defects:		Crown: too large, obstructing path

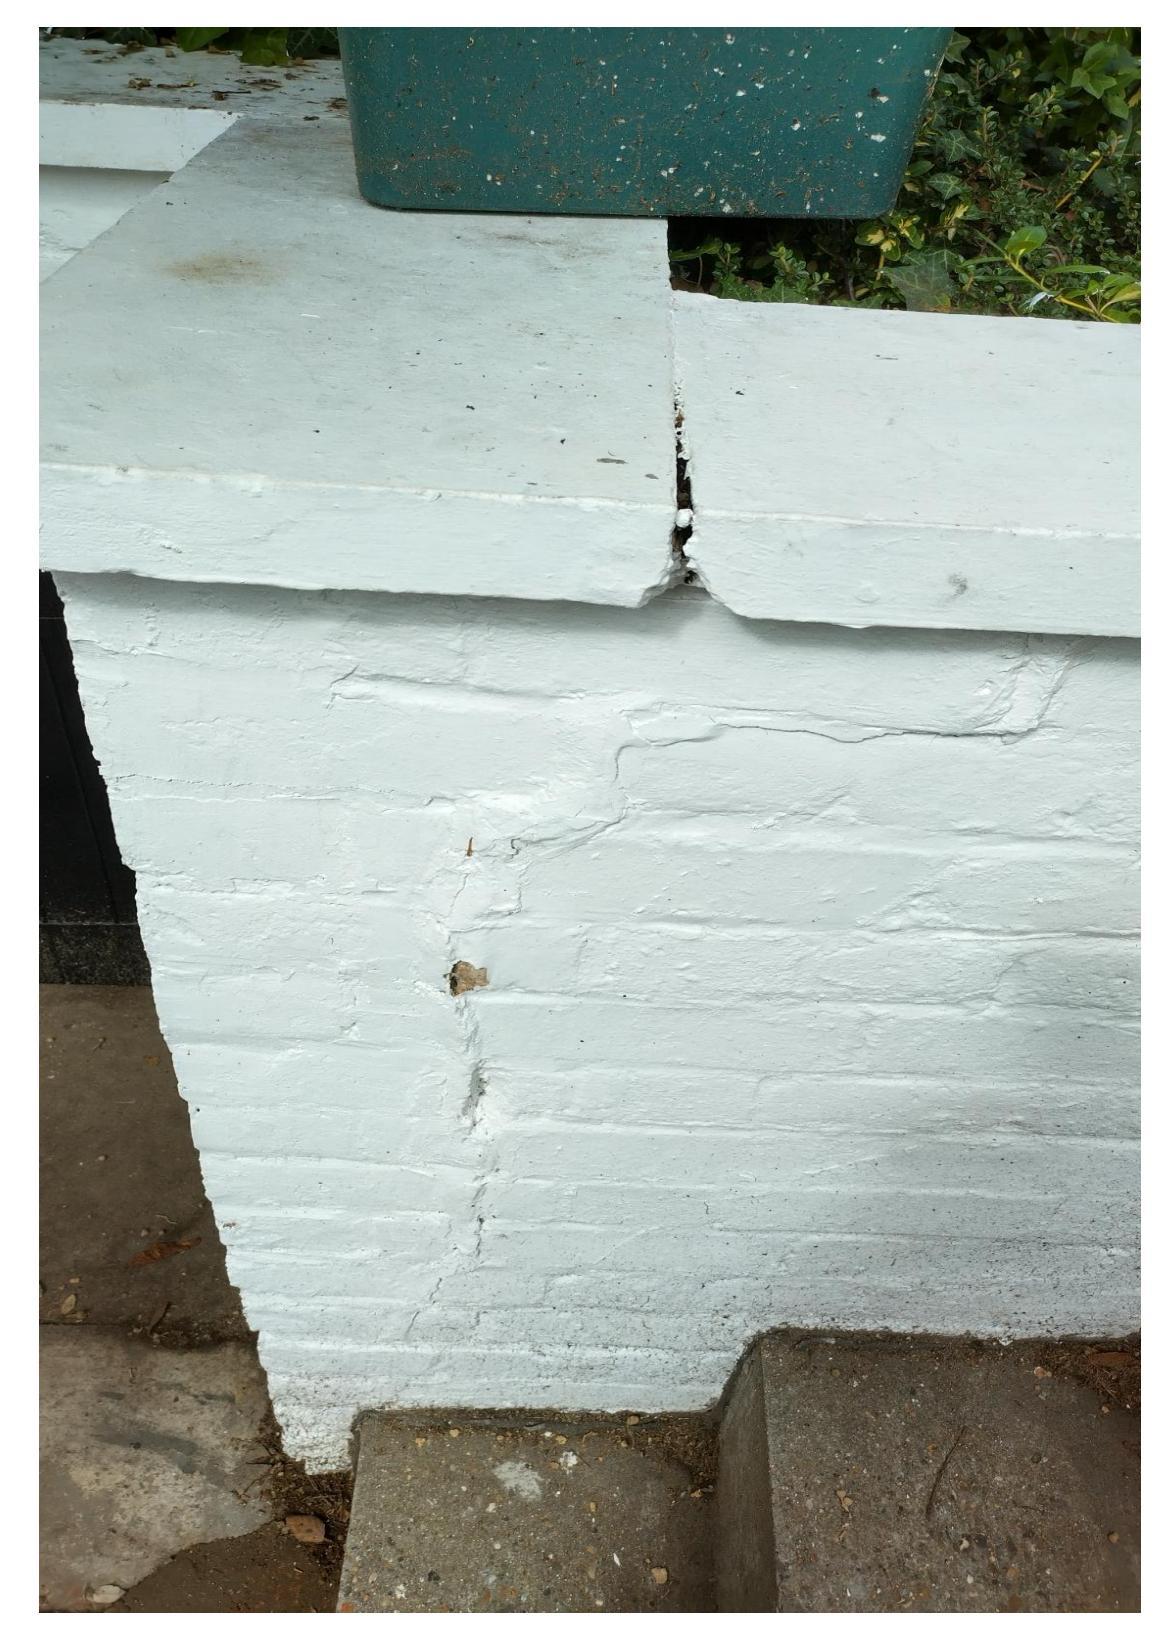
- Cracking to front garden walls, but not the new front boundary wall (Photo 5),
- Cracking to right side gate pier to boundary wall (Photo 6),
- Surface damage/cracks (Photo 7),
- Damage to front portico and steps (Photo 8 and 9),

The pattern of damage is consistent with volumetric changes in the soil. The cracks to the walls and surfaces could be resulting from differential downwards movement. The movement of the portico and stairs away from the building is typical of subsidence damage where there are differing depths of foundations again resulting in differential movement.

Based on the information above I would conclude that the damage to the walls and front of the house (steps and portico) is likely to have been caused by the indirect action of roots (subsidence). Due to the proximity, size and water demand of the Holm oak this is likely to be the primary cause. SG3 is also likely to be contributing due to its close proximity and the large size of shrubs.

<u>Photo 5</u> – Wall damage 1

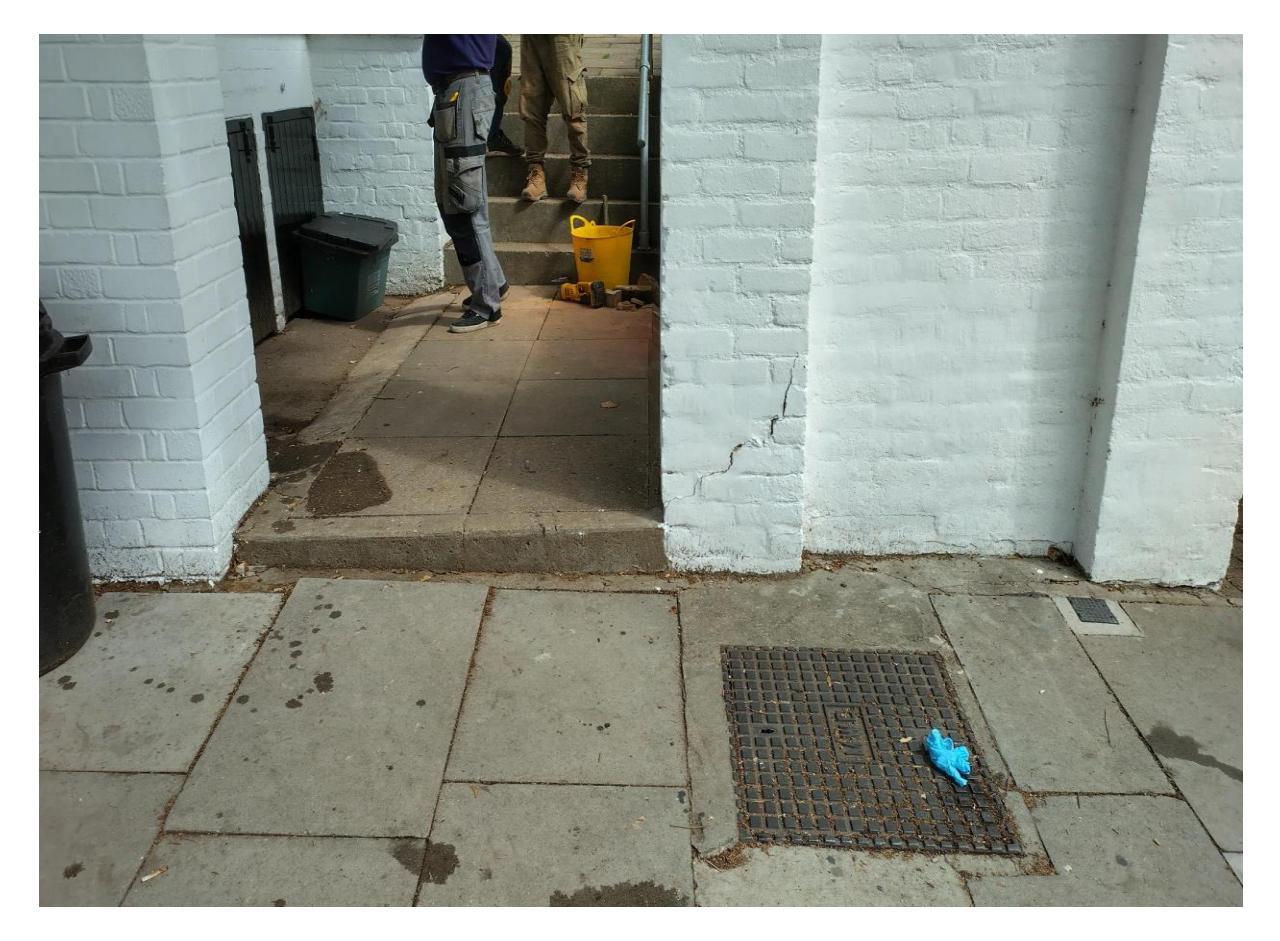
<u>**Photo 6**</u>– Wall damage/gate pier (2)

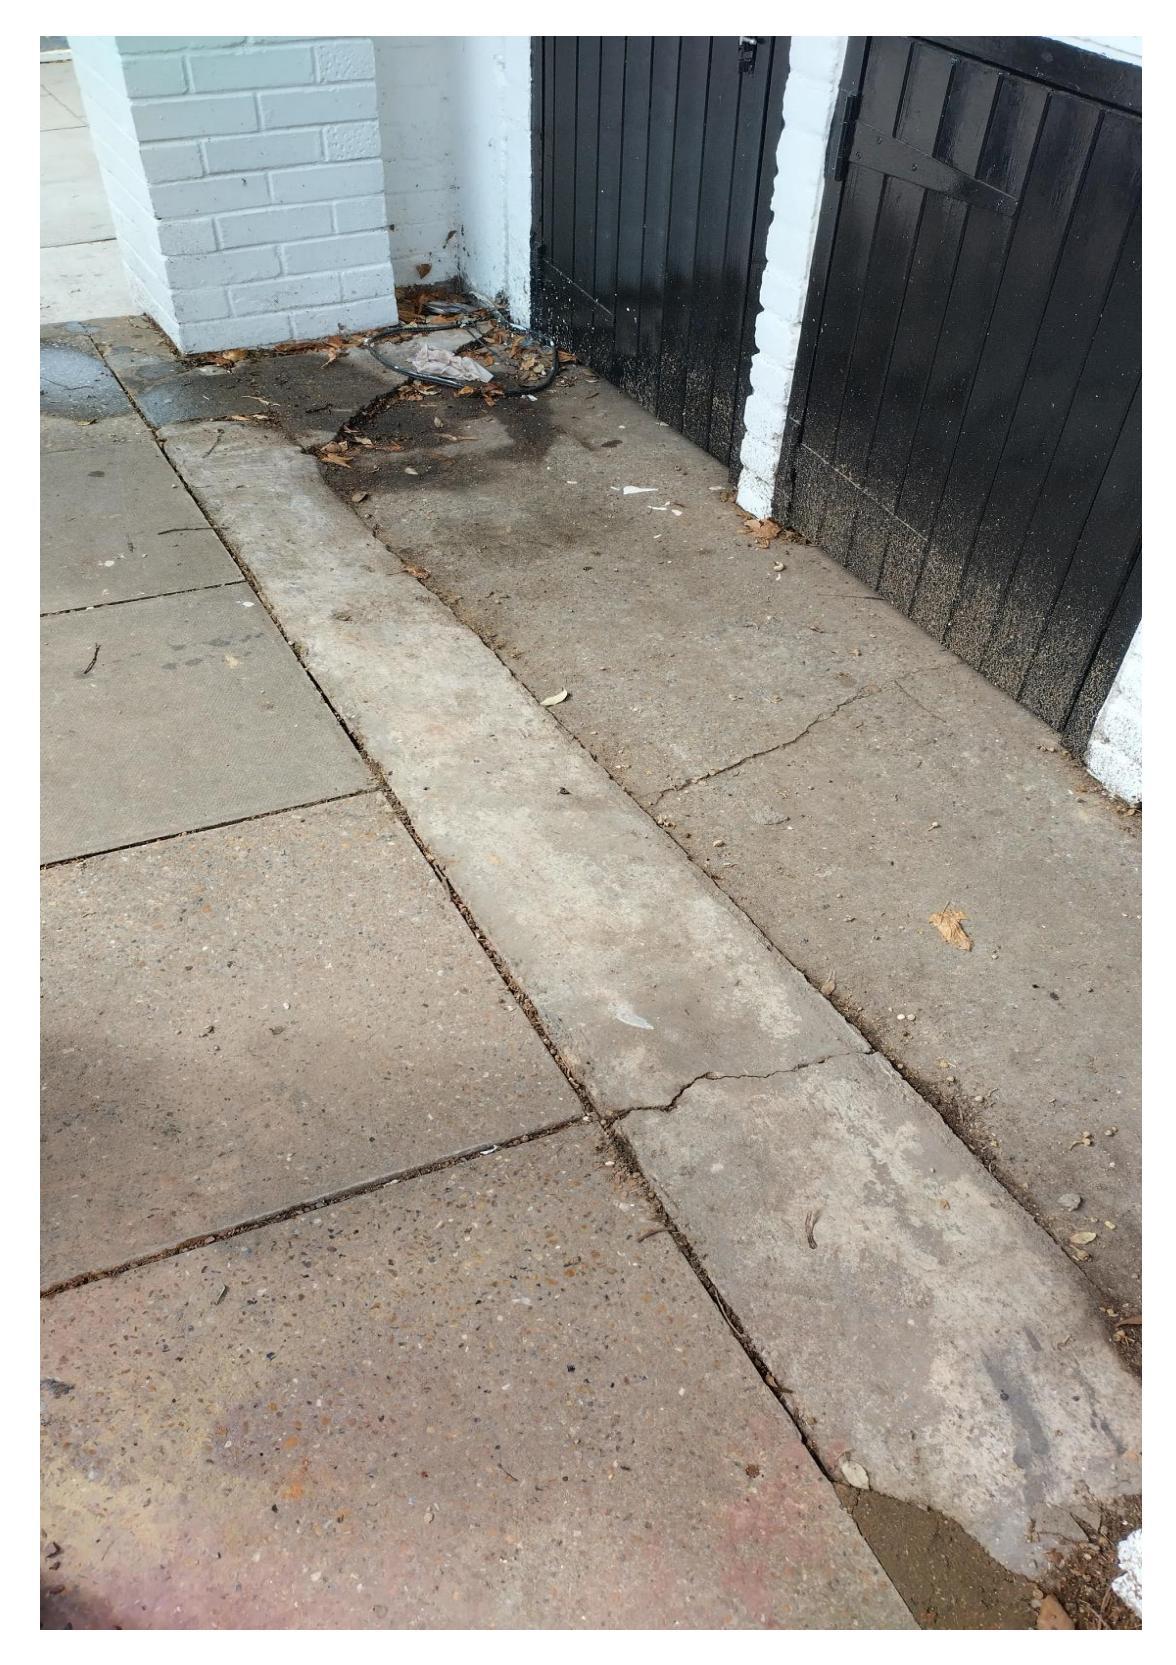
Photo 7 - Surface damage

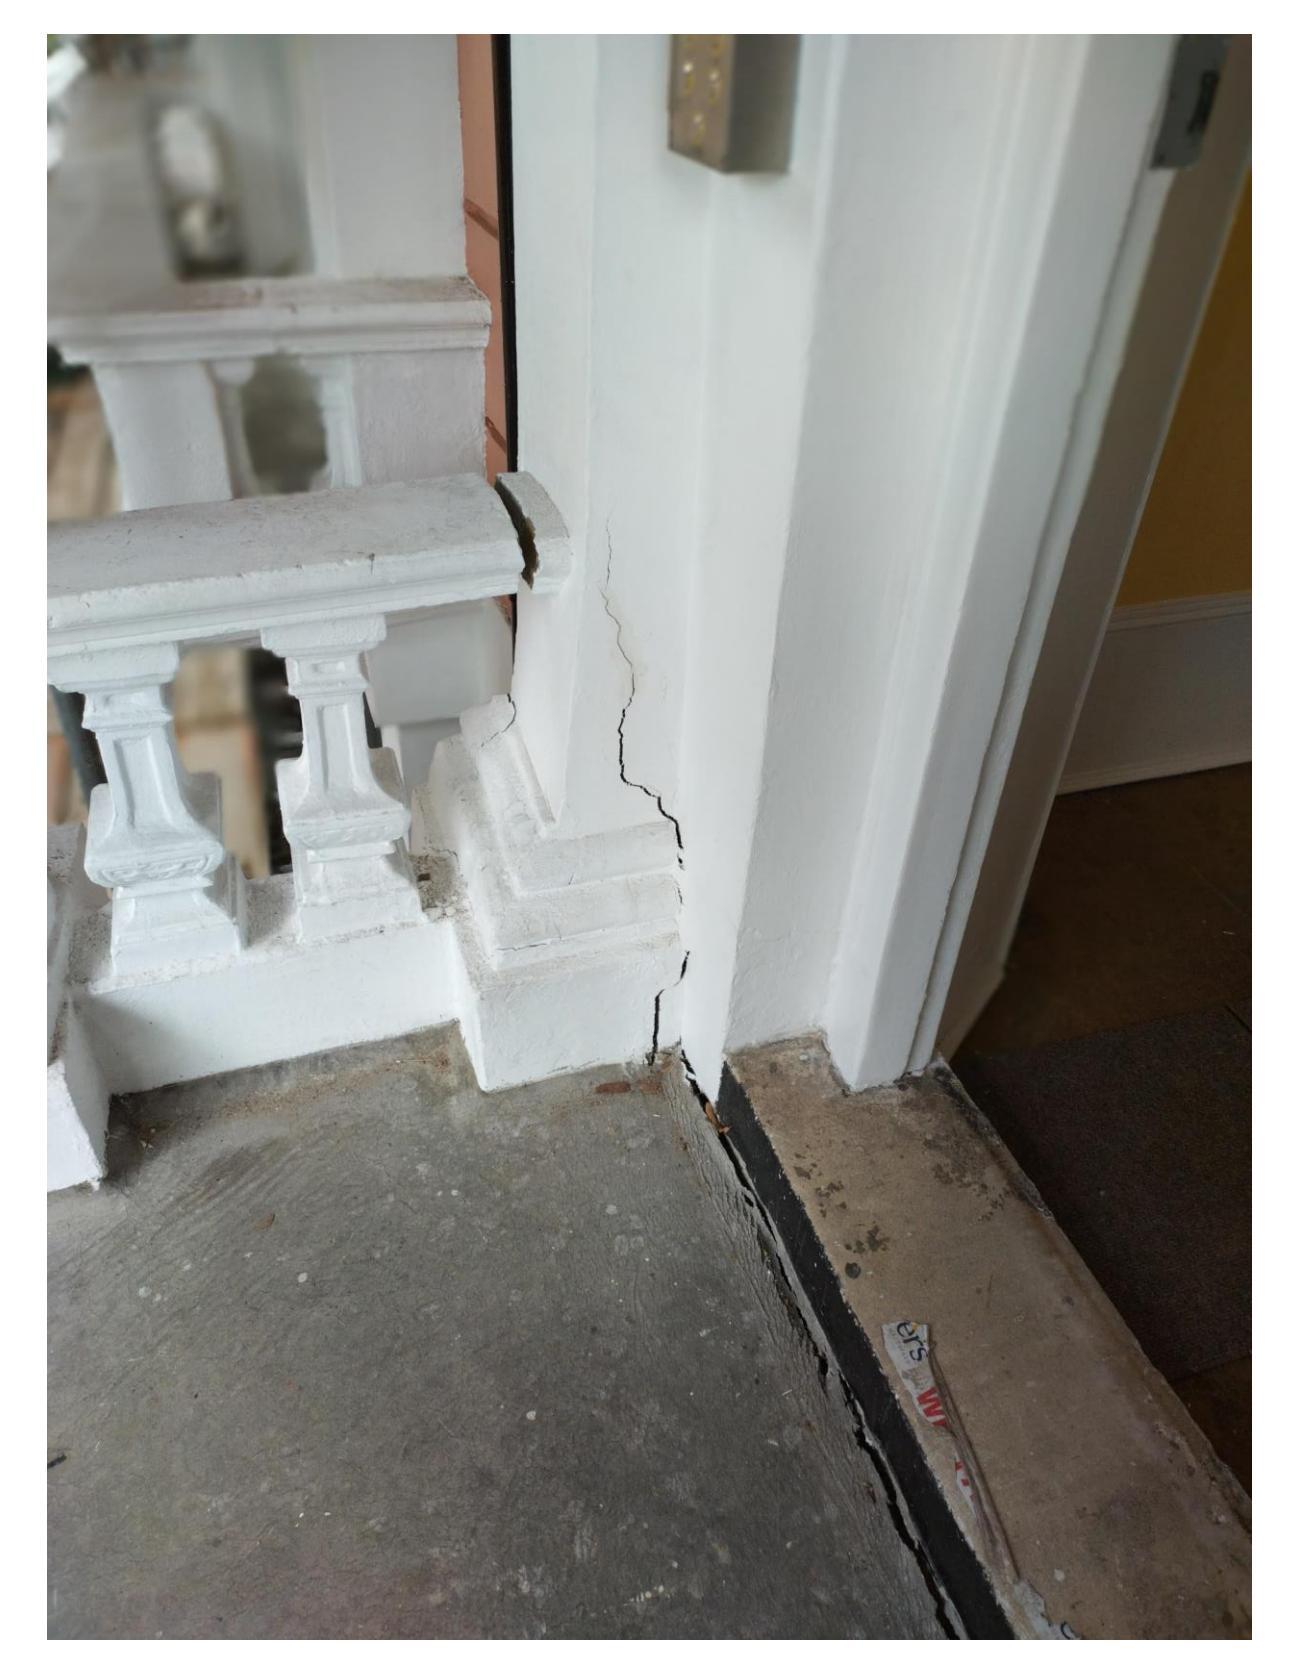
<u>Photo 8</u> – Portico Damage

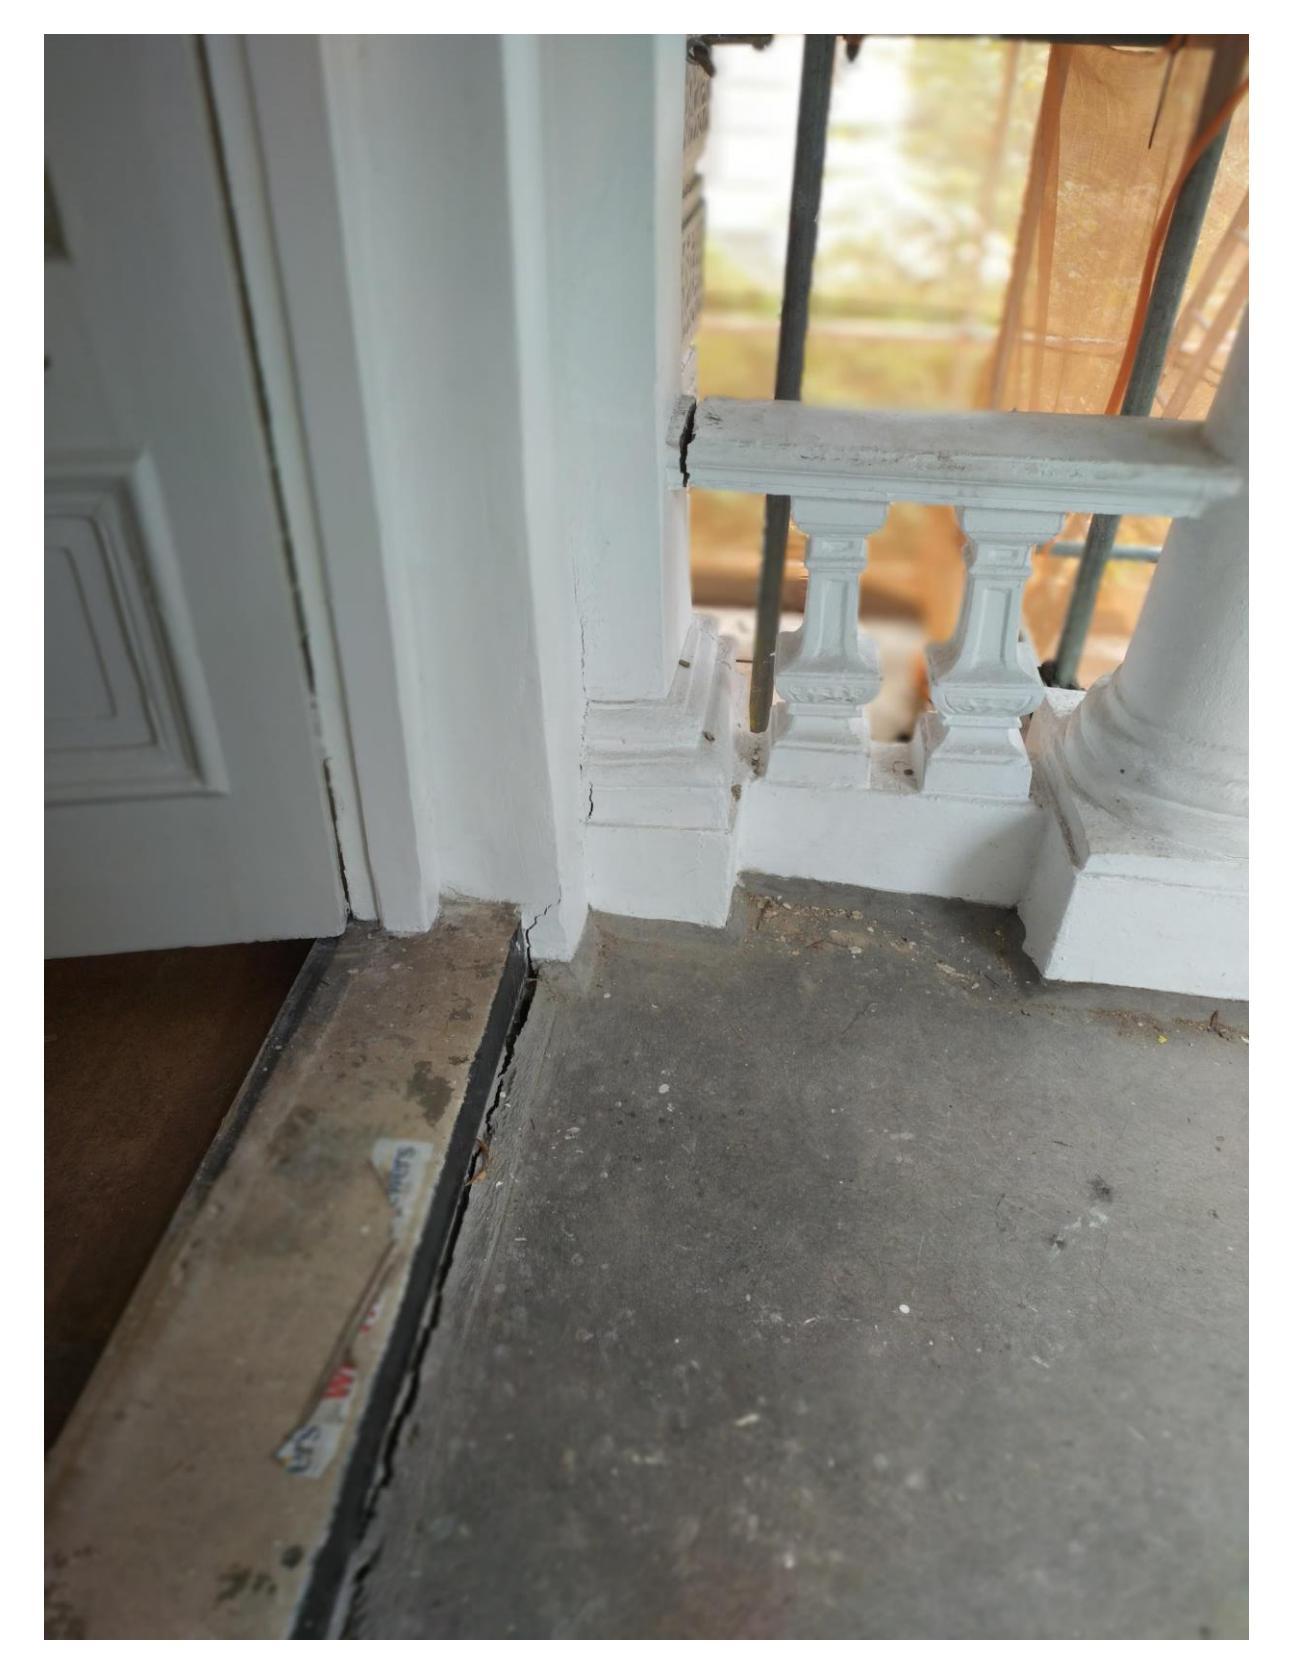
<u>**Photo 9**</u> – Step damage
