1.1.1. We are instructed to detail the tree protection and site monitoring for the approved development at 51 Argyle Street, London, WC1H 8EF. Planning Permission reference 2021/4281/P has been granted subject to the following planning condition relating to tree protection.

## Kings Cross Neighbourhood Centre at 51 Argyle Street London WC1H 8EF.

Update to tree survey 6<sup>th</sup> March 2025.

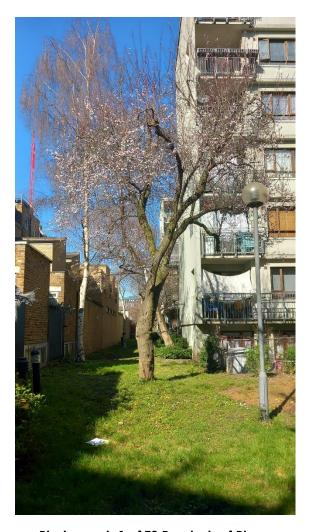
- 5.1.1. The site was visited on 6<sup>th</sup> March 2025 to reinspect the trees and update the tree survey. At this time fungal brackets of *Ganoderma* were noted on the trunk of tree 2 (Purpleleaf Plum) refer to additional notes and photographs included at the end of this report. In view of the nature of the work proposed within the RPA of this tree, in particular, the groundworks associated with the installation of the rear extension and installation of new hard surfaces, and the mode of decay of this fungus it is recommended that tree 2 is removed before any development work commences on the site. Once the development work has been completed an additional new tree can be planted to ensure the continuation of canopy caver at this property.

Photograph 1 of T2 Purple-leaf Plum.

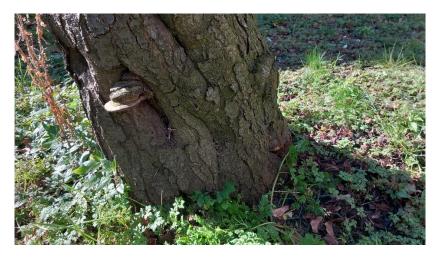
Photograph 2 showing fungal brackets of Ganoderma species on south & east sides of trunk of T2.

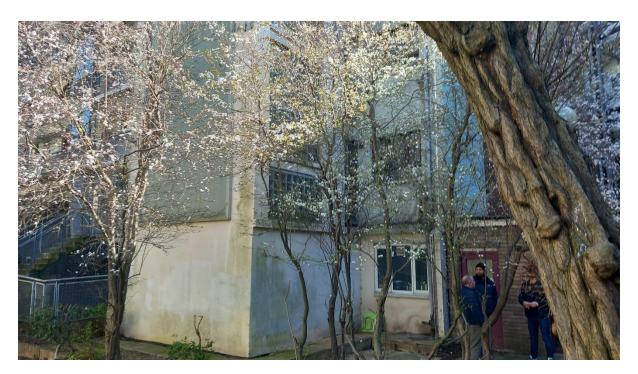
Photograph 3 showing Cherry Plum suckers adjacent to building that require removal.

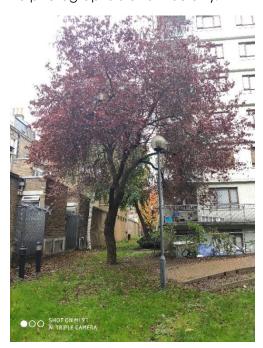
- 5.4.2. Trees 2 to 6 are considered to be of low category reflecting their small size and restricted amenity value. These trees are growing at the rear of the existing Community Centre building and so are of restricted public amenity value (refer to photographs 3 to 6 below).
- 5.4.3. Trees 7, 8 and 10 have been categorised as B2. Trees 7 and 8 are in good condition and of long-term potential and tree 10 is a prominent tree at the front of the buildings (refer to photographs 6 and 7 below).

Photograph 3 showing tree 2.

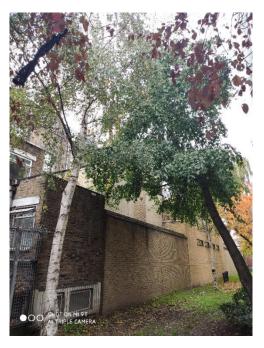
Photograph 4 showing trees 3 and 4.

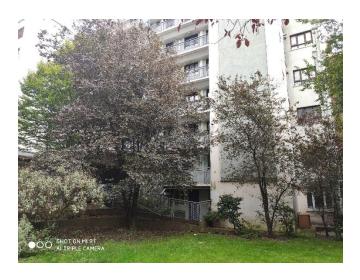
Photograph 5 showing trees 5 and 6.

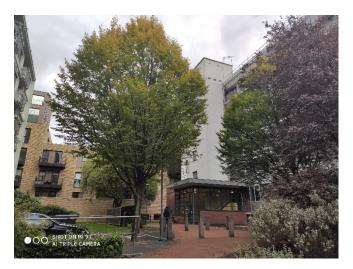
Photograph 6 showing tree 5 to right of tree 7 at centre.

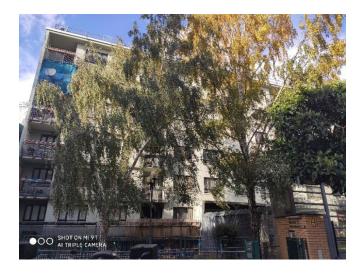
Photograph 7 showing trees 9 and 10 at the front of the building.

- 6.1.7. Tree 10 (Downy Birch) is located at the front of the property within the existing stepped and ramped access to the building and the. There are several elements of hard landscaping and hard surfacing making the prediction of the root locations difficult. The existing ground level slopes downward towards the existing building and the encroachment within the RPA to create the lower ground level patio area is less than 15% of the RPA. Birch trees tend to be shallow rooted and intolerant of root damage so any works within the RPA will require careful
