# **No.70 Great Russell Street** Results of Stair Opening Up Works

This report summarises the results of the opening up works to the existing staircase between ground and first floor level within No.70 Great Russell Street.

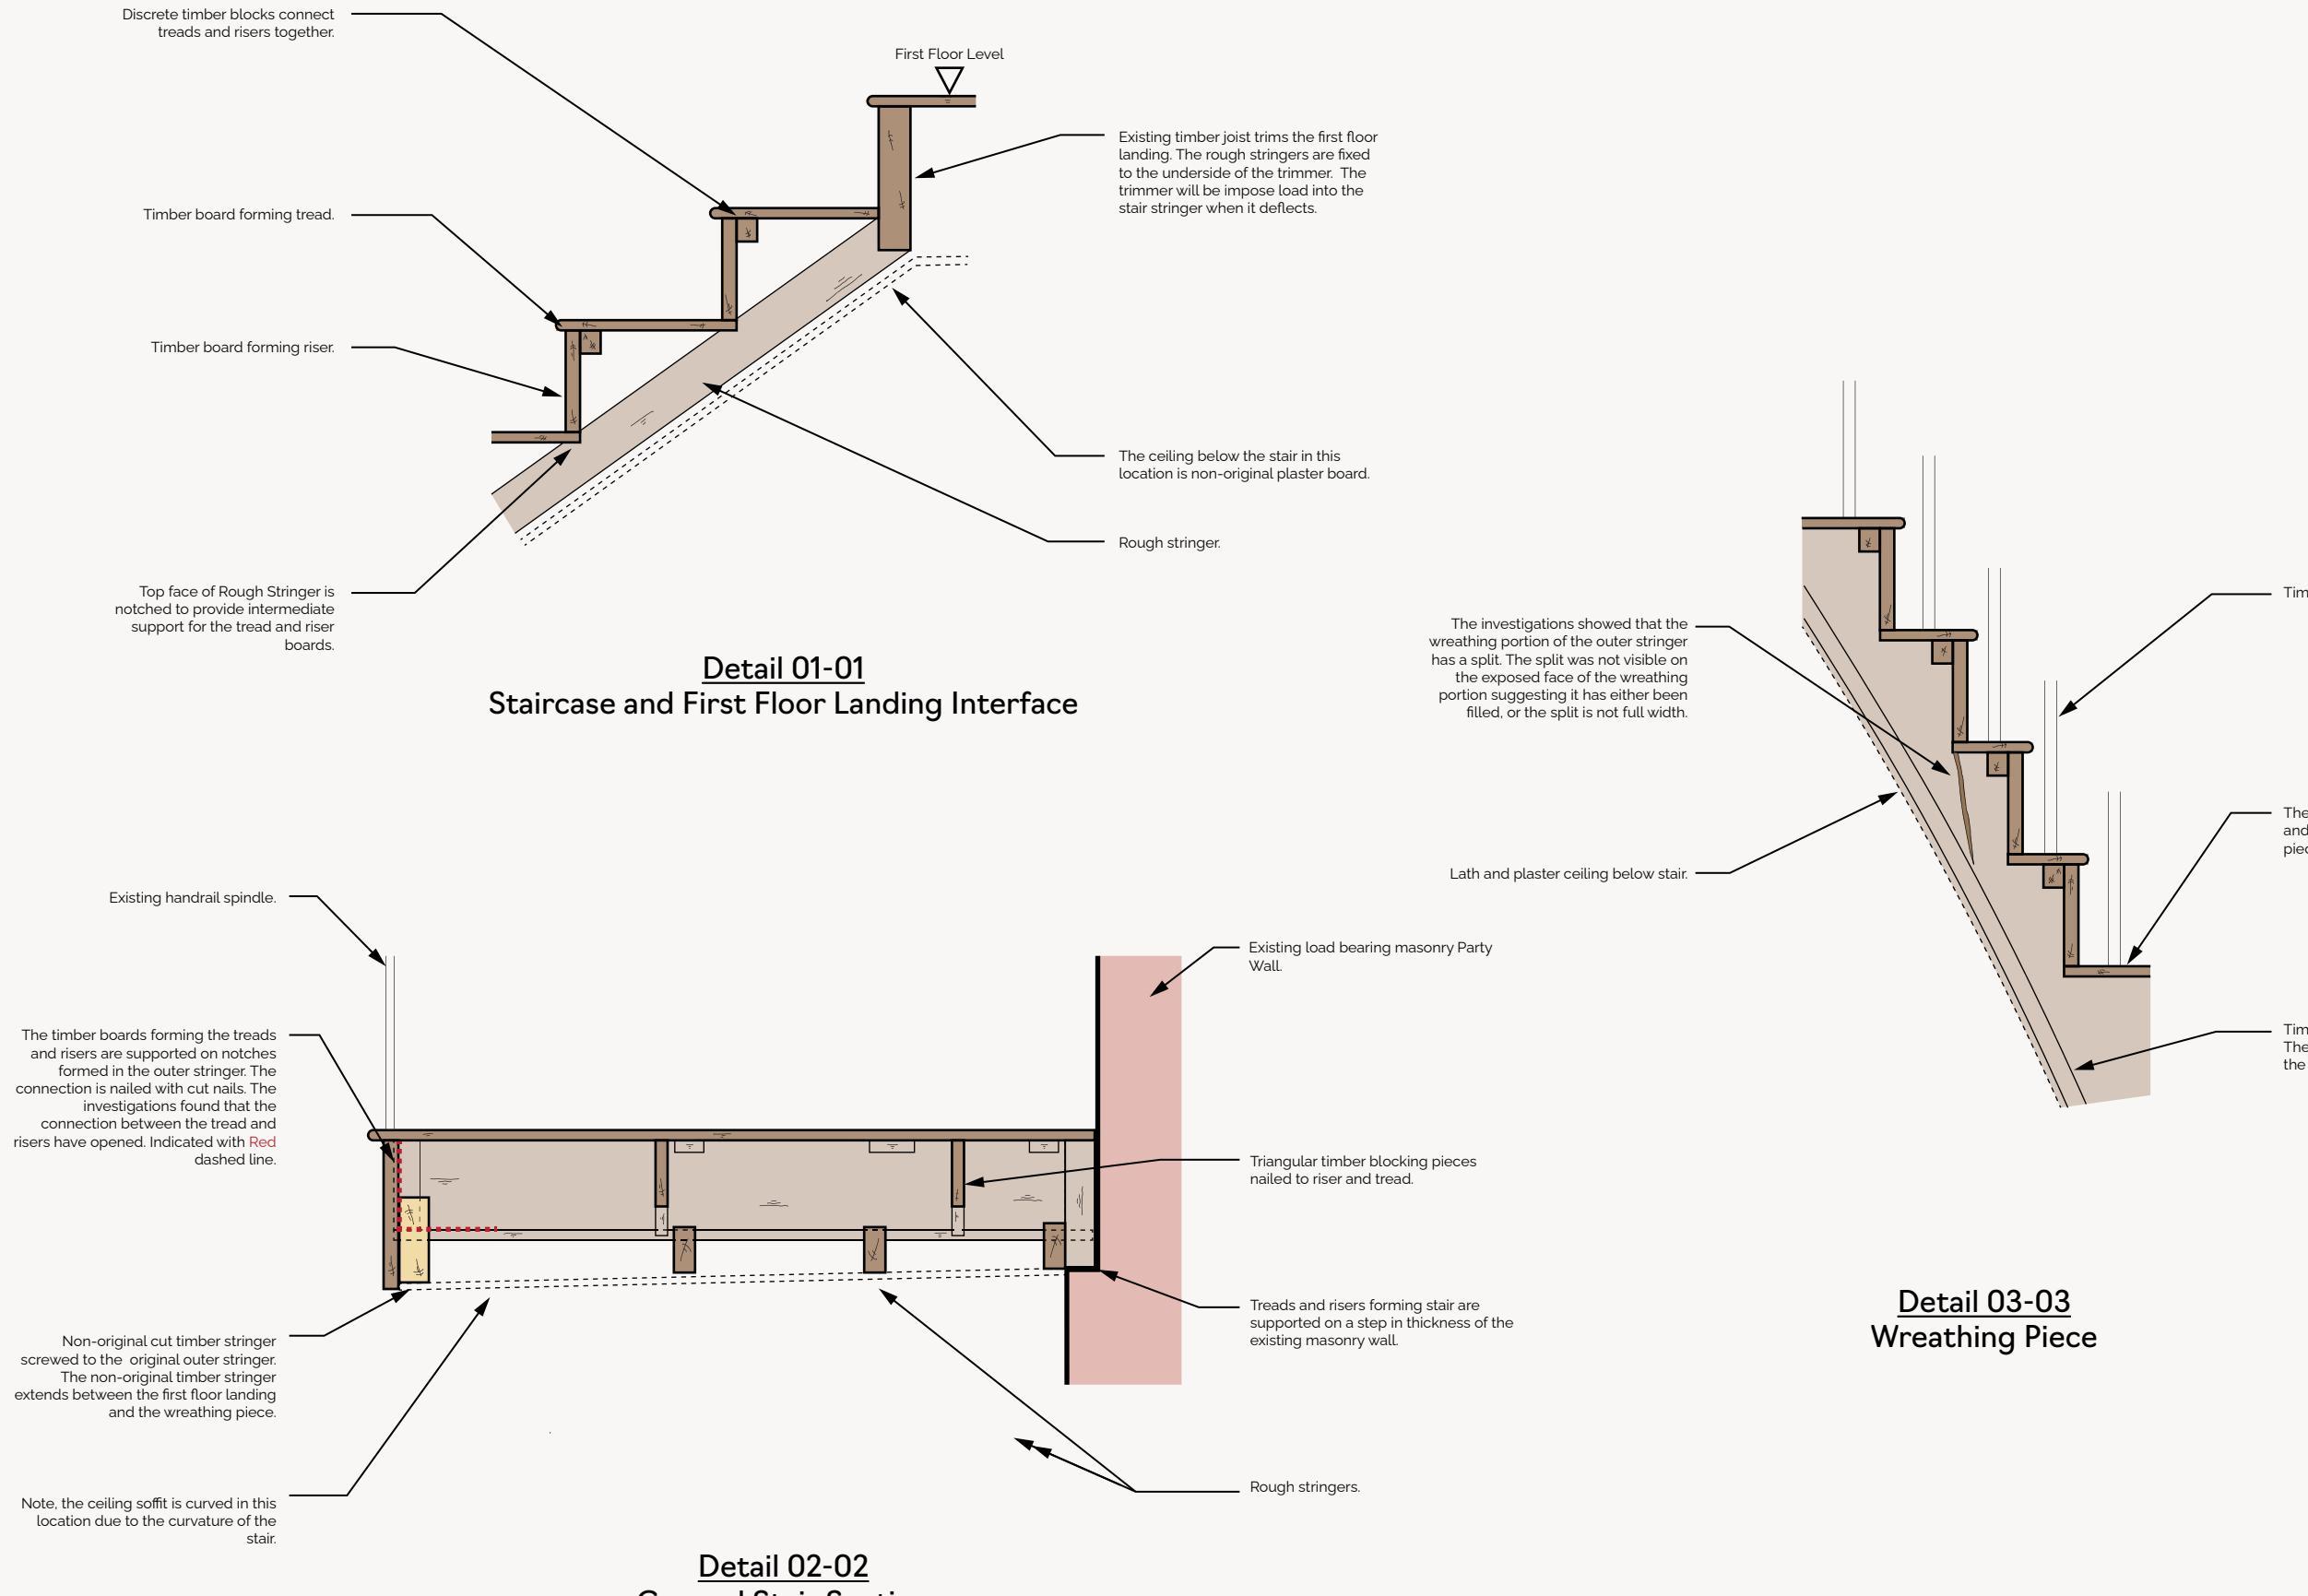
General Stair Section

The timber boards forming the treads and risers are housed into the wreathing piece as indicated in Detail 02-02.

Timber batten fixed to wreathing portion. The laths forming the ceiling are fixed to the batten.

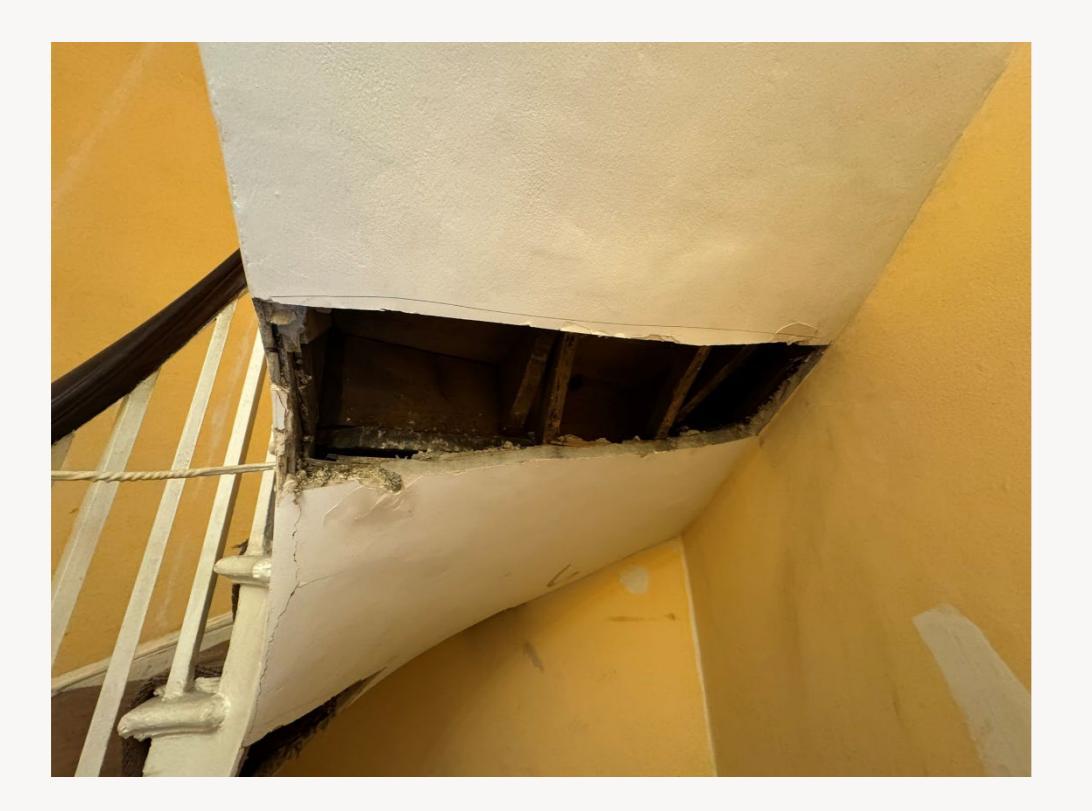
Photo 01

General photo showing the extent of opening up undertaken. N/A

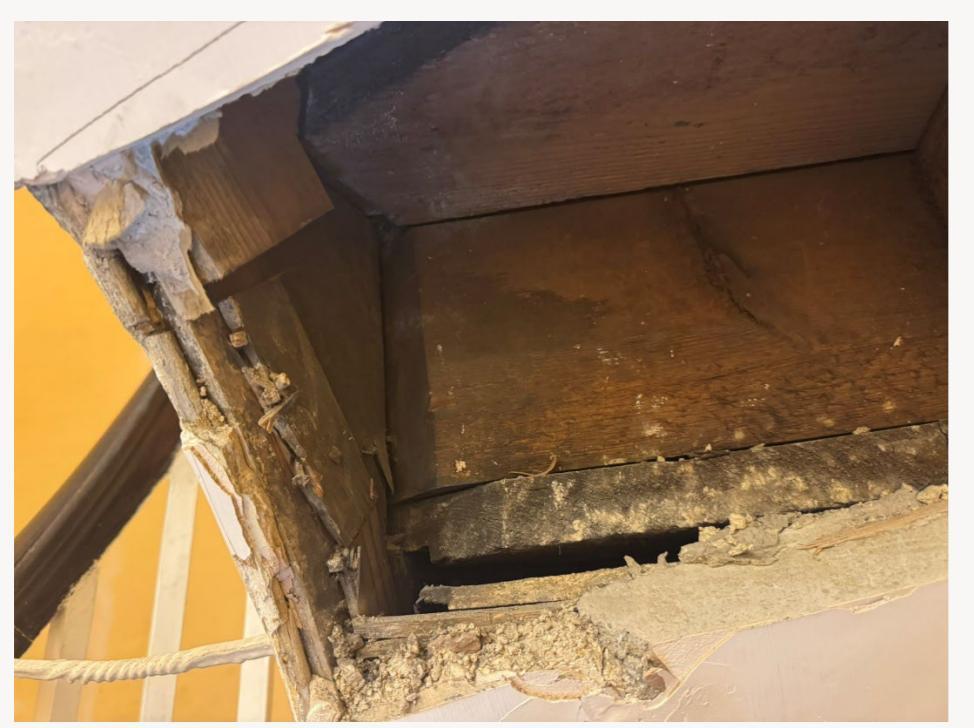
## Photo 02

The photo shows the connection of the timber boards forming the treads and risers to the outer stringer. The connection is secured with cut nails. The connection between these elements appears to have opened. This will reduce the load capacity of the connection and the robustness of the stair.

The connection between the riser board and stringer is to be improved by installing a proprietary steel angle bracket over the connection. The connection between the tread board and the stringer is to be improved by installing a new timber blocking piece to the side of the stringer, below the tread. The blocking piece is to be fixed to both the stringer and tread board.

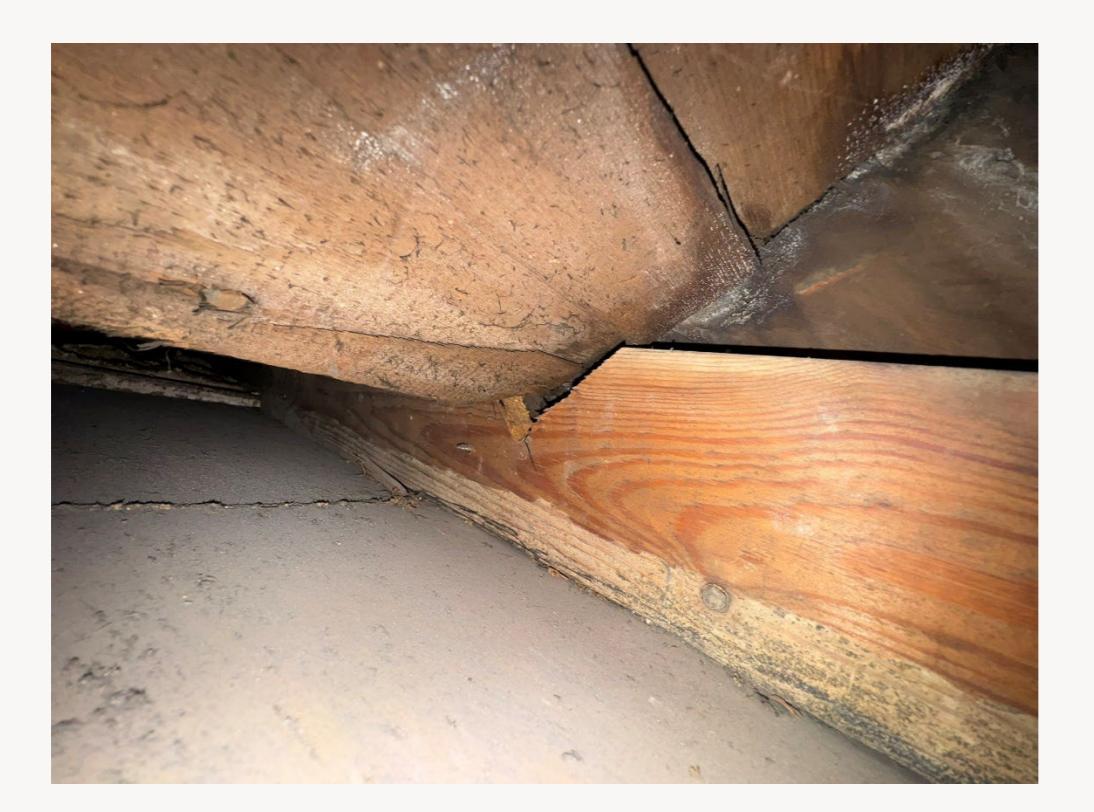
## Photo 03

The photo is taken looking back up the stair and shows that a non-original cut stringer has been installed adjacent to the outer stringer. The detailing of the non-original stringer is poor, with gaps between the nonoriginal stringer and the original stair structure.

Hardwood folding wedges are to be installed between non-original stringer and original stair structure and secured in place with screws.

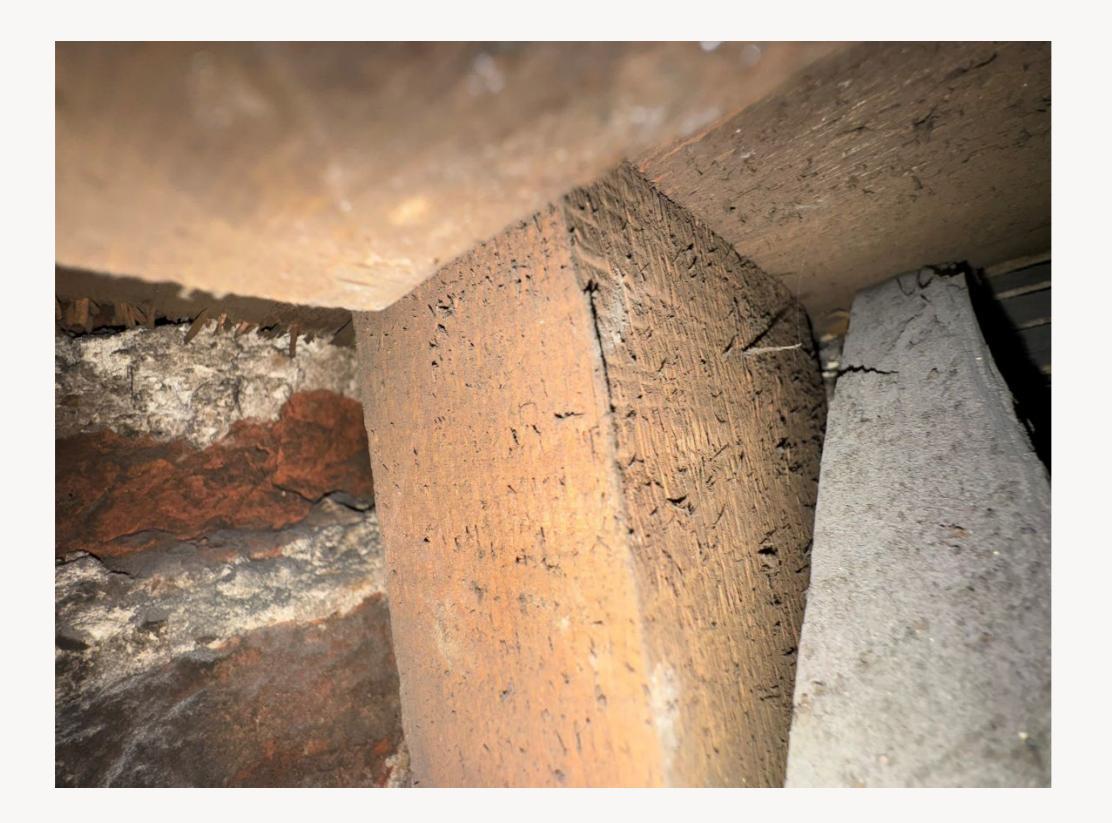
#### Photo 04 Opening Up Location OU02

The photo is taken looking up the stair and shows the interface between N/A the stair structure and the load bearing masonry Party Wall. The tread and riser boards are supported on timber packers that bear onto a ledge formed in the masonry wall.

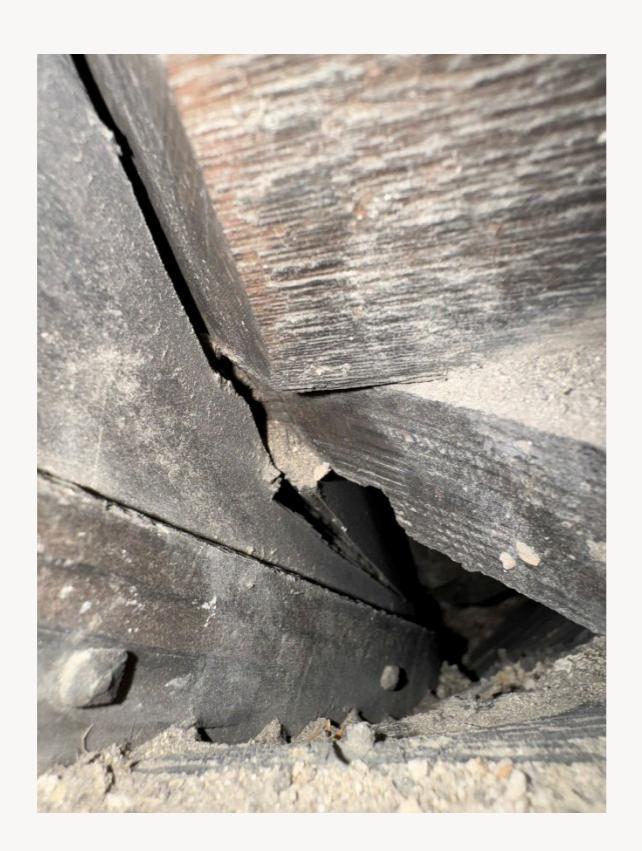
Photo 05

The photo is taken looking down the stairs towards the wreathing portion of the outer stringer. We observed that the stringer has split in this location. The split is likely to be due to localised overstressing of the stringer caused by the movement of the stair as described in our earlier report. The split will be significantly reducing the robustness of the stair. We did not see any obvious signs of the crack on the external decorated face of the stringer. This indicates that the split is either localised or it has been redecorated in the past.

The stringer should be reinforced to add back the lost robustness caused by the split. Strengthening works are likely to comprise carefully installing thin layers of plywood over the crack to help transfer loads past the defect. The plywood would be glued and screwed to the outer stringer. The repair would be hidden by the ceiling once reinstated.

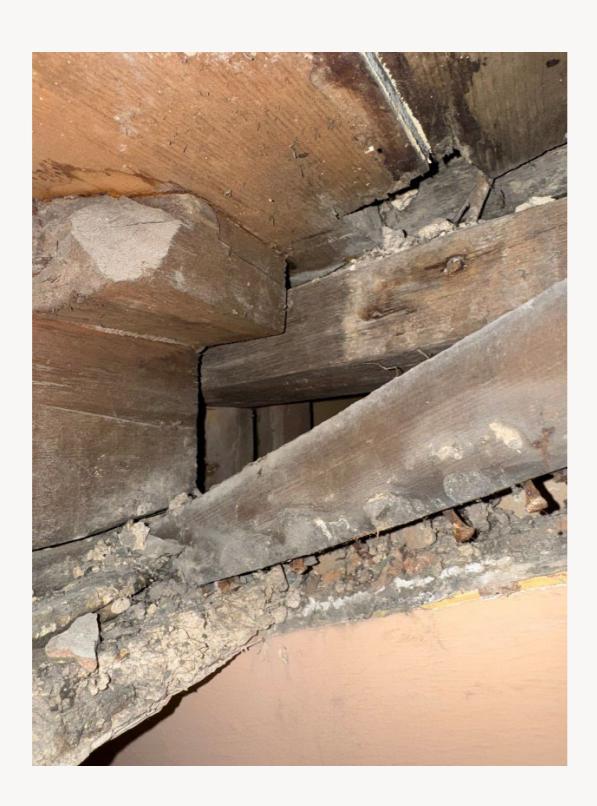
Photo 06

The photo shows the connection of the stair to the curved timber studwork wall. The connection details are ad-hoc and lack robustness with limited bearing to the tread and riser boards.

The connection between stair and the stud wall is to be improved by installing proprietary steel angle brackets and timber packers between the key structural elements.
