14 Templewood Avenue, London, NW3 7XA

Roof – Heritage Statement

Following on from listed building consent (ref: 2024/3436/L)

April 2025

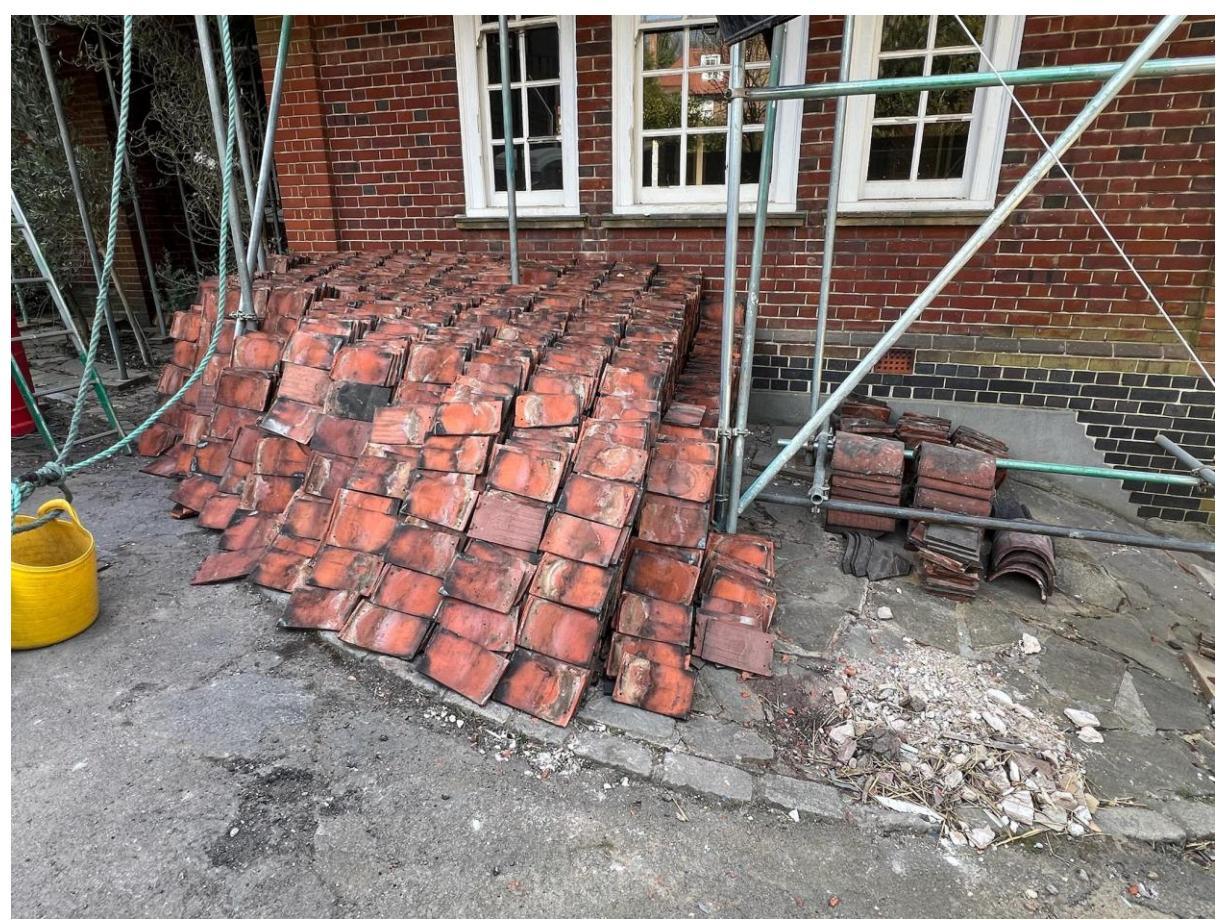
Figure 1: Attempted salvaged roof tiles on site. Though these roof tiles did not break on removal, on closer inspection, the tiles have evidence of decay and are considered beyond salvage and not fit for purpose (April 2025).

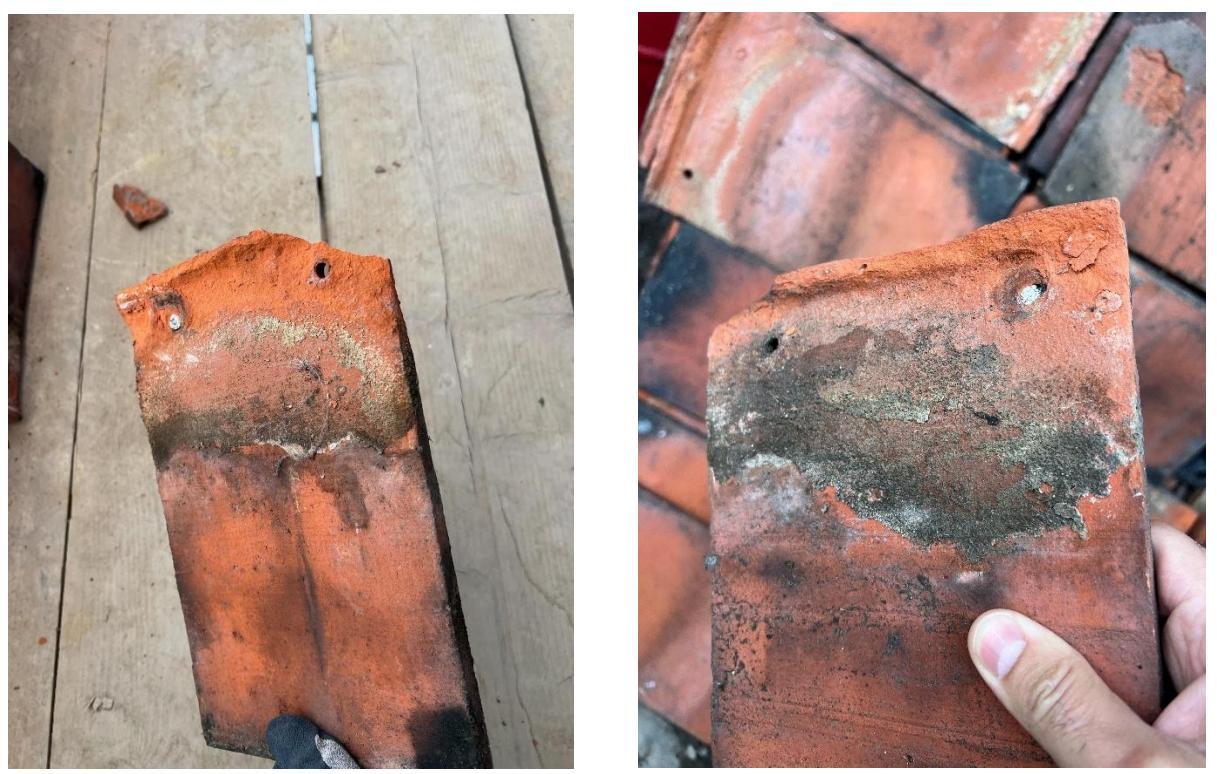
Figure 2: Attempted salvaged roof tile showing staining, discolouring, spalling and corner breaks (April 2025).

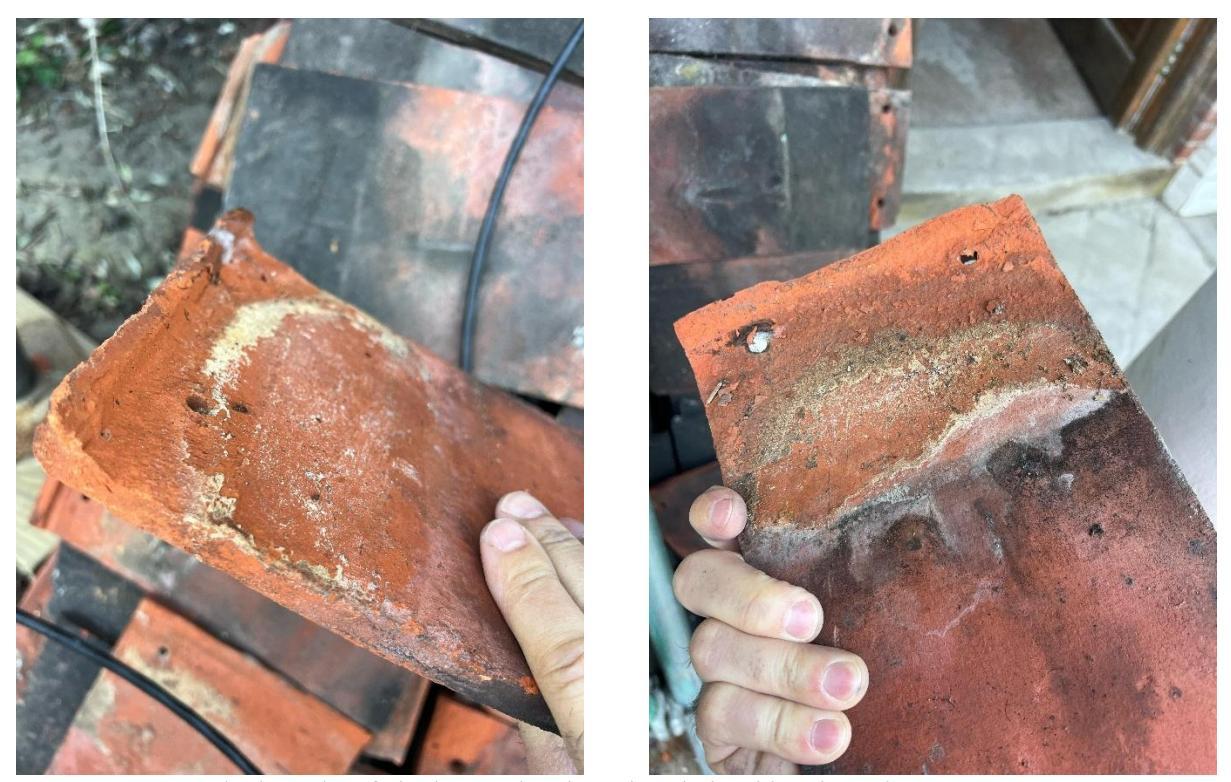
Figure 3: Attempted salvaged roof tile showing breaks in the nib detail (April 2025).

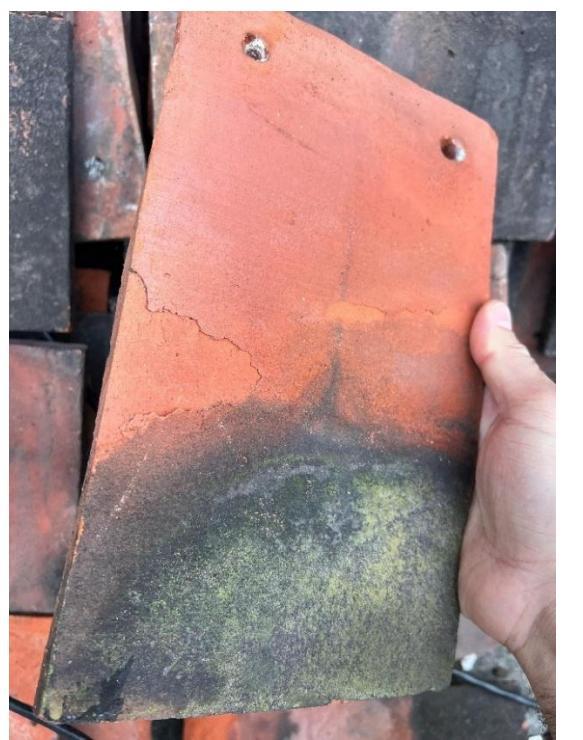
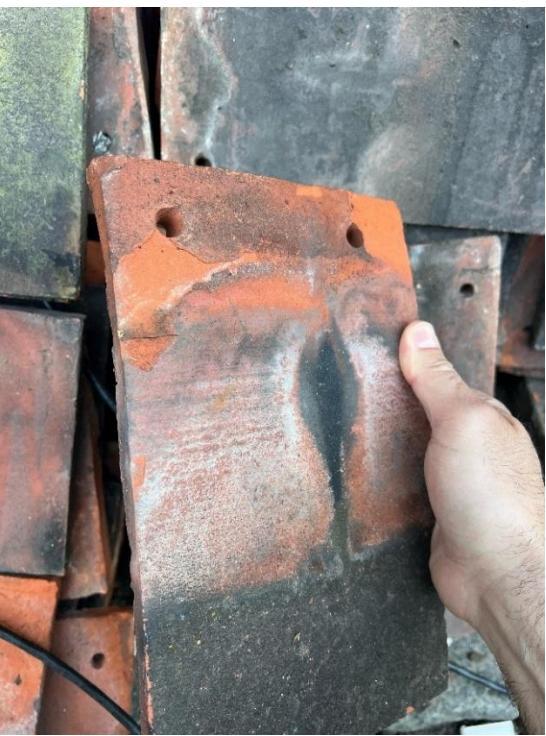
Figure 4: Attempted salvaged roof tile showing staining, discolouring and spalling. As noted, these tiles are decaying and will continue to decay if reused (April 2025).

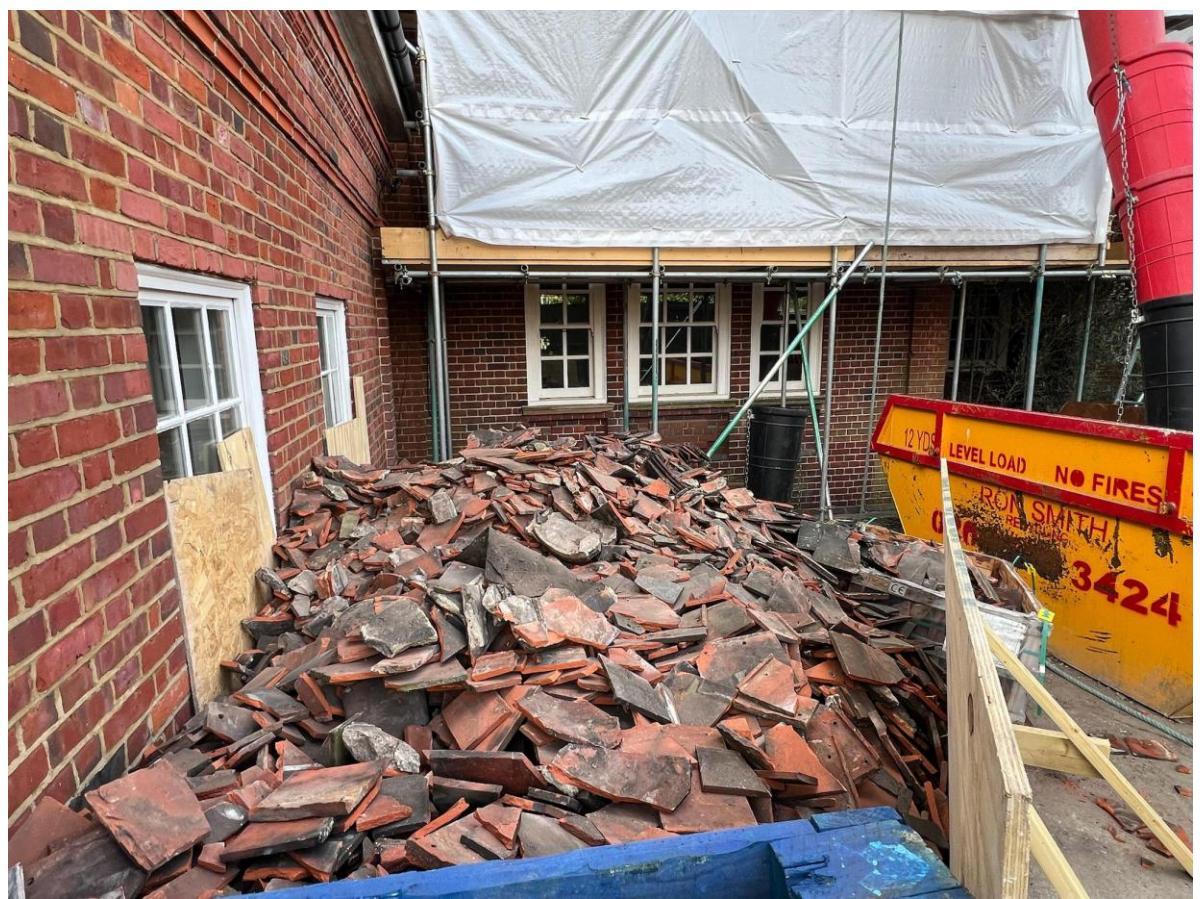
Figure 5: Existing roof tiles considered damaged and unsalvageable on site. The tiles broke on removal and whilst in situ on the roof (April 2025).

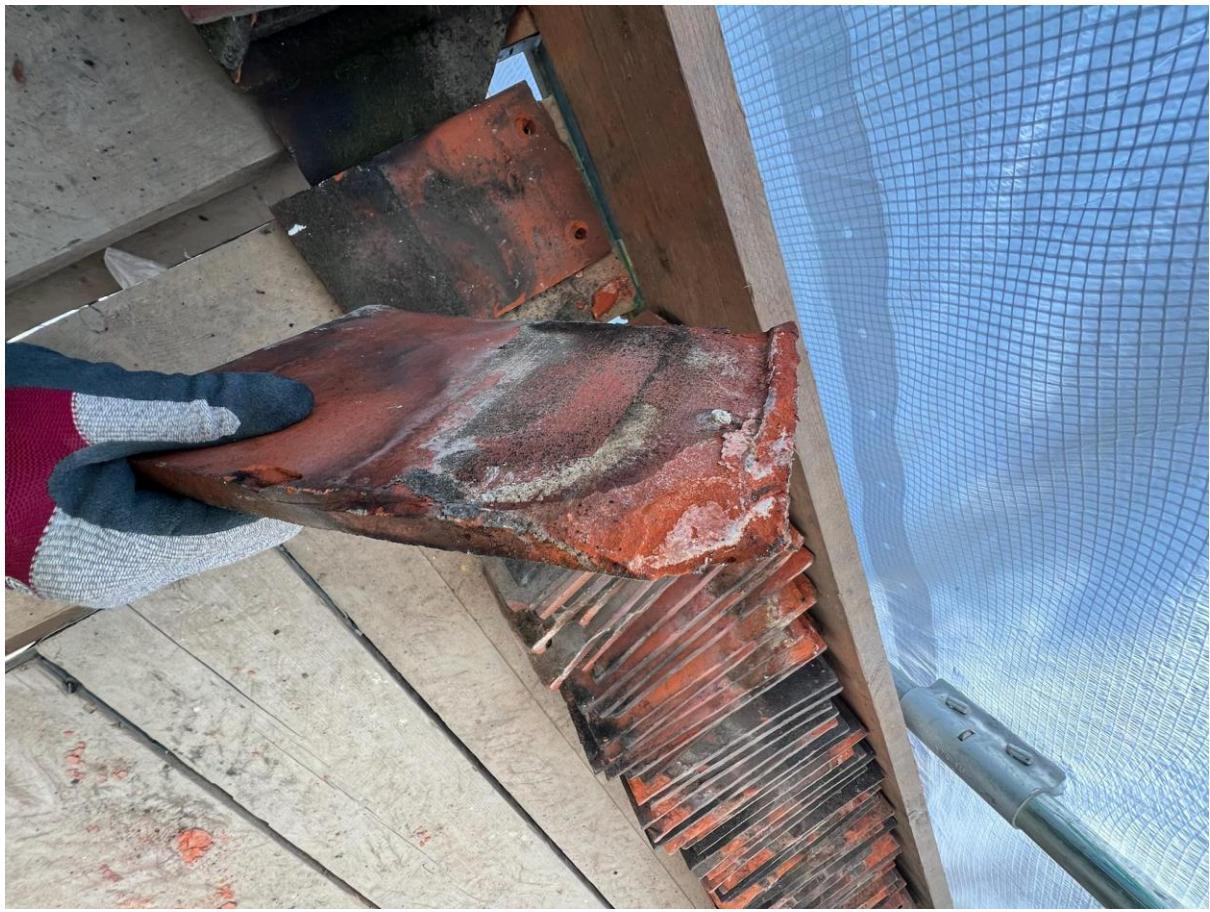
Figure 6: Existing damaged roof tiles showing breaks, nib breakage, delamination, discolouring and staining (April 2025).

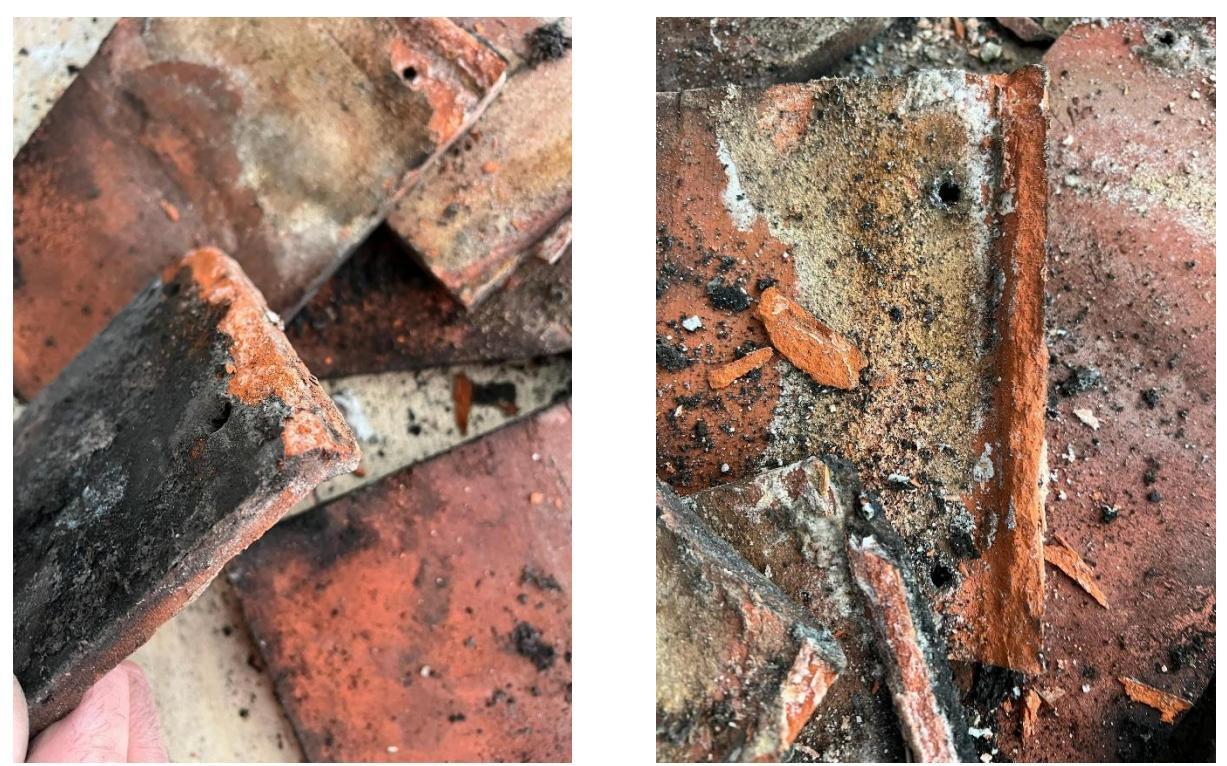
Figure 7: Existing damaged roof tiles showing nib breakage, discolouring, and spalling (April 2025).

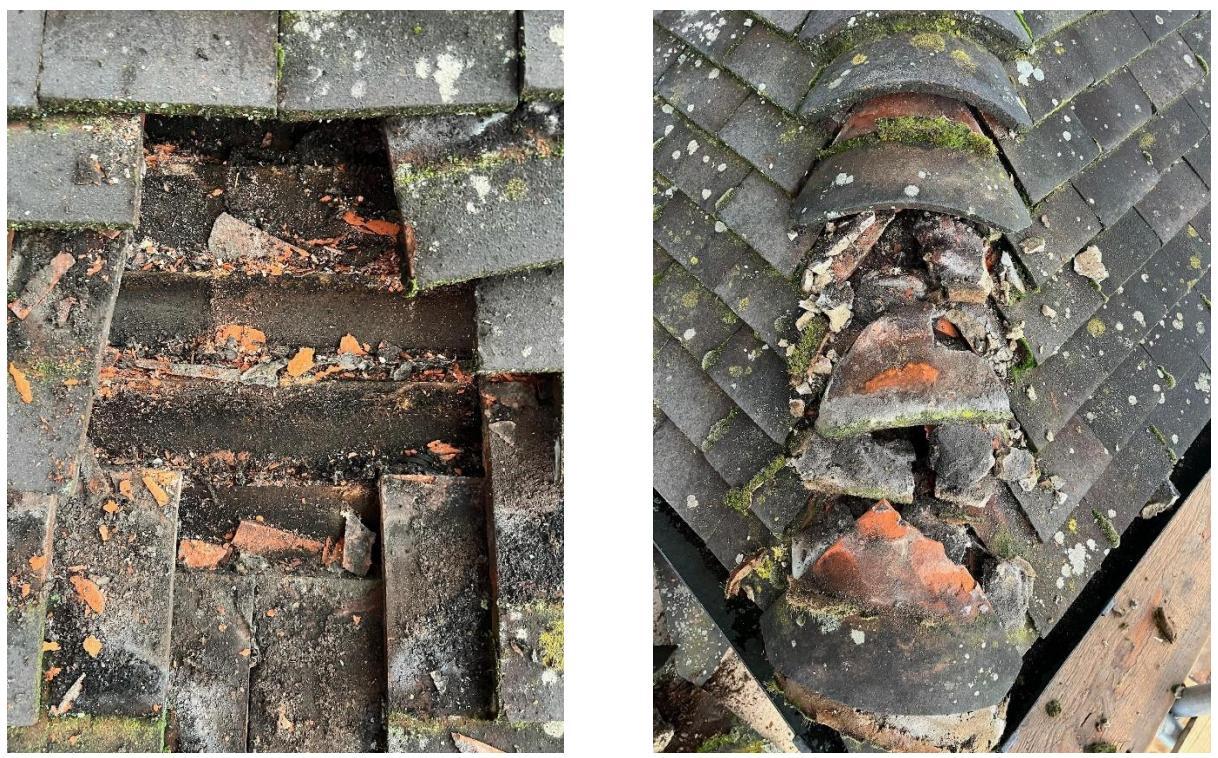
Figure 8: Evidence of pieces of roof tile as a result of breakage and spalling, as well as damaged roof tiles in situ (April 2025).
