ROOF CONDITION SURVEY

28494 14 Templewood Avenue

RAM Ref:	28494
Survey Date:	20/03/2025
Project:	Coach House
Address:	14 Templewood Avenue, Hampstead
Client:	Livin Construction Ltd

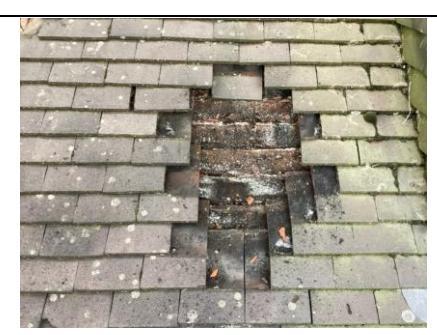
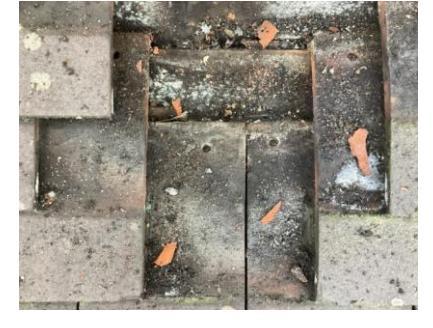
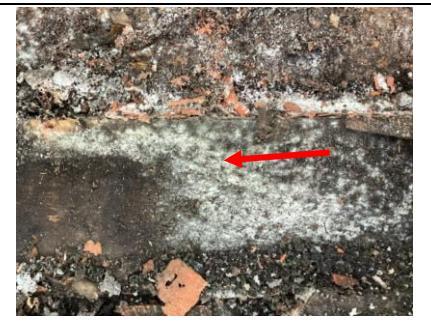
Core 1

Continuous nibbed machine-made clay plain tiles Hardwood feather edged board

White mould on timber

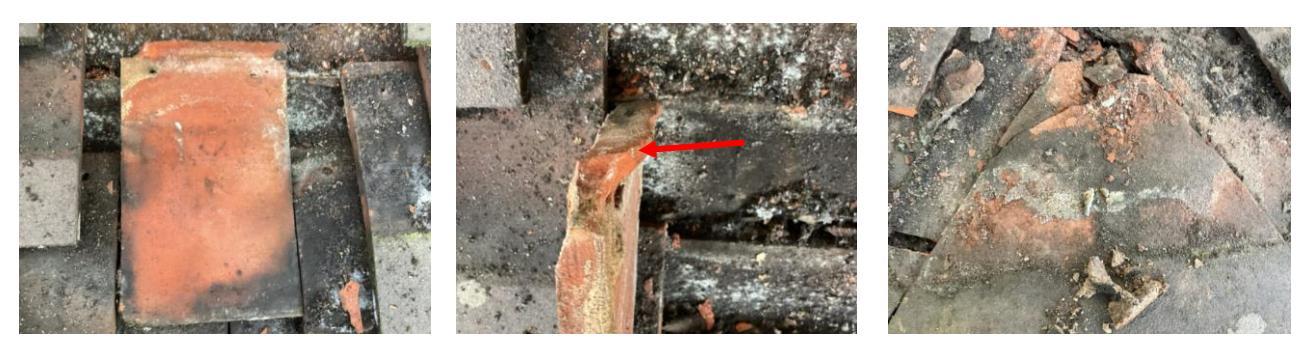
Damage to continuous nib.

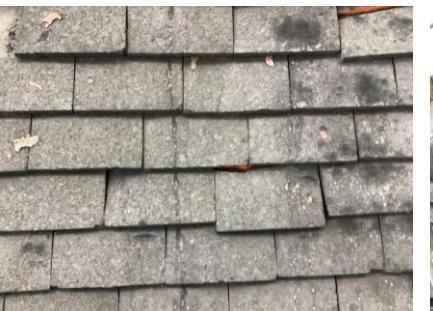
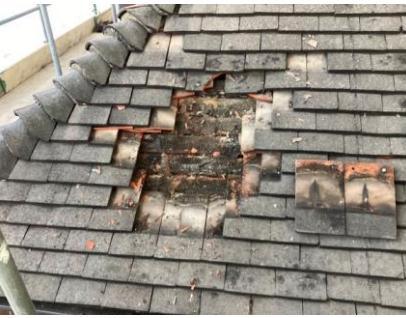
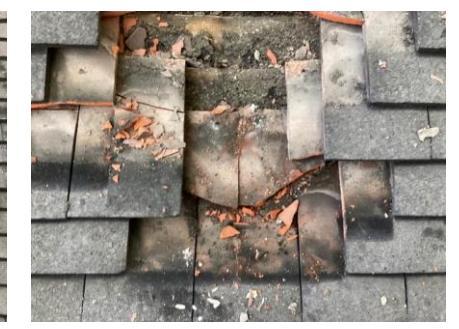
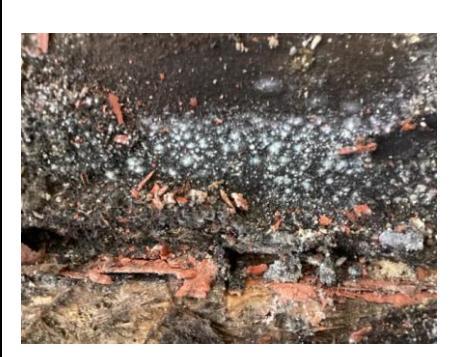
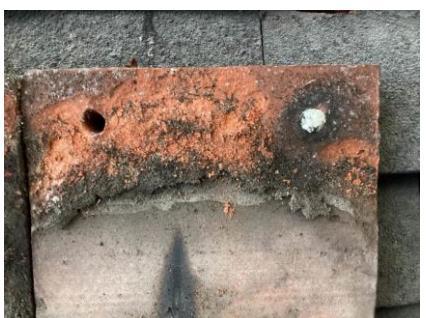
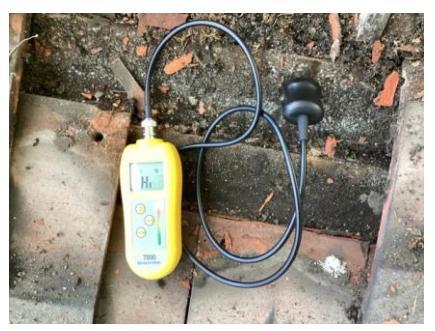
Core 2

Continuous nibbed machine-made clay plain tiles Hardwood feather edged board

White mould

Spalling to head of tile

High moisture readding to timber

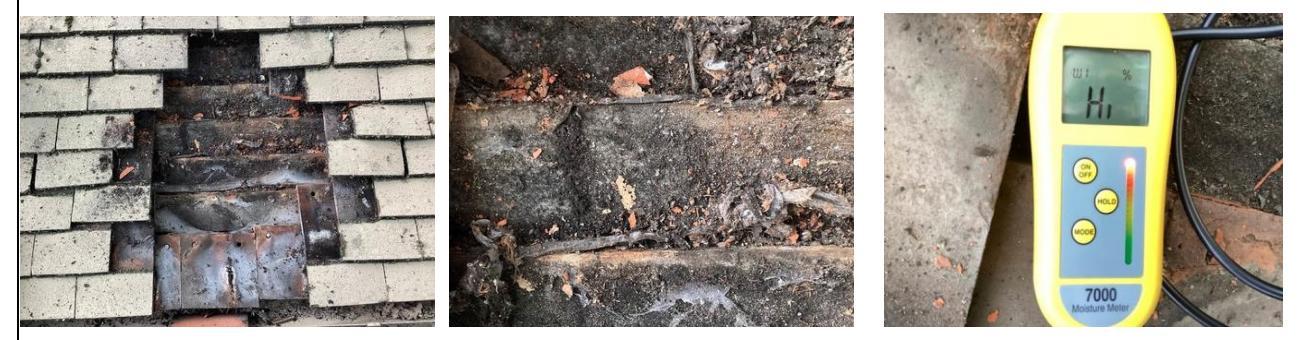
Core 3

Continuous nibbed machine-made clay plain tiles Hardwood feather edged board

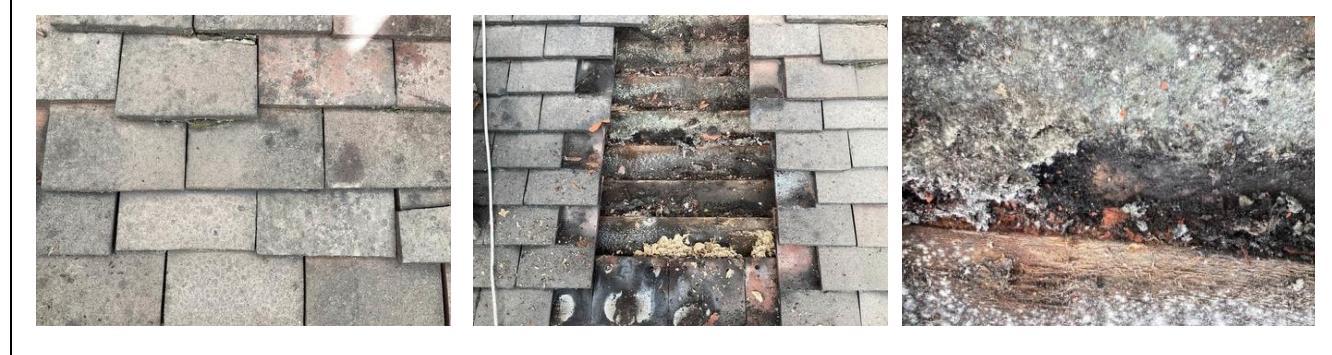
Core 4

Continuous nibbed machine-made clay plain tiles Hardwood feather edged board

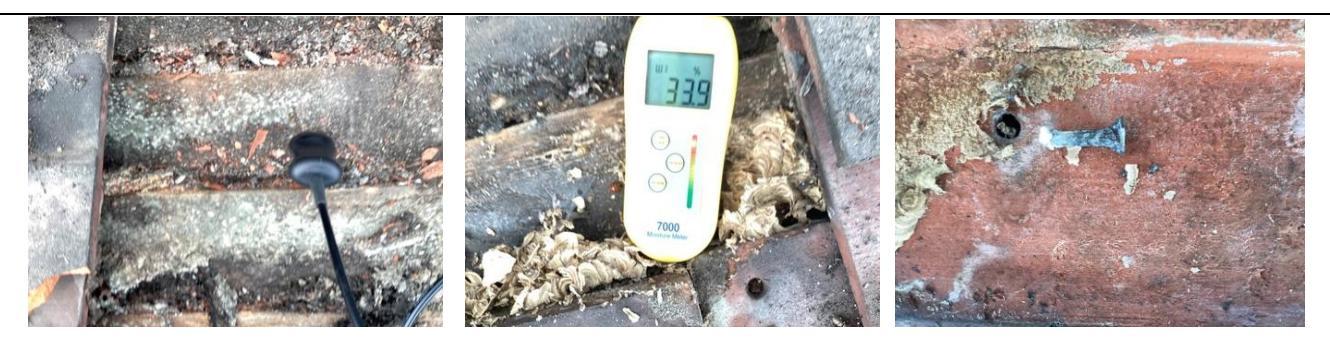
Nail snapped due to nail fatigue

More than 50% of the tiles that we removed that were nailed had a high degree of nail fatigue, resulting in many nails breaking when we tried to remove them.

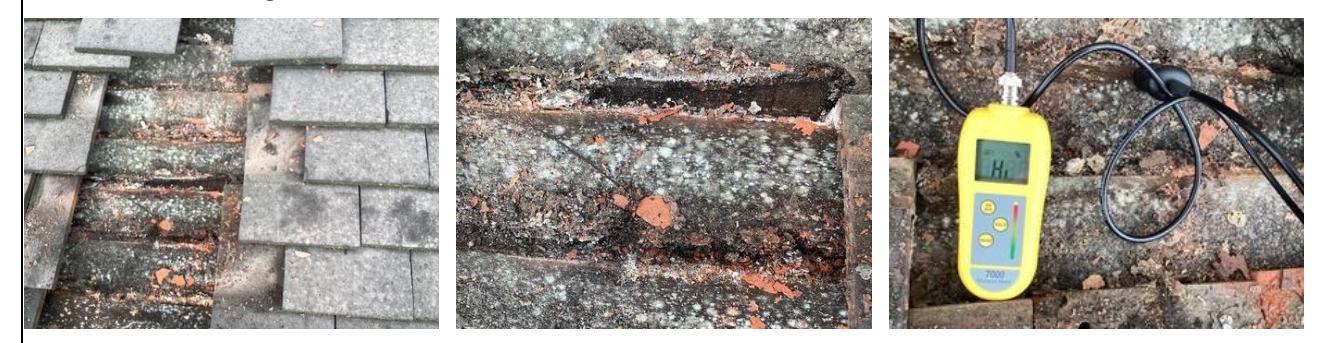
Core 5

Continuous nibbed machine-made clay plain tiles Hardwood feather edged board

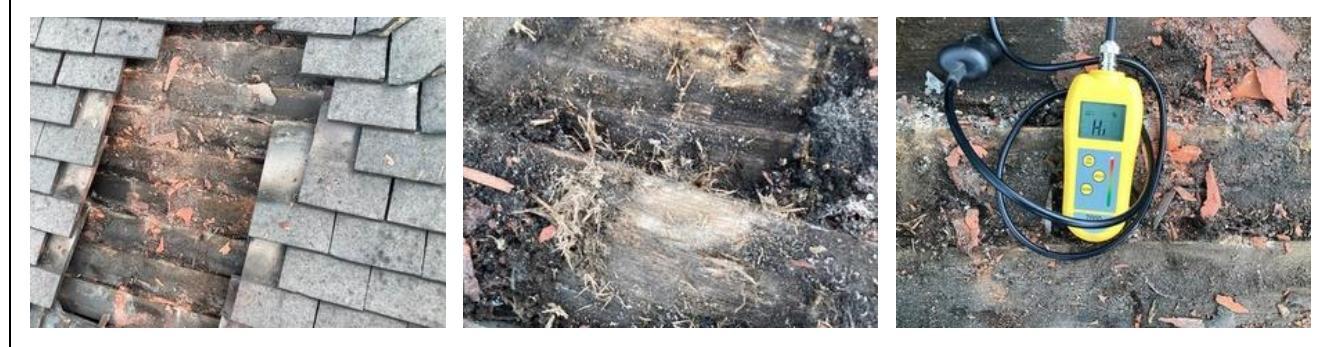
Core 6

Continuous nibbed machine-made clay plain tiles Hardwood feather edged board

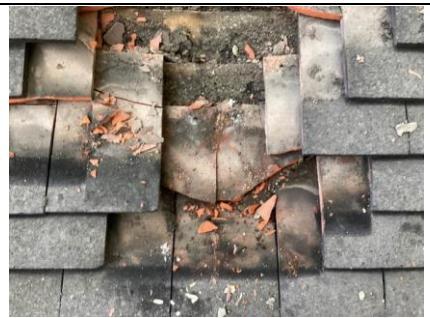
Moisture meter readings were taken at all locations where tiles were removed, and the roof exposed. In all locations the readings were found to be high despite the fact that a temporary roof has been in place over the property for two or three months.

Tiles damp under laps

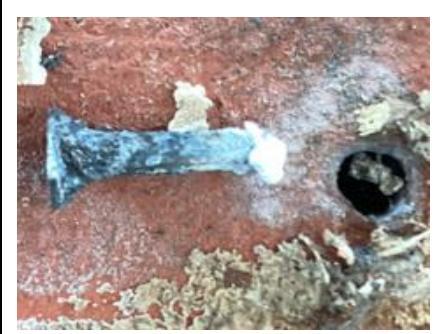
Nail fatigue

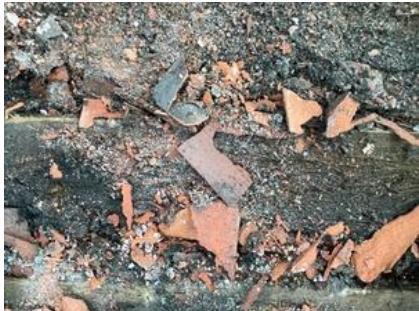
Where tiles have been subjected to the elements they appeared mainly in reasonable condition for their age and type. However, the reverse face of the tiles all showed a degree of age-related degradation as a result of spalling.

Spalling residue

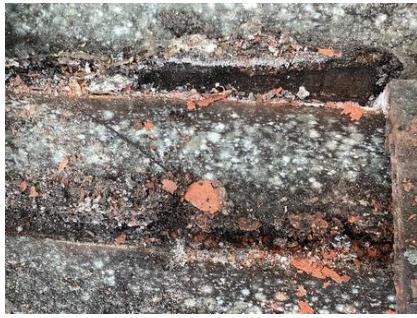
The underlying feather edge timber boarding had varying degrees of white mold present. White mold is a type of fungus that thrives in moist environments and can cause damage to the wood and can cause health problems if left untreated.

White mould on timbers

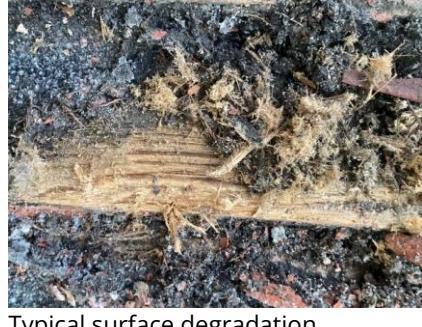
Typical surface degradation

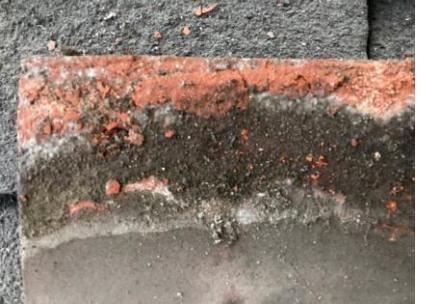
Spalling to tiles

The spalling of the tiles shows that they are starting to break down. This results in them becoming more absorbent and therefore more susceptible to damage from the freeze-thaw process. This will lead to further tile failure going forward.

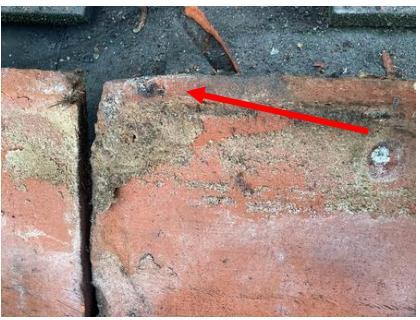
This has also resulted in varying degrees of damage to the nibs on all of the tiles. This will compromise their ability to be held in position.

Typical damage to nibs

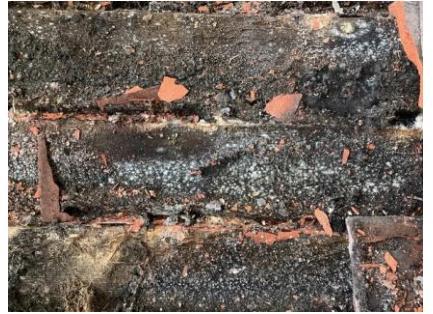
Typical mould on timbers

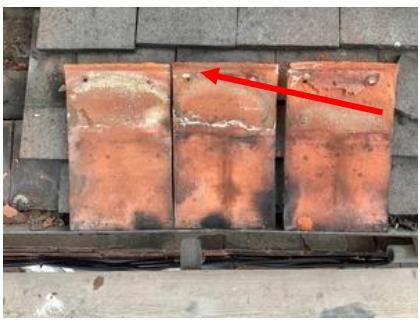
Typical damage to nibs

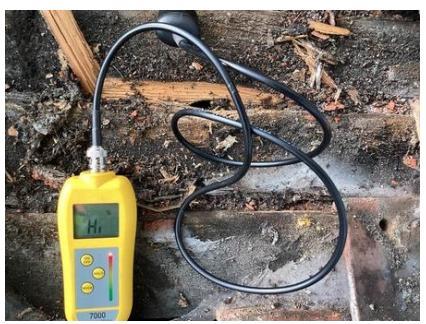
Moisture content readings were taken in all core locations. All bar core 4 registered as high, above the numerical reading, showing a moisture content in excess of 40%. Core 4, to the rear of the property, showed a reading of 33.9%. This is still relatively high considering this is the southeast elevation and in sunshine for most of the day.

Widespread high moisture

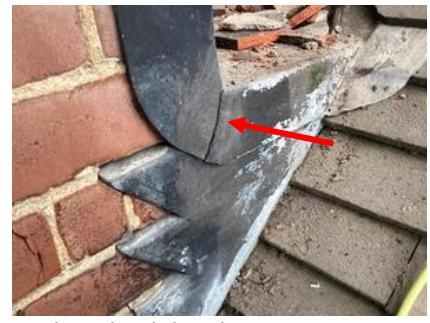
Flashings and valleys within the roof areas were covered in lead sheets. In some of these there was evidence of cracks and others had signs of historic repairs using flashing tapes and other alternative materials.

Split to lead detail

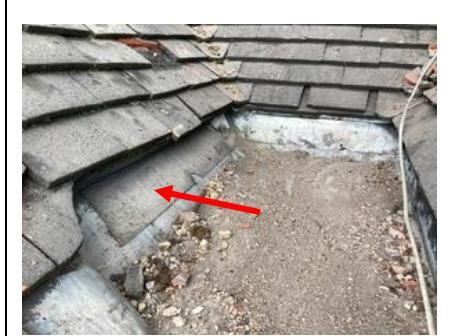
Flashband repair to lead valley

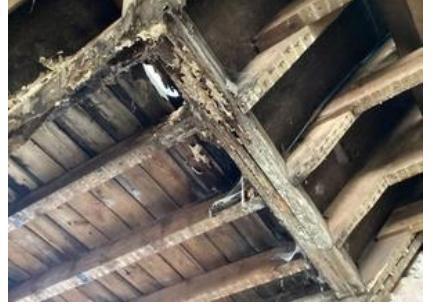
Internally we examined the timbers and found multiple areas where serious damage to timber had occurred as a result of water ingress.

Typical rotten timber

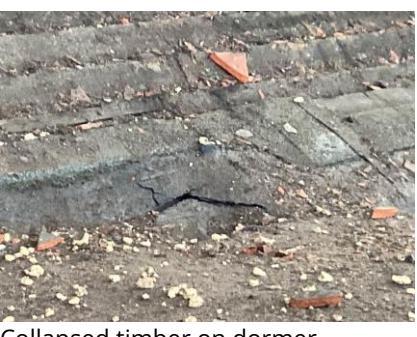
Collapsed timber on dormer

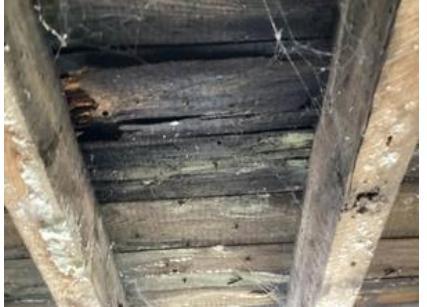
Typical rotten timber

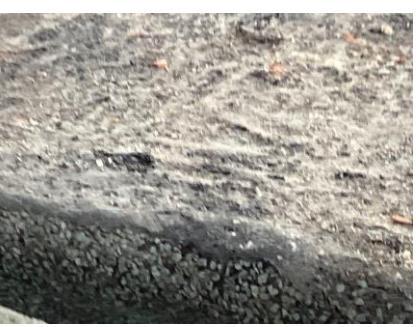
The roof has multiple dormers, mainly covered in reinforced bituminous membranes that seem poorly installed and in poor condition. These would almost certainly have been clad in lead originally and judging from their appearance and condition we would suggest that many were recovered when the property was reroofed with the existing tiles., (40-50 years)

Poor condition dormer felt

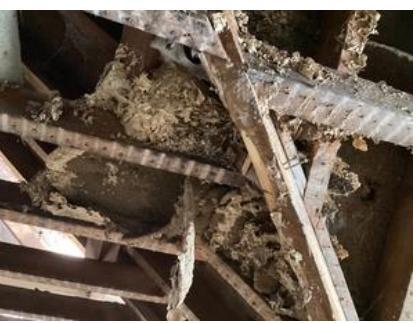
Typical rotten timber

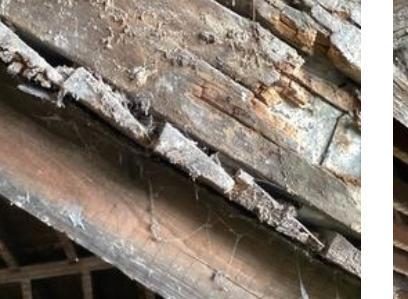
Typical rotten timber

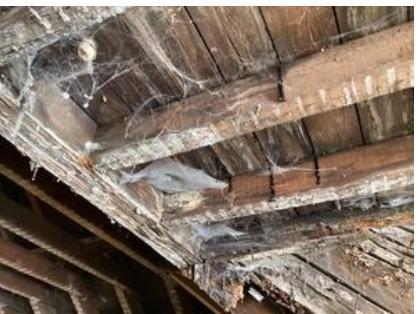
Typical rotten timber

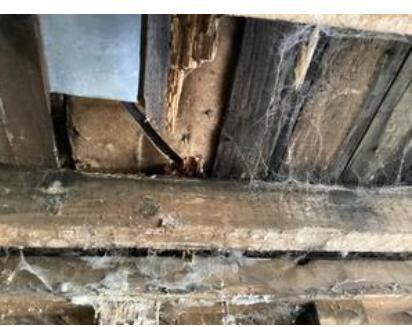
Typical rotten timber

Our recommendation for re-roofing would be to strip the existing roof back to rafter to enable the installation to follow current building regulations and incorporate a moisture permeable under tiling membrane and new tanalised treated battens and new clay plain tiles.
