Arboricultural Planning Report For:

109 Canfield Gardens

Client:	Justin De Wan
Report Date:	27/04/2025
Survey Date:	23/04/2025
Report Ref.:	25 2758 AZ Canfield Gardens
Rev. No.:	-
Checked By:	KM

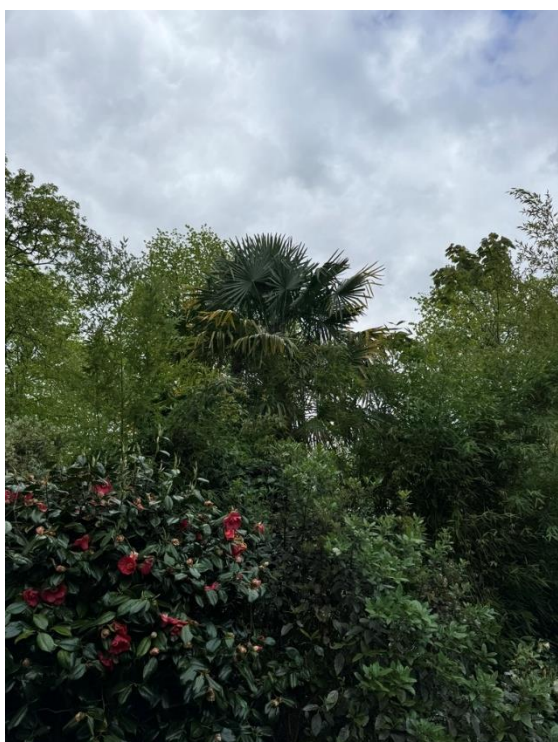
Photograph 4: T7

7	T	Trachycarpus fortunei (Chusan Palm)	6	250	Y	1	1.5	1.5	1.5	1.5	2.5	N	2.5	N	Early Mature	Good	Good	No works	20+	C2	Situated in adjacent garden, with no access of visibility below 2.5m; measurements estimated. No major defects noted.
