Arboricultural Appraisal Report

Subsidence Damage Investigation at:

222 Finchley Road London NW3 6DH

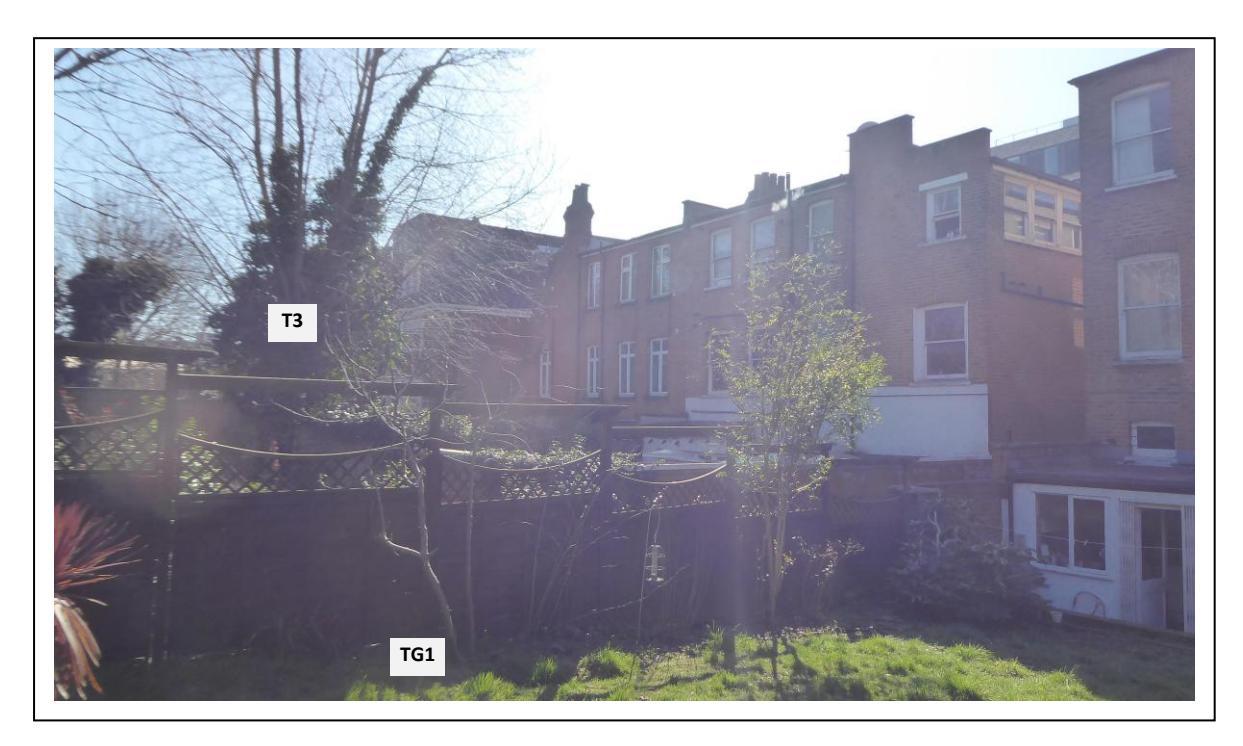
Of the roots recovered, the most significant are the Salicaceae spp. roots. These will emanate from T3 Poplar, confirming its influence on the soils below the foundations.

Based on the information currently available, engineering opinion and our own site assessment we conclude there is damage consistent with shrinkage of the clay subsoil exacerbated by the soil drying effects of vegetation. Having considered the information currently available, it is our opinion that T3 Poplar is the principal cause of the current building movement and damage.

View of T3 Poplar with TG1 visible to foreground

If an arboricultural solution is to be implemented to mitigate the influence of the trees/vegetation considered to be responsible for the movement/damage, we recommend that T3 Poplar is removed. (see Table 1).

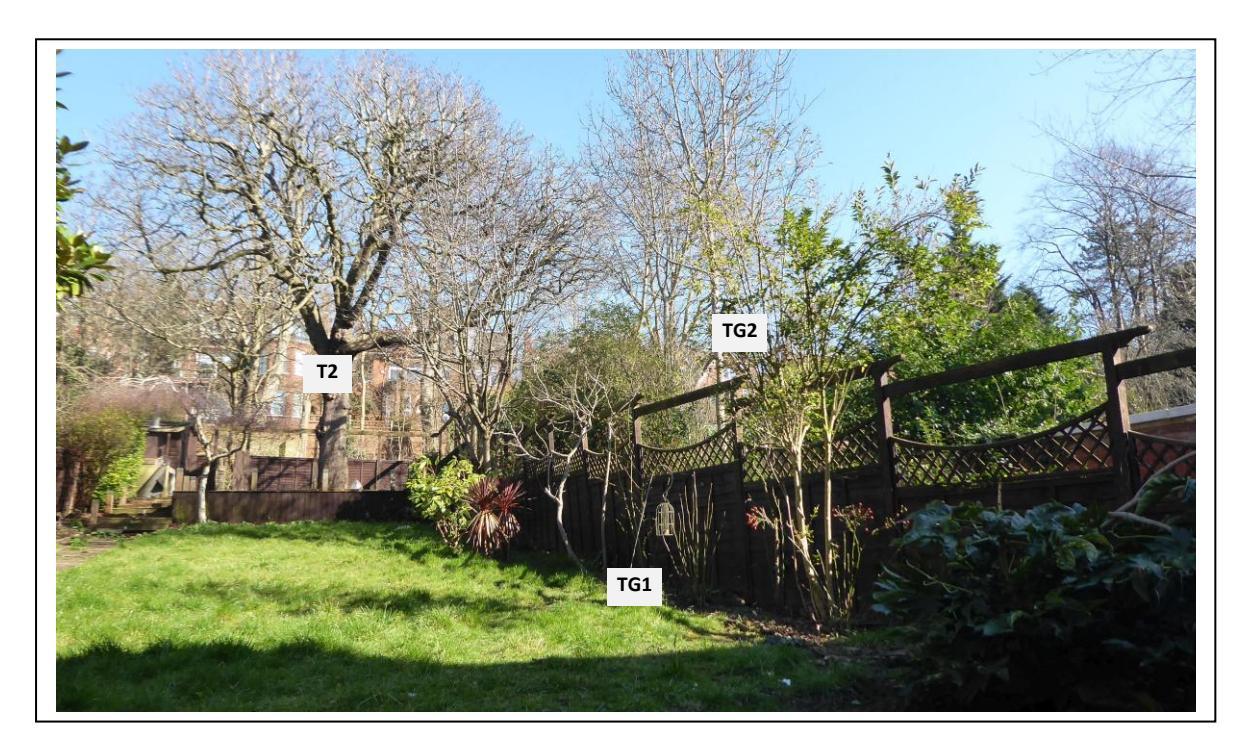
View of T2 Horse Chestnut, TG2 Ash group and TG1 mixed spp. group

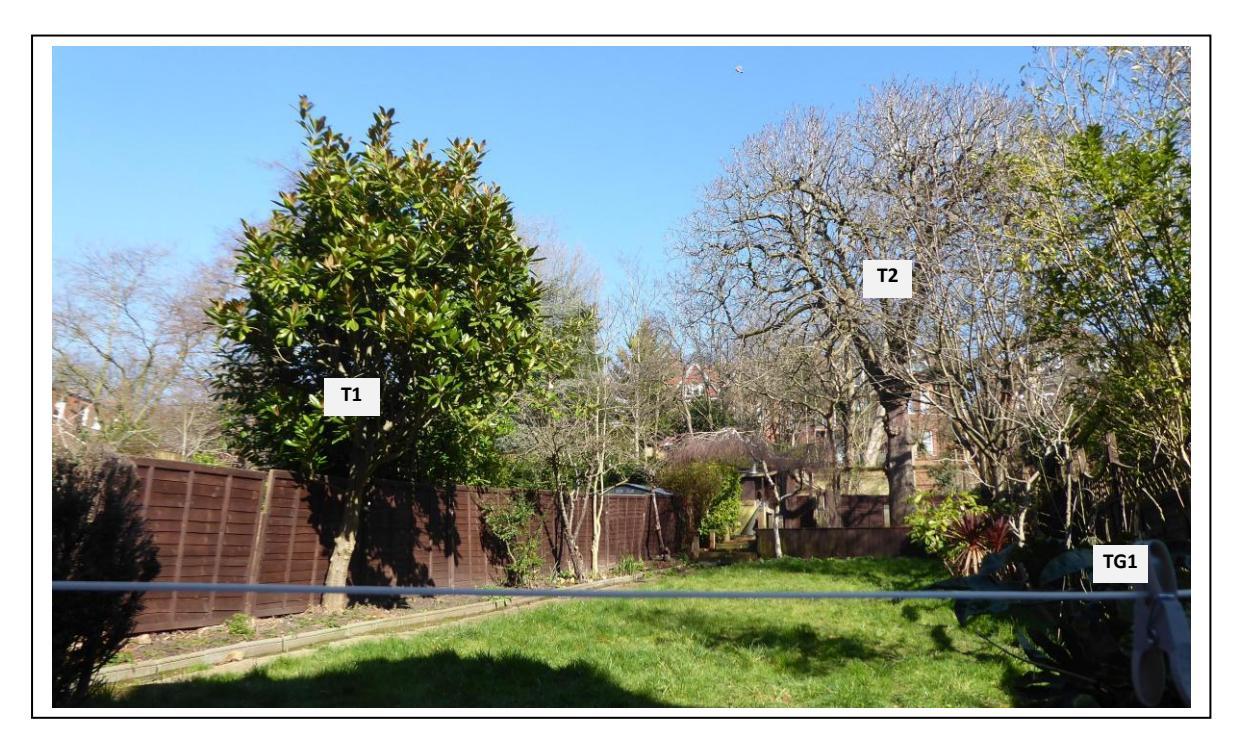
View of T1 Magnolia, with T2 Horse Chestnut and TG1 group to right

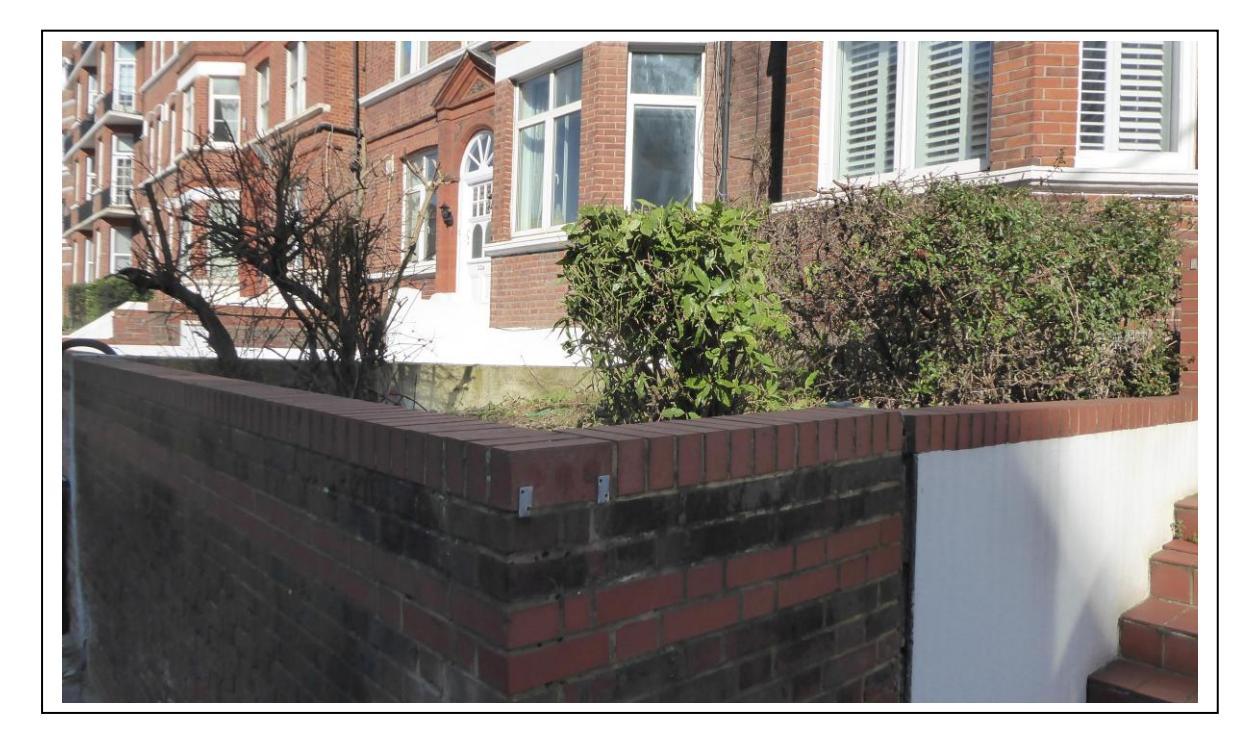
View of SG1 group

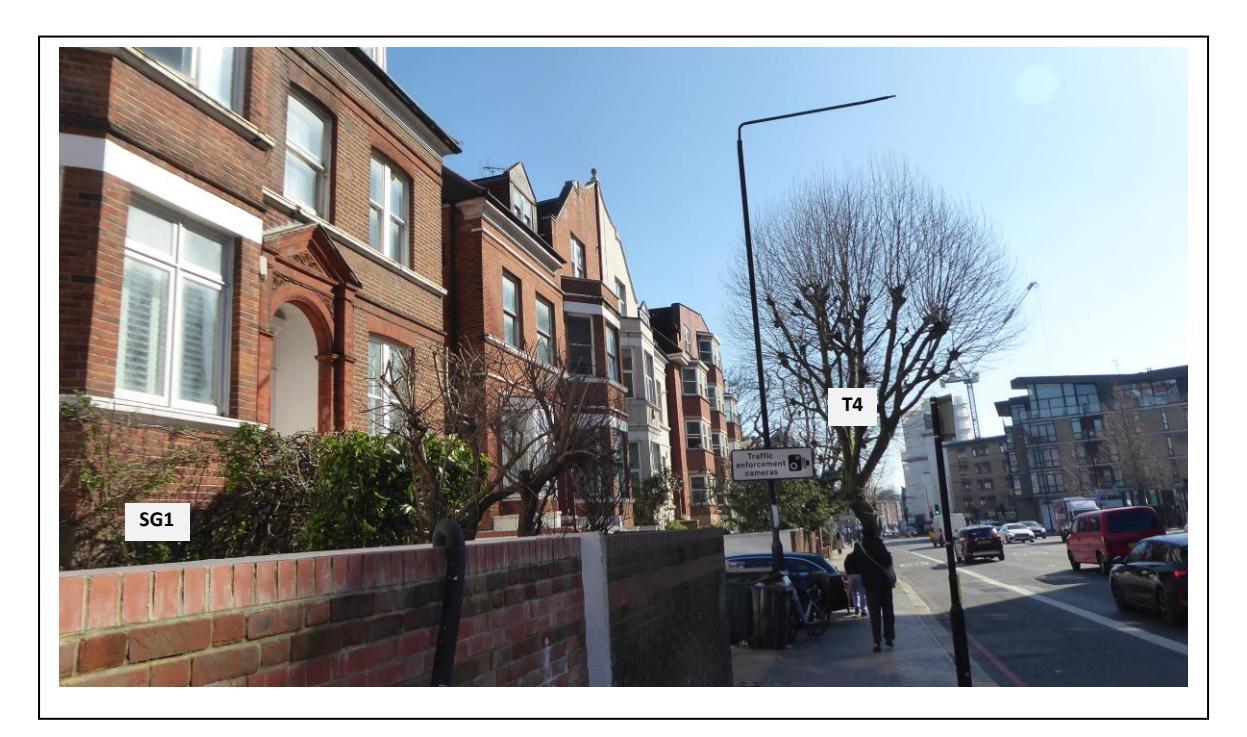
View of T4 London Plane, with SG1 shrub group visible to left of frame
