# BS5837 Arboricultural Impact Assessment

35(A) Buckland Crescent, London, NW3 5DJ

Client: William Carter Limited

Job Reference: 02008R

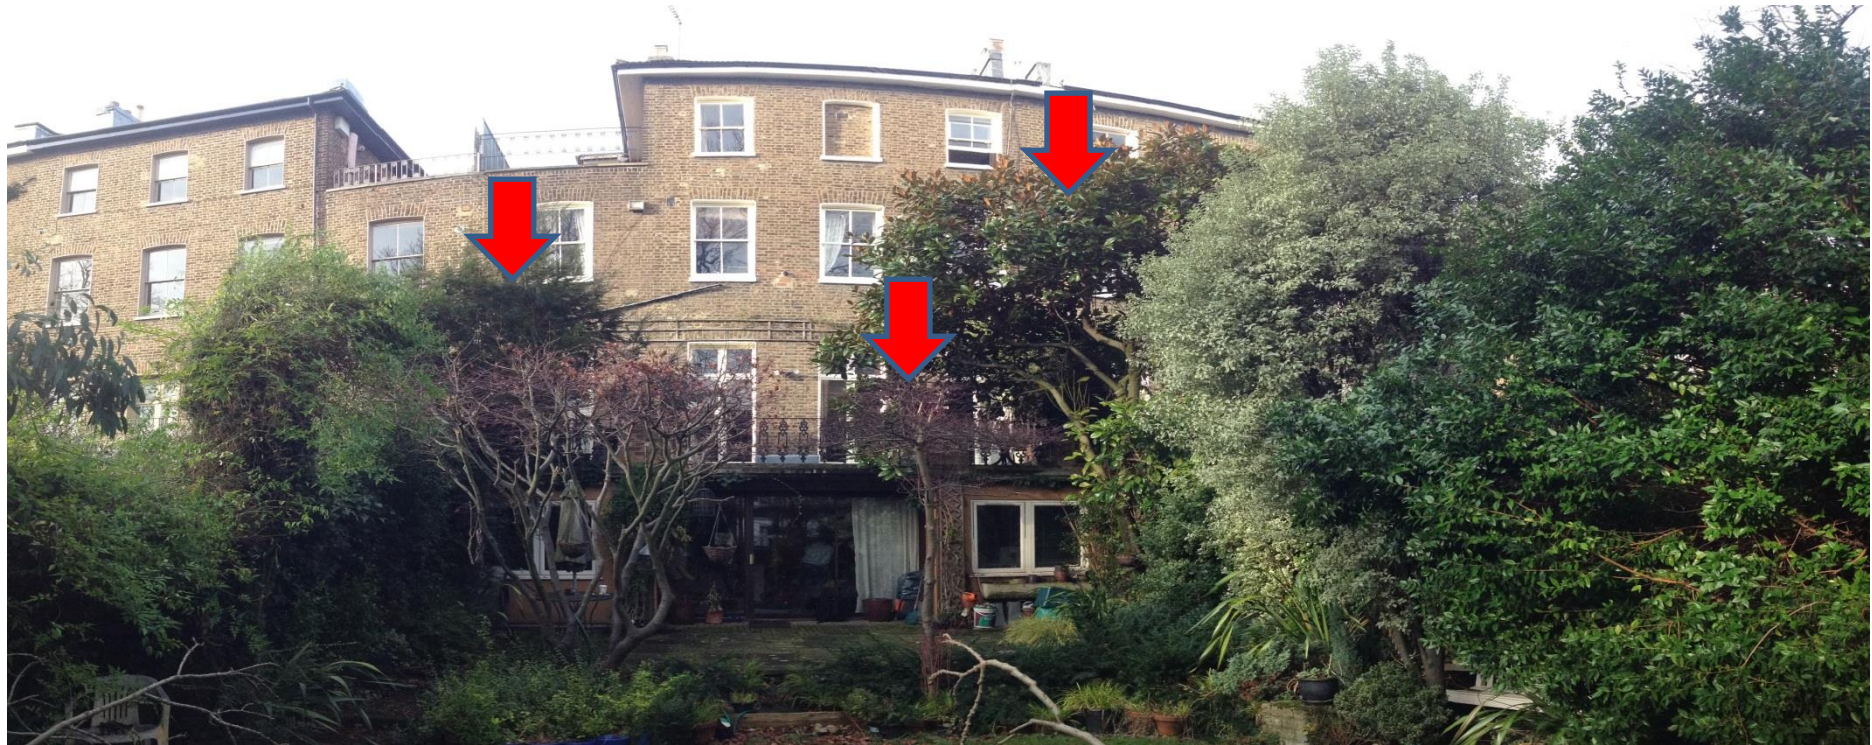
5.3.2 T1, 2 & 4 are on the very verge of CA size threshold for notification. T5 is a larger Magnolia tree but this is not visually significant from a public place and is growing in very close proximity to the existing building. It has a large [included union](#) at the base of the main stem It is not considered a suitable tree for long term retention within a TPO.

**Image 1** – T1 (l) to T5 (r) – Trees to be removed indicated by arrow (Note: T2 too small to be seen)

Tree No.	Species	Proposed Tree Works	Observations	BS Cat
T1	Box	Remove to facilitate development	Previous pruning wounds, very close to the building. Visually insignificant to wider amenity.	C
T2	Acer	Remove to facilitate development	Previously pruned. Small and visually insignificant to wider amenity.	C
T4	Cornus	Remove to facilitate development	Topped small and visually insignificant to wider amenity.	C
T5	Magnolia (grandiflora)	Remove to facilitate development	Twin stemmed tree from 0.5m. Ivy and location hindered full inspection. Basal included union.	C

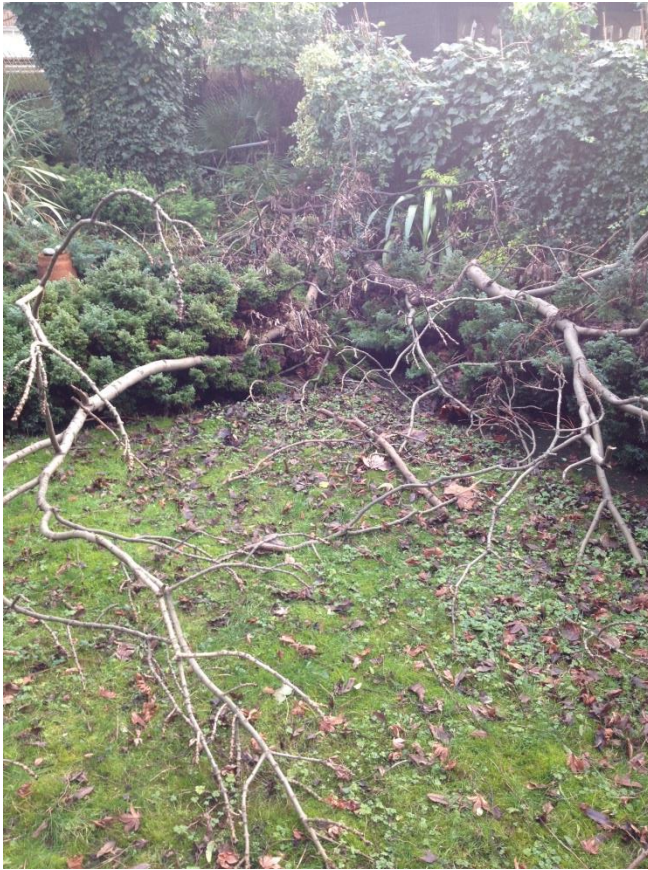
- 4.4 T6 (Ash) has 2 large decay pockets and [Inonotus hispidus](#) fungal fruiting bodies were noted high on the western stem. The tree has been braced. We are advised that this tree may be subject to a TPO. A large limb has recently been shed from the western stem. Tree works in accordance with the enclosed schedule are therefore advised to address safety concerns and reduce the canopies exposure and hopefully prolong the retention life of the tree. It should be inspected again within 3-5 years of this report.

**Image 2 – Recently lost limb from T6 (Ash)**

Tree No.	Species	Proposed Tree Works	BS Cat
T6	Ash	Crown reduce by 3-4m to reduce leverage on the areas of decay on the main stem. Monitor condition and fungal pathogen progress.	B1

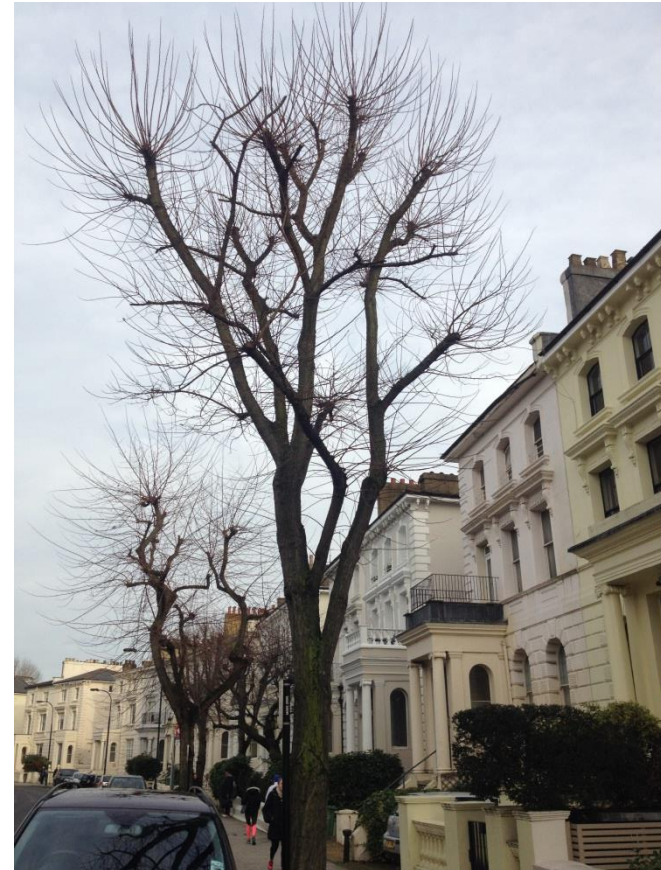
BS 5837 Cat	A	B	C	Summary
RPA Incursion	-	-	-	Subject to the removal of T1, 2, 4 & 5 there will be no RPA incursions from the proposed development.
<b>Note:</b> The local authority tree to the front of the property is not included within this report. The tree is surrounded by hard standing and as such the ground will not compress regardless of the construction activity to the front of the property. Subject to suitable shielding of the main stem by a plywood frame erected prior to construction there is envisaged to be no potential adverse effect on this tree.

**Image 3 – Local authority tree. Lower stem to be shuttered with ply**

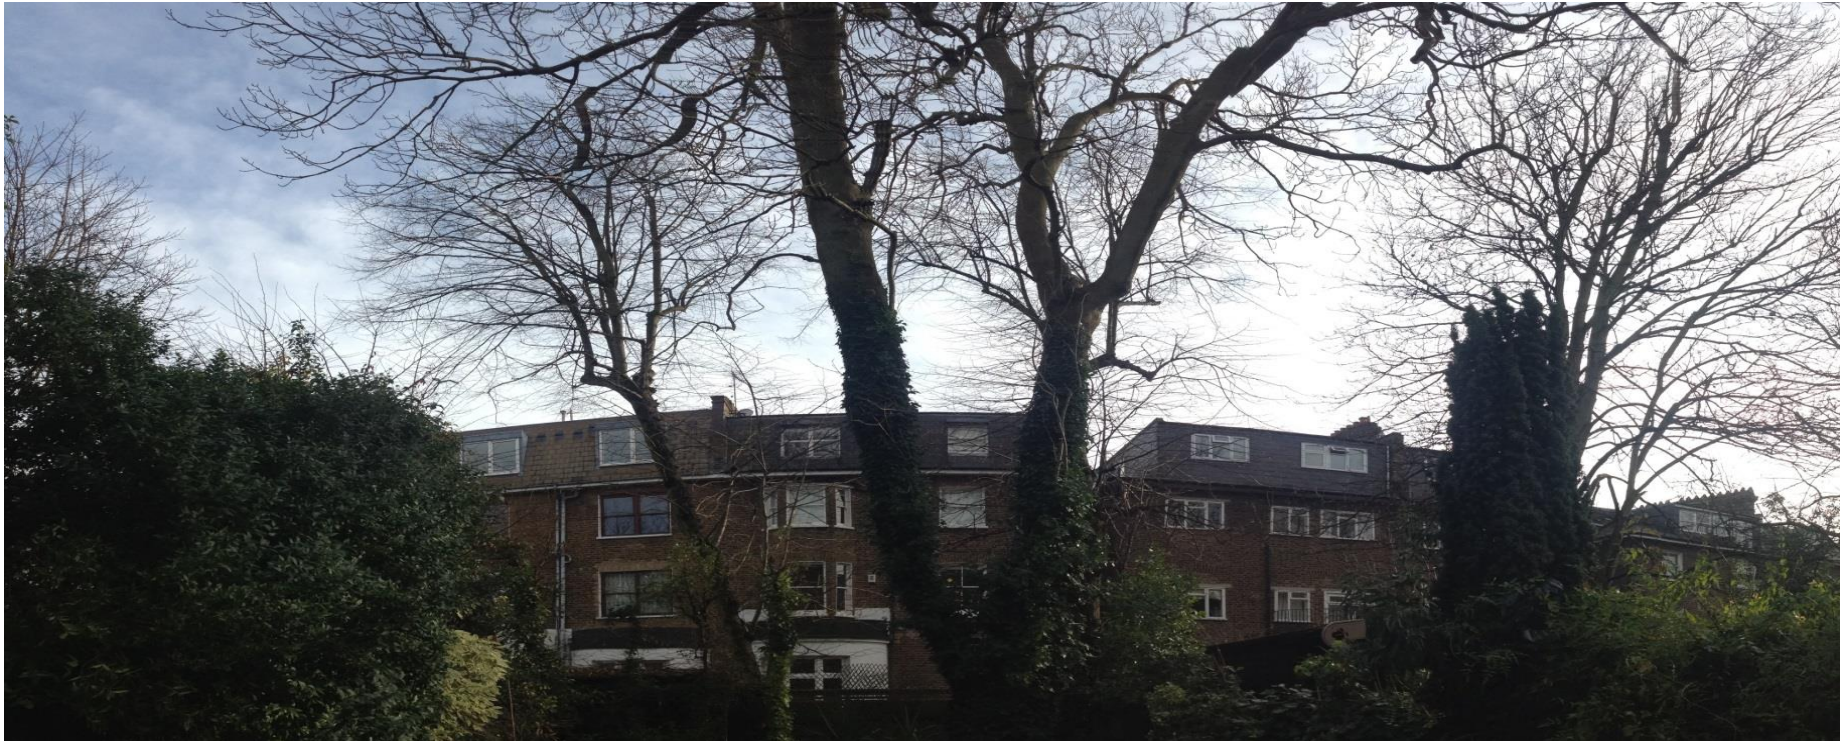
- 4.3 T6, 7, 8 & 9 are located to the north of the property. T9 is a 3<sup>rd</sup> party tree. T6, 7 & 8 are away from the proposed development and there is likely to be no impact on them if they are protected by virtue of a single fence line across the garden during construction and in accordance with this report.

**Image 4** – T7 (l) to T9 (r) – All trees to be retained. (**Note:** T8 obscured)
