ARBORICULTURAL IMPACT ASSESSMENT REPORT:

Proposed Flats
10a Oakhill Avenue
London
NW3 7RE

Ref: MEA/10aOA /AIA/03

Date: 7th February 2014

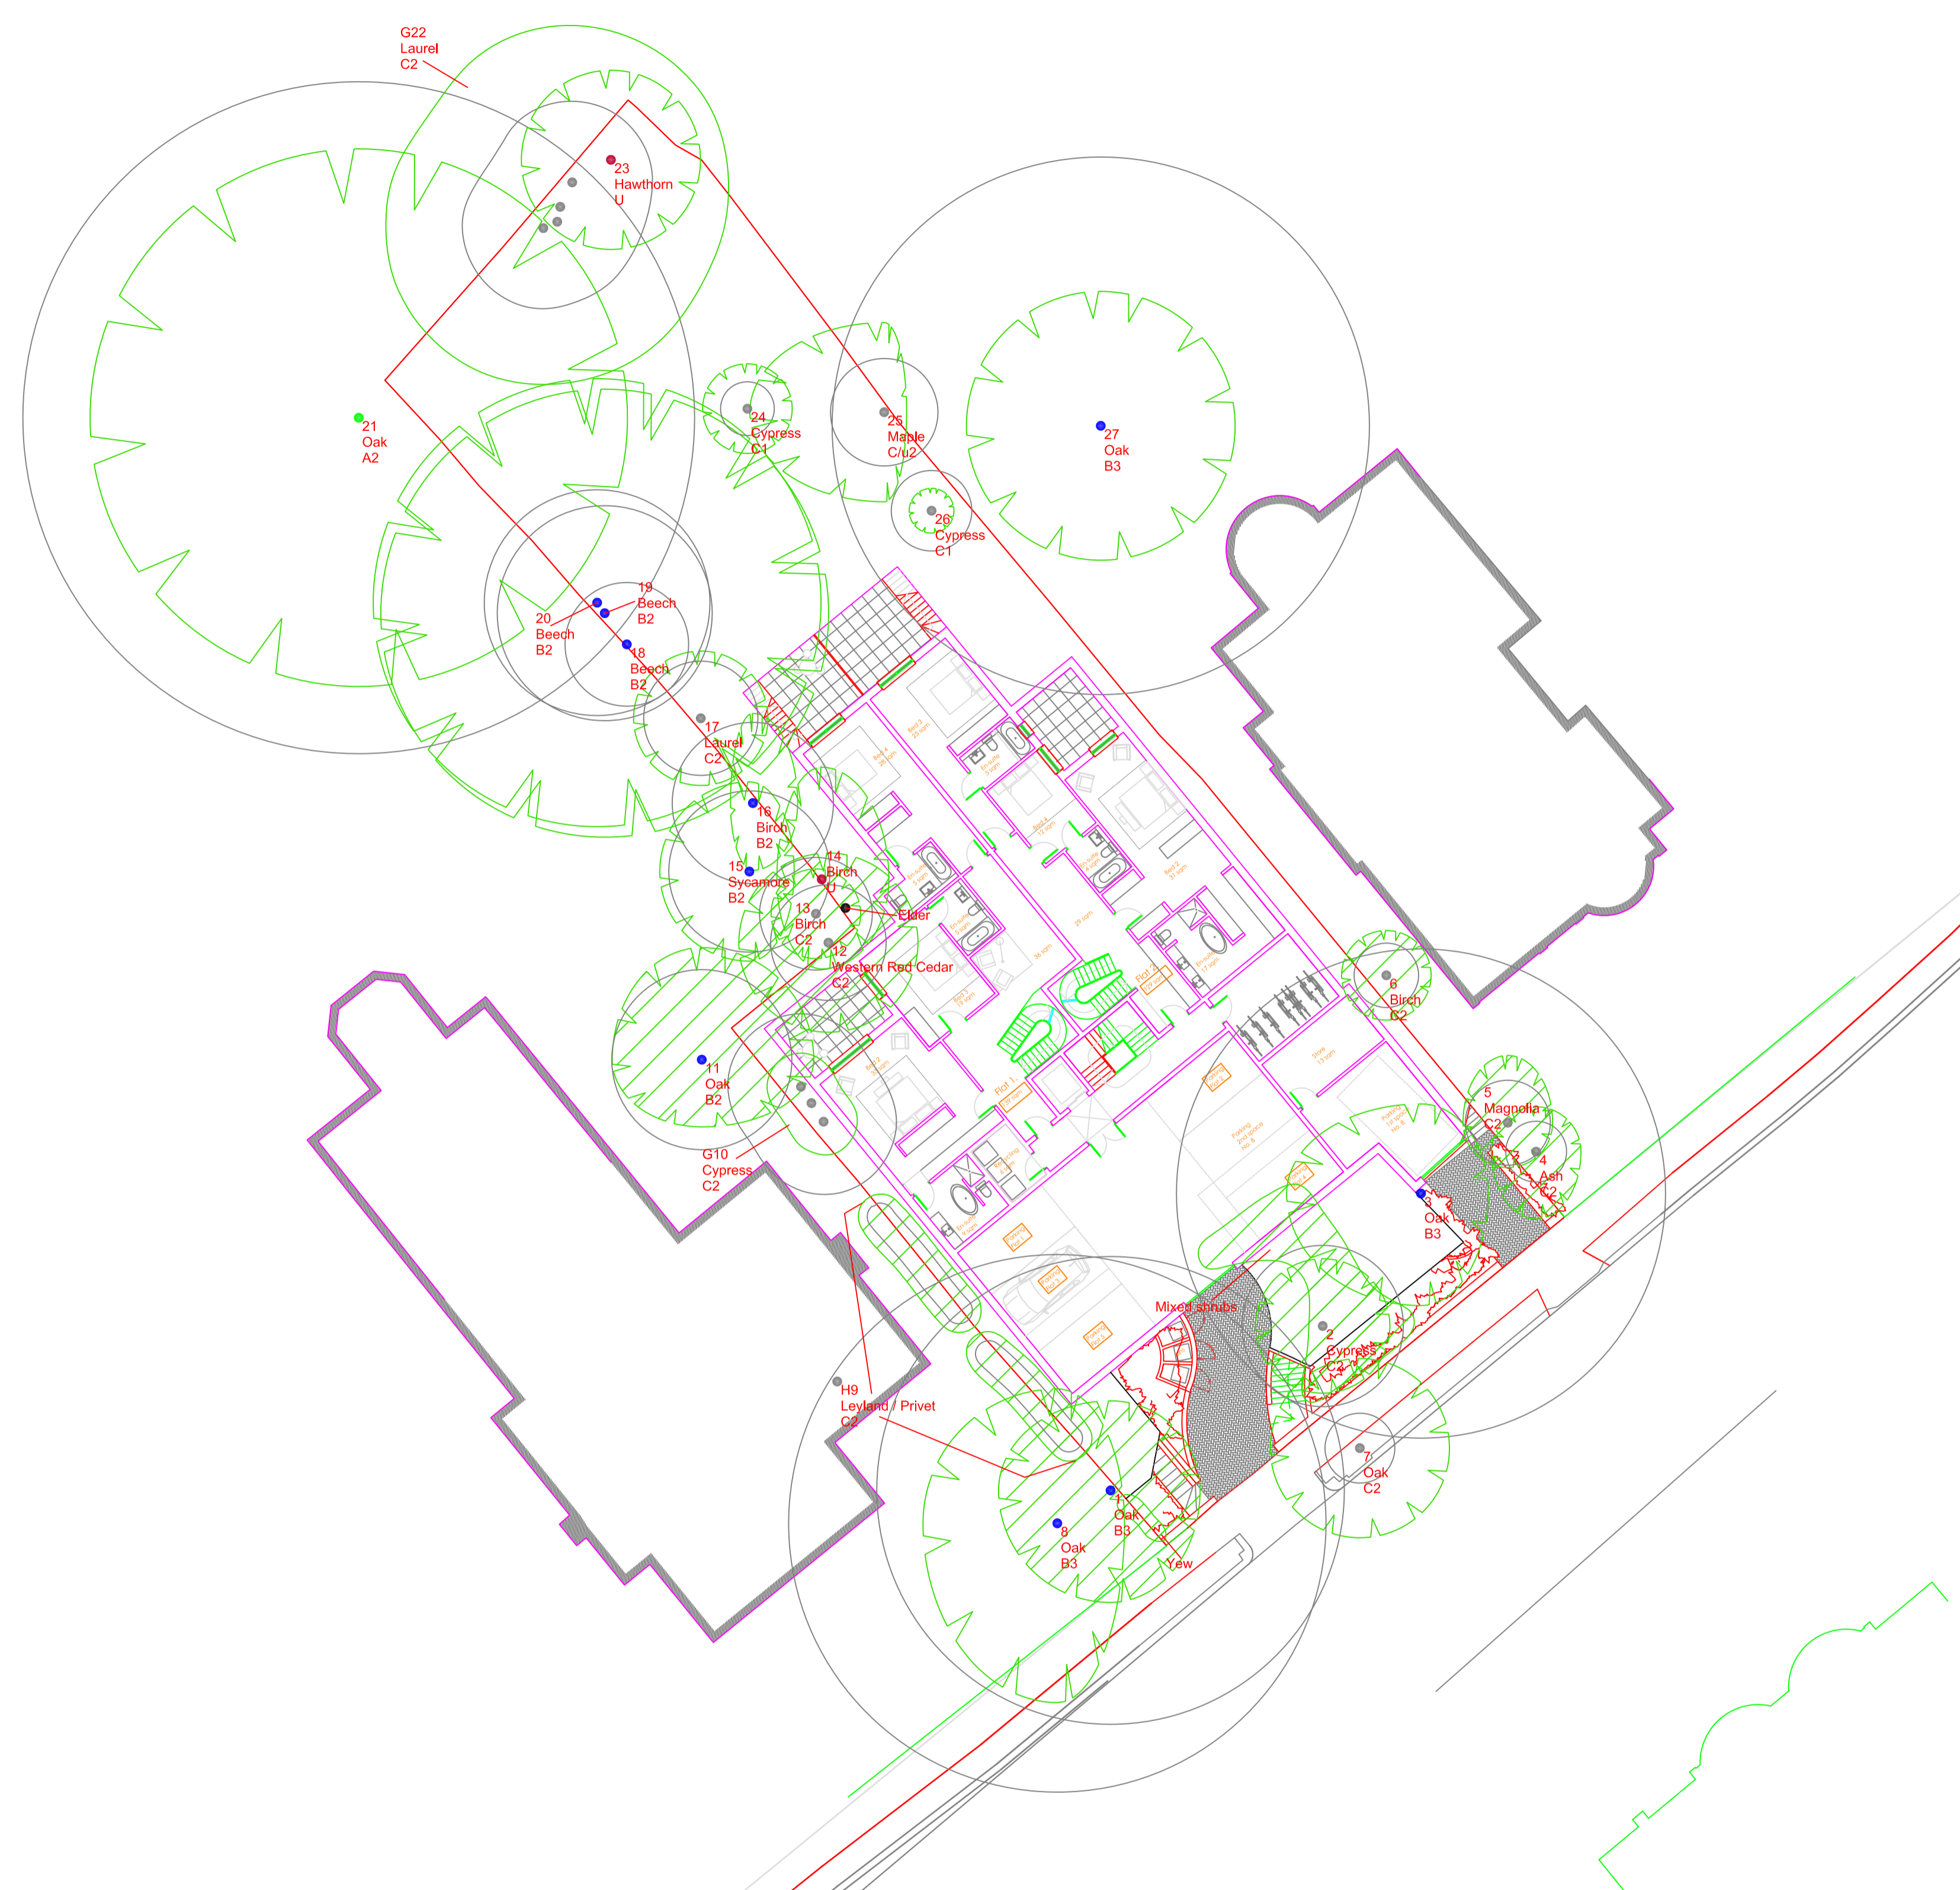
ARBORICULTURAL IMPACT ASSESSMENT PLAN

- 1.3 The primary impacts in the current proposals are very similar to the previous scheme for flats on this site. They comprise the felling of two category 'C' trees/ groups (G10 Leyland cypress hedge and T2 Leyland cypress). These rate as low impacts with no significant effect on the visual character of the local conservation area. Further low impacts from the extension of the lower ground floor (LGF) occur to the theoretical RPA's of category 'B' trees T1 (5.4%), T8 (3.9%), T16 (6%) and T27 (4.2%), with theoretical medium impacts to T12 (22%). These theoretical encroachments are reduced further in practice by existing site limitations such as changes in level and drainage (as indicated by manhole covers within the RPA). T3 may also incur theoretical impacts from the removal of the existing step and replacement with new; level differences in the site will have significantly affected the root colonisation of this tree. Thus, the primary impacts are likely to be very low/low, given sufficient site investigations and mitigation: the foundations and existing hard-standing within the RPA's should be manually excavated, with any roots found pre-emptively pruned; roots over 25mm should be pruned under arboricultural supervision. Trial pits are recommended to further assess actual RPA encroachments.

- 1.4 The proposed hard landscaping works will affect trees T18 - T21, T25 - T27, with the removal of existing hard landscaping features such as retaining walls and paths, in addition to the potential raising of the ground levels within the RPA of these trees. Providing the walls are removed carefully and the ground levels raised with coarse granular material without disturbing the roots below the existing surfaces, the impact will be low.

- 1.5 The canopy of T12 (a category 'C' western red cedar) will require cutting back to the boundary facilitate construction of the new elevation. The impact to the tree will be moderate, but to the public, very low.
