Landmark Trees

ARBORICULTURAL IMPACT ASSESSMENT REPORT:

Proposed Single Dwelling
10a Oakhill Avenue
London
NW3 7RE

Ref: MEA/10aOA /AIA/02

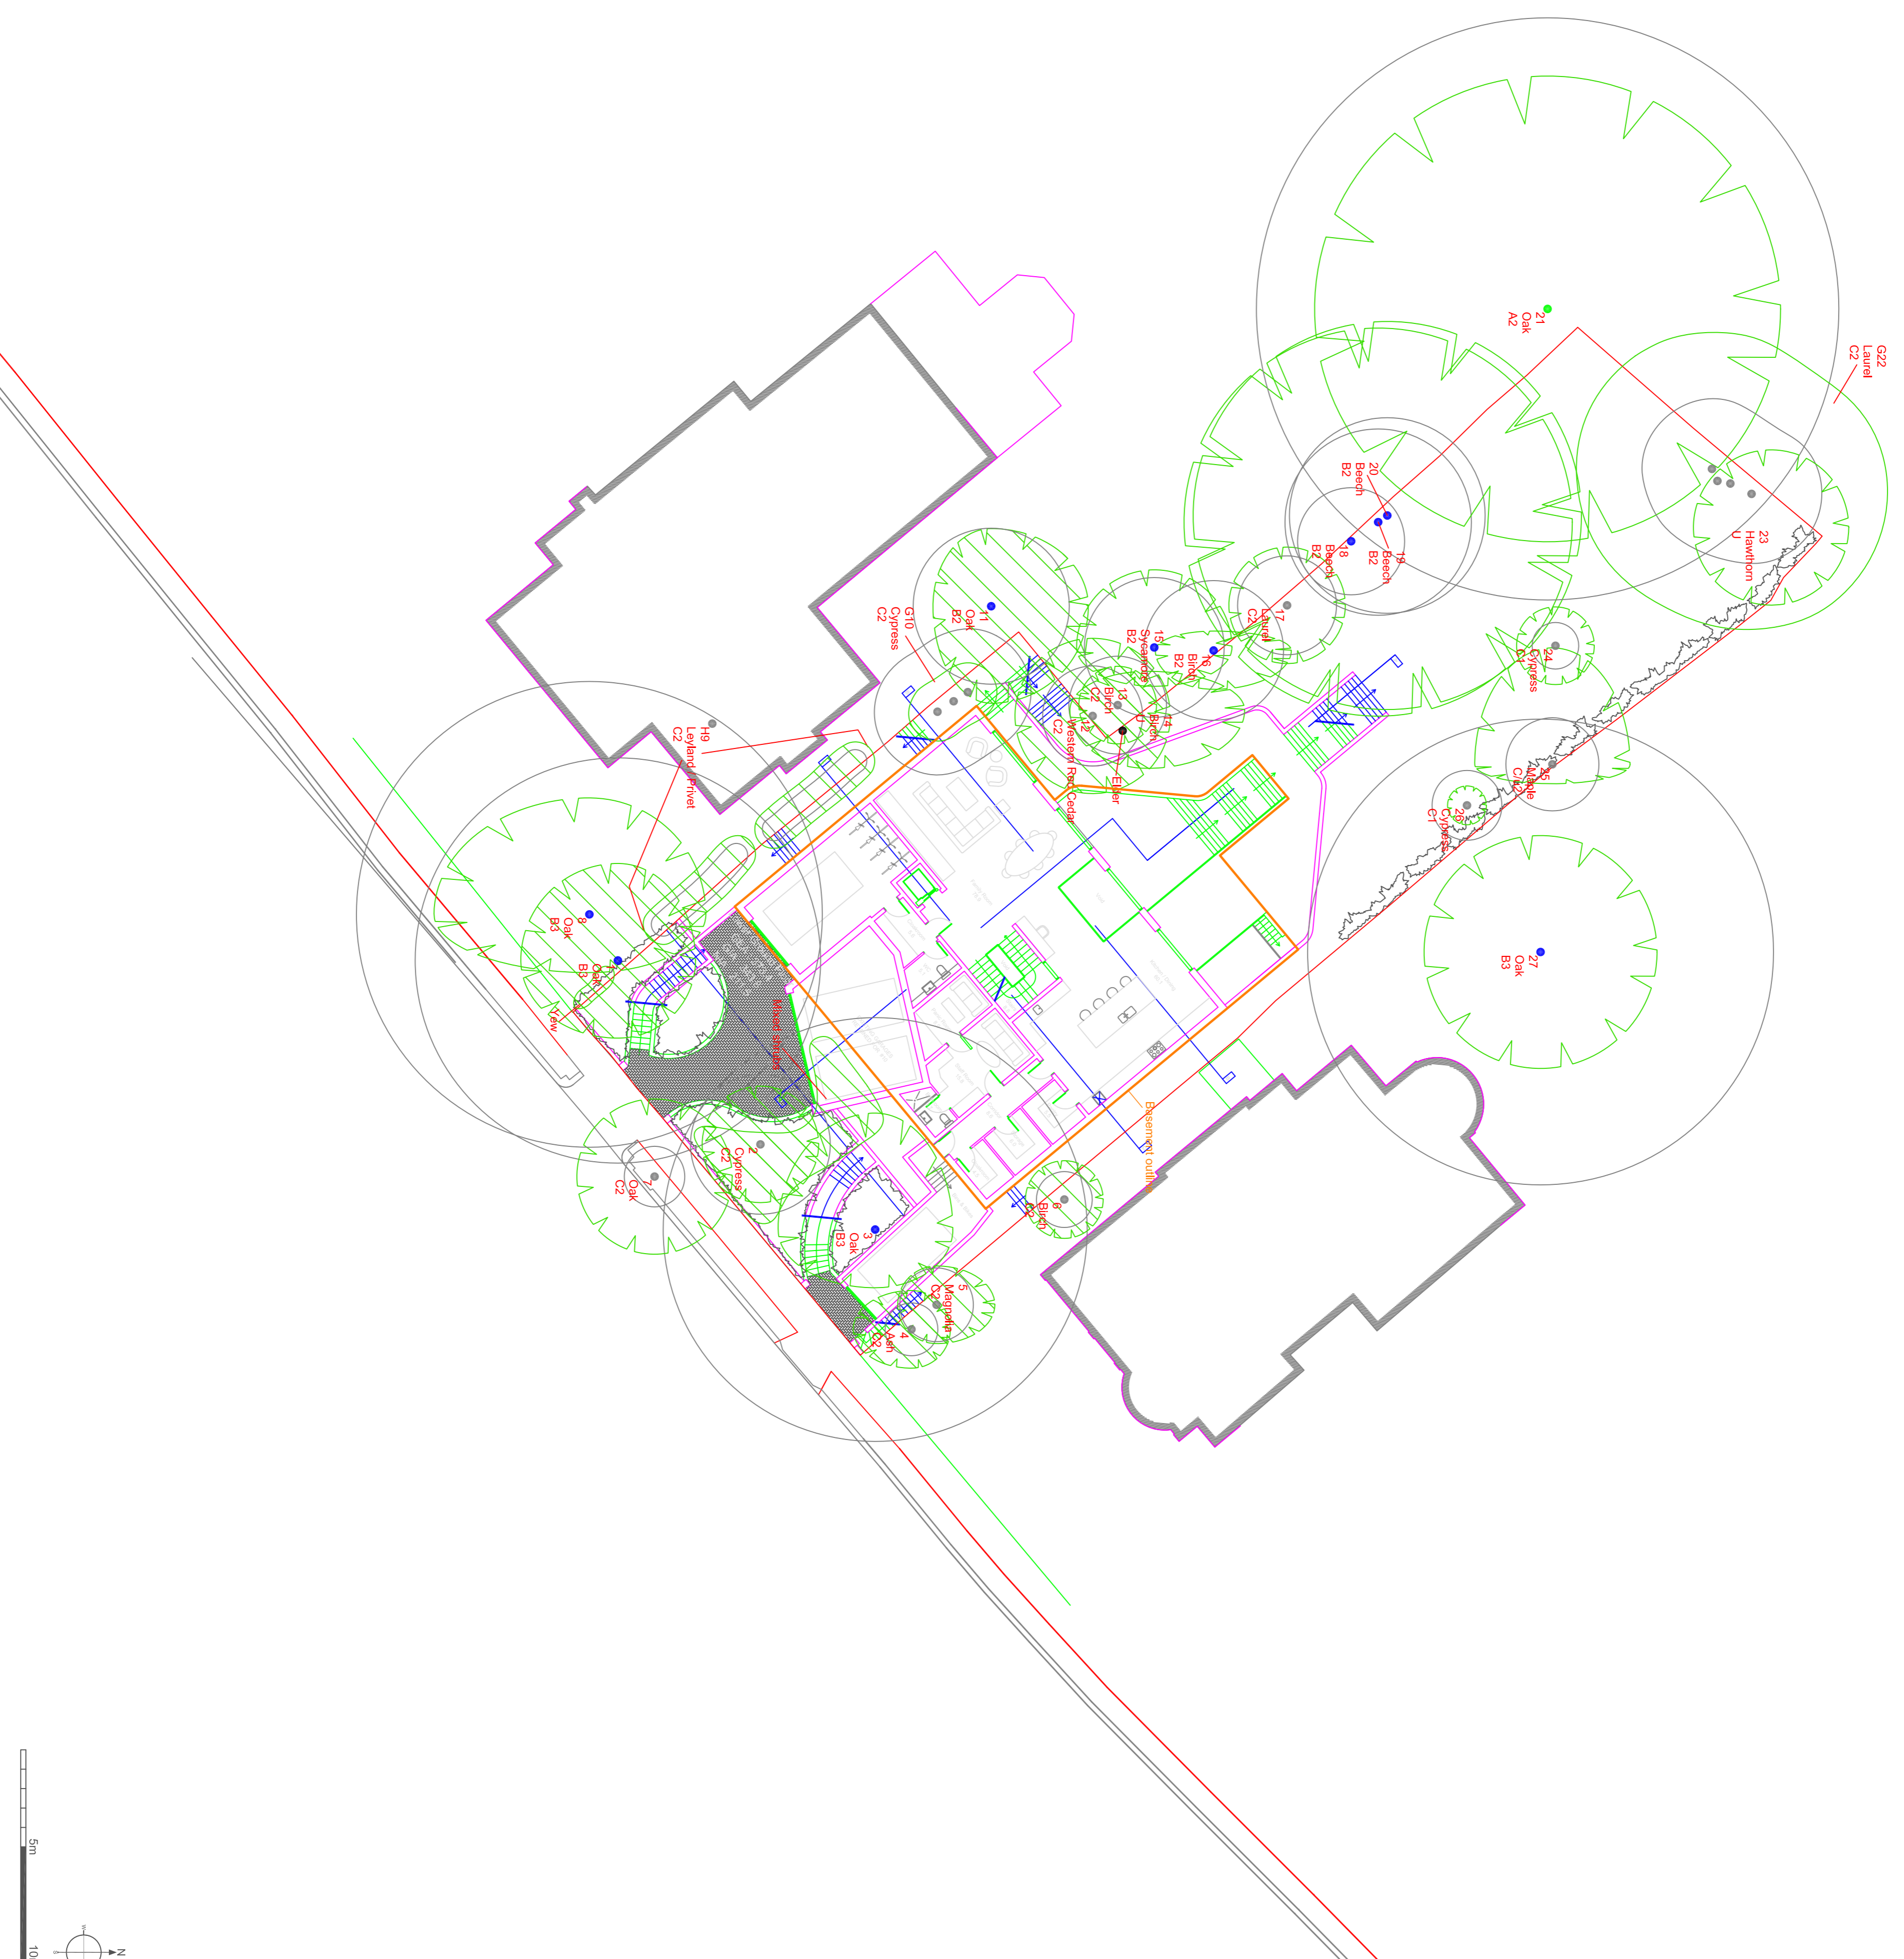
ARBORICULTURAL IMPACT ASSESSMENT PLAN

- 1.5 The proposed hard landscaping works will affect trees T18 - T21, T25 - T27, with the removal of existing hard landscaping features such as retaining walls and paths, in addition to the potential raising of the ground levels within the RPA of these trees. Providing the walls are removed carefully and the ground levels raised with coarse granular material without disturbing the roots below the existing surfaces, the impact will be low.

- 1.6 The canopy of T12 (a category 'C' western red cedar) will require cutting back to the boundary facilitate construction of the new elevation. The overall cumulative impact to the tree will be moderate, but to the public, very low.
