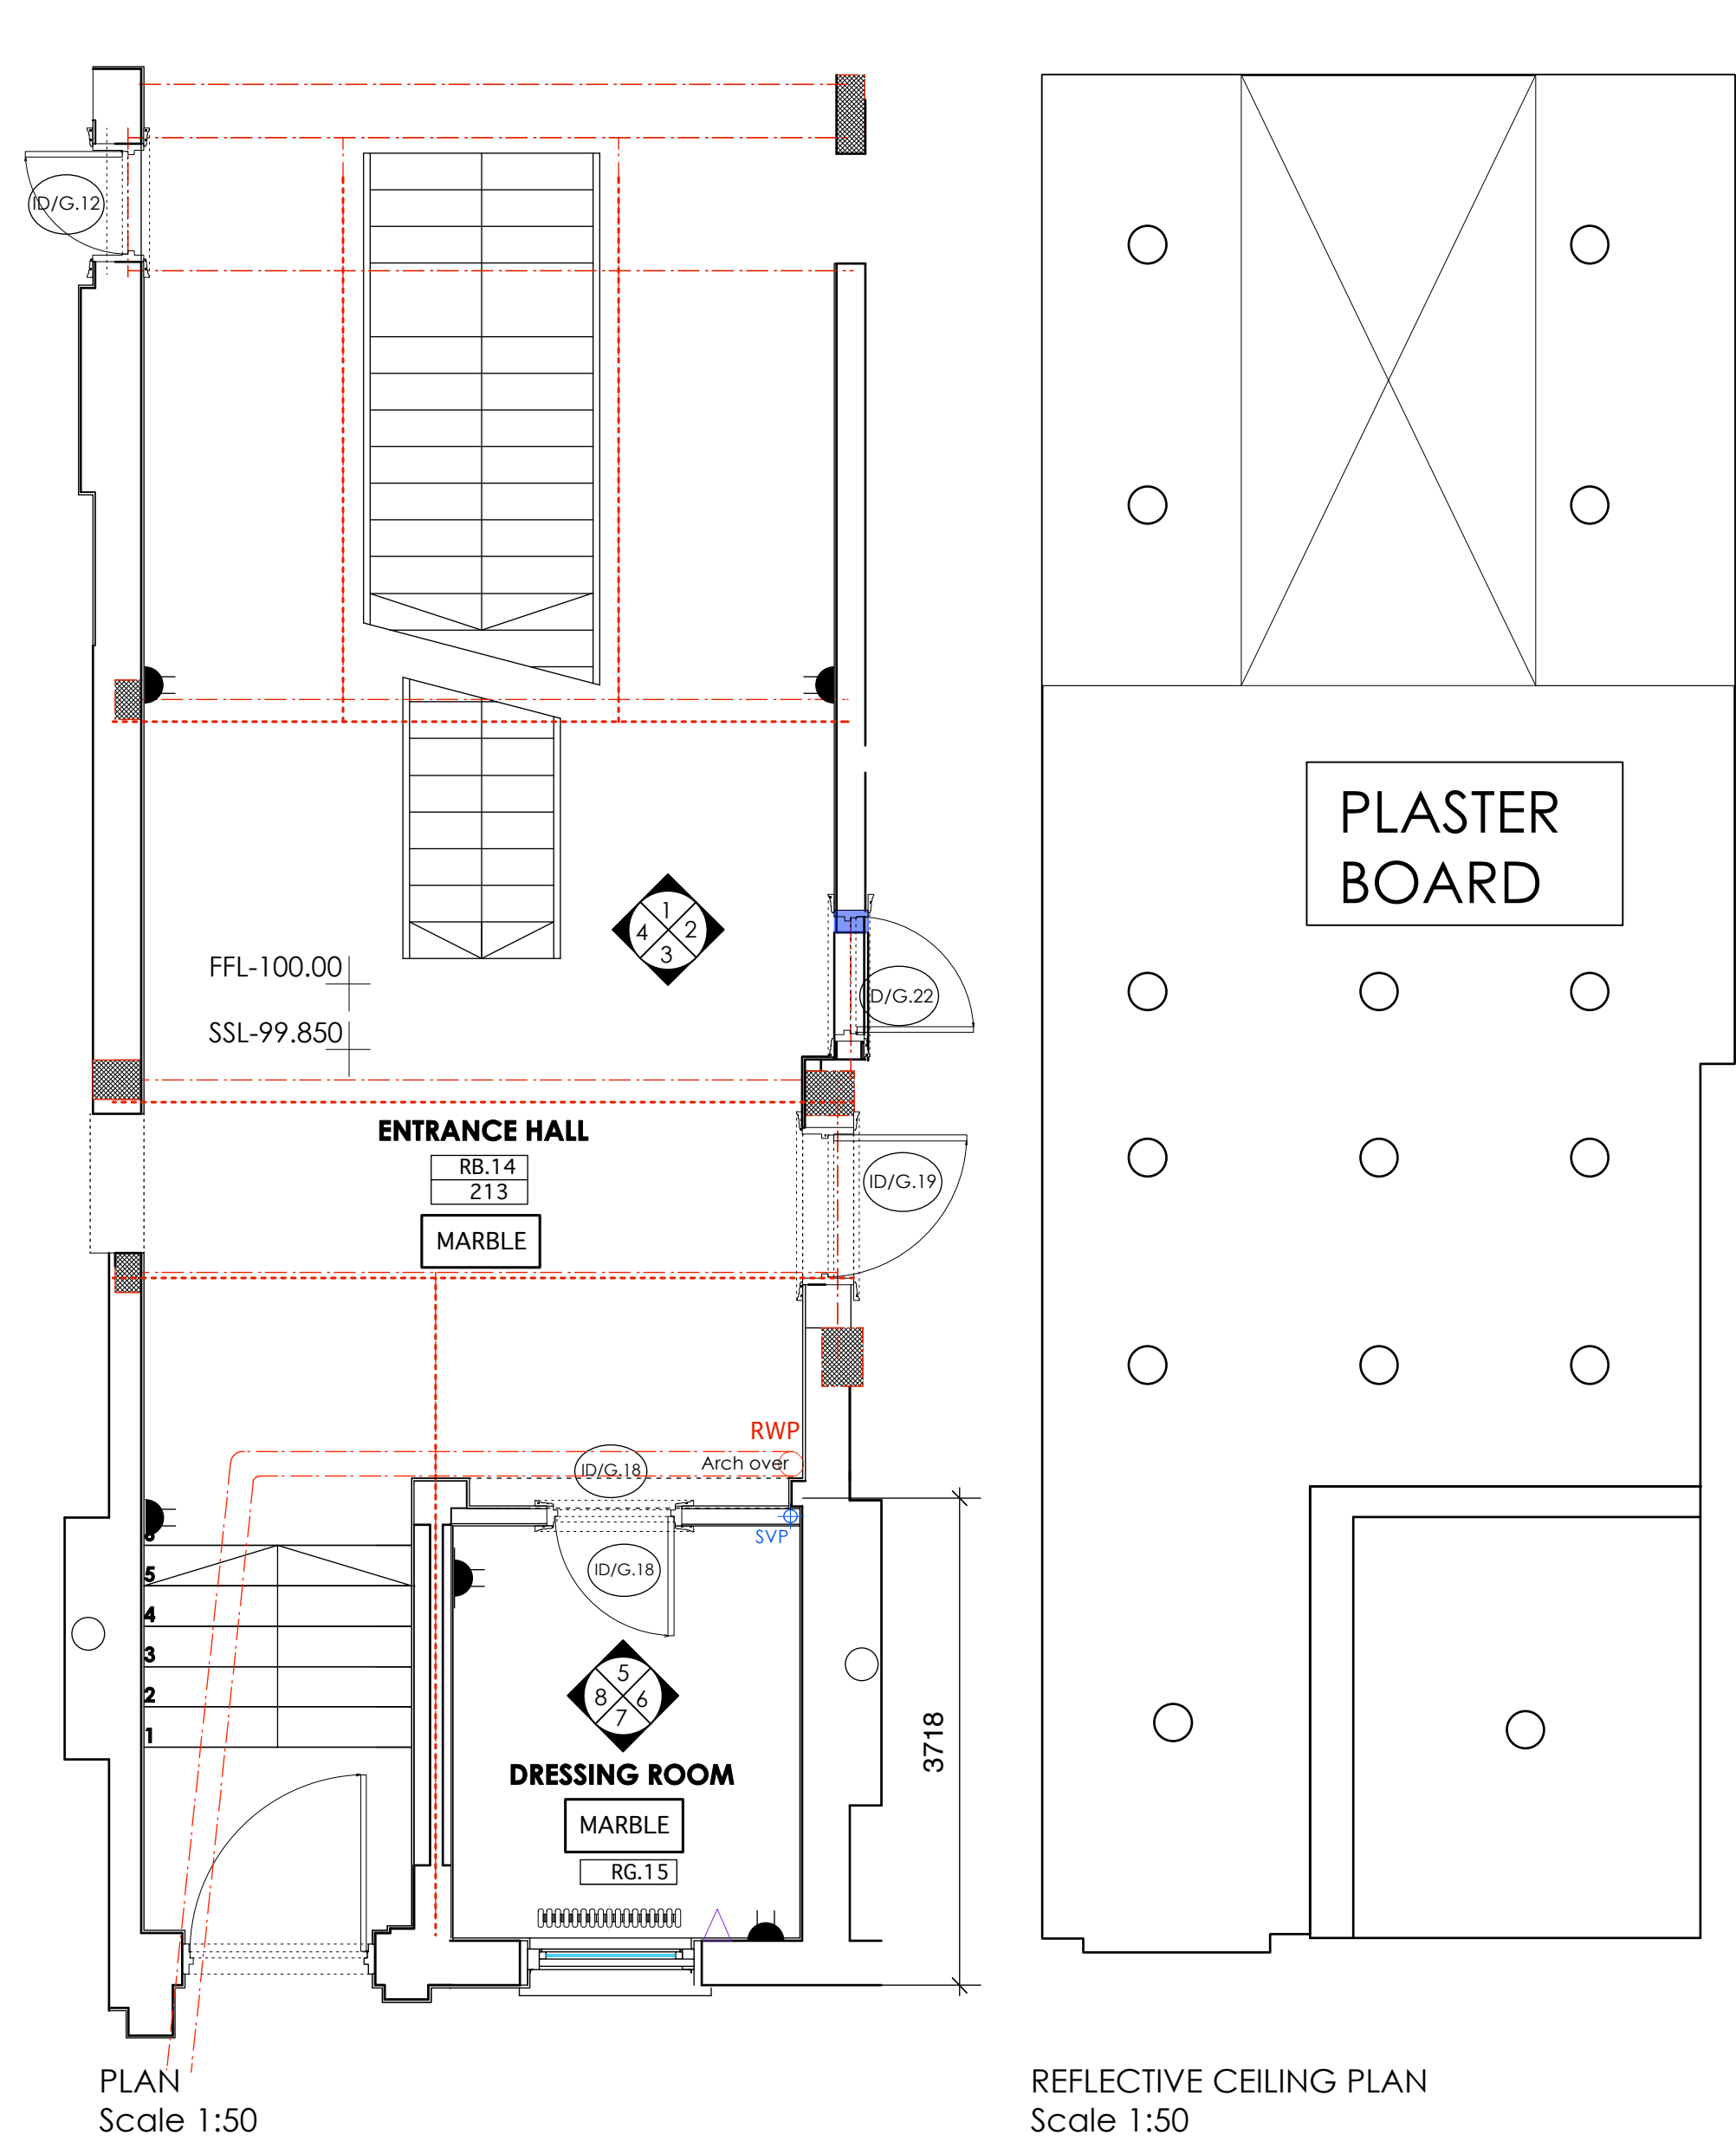
Timber infill removed to expose arched opening, now filled in with brickwork to enclose dressing room

Splayed casement window shown in photograph no longer on site. Replaced EW/G.22 on site.

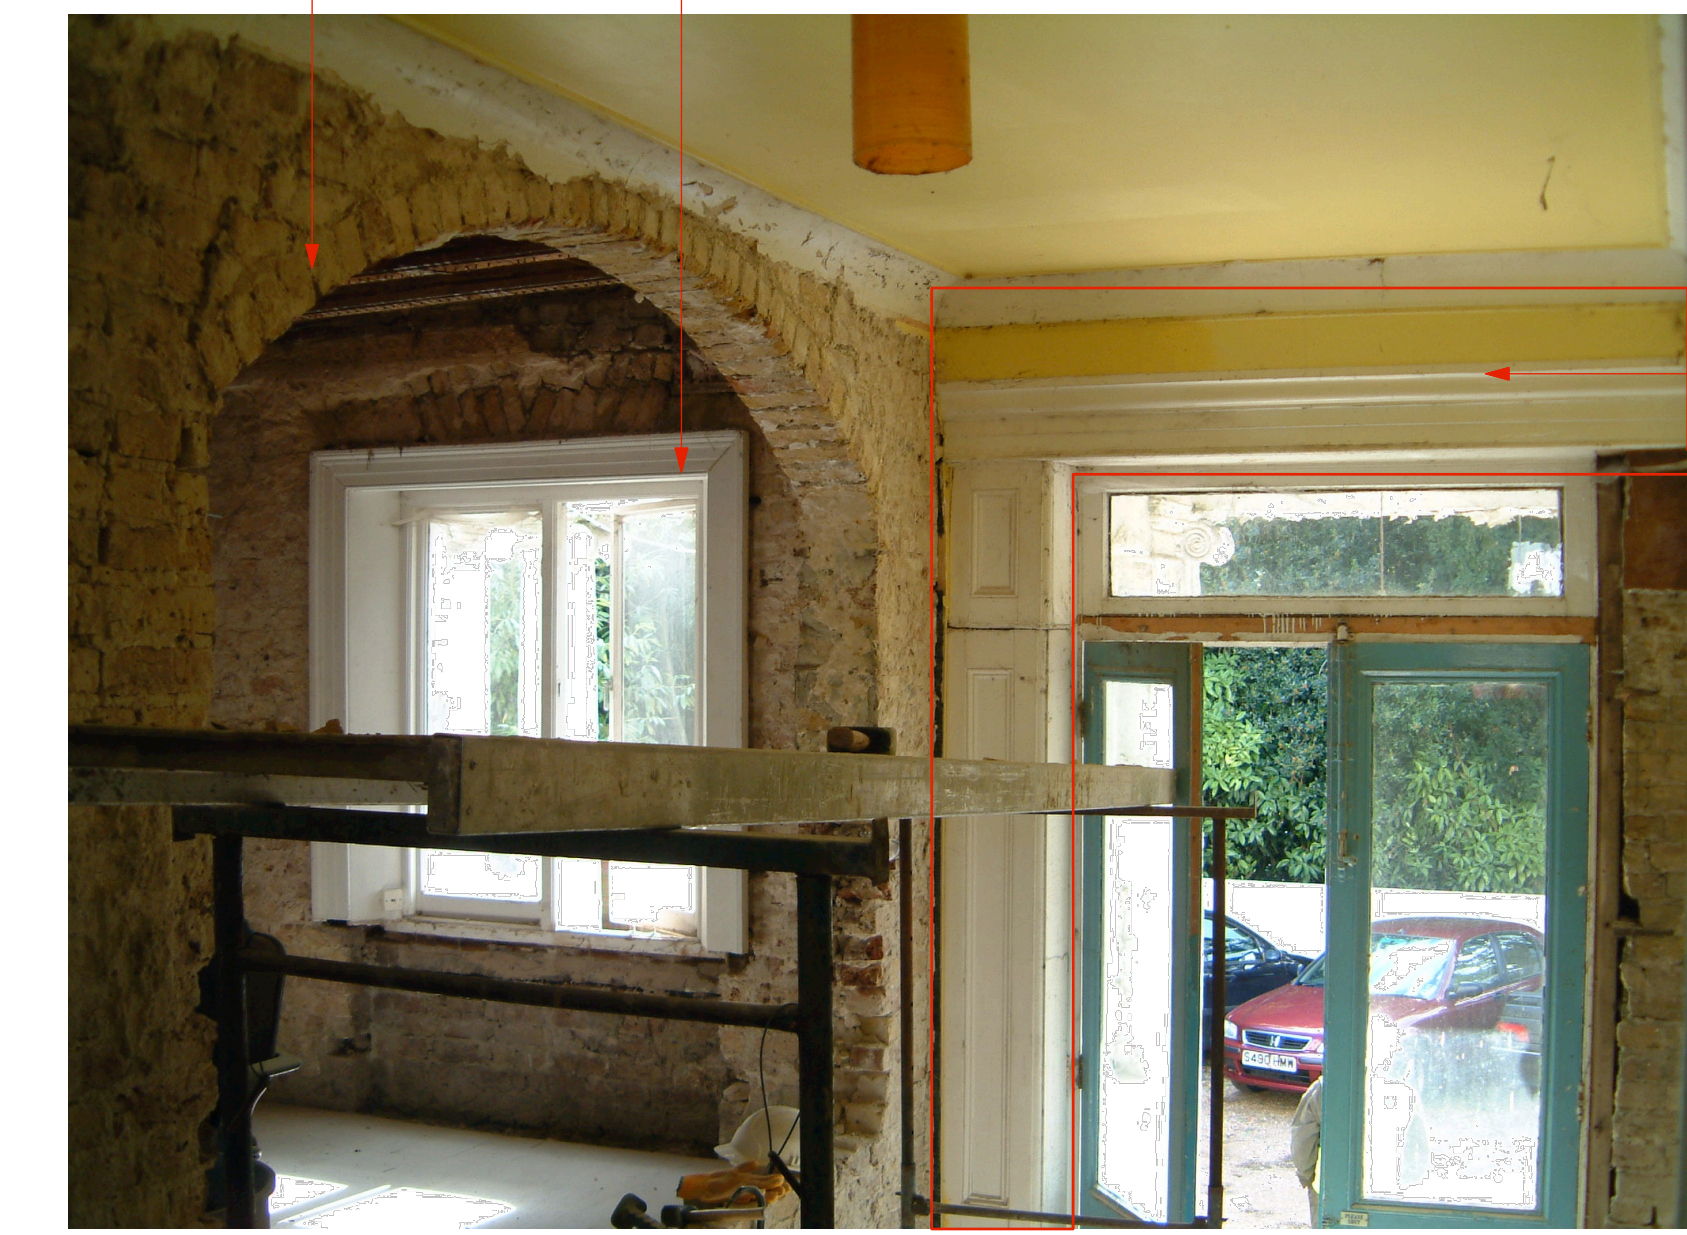
Check new FFL against FFL in listed part of the building

South entrance joinery framing to be carefully restored
