AGAR GROVE TREE SURVEY AND IMPACT ASSESSMENT DECEMBER 2013

Tree Survey, Arboricultural Impact Assessment Preliminary Arboricultural Method Statement & Tree Protection Plan In Accordance with BS 5837:2012

Proj. No 3743	Agar Grove, Camden, London			
Client:			Grant Ass	sociates
Date of Report:		19/11/2013	Revision:	Original

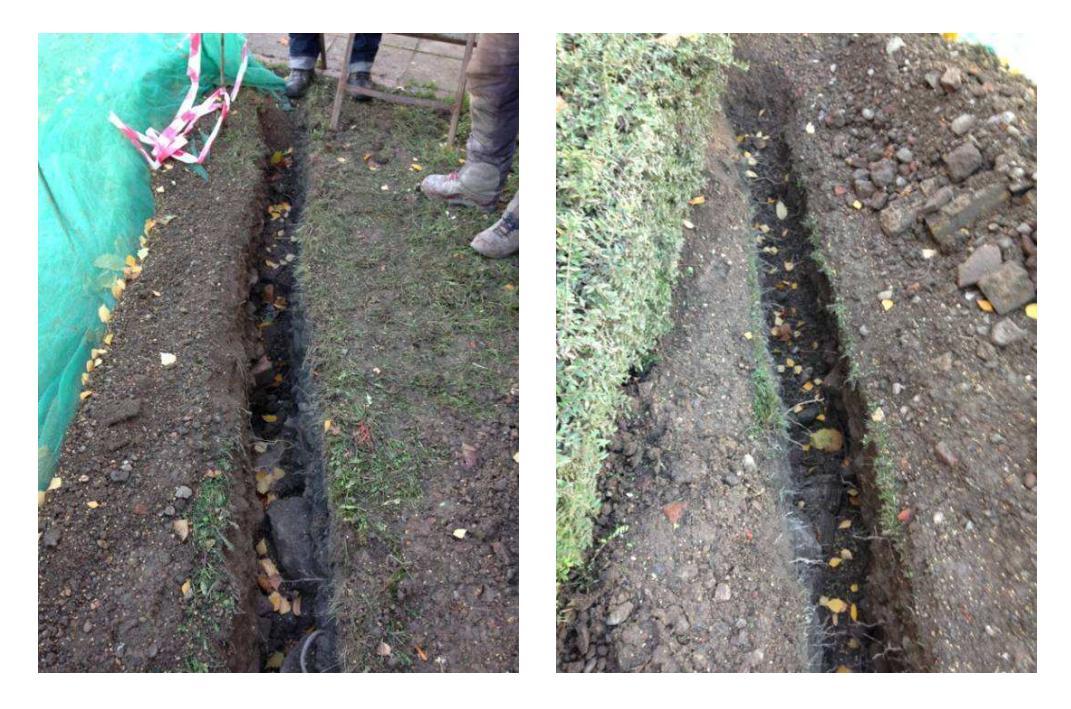
T033

A 5m long trench was excavated within an area of grass to a depth of approximately 450-500mm. The base of the trench was filled with large bricks and building rubble preventing deeper investigation.

Small fibrous roots were found in the top 50mm, below this only a few small roots were found.

Given the small volume of roots found it is our opinion that the proposed root pruning to facilitate the building foundations will not have an adverse impact on T033. It is recommended a minor crown reduction is undertaken to reduce the sail area and provide clearance for construction access.

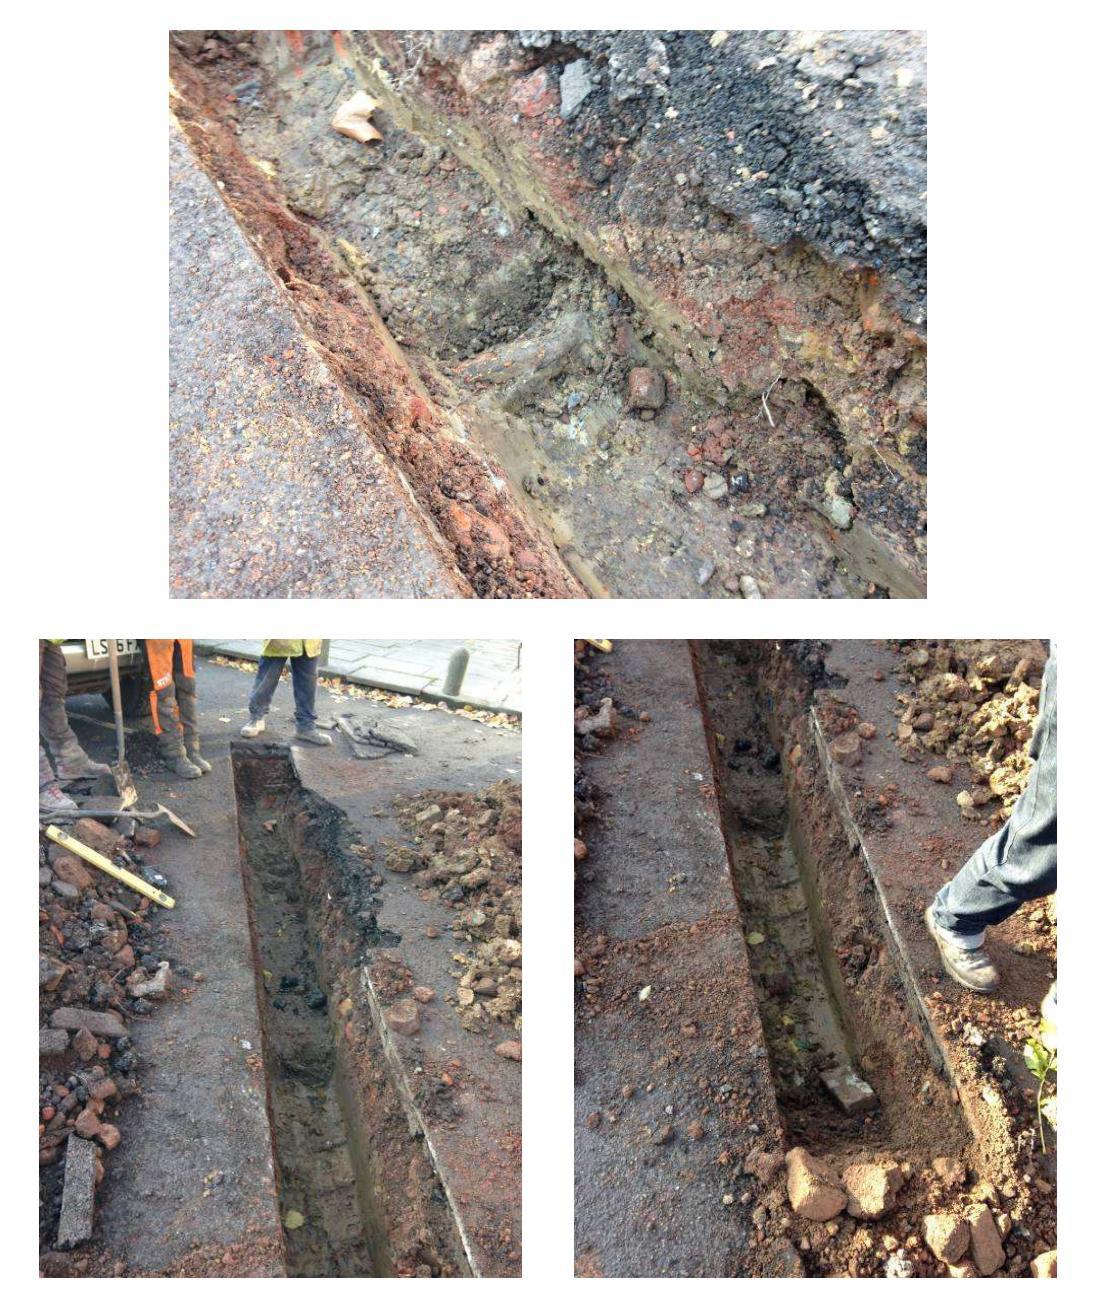
A 5m long trench was excavated within a tarmac car park to a depth of approximately 450-500mm. The top half of the trench features 50mm of tarmac with a sub-base of approximately 250mm. Below this the soil consisted of heavy clay.

A small volume of fibrous roots were found in the sub-base material and two larger roots of approximately 50mm were found at a depth of 450mm within the clay.

Given the small volume of roots found it is our opinion that the proposed root pruning to facilitate the building foundations/service trench will not have an adverse impact on T038. It is recommended a minor crown reduction is undertaken to reduce the sail area and provide clearance for construction access.

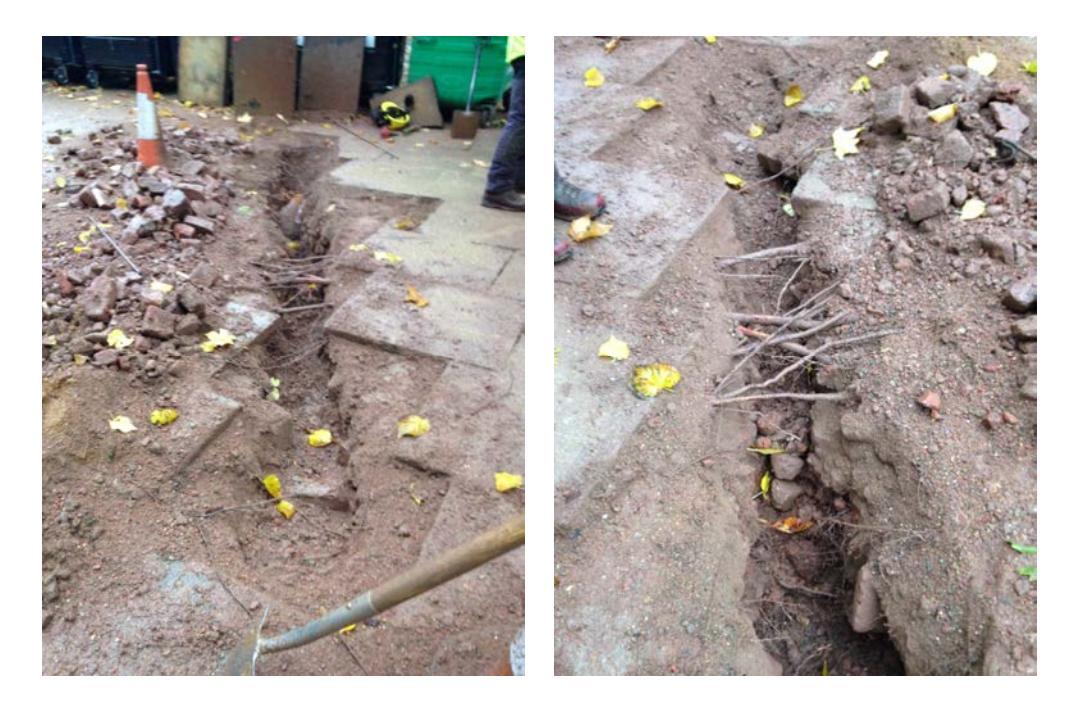
A 5m long trench was excavated within an area of hard surface covered with paving slabs. The trench was excavated to a depth of approximately 350-400mm. A thin layer of sub-base was present below the paving slabs, with a soil comprising of dense building rubble beneath this. Due to the large volume of bricks present it was not possible to excavate deeper that 400mm.

A large volume of roots were found in the thin sub-base directly beneath the paving slabs, below this only minor fibrous roots were found in the building rubble.

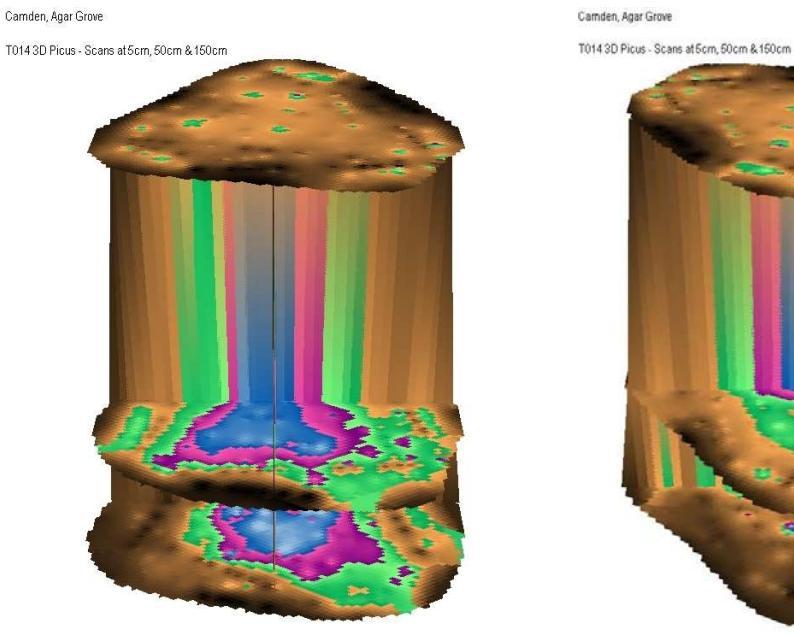
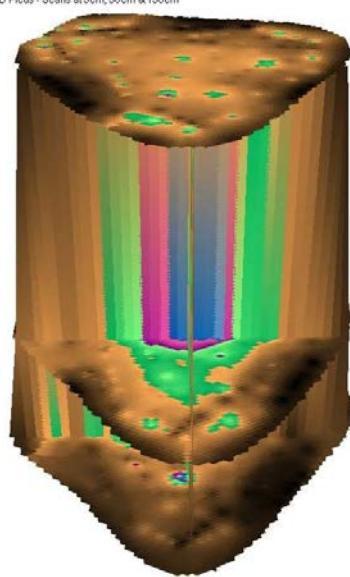
3D Picus result of T014. Scans taken at 5cm, 50cm and 150cm above ground level.
