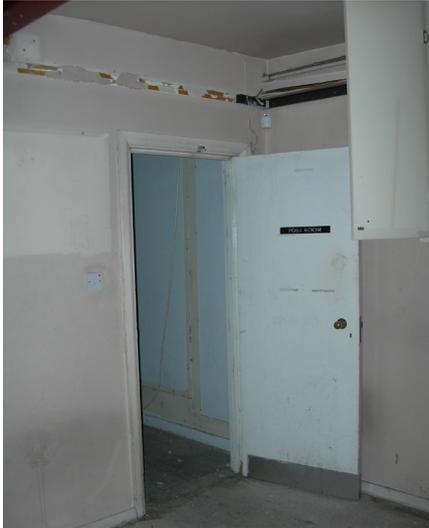
Photograph 01: existing basement level door leaf DB05 (TV/Games Room/Room B01), note modern chamfered skirting, no cornice

Basement : DB05, DB06, DB07, DB11
Refer to 1257-608 for proposals

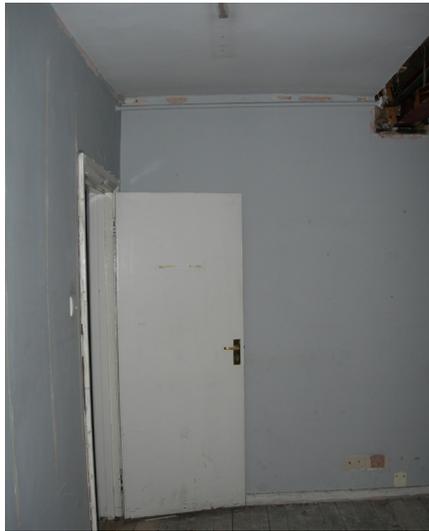
Photograph 02: existing basement level door leaf DB06 (Basement Bedroom/Room B02), existing modern chamfered architrave and skirting, no cornice

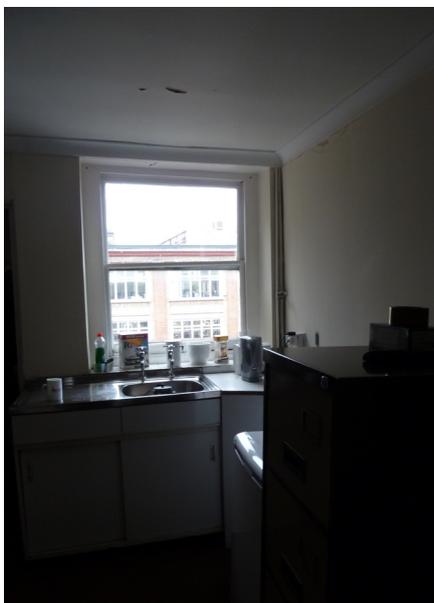
Photograph 03 (left): existing modern coving to Rear Attic Room (Bedroom 04/Room T02)

Refer to 1257-608 for proposals

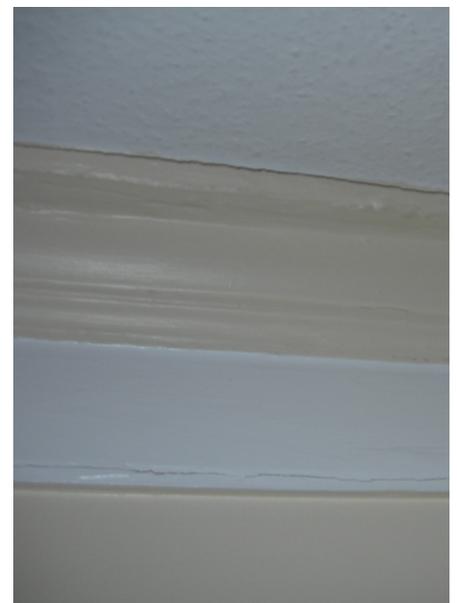
Photograph 04 (right): existing fragment of cornice to Attic Bedroom 05 (Room T01) and stairwell (Room T03) to be replicated for Basement Rooms and Attic Rooms to replace modern coving & to reinstate where cornices are missing

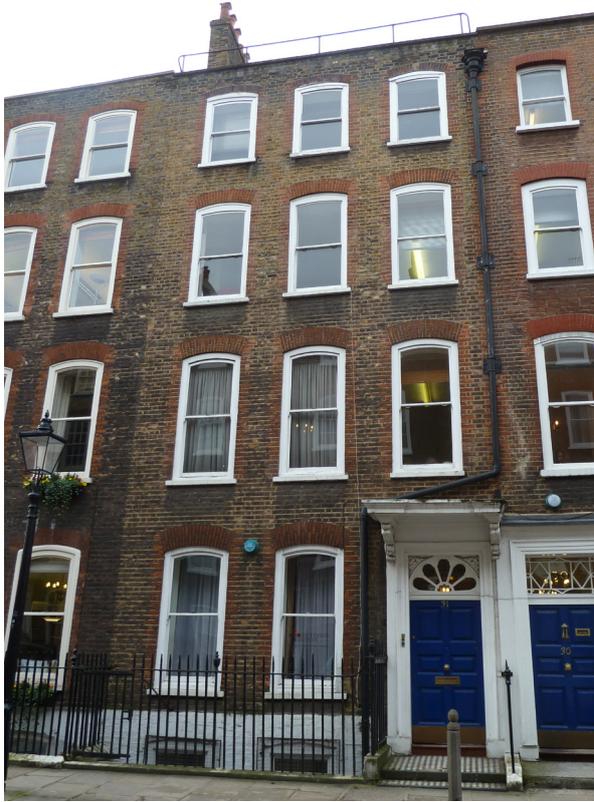
Photograph 04:
 Front (North East) Elevation showing modern clear float glazing without glazing bars

5c **Windows-** Refer to drawings 1257-500 & 1257-501
 New Sashes to existing box frames to front (North East) elevation
 Refer to 1257-500 Rev.A for proposals

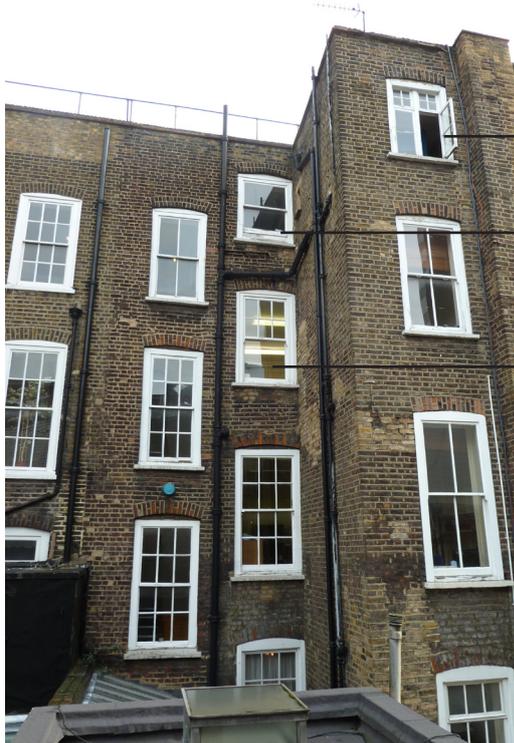
Photograph 05: Rear (South West) Elevation

- WT06- Existing modern casement replaced within existing brick window opening, new box sash window with 6 over 6 lights using lamb's tongue hw glazing bars and restoration glass
- WT05- Window opening altered to original proportions, new box sash with 6 over 6 lights with lamb's tongue hw glazing bars & restoration glass
- WS05- Lower Sash replaced with 6 over 6 lights with lamb's tongue hw glazing bars & restoration glass

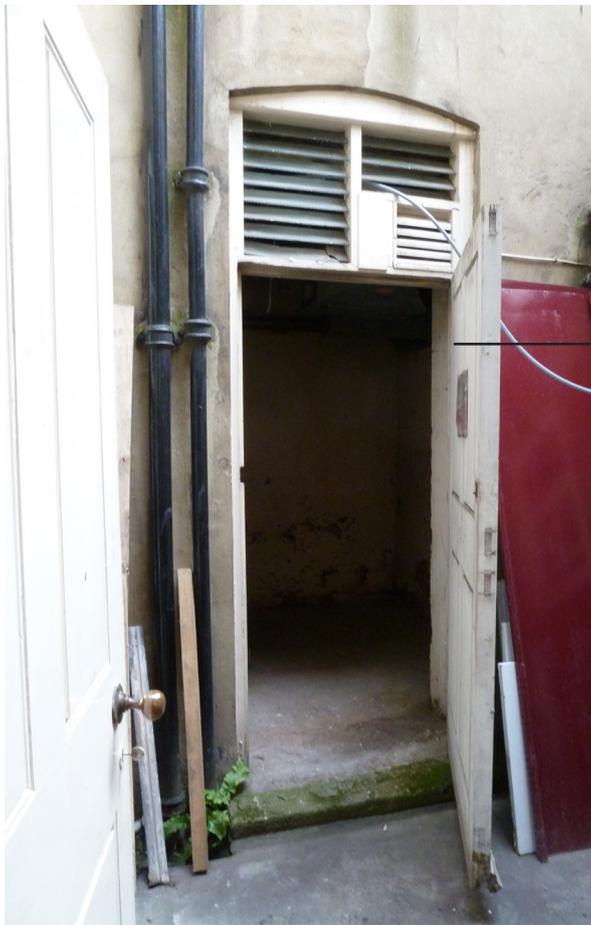
Photograph 06: WB06
Basement doorway changed to window opening and fitted with new vertically sliding sash window with 6 over 6 lights using hw glazing bars (mouldings to match original adjacent window WB03), restoration glass (refer to 1257-501 Rev.A)

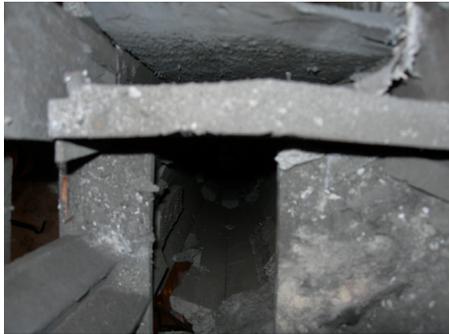
Photograph 08 (left) View looking down the hollow carved ground floor pilaster located in Ground Floor Room (G02/G03)

Photograph 09 (right) Existing steel post located in the Ground Floor Hallway (G01)

The engineer's structural analysis concludes that complete removal of the existing steel posts and beams is not feasible. We have therefore re-evaluated their size and location on each floor. The following photographs show the affected areas. Where possible we have tried to adapt the panelling to accommodate the steelwork so that it is completely concealed from view. In the rear rooms at ground, first and second floor levels, the room panelling has been moved forwards into the room in order for two slim line posts (50x100mm) to be inserted between the stairwell panelling and room panelling. This will involve minimal alterations to the cornice and the removal of the larger (152x152) steel posts which were boxed in at each level.

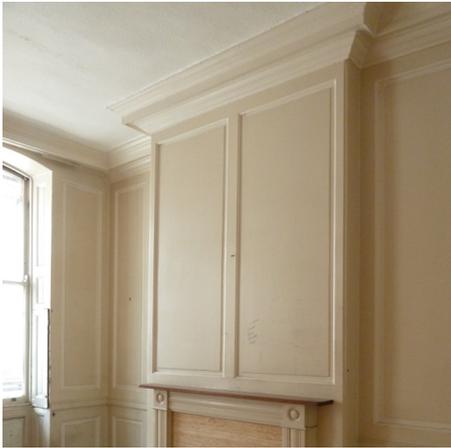
Photograph 13 (left) Existing modern panelling above first floor level fire surround in front room (Room F01)

Refer to approved drawing 1257-602 Rev.P3

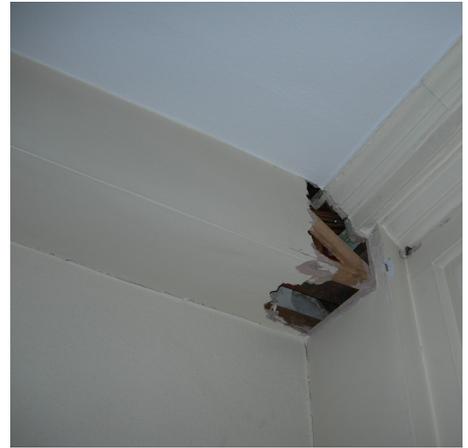
Photograph 14 (right) downstand steel beam and post to be replaced by smaller post concealed within the existing panelling.

Photograph 15 (right) Existing steel post in 1st floor level rear room to be replaced by two 50x100mm posts concealed between stair and room panelling
Refer to 1257-607 Rev.A

Refer to 1257-607 Rev.A

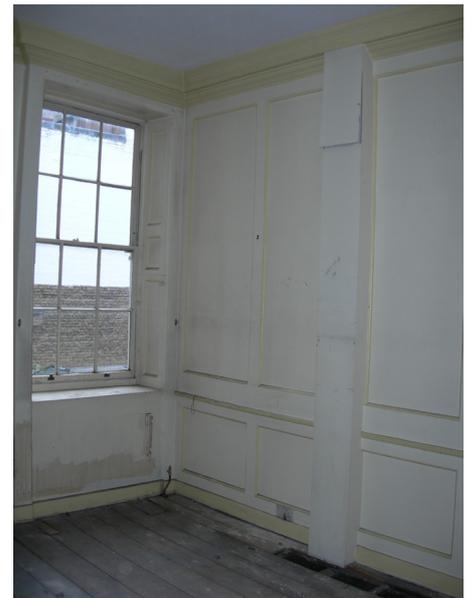
Photograph 16 (left) Steel post located in rear room at Second Floor Level (Room S02)
Refer to 1257-606 Rev.A

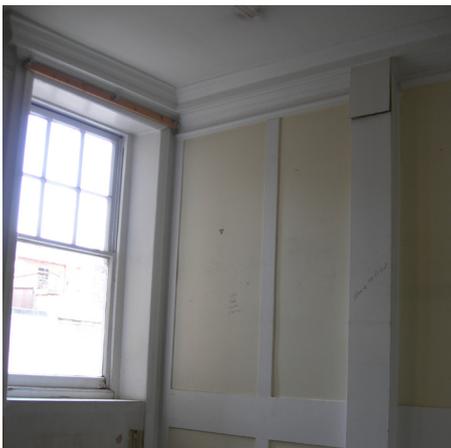
Photograph 17 (right) Steel post in stairwell at Second Floor level (Area S03)
Refer to 1257-606 Rev.A

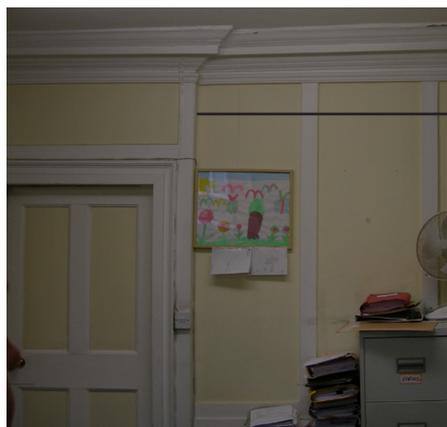
Photograph 18 (right) Existing 'step' in panelling to partition wall between front and rear rooms at Second Floor Level (Room S01/S02).
NOTE: a similar detail occurs at first floor level
