ARBORICULTURAL IMPACT ASSESSMENT REPORT:

99a Frognal, Hampstead London NW3 6XR

Ref: HVC/FRG/AIA/03

Date: 20th September 2013

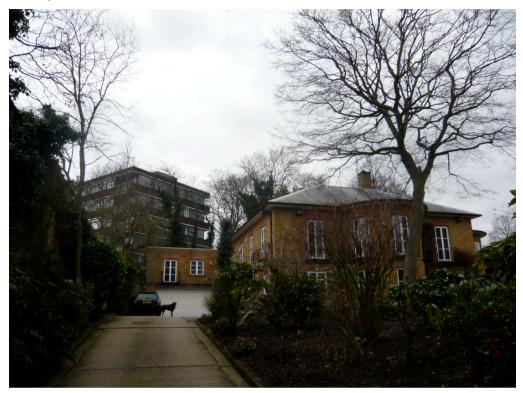
Photograph 1: Existing dwelling at 99a Frognal, Hampstead, London

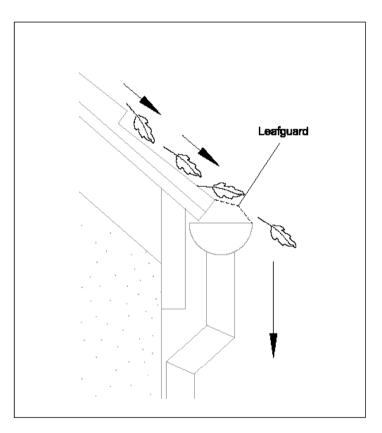
Figure 5: Filtration traps, as shown above, could be fitted on the gutters which can easily be maintained at 2-3m above ground.

- 6.3.4 The immediate canopy encroachment from G7 can be avoided by cutting back the existing canopies.
- 6.3.5 Nuisance deposition can be mitigated with regular crown cleaning and filtration traps on the guttering (see Figure 5 below). Alternatively, a green roof construction might be considered.
